Title: Analysis of an Unexpected Reaction Observed During Drumout Activities,
Feb. 26, 2021, TA-55 PF-4

ANALYSIS OF AN UNEXPECTED REACTION OBSERVED DURING DRUMMOUT ACTIVITIES, FEB. 26, 2021, TA-55 PF-4

CAUSAL ANALYSIS TEAM INVESTIGATION RESULTS AND RECOMMENDATIONS

ORPS: NA-LASO-LANL-TA55-2021-0005

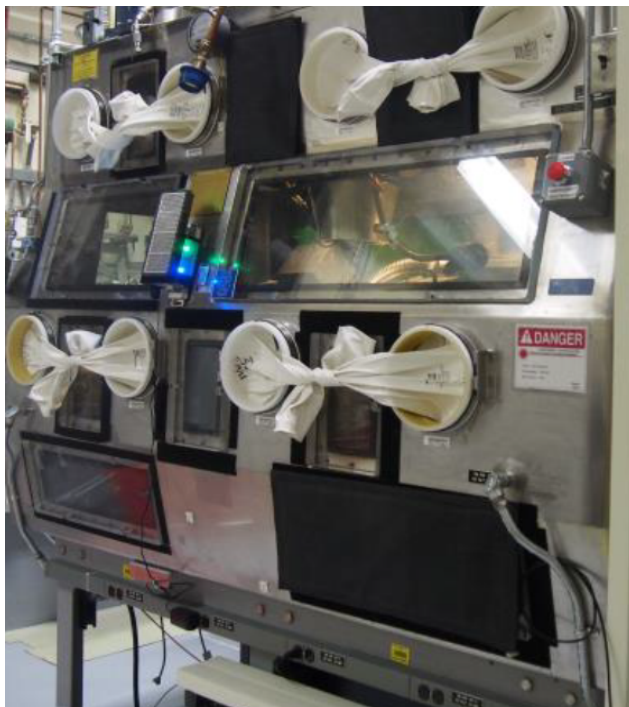
FIGURE 2- COLD LASER WELDING BOX

Also on February 19, 2021, The PT-3 welding operators bagged the LGAC filter for removal from the glovebox. The LGAC filter changeout is not described in welding operations procedure, TA55 –DOP-1127, *Laser Welding Operations*. It is also not specifically described in the PT-3 box maintenance procedure, PA-IWD-01157, *Laser Welding Maintenance and Testing*, although Operators indicated they considered the activity part of General Maintenance during which they followed a process of segregating like materials prior to bagging the waste out of the laser welding glovebox. A photo of the glovebox is included, below:

Following this process, the PT-3 operator first dropped some “cushioning” material into the bottom of the drum consisting of bags and gloves that were also bagged. The PT-3 operator then raised one of the bags containing a “dirty” HEPA filter for observation. The bagged filter was then dropped into the drum. Following the same process, the PT-3 operator then dropped an empty conflat container made of stainless into the partially filled drum. The conflat fell approximately 3-4 feet from the release point and struck the bag containing the HEPA filter. Personnel described a cone of red, yellow and white “sparks” as soon as the conflat struck the bag.

Direct Cause: Dropping the conflat container resulted in a tear to the bag containing the HEPA filter, thereby releasing unoxidized titanium particulate into glovebox air. As noted, titanium in powder form is a combustible material (requires ignition) that exhibits pyrophoric-like characteristics (NFPA 484). The rapid expulsion of the titanium powder from the bag is believed to have produced sufficient friction to generate sparks.

- Pre-jobs that involve working in or removing items/materials from inert gloveboxes must include a discussion of the lessons learned from this event as it applies to the evolution (e.g., the operational process output constituents and their potential hazards and controls.)*

- Ensure potential pyrophoric hazards associated with inert boxes are captured and controlled in corresponding work control documents (DOPs and IWDs). *
- Develop and implement passivation criteria for anything coming out of an inert box with potential pyrophoric hazard (such that it can be demonstrated in a manner that is visible at VI).
- Revise PA-AP-01000 to include required waste reviews.
- Revise P101-28 to more fully address hazards and controls associated with inert gloveboxes. (Glovebox Safety)
- ALDWP must ensure that change control practices are developed and implemented to re-evaluate the hazards and controls associated with changes to processes, including scale-up and modification of materials. These would include changes outside the current scope of TA55-AP-122, *TA-55 New/Revised/Restarted Activity Approval Process*.
