## **Appendix C**

### **Ecological Restoration**

### **C.3.0 Site and On-Site Disposal Facility Inspections**

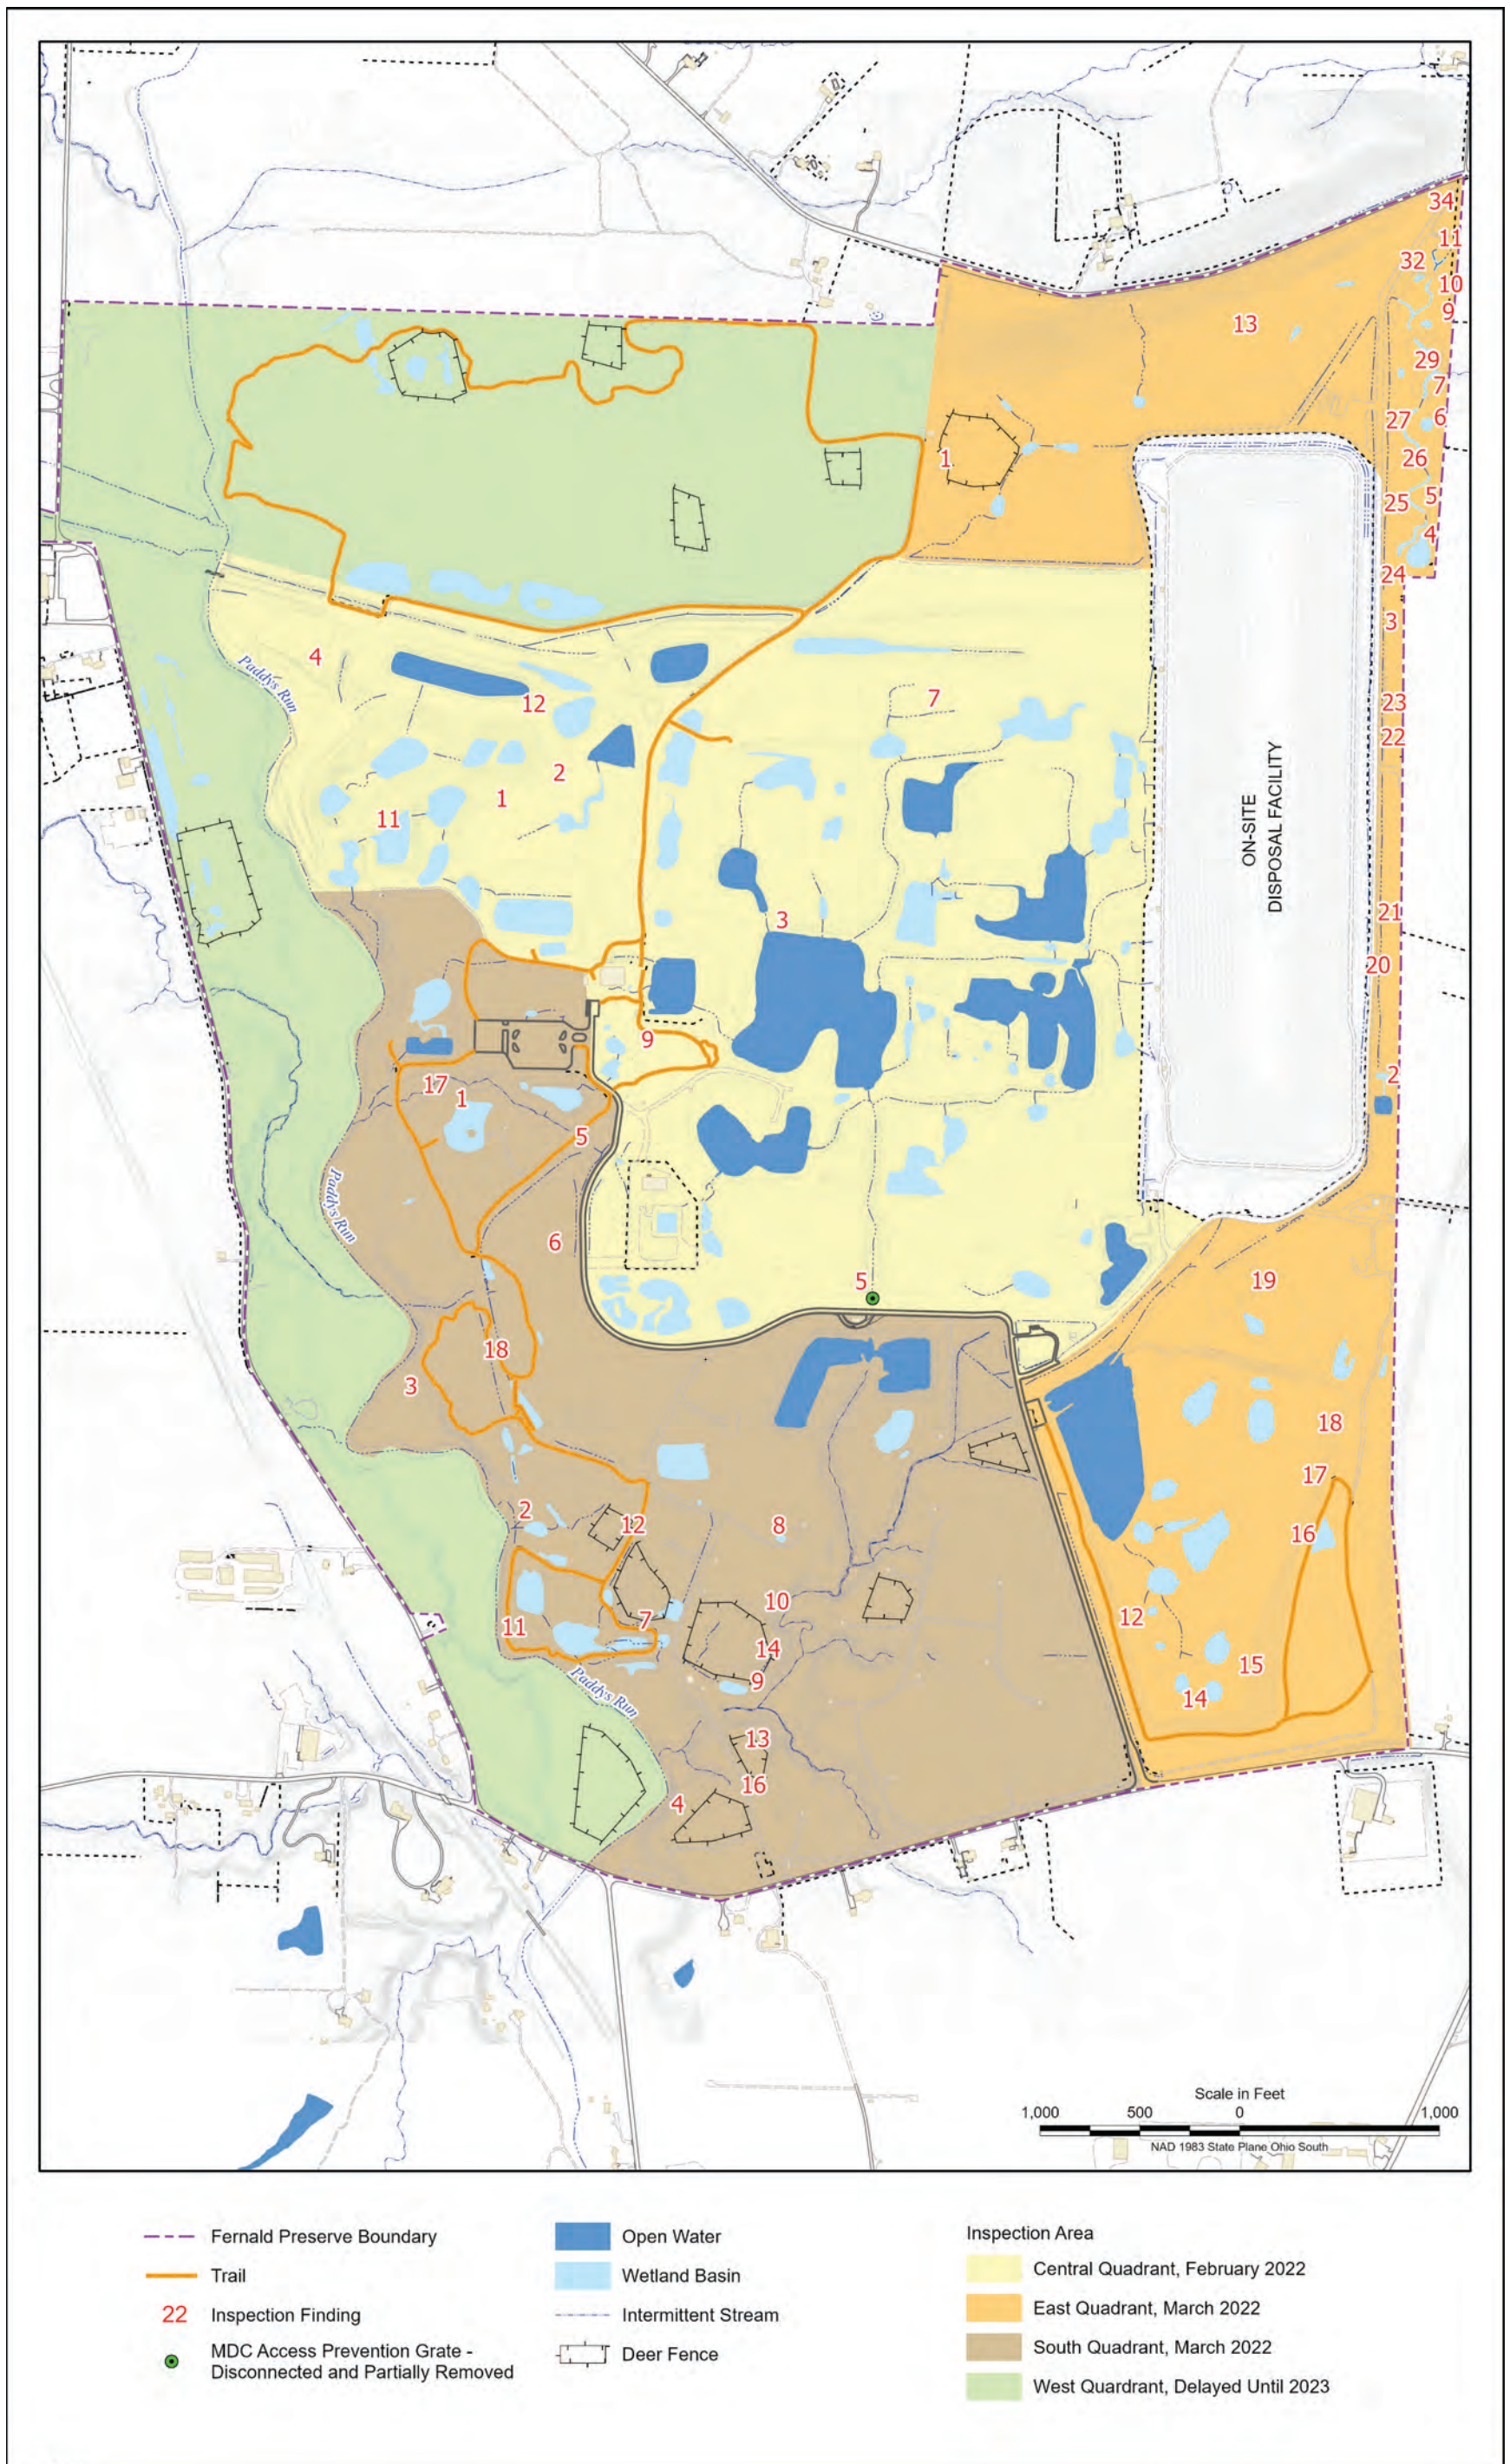
Figure C-3. Site Inspection Findings, 2022

Site inspection finding locations are identified on Figure C-3; OSDF finding locations are identified on Figures C-4A and C-4B. Follow-up maintenance activities are conducted to address findings from site and OSDF inspections. For some findings, it is determined that continued monitoring or no action is required. Some 2022 inspection findings remain to be addressed. DOE continues to resolve older findings even as new ones are generated.

The 2022 quarterly site inspection findings, resolution detail, and date of resolution are presented by quadrant in Tables C-3 through C-5. The approximate location of each finding for which a location was identified during the inspection is presented in Figure C-3. Similar to the findings from recent years, site inspection findings for 2022 consisted mainly of the presence of noxious and invasive vegetation and damage to deer enclosure fencing. Only one inspection finding was reported in the 2022 quarterly inspection reports. The finding was identified during the December 2022 point-specific institutional control inspection and is associated with the main drainage corridor culvert access control grating. The culvert, along with an adjacent 18-inch culvert that is completely buried, was left in place even though it has fixed radiological contamination. These culverts are located directly below the OSDF leachate conveyance system and the main effluent line running between the Converted Advanced Wastewater Treatment facility and the Great Miami River. Because of their location, these culverts could not have been removed without potentially impacting ongoing Converted Advanced Wastewater Treatment and OSDF operations. Instead, metal grating was installed to prevent access to the 60-inch culvert.

Map Number	Inspection Finding	Finding Resolution or Path Forward	Date Resolved
1	Teasel	Herbicide applied	6/27/2022
2	Culvert blocked	Removed blockage	2/23/2022
3	Animal burrows and slumping	To be determined	To be determined
4	Top missing from barn owl box	No action required	12/29/2022
5	Pear trees	Herbicide applied	3/15/2023
6	Mugwort rosettes	Herbicide applied	6/16/2022
7	Phragmites	No action required	6/28/2022
8	Concrete	Free released and disposed <sup>a</sup>	3/15/2022
9	Asphalt	Free released and disposed <sup>a</sup>	3/15/2022
10	Rubber	Free released and disposed <sup>a</sup>	3/15/2022
11	Plastic	Removed plastic	4/6/2022
12	Hard black plastic embedded in turf	Removed plastic	4/6/2022

Map Number	Inspection Finding	Finding Resolution or Path Forward	Date Resolved
1	Phragmites	No action required	6/29/2022
2	Concrete	Free released and disposed <sup>a</sup>	3/15/2022
3	Tree protection cages and metal posts	To be determined	To be determined
4	Transite	Free released and disposed <sup>b</sup>	3/15/2022
5	Bundle of silt fence	Silt fence discarded	4/6/2022
6	Blue surveyor flag	No action required	4/1/2022
7	Hole in deer fence	Deer fence repaired	4/13/2022
8	Unvegetated area	No action required	4/6/2022
9	Hole in deer fence	Deer fence repaired	4/28/2022

Map Number	Inspection Finding	Finding Resolution or Path Forward	Date Resolved
10	Erosion and exposed landscape fabric	To be determined	To be determined
11	Geotextile exposed	No action required	12/29/2022
12	Hole in deer fence	Deer fence repaired	4/7/2022
13	Hole in deer fence	Deer fence repaired	4/7/2022
14	Section of deer fence down	Deer fence repaired	4/28/2022
15	Deer fence torn and down	Deer fence repaired	4/14/2022
16	Deer fence gate open	Deer fence gate repaired	4/6/2022
17	Honeysuckle	Herbicide applied	11/8/2022
18	Honeysuckle	Herbicide applied	11/2/2022
19	Concrete	Free released and disposed <sup>a</sup>	3/15/2022

Map Number	Inspection Finding	Finding Resolution or Path Forward	Date Resolved
1	Holes in deer fence	Deer fence repaired	4/14/2022
2	Broken drainpipe and erosion	No action required	4/14/2022
3	Pears and honeysuckle	Herbicide applied	1/11/2023
4	Pear trees	To be determined	To be determined
5	Teasel	To be determined	To be determined
6	Corrugated plastic on tree	Removed plastic	4/11/2022
7	Pear trees	To be determined	To be determined
8	Teasel	To be determined	To be determined
9	Corrugated plastic	Removed plastic	4/11/2022
10	White corrugated material	Removed material	4/11/2022
11	Pear trees and honeysuckle	To be determined	To be determined
12	Tree protection cage buried in grasses	Removed deer cages	4/13/2022
13	Deer fence post	Removed deer fence post	4/13/2022
14	Pear trees	Herbicide applied	4/21/2022
15	Pear trees	Herbicide applied	4/21/2022
16	Pear trees	Herbicide applied	10/27/2022
17	Pear trees	Herbicide applied	10/27/2022

18	Pear trees	To be determined	To be determined
19	Teasel	Herbicide applied	6/8/2022
20	Teasel	To be determined	To be determined
21	Poison hemlock	To be determined	To be determined
22	Pear trees	To be determined	To be determined
23	Bottom falling out of kestrel box	Repaired kestrel box	4/14/2022
24	Pear trees and honeysuckle	To be determined	To be determined
25	Honeysuckle and autumn olive	To be determined	To be determined

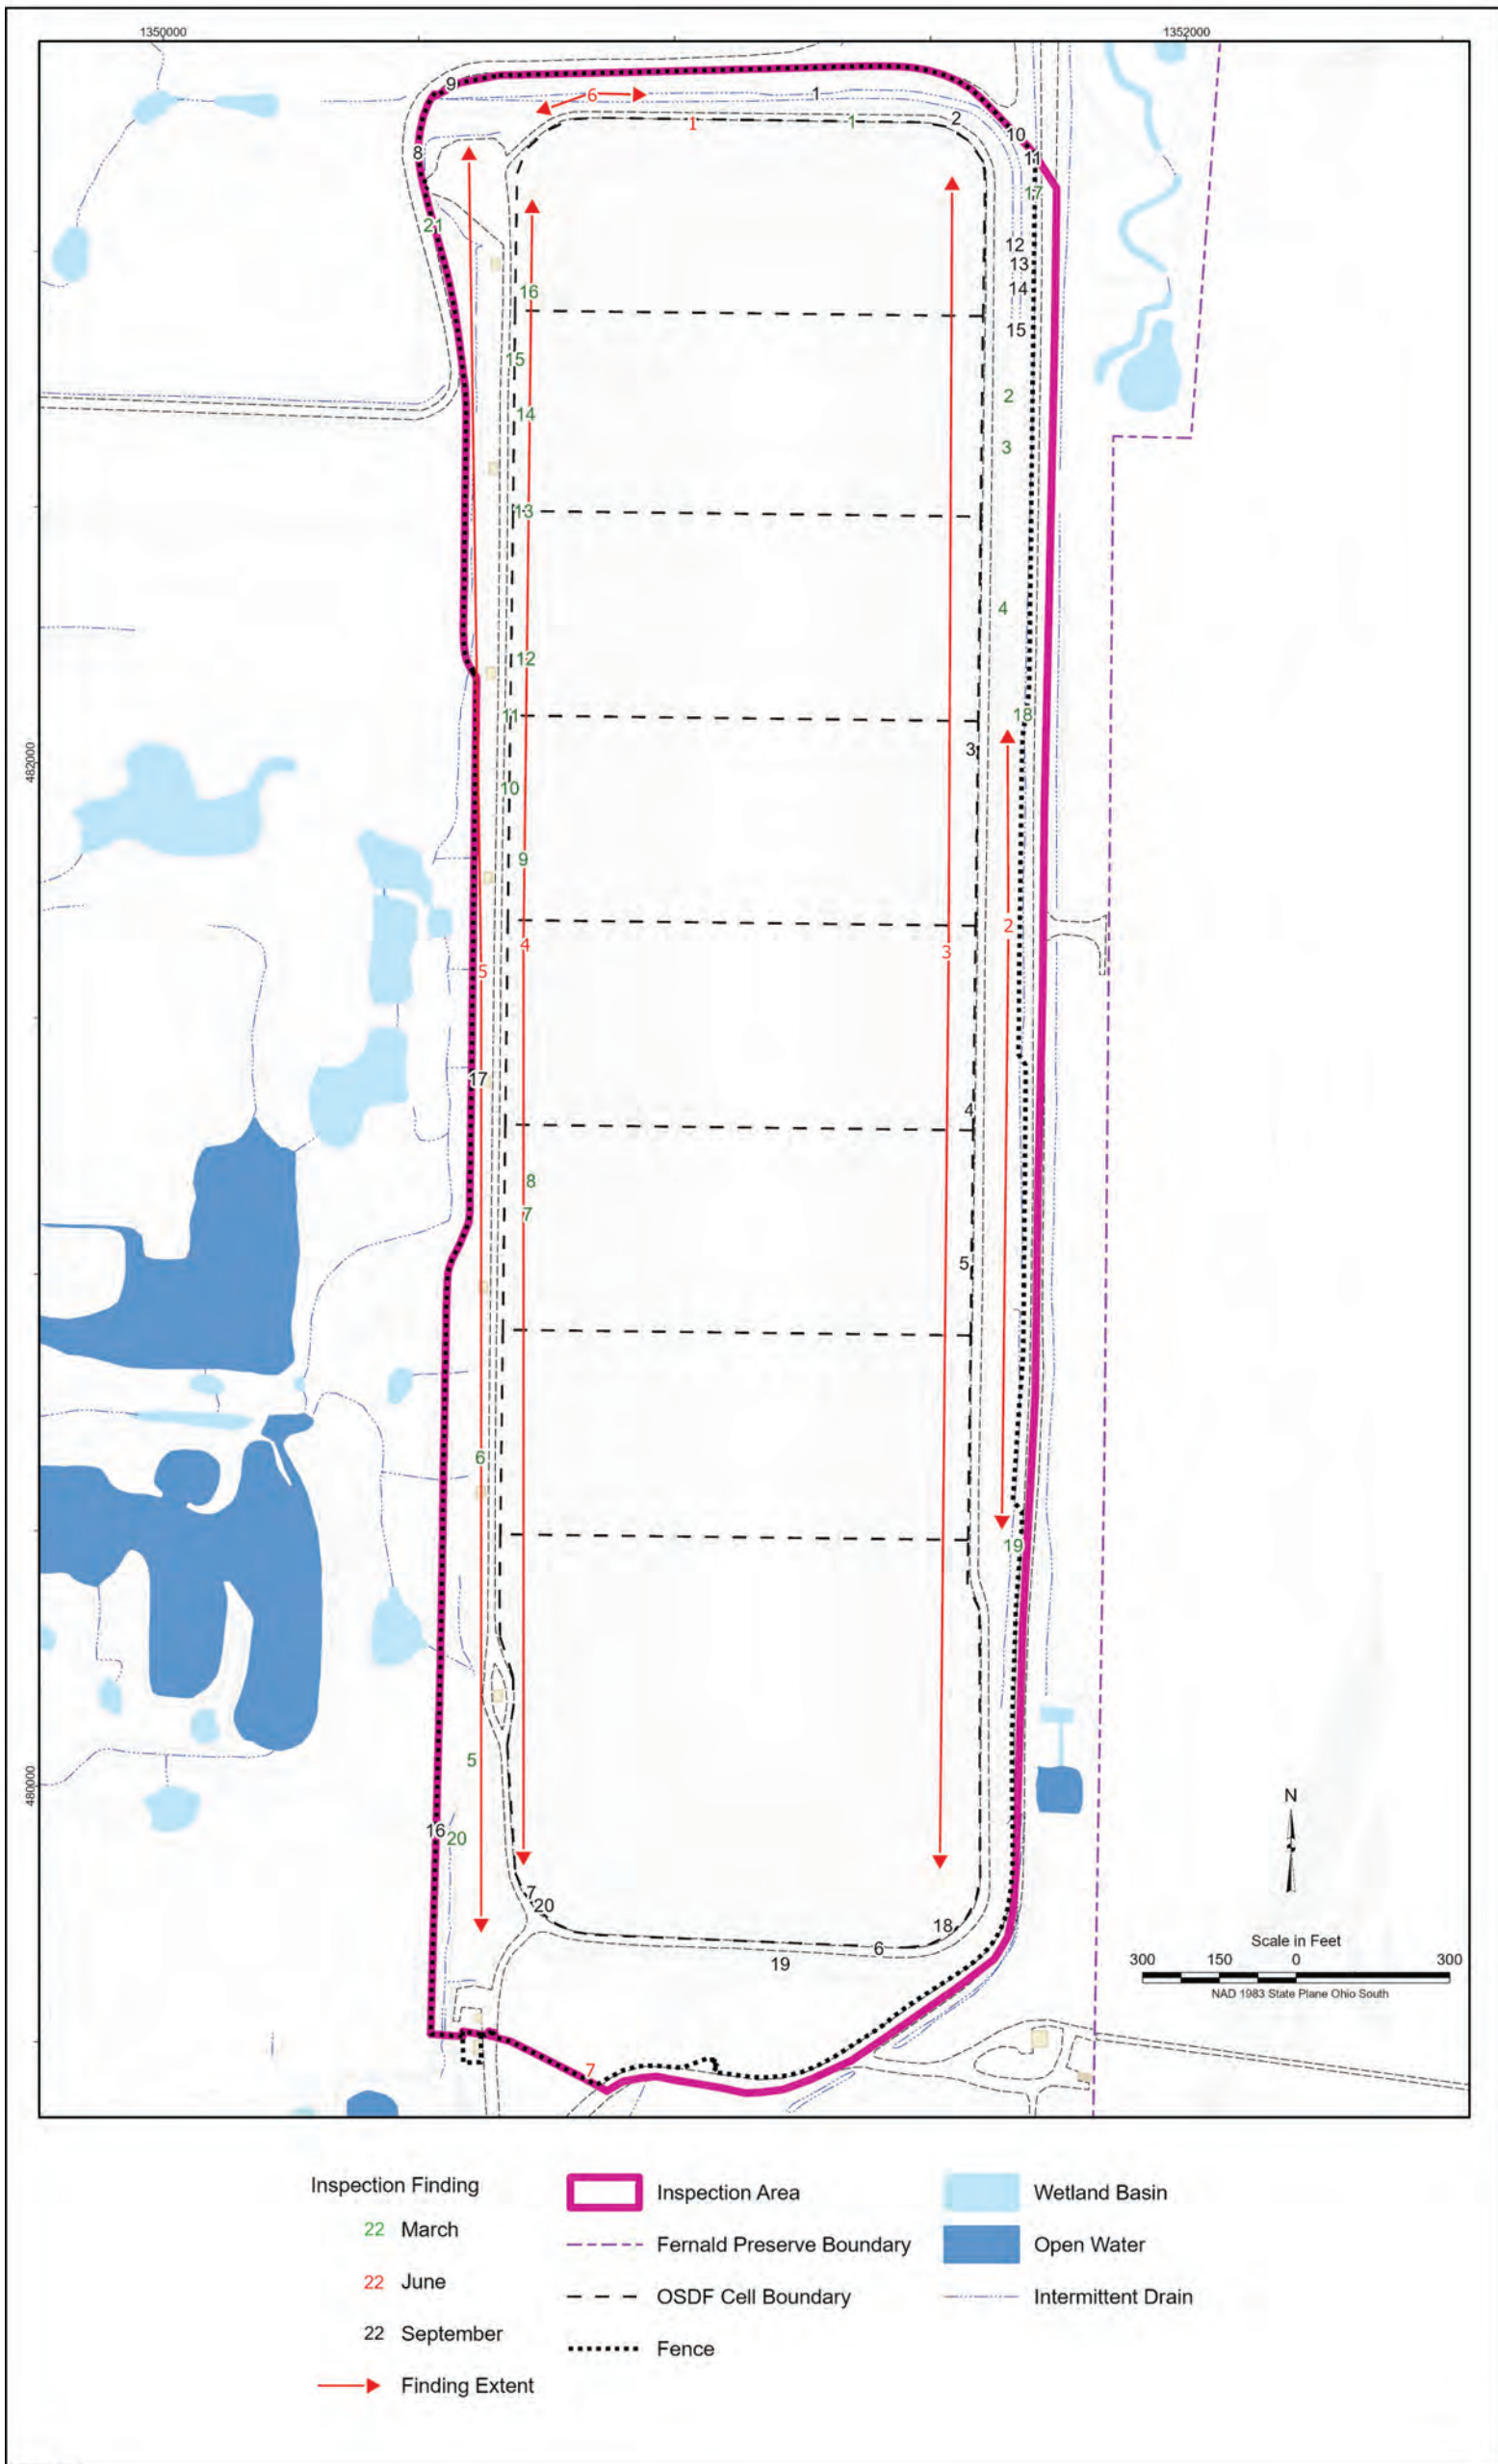
Figure C-4A. OSDF Inspection Findings, March, June, and September 2022

OSDF inspections consist of a quarterly walkdown around the perimeter of the OSDF and an annual walkdown of the vegetated cap. Erosion rills, animal burrows, noxious weeds, woody vegetation, settlement cracks, and other indications that there may be an issue with the proper functioning of the cap are identified and repaired. Tables C-7 through C-10 provide the 2022 OSDF findings, resolution detail, and date of resolution. Figure C-4A identifies the approximate location of each listed finding for the March, June, and September inspections. Figure C-4B identifies the approximate location of each listed finding for the December inspection, which was the annual vegetated cap walkdown. In 2022, there were no signs that the integrity of the cap had been compromised. As in previous years, findings consisted mainly of woody vegetation and noxious weeds. Callery pear (*Pyrus calleryana*) and other woody vegetation continue to invade the OSDF cap. Field personnel physically remove or apply herbicide to woody vegetation to keep trees from becoming established on the cap.

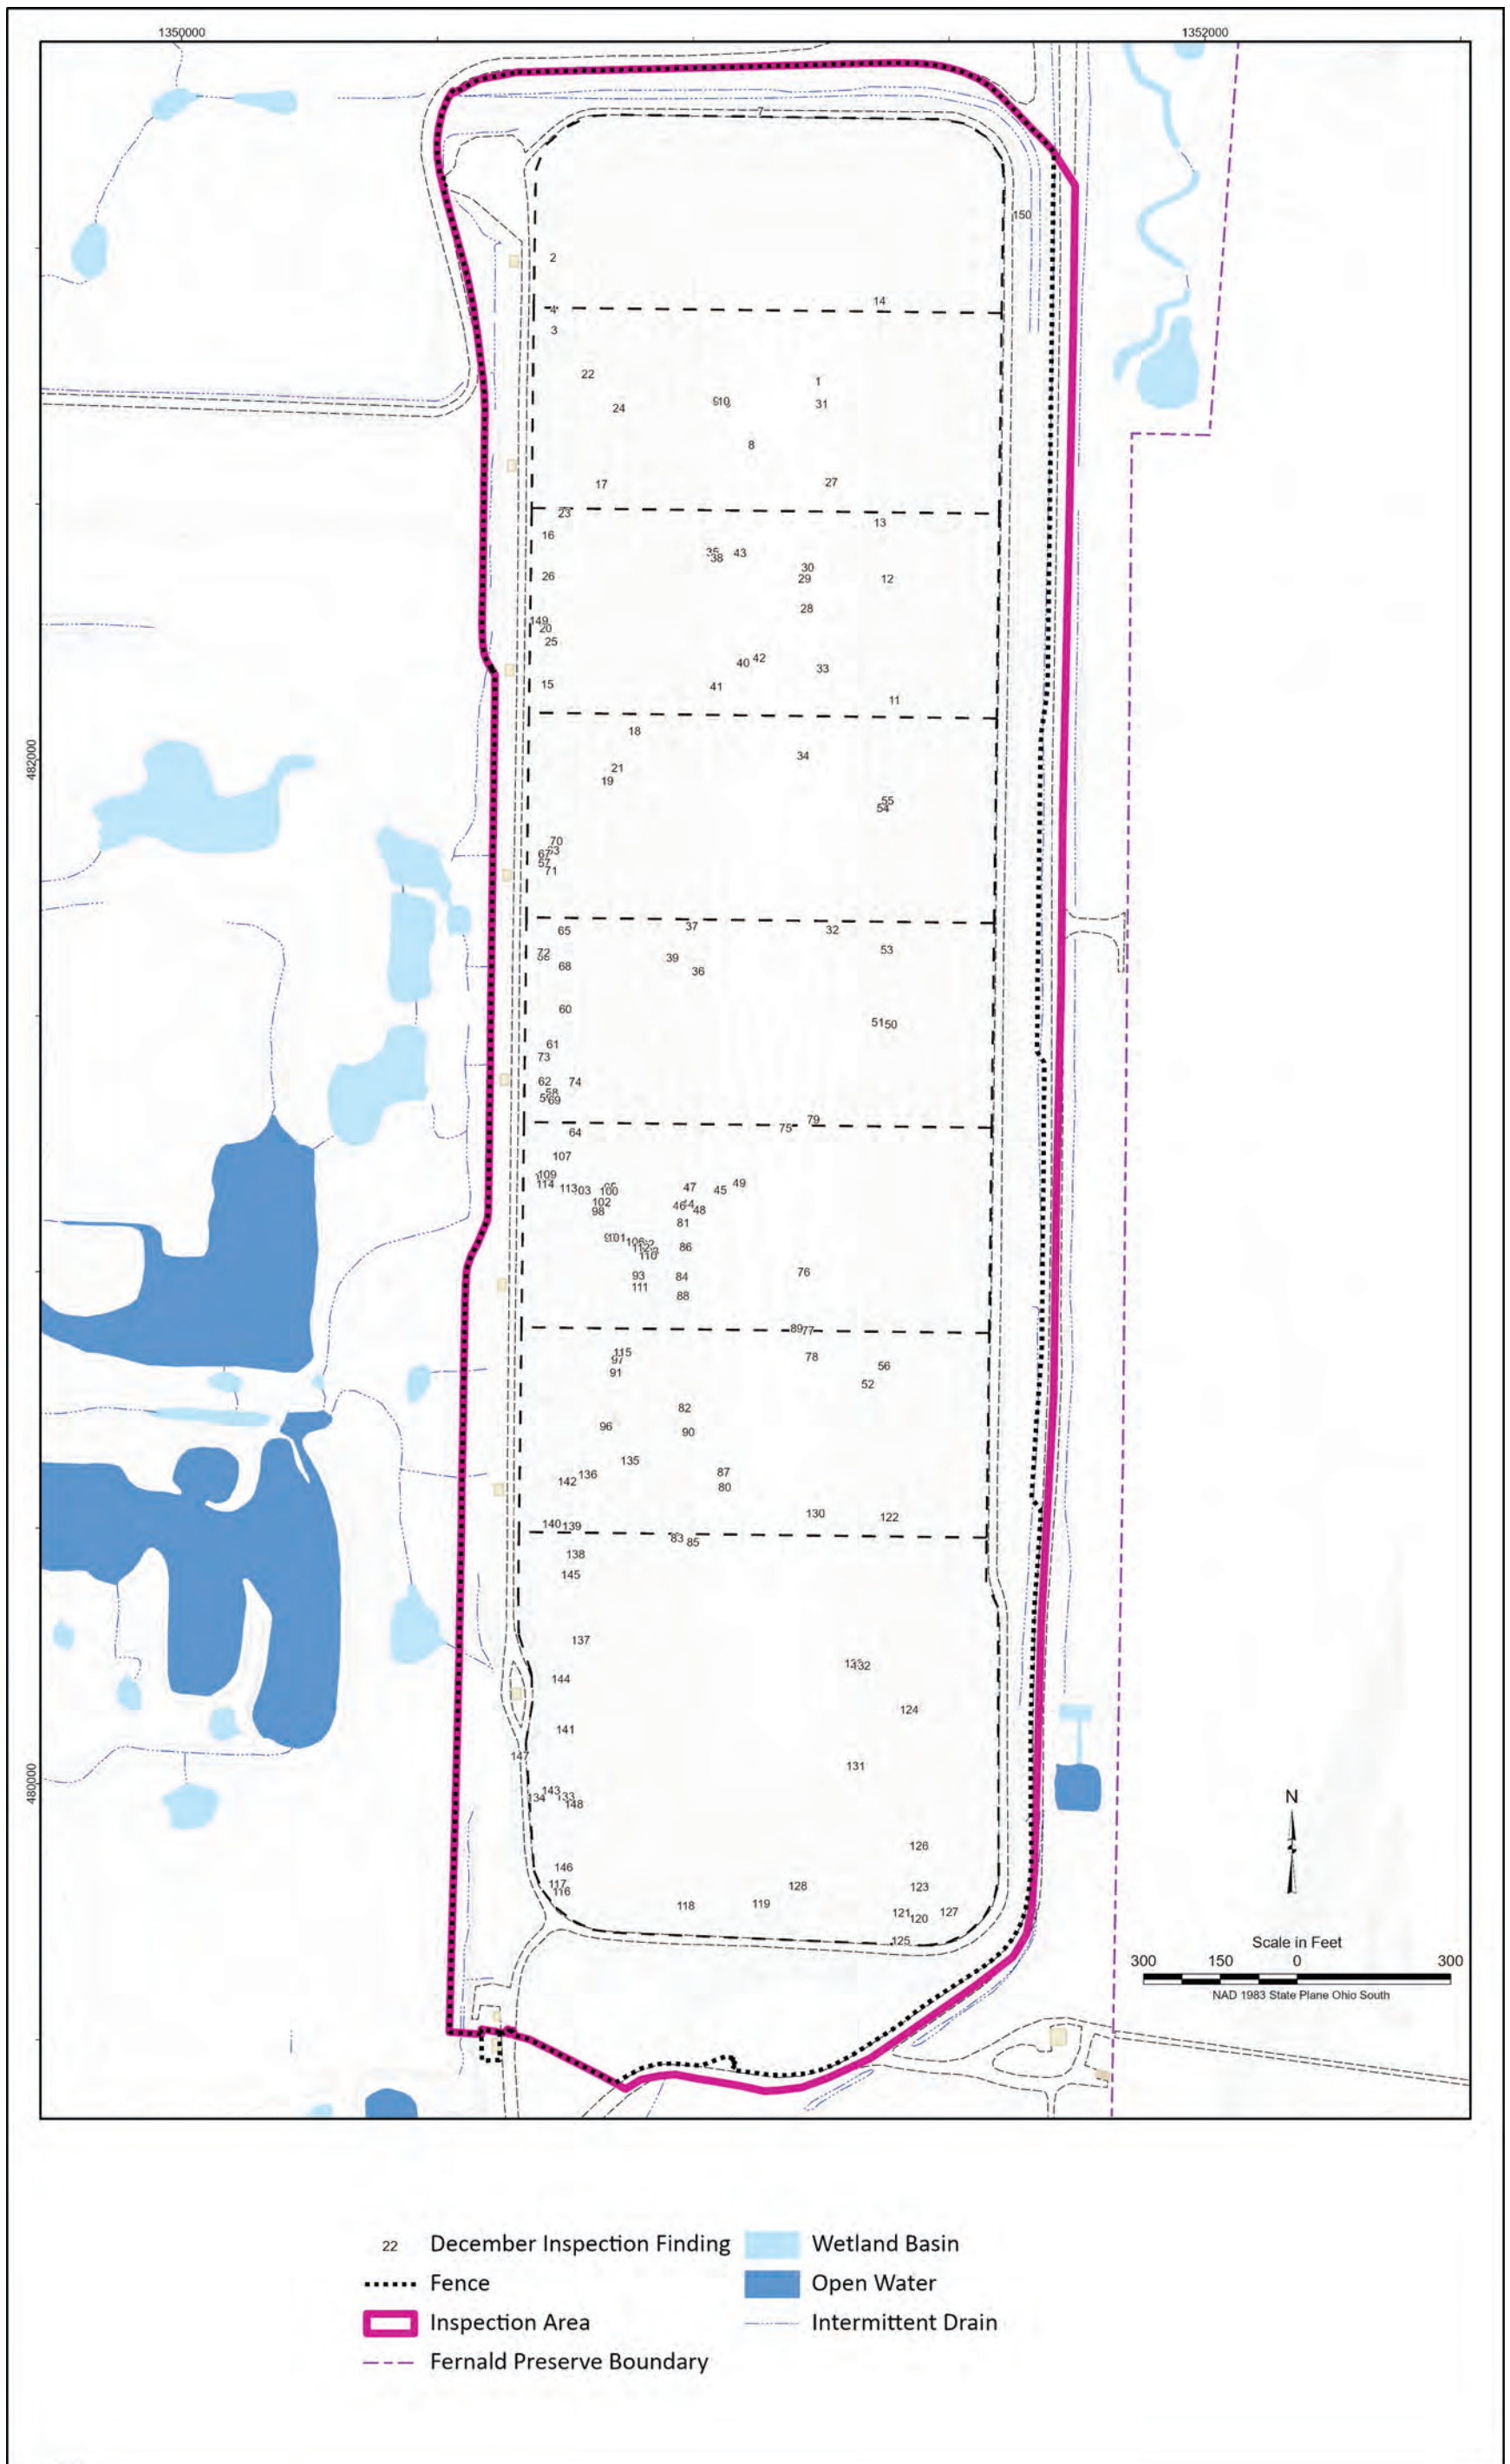
Figure C-4B. OSDF Inspection Findings, December 2022

Table C-10. OSDF Inspection Findings, December 2022 (continued)

Map Number	Inspection Finding	Finding Resolution or Path Forward	Date Resolved
136	Callery pear	Herbicide applied	3/9/2023
137	Callery pear	Herbicide applied	3/9/2023
138	Callery pear	Herbicide applied	3/9/2023
139	Callery pear	Herbicide applied	3/9/2023
140	Callery pear	Herbicide applied	3/9/2023
141	Callery pear	Herbicide applied	3/9/2023
142	Callery pear	Herbicide applied	3/9/2023
143	Callery pear	Herbicide applied	2/23/2023
144	Callery pear	Herbicide applied	3/9/2023
145	Callery pear	To be determined	To be determined
146	Callery pear	Herbicide applied	2/23/2023
147	Honeysuckle	To be determined	To be determined
148	Callery pear	Herbicide applied	2/23/2023
149	Honeysuckle	Herbicide applied	3/20/2023
150	Erosion	To be determined	To be determined
