Steve Layman to record
NAA-SR-4488 (suppl)
COPY 56A

SRE FUEL ELEMENT DAMAGE
FINAL REPORT

OF
THE ATOMICS INTERNATIONAL AD HOC COMMITTEE

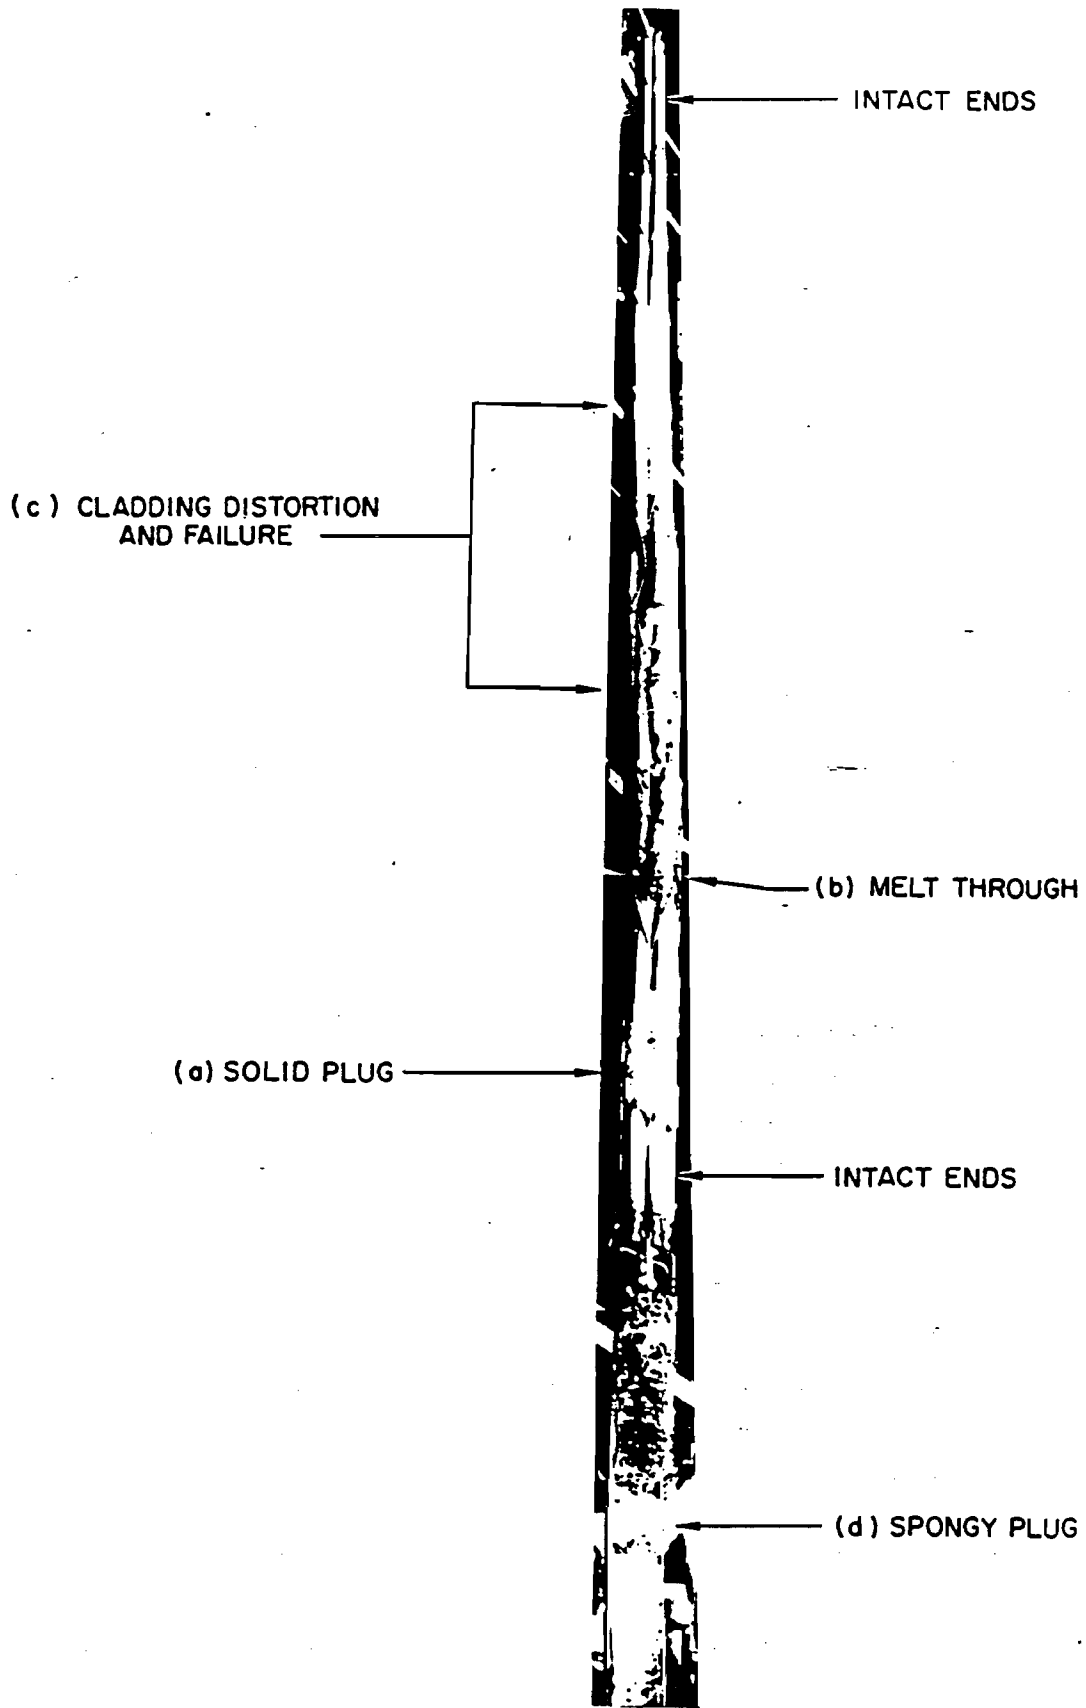
Figure III-1. Fuel Element From Channel R-24

The results are shown in Figure III-1. Several features should be noted: (a) the solid plug of material about 1-ft above the bottom of the fuel rods, (b) the Fe-U alloy melt-through area about one-third of the way up the element and extending for several inches, (c) the region above the melt-through where the cladding had been distended until it burst, and (d) the black spongy plug in the channel below the element.

The solid plug was determined metallographically to consist of Fe-U alloy of near-eutectic composition. Its source was the melt-through area above, from which Fe-U alloy, formed near the surface of the slugs, penetrated and destroyed the cladding.

The cladding breaks above the melt-through area were typical of a ductile material, and cladding pieces from this area were readily bent with the hot cell manipulators. There was no evidence of Fe-U diffusion in this area; the failure is attributed to swelling of the fuel from thermal cycling.

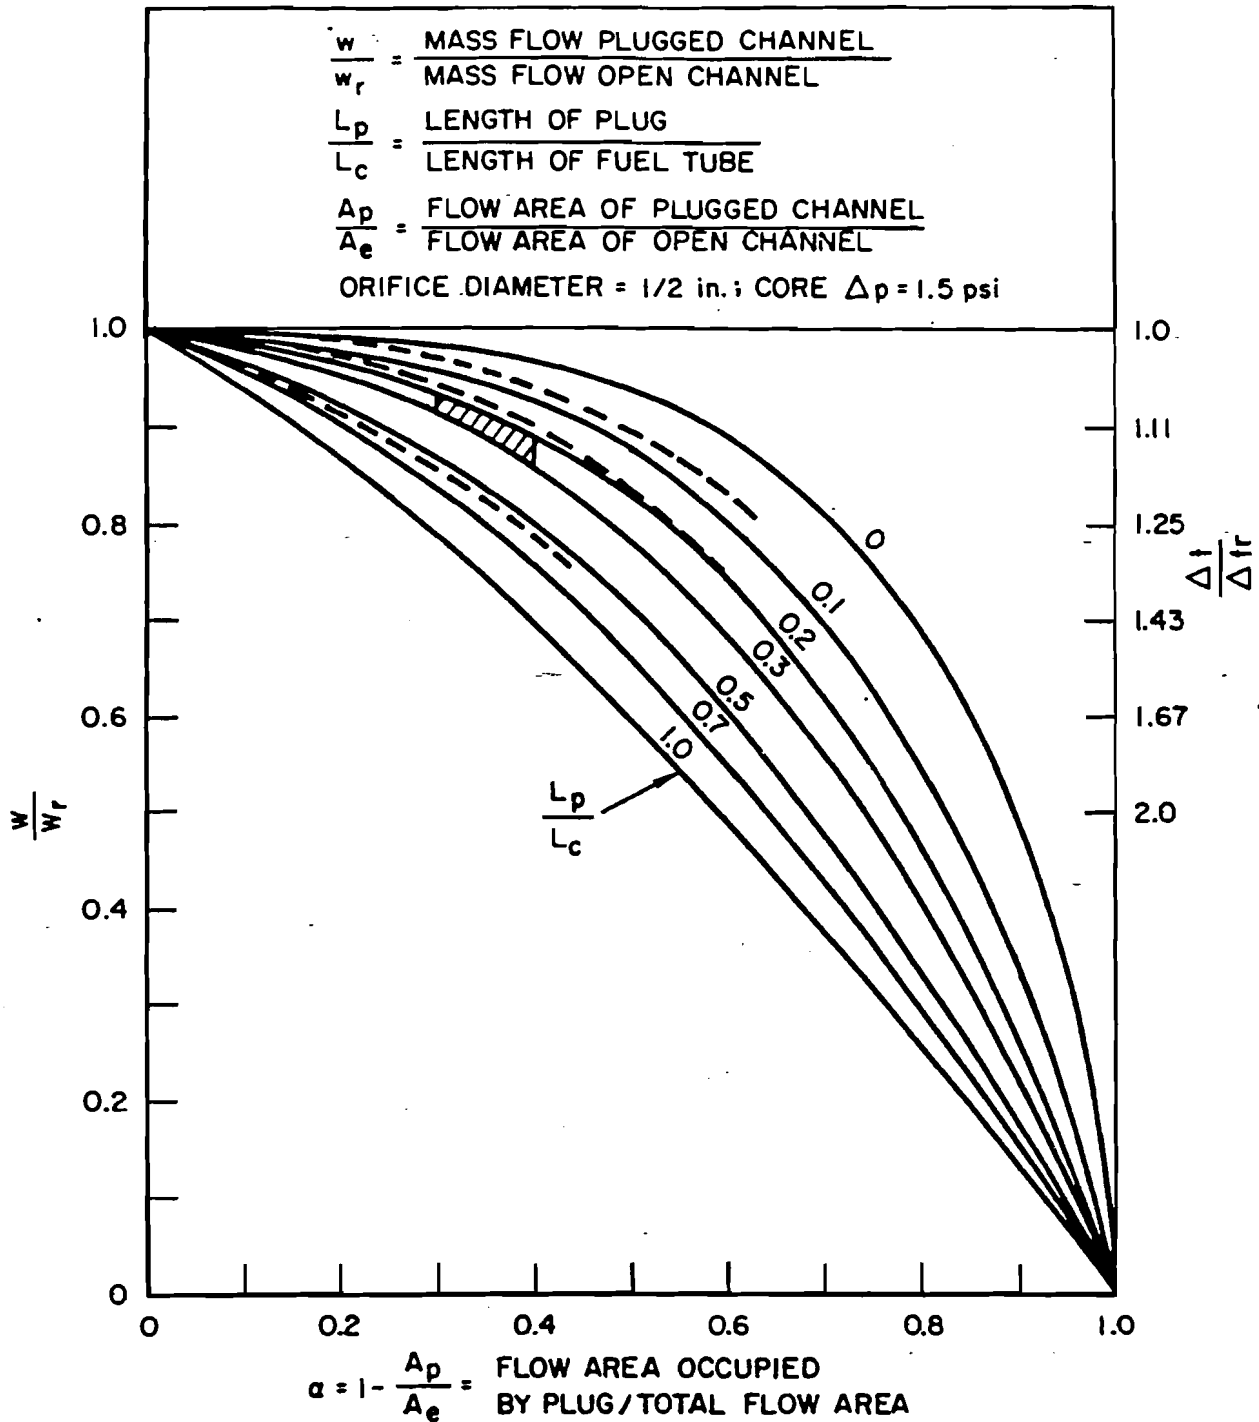
Figure III-4. Mass Flow Reduction in SRE Fuel Channel Due to Formation of Plugs in Fuel-Tube Region

The plugs must have been large in order to reduce flow in a given channel to one-third of nominal flow. The relationship of flow to plug geometry in a channel is indicated in Figure III-4. As shown in the figure, a very short plug (thin

plate) would have to occupy about 95% of the flow area around the fuel rods to reduce flow to one-third; if the plug were as long as the channel, it would have to occupy about 75% of the flow area to reduce flow to one-third. The calculations leading to Figure III-4 assumed no plug porosity. With some flow through the plug, the plug would have to occupy a still larger fraction of the channel to restrict flow a given amount. The few observations of the spongy plugging material, in channel R-24 and on top of the core, together with the data of Figure III-4, would indicate that the plugs were probably long (a few feet) and occupied most of the flow cross sectional area.

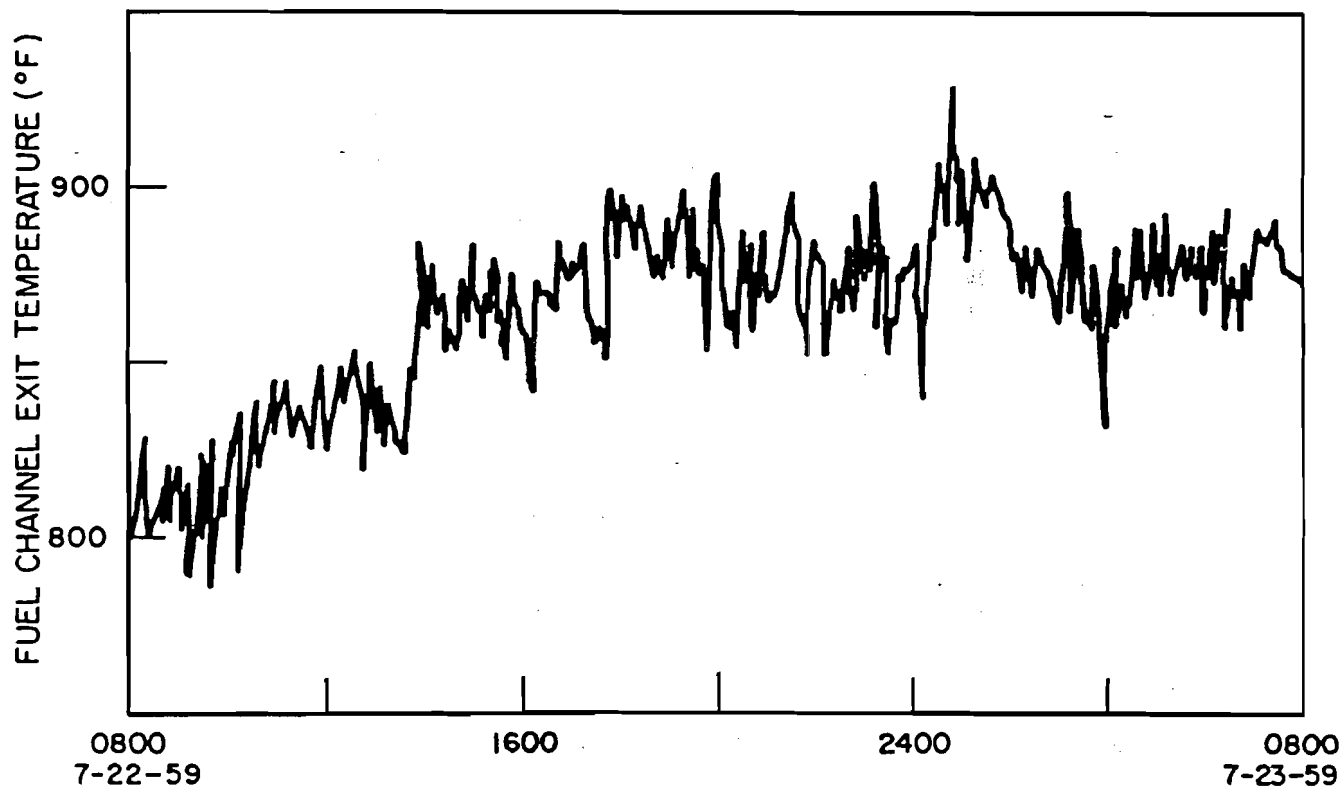
Figure III-5. Outlet Temperature for Channel R-24

A careful review of the chart from run 14 showed that all of the channels in which fuel failures occurred had shown fluctuations in outlet channel temperatures. The record of temperatures from channel R-24 for a typical 24-hr period is shown in Figure III-5. Fluctuation in outlet channel temperatures also occurred for a few hours in some channels in which the fuel elements did not fail. The element from R-25, in which temperature fluctuations occurred for only part of the run, suffered the least damage of the thirteen damaged elements. The temperature history for R-25 over a 24-hr period is shown in Figure III-6. Some indication of the relation between fuel temperatures at some regions of the element and the outlet channel temperatures can be gained from the data for R-55

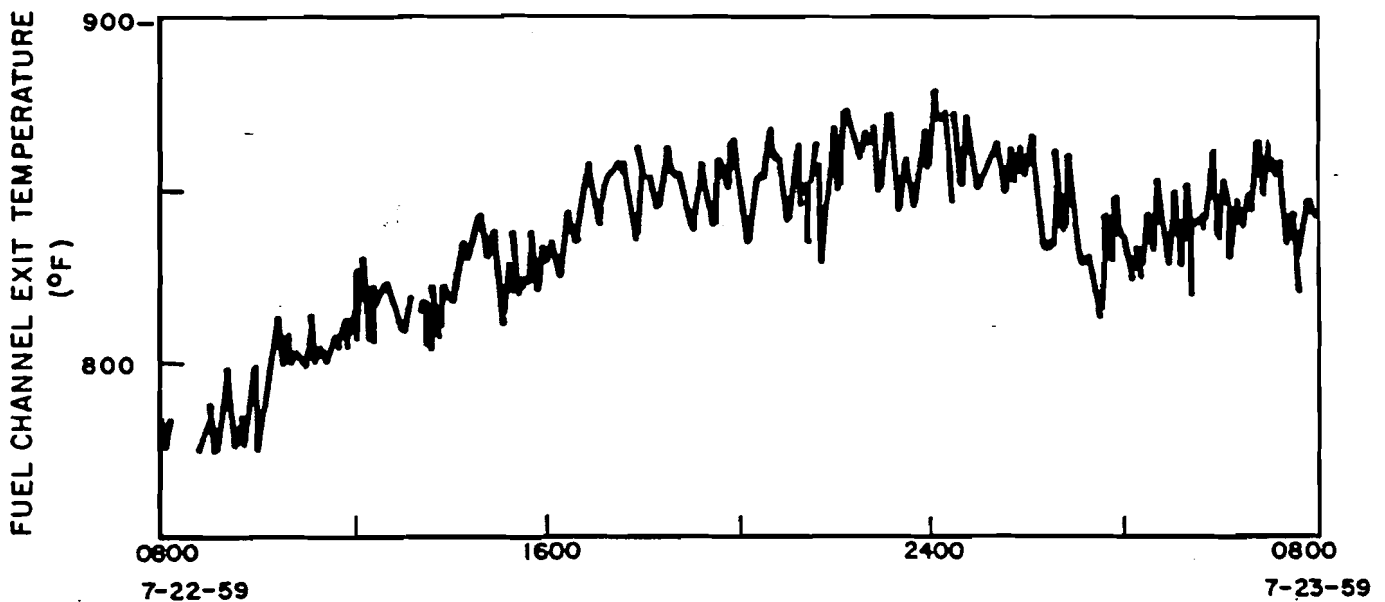
Figure III-7. Outlet Temperature for Channel R-55

shown in Figures III-7 and III-8. As indicated by the figures, the fuel temperature was cycling over a range of about 150°F while outlet channel temperature variation was about 50°F.
