The Technology Of Nuclear Reactor Safety

Reactor Physics
and Control

CHAPTER 11

Accidents and Destructive Tests

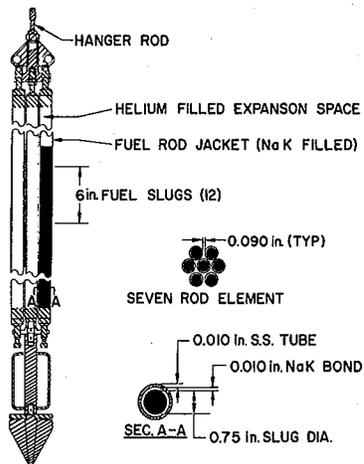
FIG. 3-11 SRE fuel element.

to be slightly dirty, but in good condition." An attempt was made to wash one element, but during the operation a pressure excursion occurred which severed the hanger (see Fig. 3-11) and lifted the shield plug out of the wash cell. It is believed that hydrocarbons from the breakdown of Tetralin could cause sodium to be trapped in the holddown tube on the hanger rod by blocking the sodium drain holes. This sodium then reacted with the wash water. "As a result of this incident, no further washing was done." It was decided to "strip" the Tetralin and organics which would volatilize by passing nitrogen gas through the sodium system. The process had been used on October 12, 1958 to remove Tetralin from the system after the first leak. The stripping began June 17 and continued until July 5. The sodium system temperature was 350°F (177°C) initially and was raised to 425°F (218°C) by the end to help the removal. In all 400,000 ft³ (11,300 m³) of nitrogen were used and 3 pints (1.42 liter) of Tetralin and 1500 cm³ (91.5 in.³) of naphthalene crystals were removed. The system was then purged for ten hours with 4700 ft³ (133 m³) of helium and argon. The primary pump was reinstalled with a NaK-cooled freeze seal in place of the Tetralin-cooled seal, and the system was prepared for operation.*

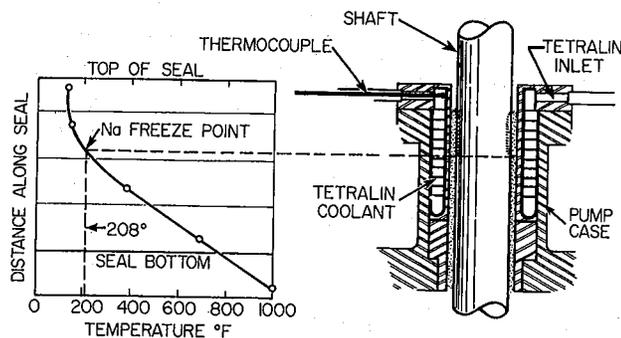
FIG. 3-12 SRE pump shaft freeze seal.

in April 1958, resulted in an insignificant amount of leakage before the freeze seal was repaired. This leak was caused by a pinhole in the freeze-seal casting. The second such leak occurred in May 1959 and resulted in somewhere between 2 and 10 gal of Tetralin being admitted to the primary sodium stream [44]. This leak was traced to failure of a thermocouple well. The Tetralin-cooled shaft seal was then replaced with a NaK-cooled seal arranged in such a way that two independent barriers would have to fail before mixing of NaK and the primary sodium could occur. As will be mentioned later, however, sufficient Tetralin had already been admitted to the system to create the condition that damaged the fuel assemblies [45]."

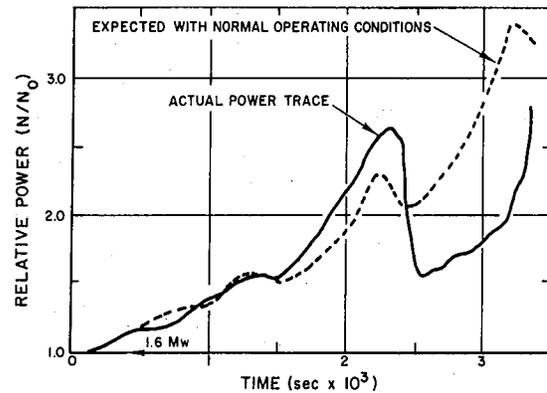
FIG. 3-13 Machine calculation I of the SRE power excursion, Zero time is 17:28 on July 13, 1959.

graphs $t = 0$ at 17:28 hours, July 13, 1959. The dotted line of Fig. 3-13 shows the course the power trace would have been expected to take if the normal reactivity coefficients and control rod worths were in effect. These calculations were made using the AIRER IBM Code.

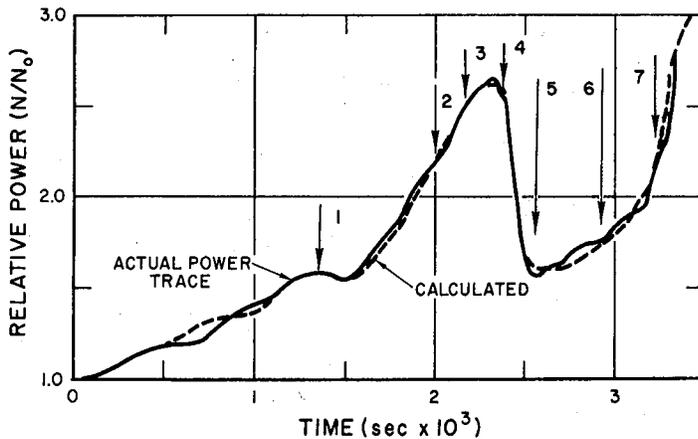
By introducing seven ramp and step changes in reactivity, Fillmore was able to get the agreement shown in Fig. 3-14. The general features can then be explained at least semiquantitatively. The slow but steady rise at a rate of +0.04% in a 3 minute ramp in spite of gradual control rod insertion and the negative Doppler effect is attributed to an abnormal rise of the temperature of the moderator which has a reactivity coefficient of $+1.7 \times 10^{-5}/^{\circ}\text{F}$ ($+3.1 \times 10^{-5}/^{\circ}\text{C}$) and perhaps also to some sodium vapor formation in partially plugged channels. (The sodium void coefficient is positive although the fuel temperature coefficient was considered to be $-1.1 \times 10^{-5}/^{\circ}\text{F}$ or $-2.5 \times 10^{-5}/^{\circ}\text{C}$.) The fast negative excursion is attributed to rod insertion reducing the increase in power rate and causing the collapse of sodium bubbles and void regions, thus improving coolant contact with the fuel. This cooling in turn reduced fuel temperature and caused a gain of reactivity because of the Doppler effect, and perhaps sodium void collapse, so that the control rods needed only to be withdrawn a little to again start the reactor up on a slow steady rise. This was followed by a fast transient which added +0.3% in a 5 to 10-sec ramp. It is postulated that this was caused by the more or less simultaneous voiding of about 10 partially plugged fuel elements. Study of the damaged fuel elements [48] seems to show that thermal cycling occurred at temperatures above the α - β phase transition of uranium which would lead to fuel ruptures and also steel-uranium eutectic formation. It is therefore postulated that several channels underwent one or more cycles of heating and sodium vapor formation followed by void collapse. The cycles in the various elements

FIG. 3-14 Machine calculation III of the SRE power excursion. Numbers indicate the following sequence: (1) start ramp $\Delta\rho/\Delta t$ of $+0.11 \times 10^{-4}\%$ /sec, thus introducing total $\Delta\rho$ of $+0.0077\%$; (2) hold first ramp constant at $+0.007\%$ and start second ramp $\Delta\rho/\Delta t$ of $-0.3 \times 10^{-4}\%$ /sec; (3) hold first two ramps constant, start third ramp of $+0.1 \times 10^{-3}\%$ /sec, thus introducing total $\Delta\rho$ of $+0.02\%$; (4) hold all three ramps constant (at $+0.0077\%$, -0.006% and $+0.02\%$, respectively), introduce step $\Delta\rho = -0.06\%$; (5) introduce step $\Delta\rho = +0.02\%$; (6) introduce step $\Delta\rho = -0.005\%$; (7) introduce step $\Delta\rho = +0.03\%$. Zero time 17:28 on July 13, 1959.

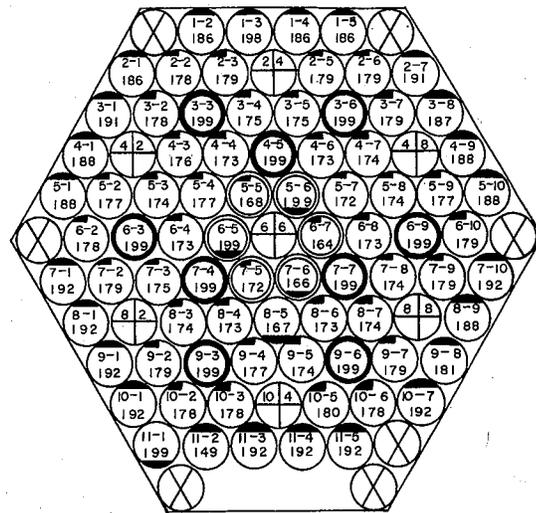
The fuel element that failed (Position 6-5) contained a special experiment designed to monitor fast neutron fluxes. The experiment consisted of a set of 7 hairlike nickel wires, each separately encapsulated in a quartz capsule and held in recesses of a 3/8 in. (9.52 mm) diameter aluminum rod. The rod in turn was encased in a 1/2 in. (12.7 mm) OD aluminum tube with 1/8 in. (3.18 mm) weep holes drilled through the wall at 4 in. (10.16 cm) intervals. This assembly was placed in the central thimble of the fuel element in the normal manner. A flow orifice at the bottom of the thimble section limited the flow to that required for cooling this rod. Other experiments were located in Positions 5-6, 7-3, 7-6, 8-5 and 11-1. Other fuel elements contained aluminum and cobalt, as indicated in Fig. 3-15.

FIG. 3-15 WTR core cross section. Normal circles indicate fuel elements, heavy circles (e.g., 3-3, 3-6, etc.) indicate control rods. Circles enclosing an X are plugged, those enclosing a + are high-pressure thimbles. The contents of the irradiation volumes are denoted by darkened areas at top and bottom of individual fuel elements: black strip across top = standard V-basket with cobalt, black half-strip across top = solid aluminum V-basket, black half-strip at bottom = experiment. Upper numbers indicate position, lower numbers denote number of grams of U²³⁵ estimated to be present at the time of the accident. (Note: For simplification letter prefixes used in reference [50] to identify positions have been omitted in the above figure.)
