Coolant Block Damages SRE Fuel

By ROBERT W. DICKINSON

Atomics International, Canoga Park, California

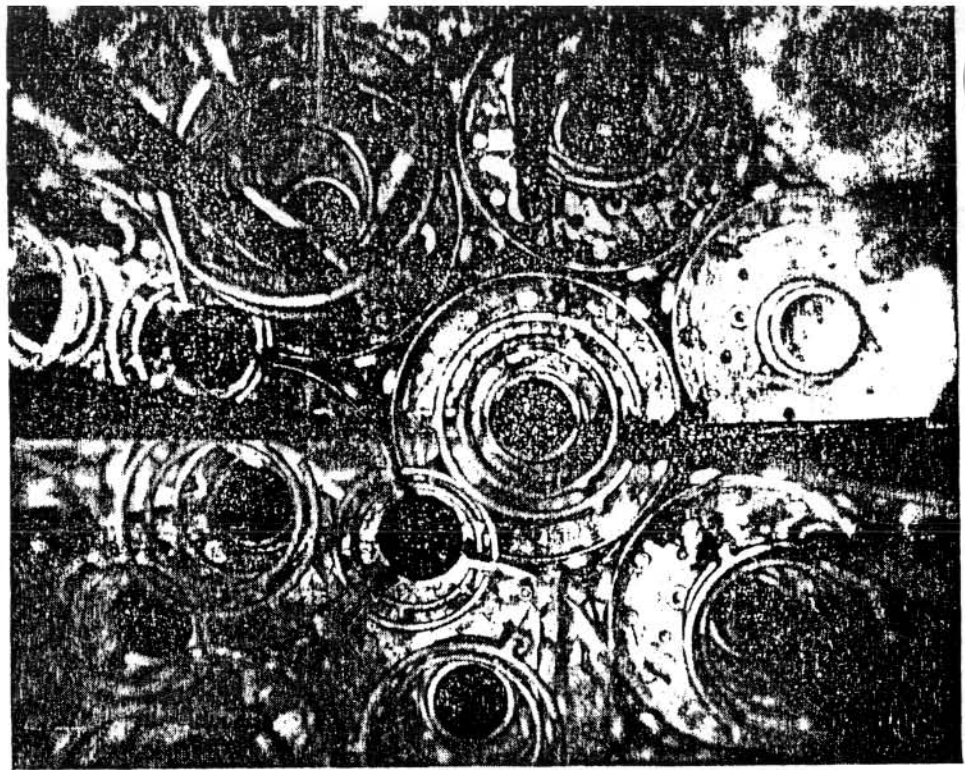
POST MORTEM VIEW of top of SRE core shows encrustation on snorkle tube vent (vertical tube) from center moderator can. Loose fuel slugs are strewn about on tops of other cans (top center). At time of picture core temperature was 325° F and radiation field below top shield 100 r/hr

An examination of the circumstances surrounding fuel-element damage was commenced immediately on discovery; deposits of a viscous, tar like substance were identified on hot-cell examination of a damaged fuel element. Deposits were observed on the top spider which supports the fuel rods and on the moderator can hold-down tube which

is installed immediately above the fuel elements. Samples of this deposit were analyzed; they proved to be carbonaceous materials containing varying amounts of hydrogen. These were apparently decomposition products of tetralin. It is reasonable to assume that such carbonaceous material is deposited at points of flow restriction and may be the primary cause of decreased coolant flow in those channels which contain damaged fuel elements.
