Group I Map

#### Site Identification:

Building 4021

Radioactive Material Handling Facility (RMHF) Waste Decontamination and Packaging

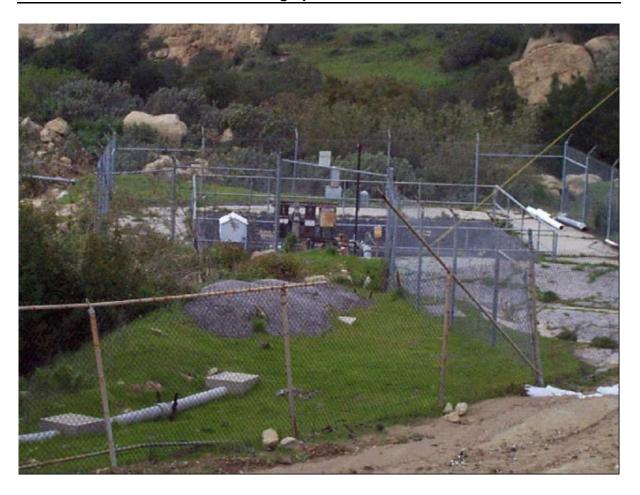
# Photograph – Site 4614

• Site 4614 is a holdup pond located at the base of the drainage channel west of the RMDF complex. The bottom and sides of the pond are lined with asphalt material.<sup>1</sup>

- Radioactive contamination exists in the pond as a result of known spills that have occurred at the RMDF/RMHF.
- There have been two notable radiological incidents associated with Site 4614:
  - On January 17, 1979, leakage from the flocculation tower associated with Building 4021 contaminated the drainage ditch and the pond itself with less than 0.4 mCi of Sr-90 and Cs-137 (A0077).
  - On January 9, 1980, a water hose broke, causing the Building 4021 tank to overflow, which then drained to the pond. This incident resulted in the released of about 100 gallons of liquid containing 1 x10<sup>-2</sup> mCi of mixed fission products (A0080).

• During the dry season when the pond dries up, the sediment is removed from the lined pond and analyzed for contamination prior to being disposed of as radioactive waste. Low levels of Cs-137 are frequently found (e.g. 34 pCi/g in 2003).<sup>4</sup>
