Steve Laxplane to record
NAA-SR-4488 (suppl)
COPY 56A

**SRE FUEL ELEMENT DAMAGE
FINAL REPORT**

**OF
THE ATOMICS INTERNATIONAL AD HOC COMMITTEE**

(1961)

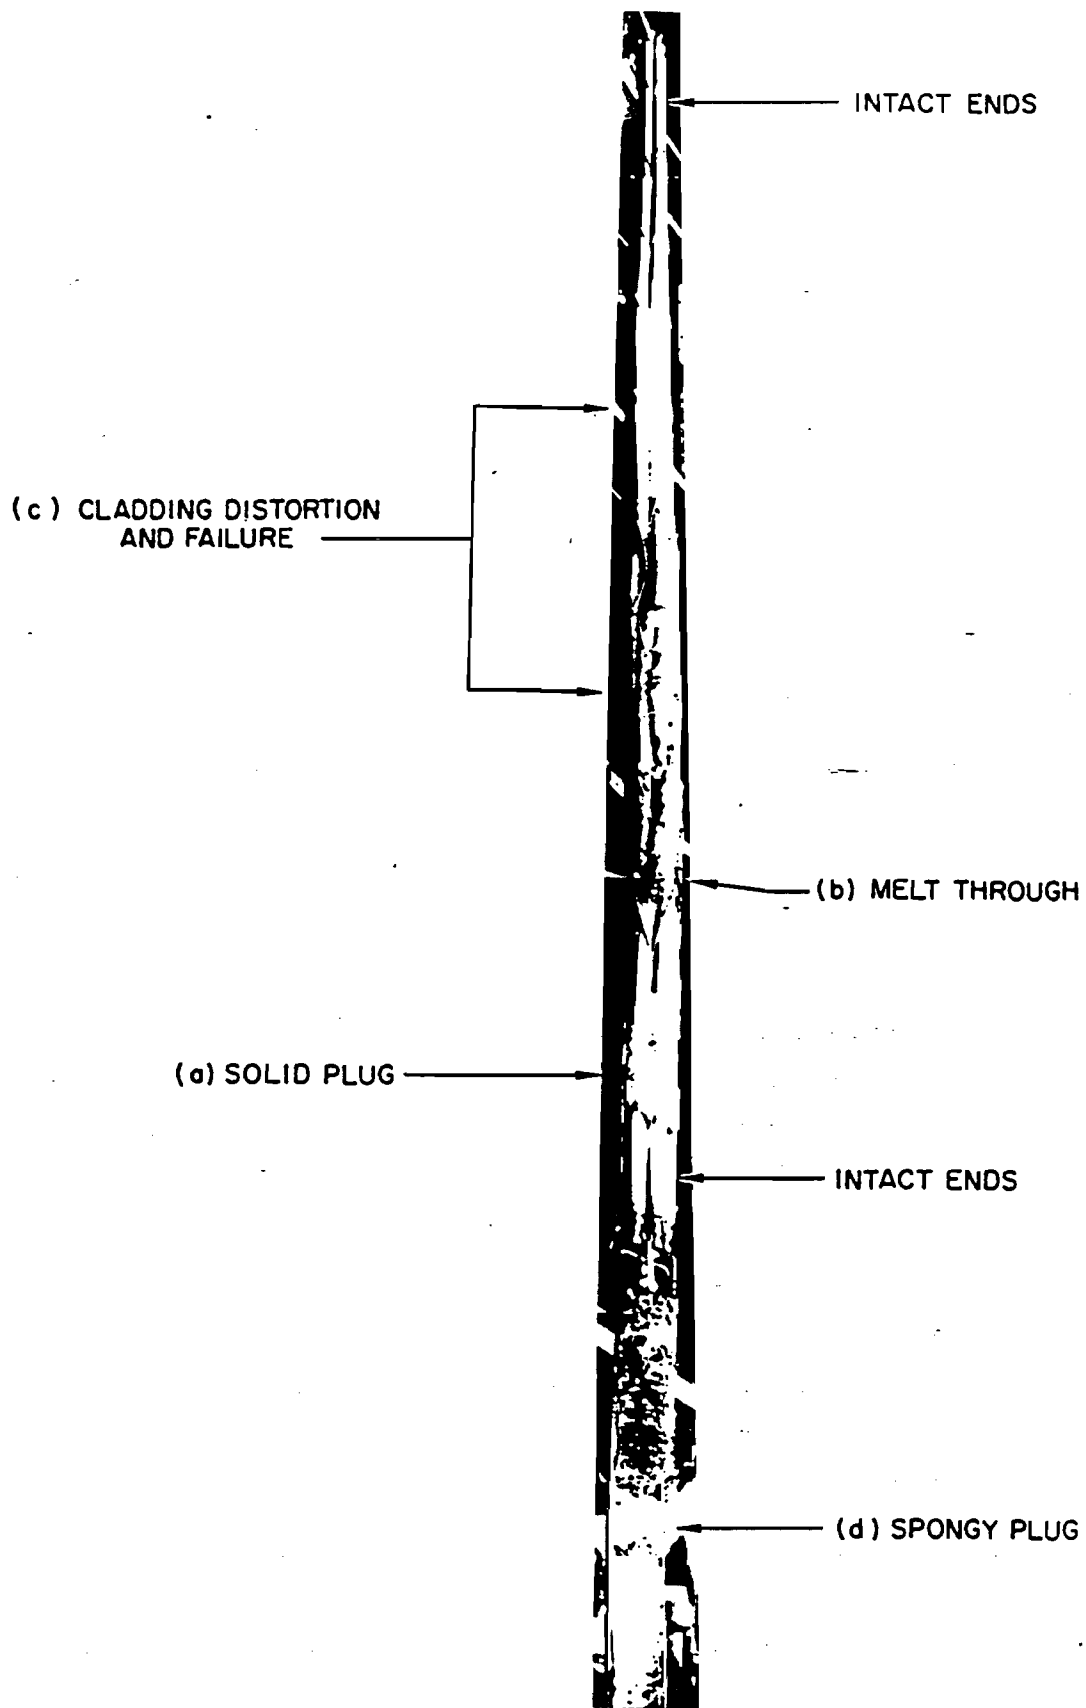
Figure III-1. Fuel Element From Channel R-24

The results are shown in Figure III-1. Several features should be noted: (a) the solid plug of material about 1-ft above the bottom of the fuel rods, (b) the Fe-U alloy melt-through area about one-third of the way up the element and extending for several inches, (c) the region above the melt-through where the cladding had been distended until it burst, and (d) the black spongy plug in the channel below the element.

The solid plug was determined metallographically to consist of Fe-U alloy of near-eutectic composition. Its source was the melt-through area above, from which Fe-U alloy, formed near the surface of the slugs, penetrated and destroyed the cladding.

The cladding breaks above the melt-through area were typical of a ductile material, and cladding pieces from this area were readily bent with the hot cell manipulators. There was no evidence of Fe-U diffusion in this area; the failure is attributed to swelling of the fuel from thermal cycling.

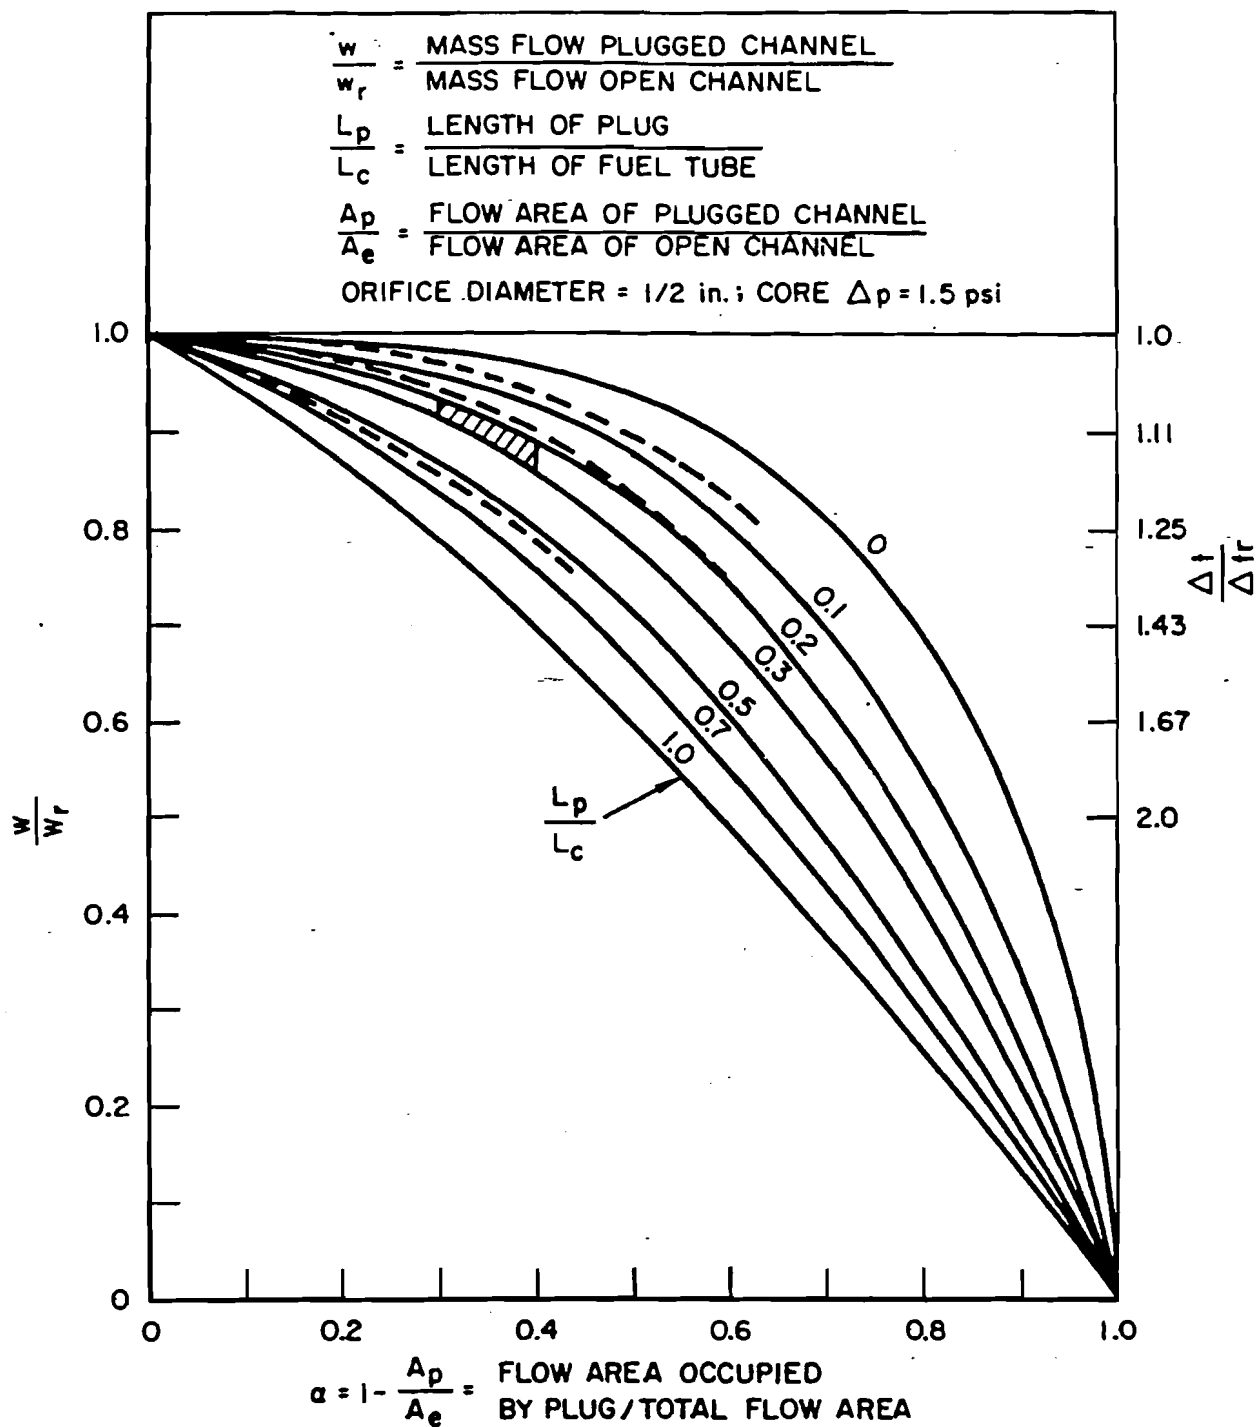
Figure III-4. Mass Flow Reduction in SRE Fuel Channel Due to Formation of Plugs in Fuel-Tube Region

The plugs must have been large in order to reduce flow in a given channel to one-third of nominal flow. The relationship of flow to plug geometry in a channel is indicated in Figure III-4. As shown in the figure, a very short plug (thin

plate) would have to occupy about 95% of the flow area around the fuel rods to reduce flow to one-third; if the plug were as long as the channel, it would have to occupy about 75% of the flow area to reduce flow to one-third. The calculations leading to Figure III-4 assumed no plug porosity. With some flow through the plug, the plug would have to occupy a still larger fraction of the channel to restrict flow a given amount. The few observations of the spongy plugging material, in channel R-24 and on top of the core, together with the data of Figure III-4, would indicate that the plugs were probably long (a few feet) and occupied most of the flow cross sectional area.

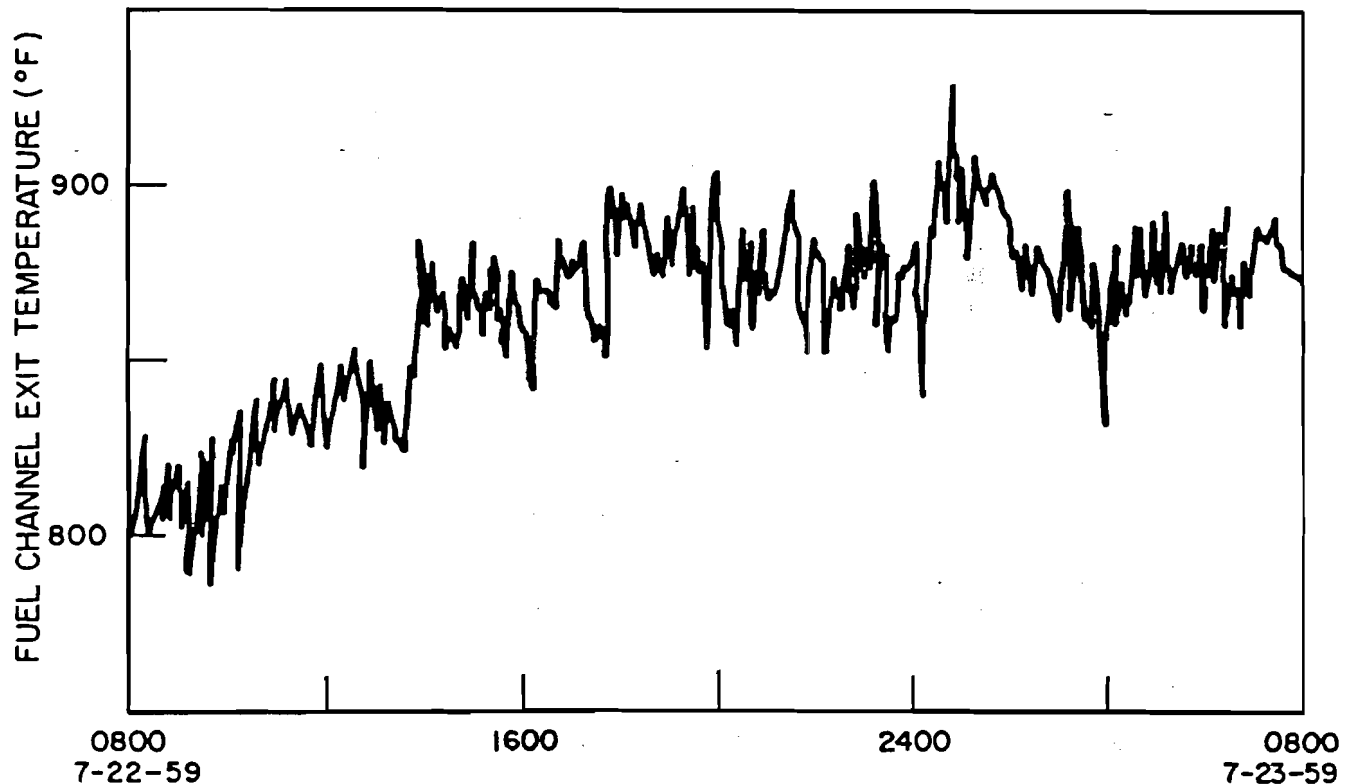
Figure III-5. Outlet Temperature for Channel R-24

A careful review of the chart from run 14 showed that all of the channels in which fuel failures occurred had shown fluctuations in outlet channel temperatures. The record of temperatures from channel R-24 for a typical 24-hr period is shown in Figure III-5. Fluctuation in outlet channel temperatures also occurred for a few hours in some channels in which the fuel elements did not fail. The element from R-25, in which temperature fluctuations occurred for only part of the run, suffered the least damage of the thirteen damaged elements. The temperature history for R-25 over a 24-hr period is shown in Figure III-6. Some indication of the relation between fuel temperatures at some regions of the element and the outlet channel temperatures can be gained from the data for R-55

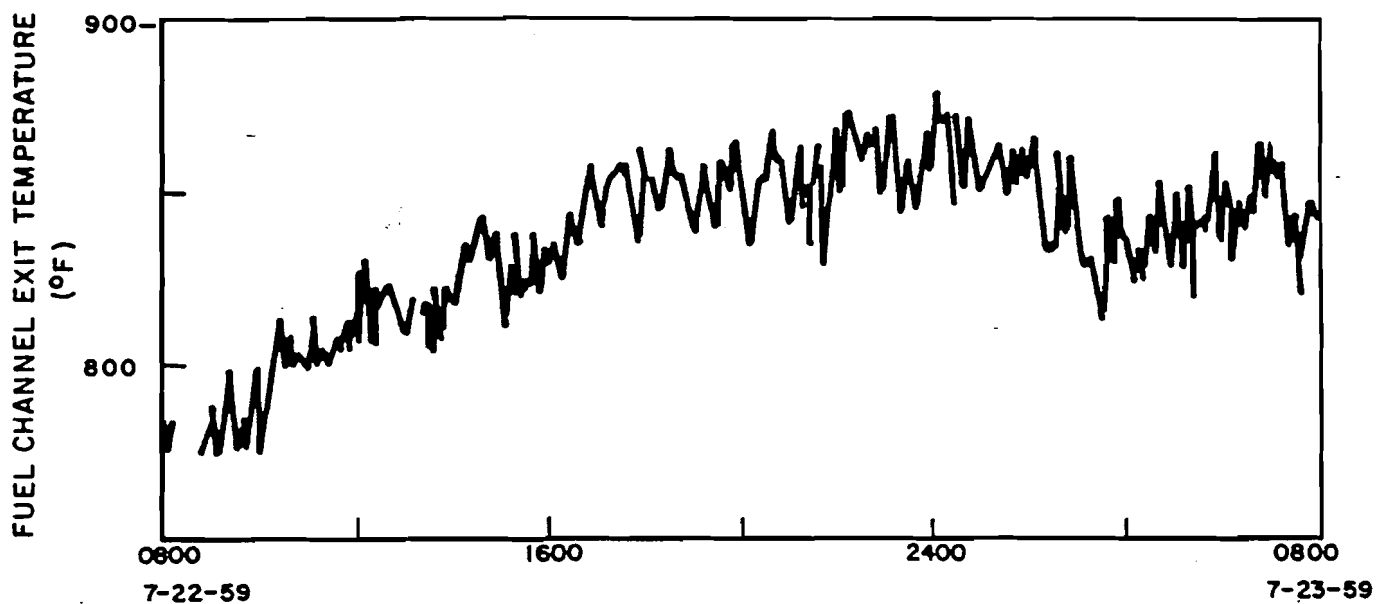
Figure III-7. Outlet Temperature for Channel R-55

shown in Figures III-7 and III-8. As indicated by the figures, the fuel temperature was cycling over a range of about 150°F while outlet channel temperature variation was about 50°F.
