**United States
Department of Energy
Office of Science**

Accident Investigation Report

**Ironworker Injured from Fall at the
Fermi National Accelerator Laboratory
Proton Improvement Plan – II Construction Project**

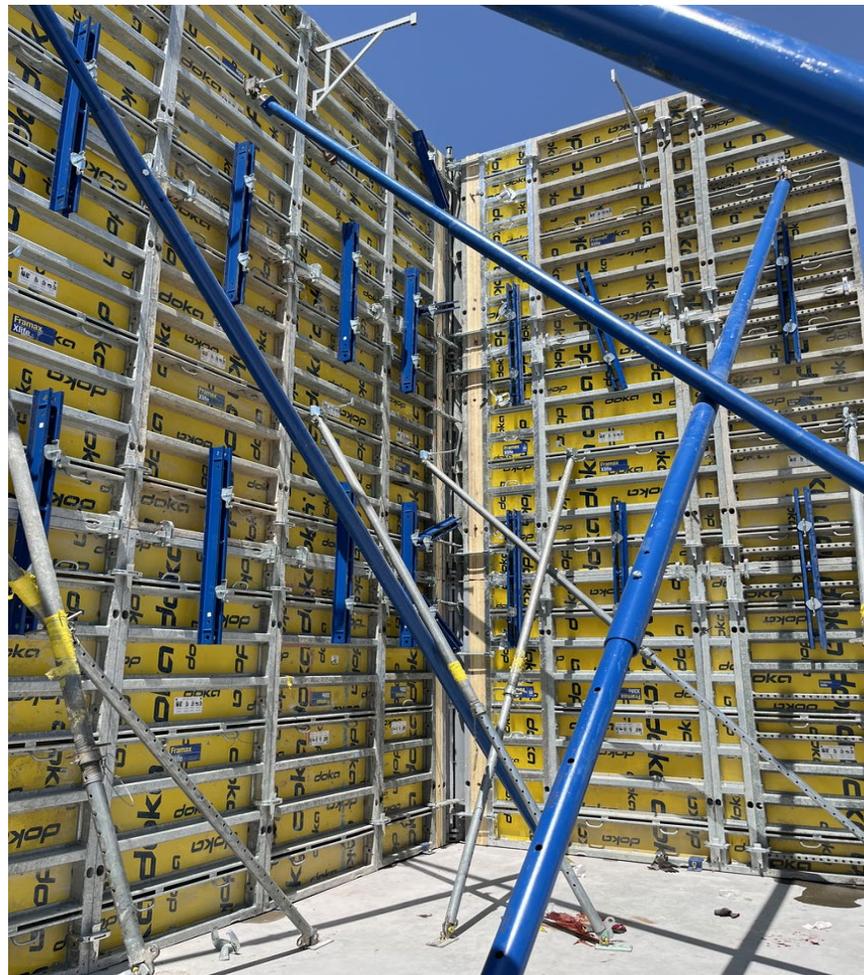
The project involves the installation of form walls including pre-assembled sections of engineered systems from Doka USA, Ltd. (Figure 2-1). Doka concrete formwork wall sections were assembled at a staging area near the edge of the excavation and lowered into the site using a crane. Wall erection for the northwest corner of the structure commenced on May 24, 2023. Starting on May 24, 2023, and continuing to May 25, 2023, WCEI construction carpenters installed several sections of Doka form walls on the north and west sides of the project. Both WCEI carpenters and Harris ironworkers had also used an aerial lift in the days prior to the accident. Moreover, carpenters had utilized the aerial lift to perform work activities in the northwest corner of the formwork (Figure 2-2).

Figure 2-1. Northwest Corner of Doka Formwork

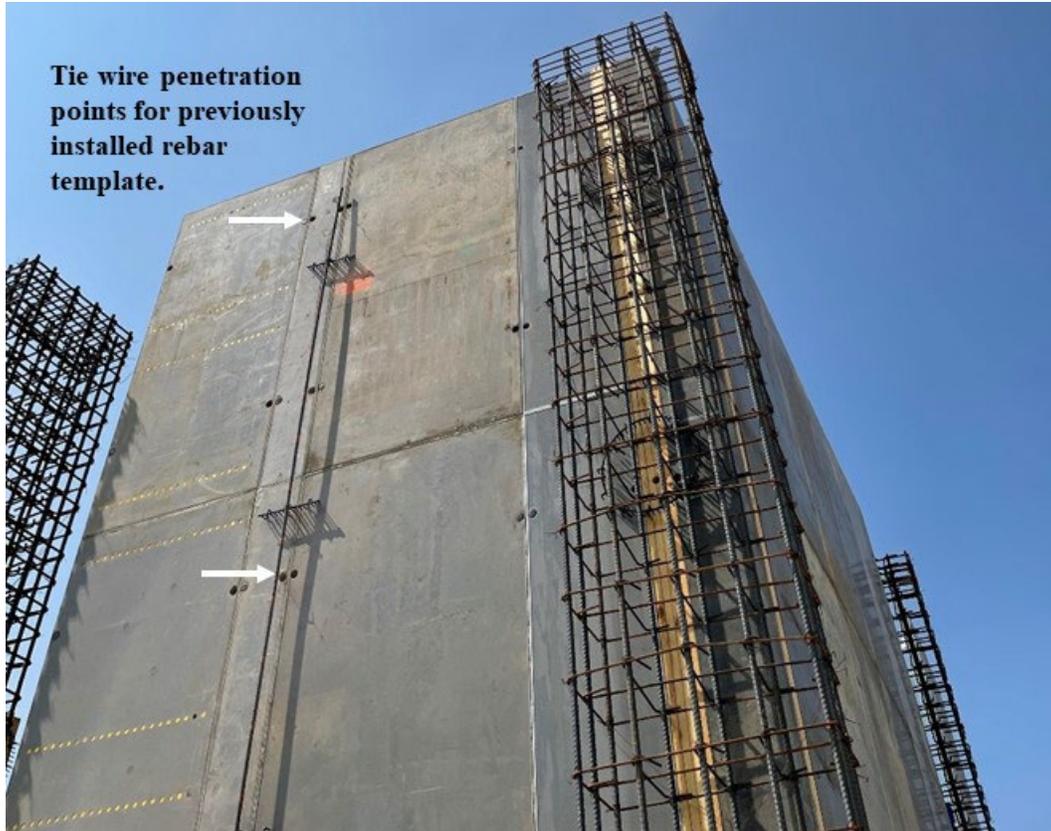
On the morning of May 25, 2023, the ironworkers used a crane to install a rebar column on the northwest corner of the forms. Subsequently, they installed a rebar template bar on the north side of the installed Doka form wall (Figure 2-3). IW1, a journeyman Harris ironworker, was assigned the task of passing wires attached to a piece of rebar through holes in the formwork at various points. Rebar ties are short sections of rebar with connecting wires which are used to secure the template bar to the formwork (Figure 2-4).

Figure 2-3. North Side of Doka Form Wall with Installed Template Bar and Tie Wire Penetration Points

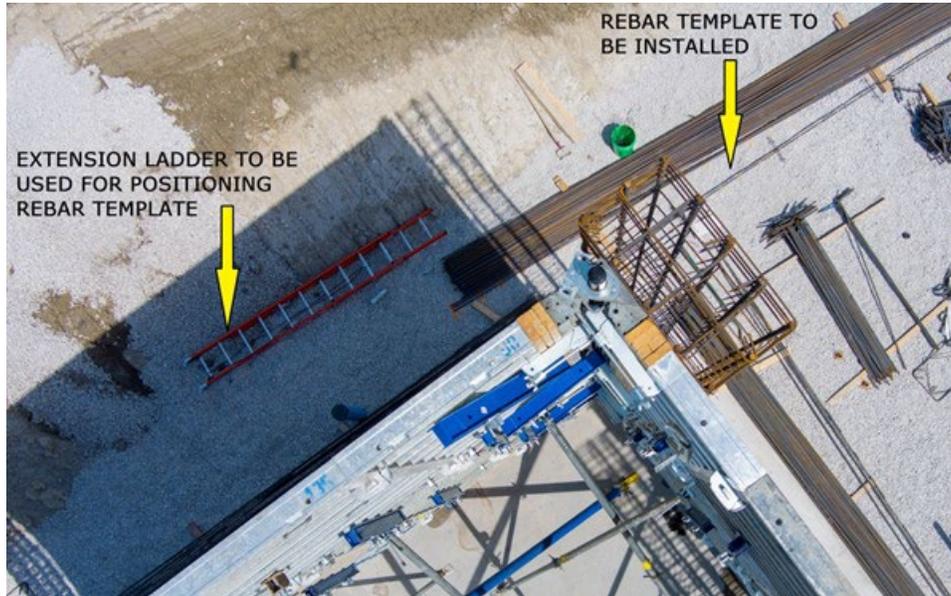
they neared the top, reaching a height of approximately 23 feet at 1301. IW1 was working alone on one side of the form wall, while three Harris ironworkers were on the other side of the wall, on the ground, preparing to raise a rebar template into place. Once in position, the rebar template was to be secured by the wires on the rebar tie inserted from the other side of the wall form by IW1 (Figure 2-5).

**Figure 2-5. Overhead View of Rebar Template to be Installed on
Opposite Side of Form Wall from IW1**

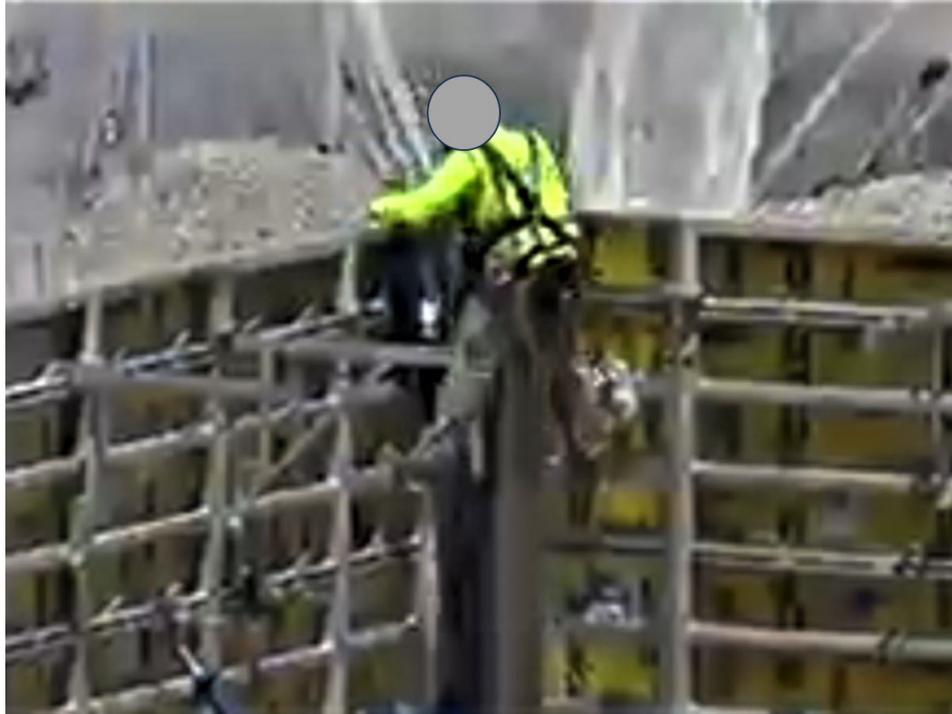
In the absence of statements from IW1 or any eyewitness to the accident, the Board relied on the PIP-II video monitoring construction progress and the FNAL security camera recording from the east side of Wilson Hall to determine the actions and conditions present that may have contributed to the worker's fall. While positioned at the inside corner of the form wall near the top, IW1 had one foot on a horizontal rib of the west form wall, and the other foot on a horizontal rib of the north form wall (Figure 2-6). At 1301, both of IW1's hands were observed to grab the top edge of the form wall intersection and shortly thereafter the worker appears to engage the wall in a manner that allows them to lean back and support their weight. The means used by IW1 to initially engage themselves to the form wall is not known. When IW1 repositioned themselves at 1302, the means of engagement with the wall became ineffective.

Figure 2-6. Construction Worker (IW1) Working on Form Wall

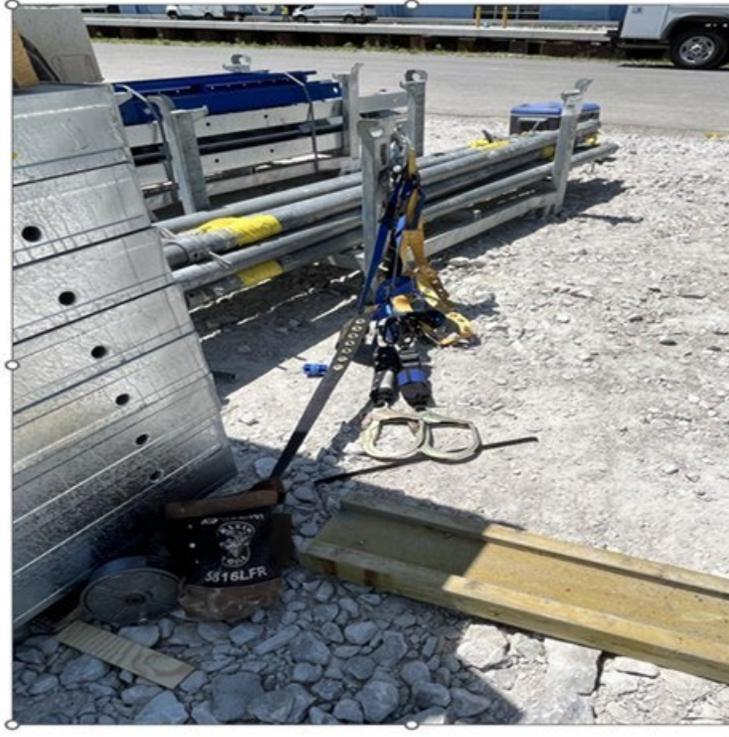
Figure 2-15. Site Safety Equipment Attributed to IW1

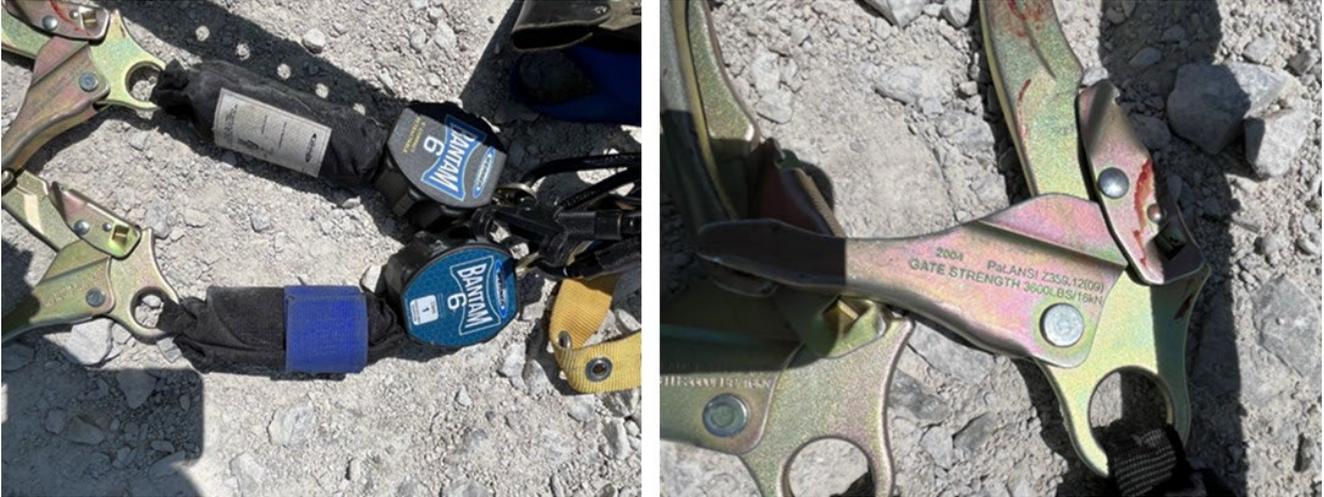
Figure 2-16. Equipment with Apparent Blood Stains

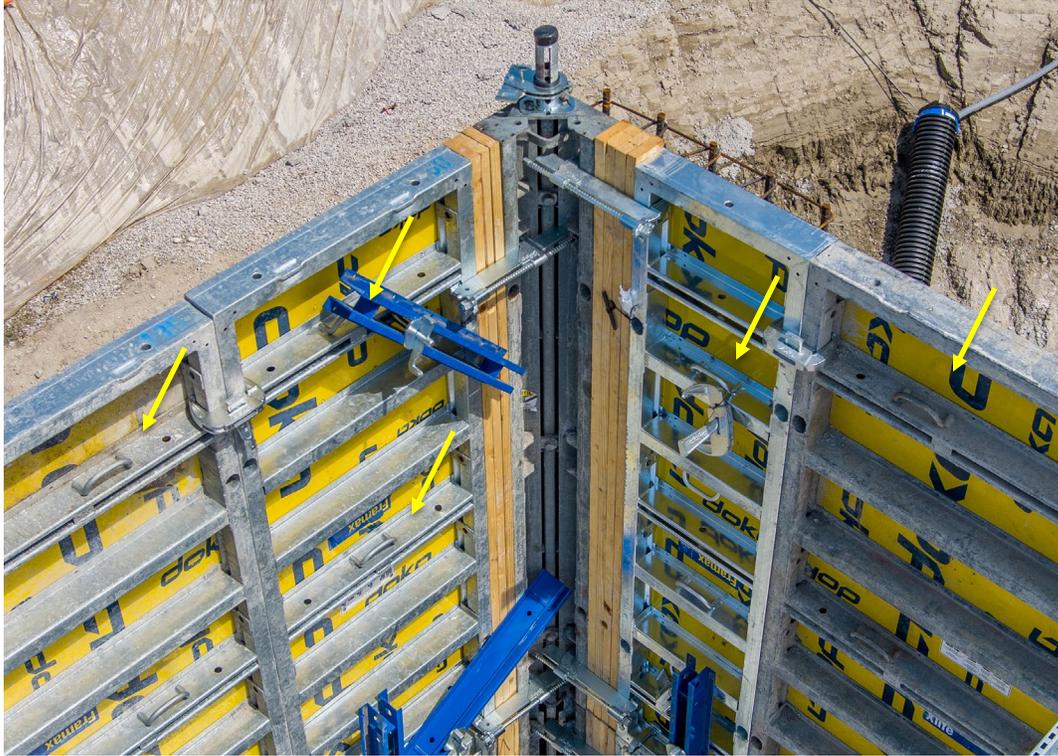
Figure 3-2. Doka Integrated Handles (Northwest Corner)

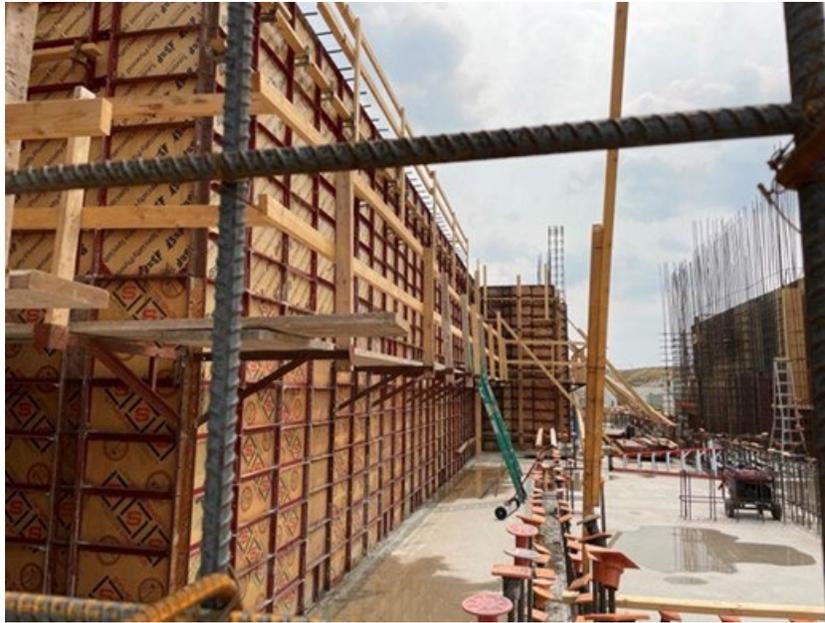
Figure 3-7. Scaffolding and Ladders on Previously Installed Symons Formwork

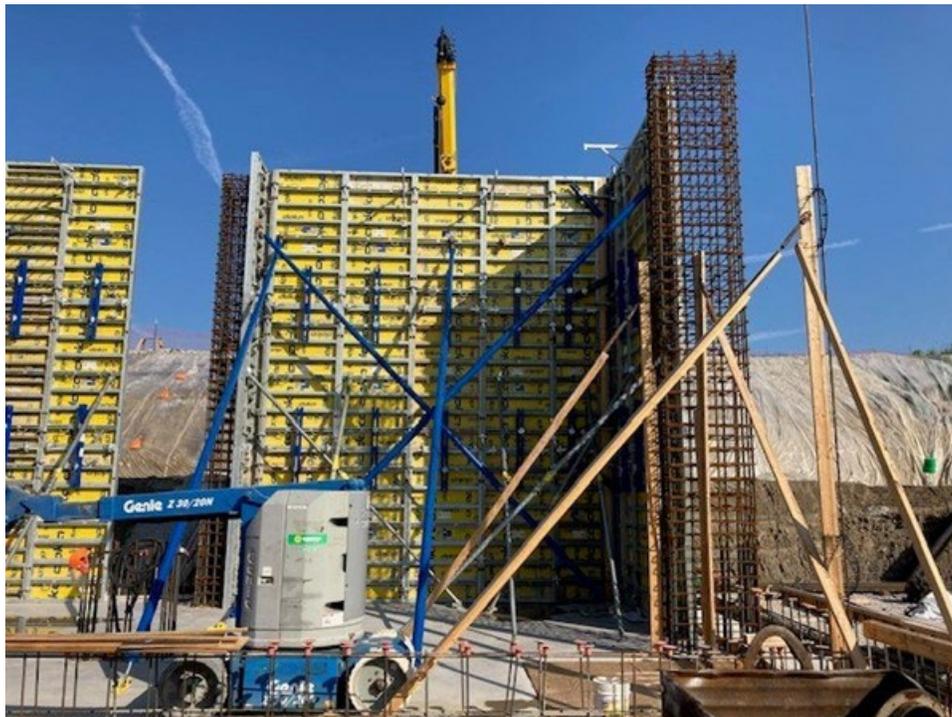
The attachment of scaffold support frames during the pre-assembly of the Doka formwork was a good practice to reduce the risks of working at heights. Also noted was the extensive use of scaffolding and ladders around the construction site, which reduces the reliance on personal fall protection systems when working at height. Coupled with the presence and use of an aerial lift at the site, and observation of new ladders across the construction site, work planning and ISM principles were applied to some work activities to mitigate the hazard of working at elevation on the PIP-II Construction Project.

Figure 3-8. Construction Site with Form Walls and Aerial Lift
