U.S. DEPARTMENT OF
ENERGY

Legacy
Management

2022 Annual Site Inspection and Monitoring Report for Uranium Mill Tailings Radiation Control Act Title I Disposal Sites

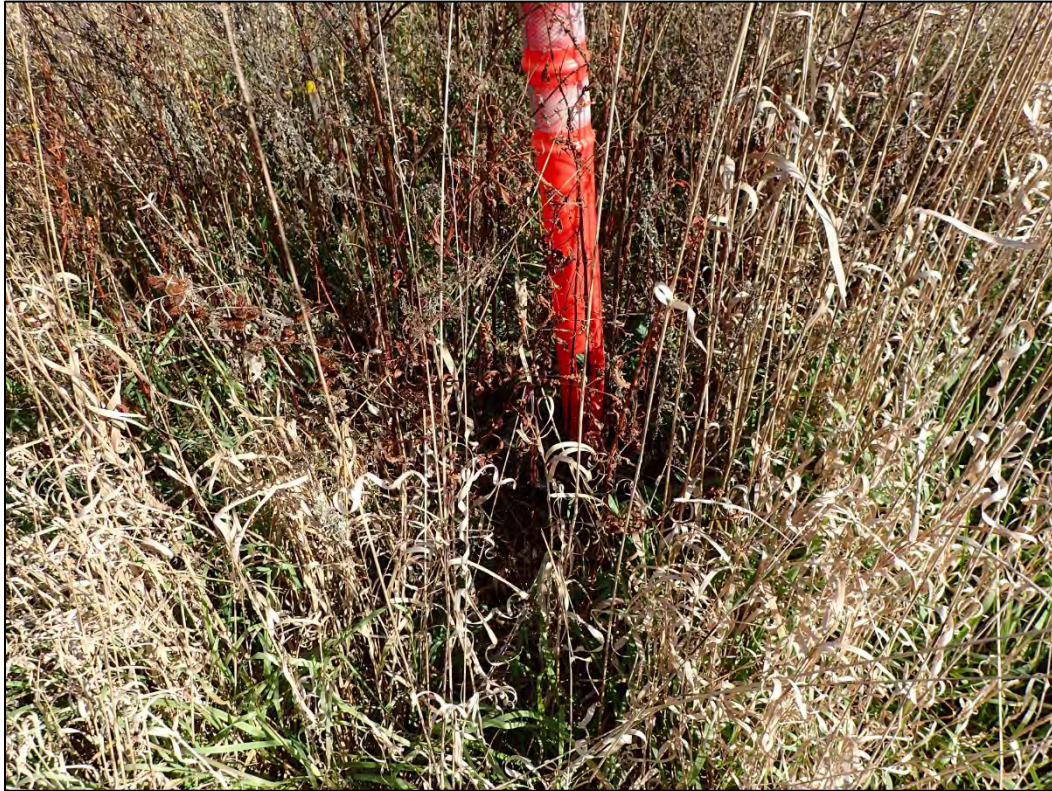
PL-7. Hole Repaired in Conservation Reuse Prairie Test Plot Area

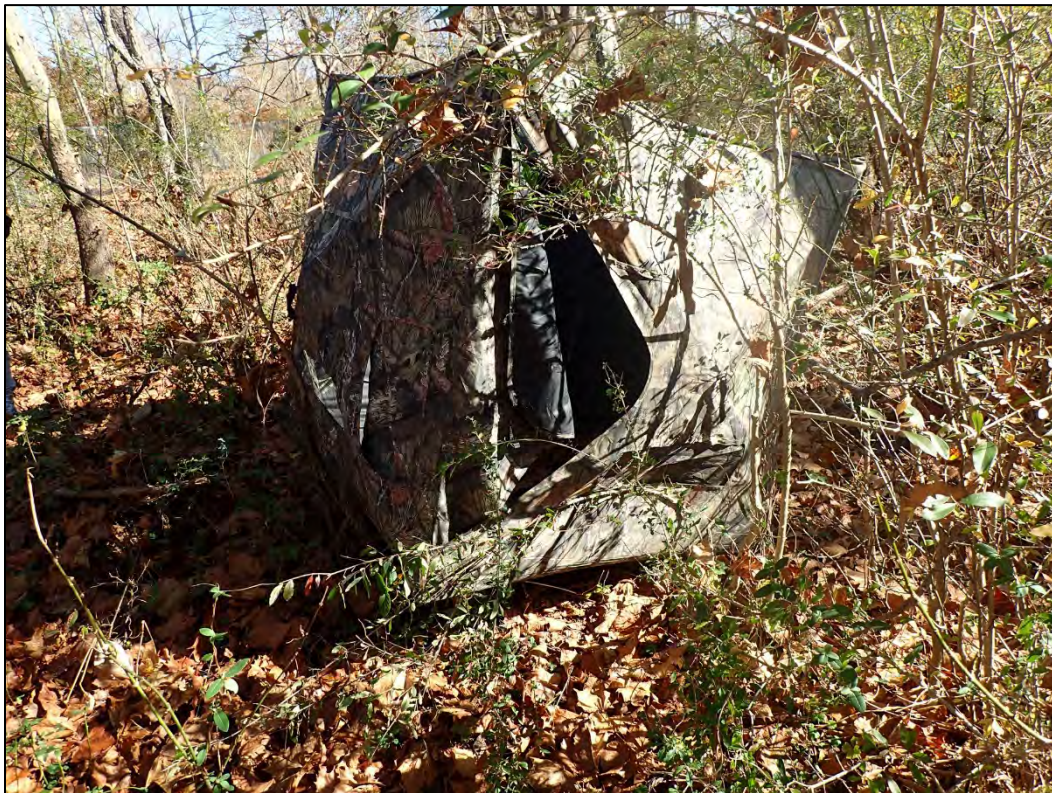
PL-8. Unauthorized Hunting Blind to Be Removed

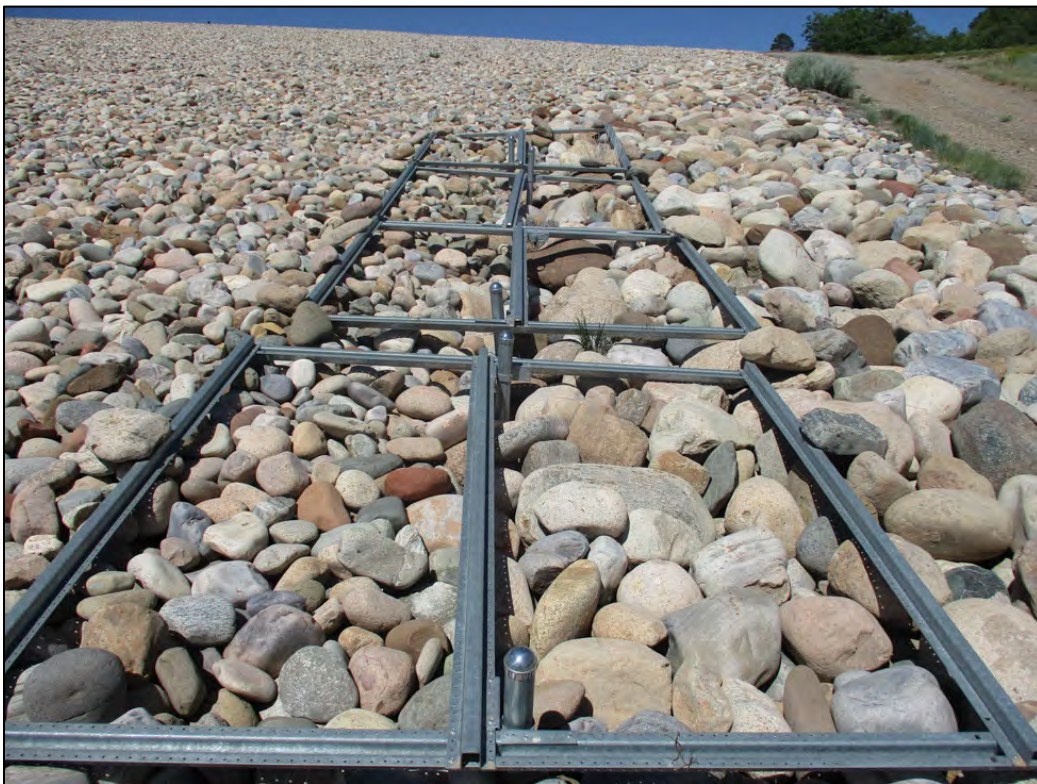
PL-6. Depression on North Toe of Disposal Cell Before Repair

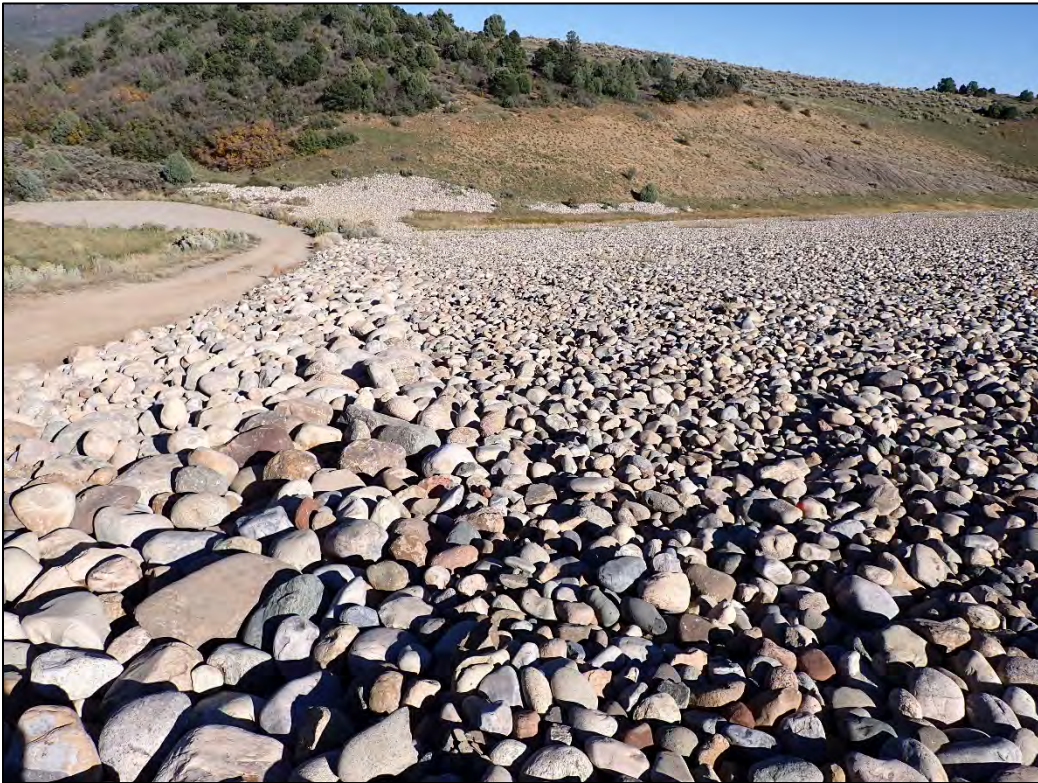
PL-7. Repair to Depression, October 2022

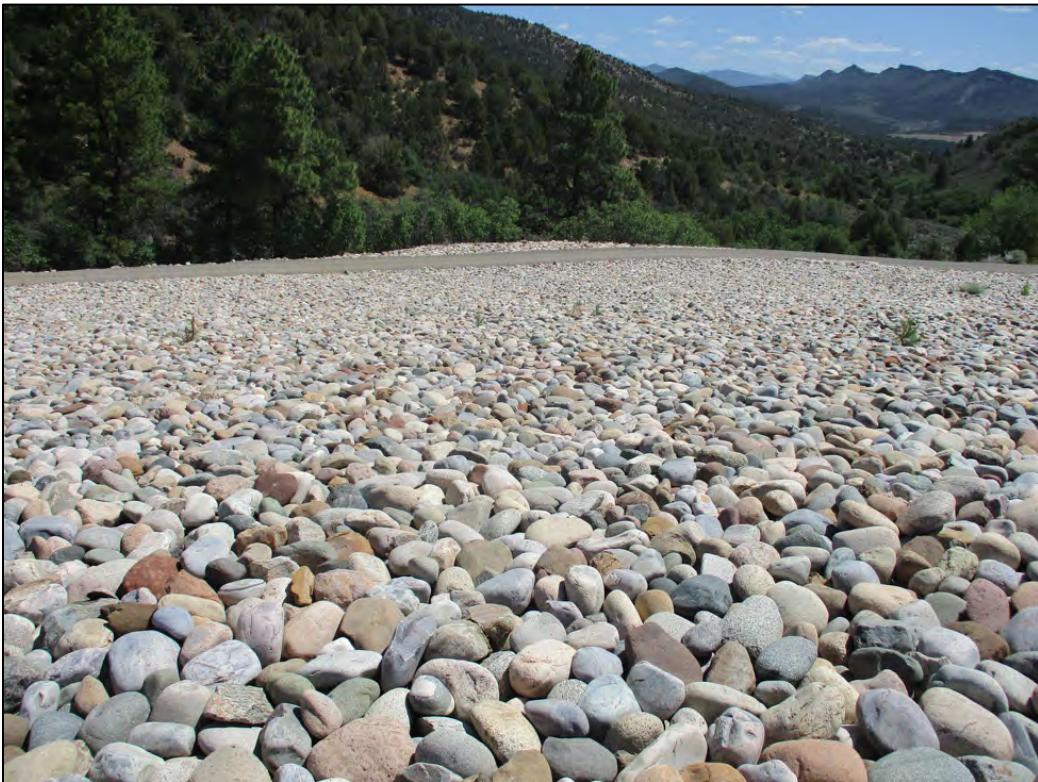
PL-8. Young Ponderosa Pines in Riprap Along North Side Slope

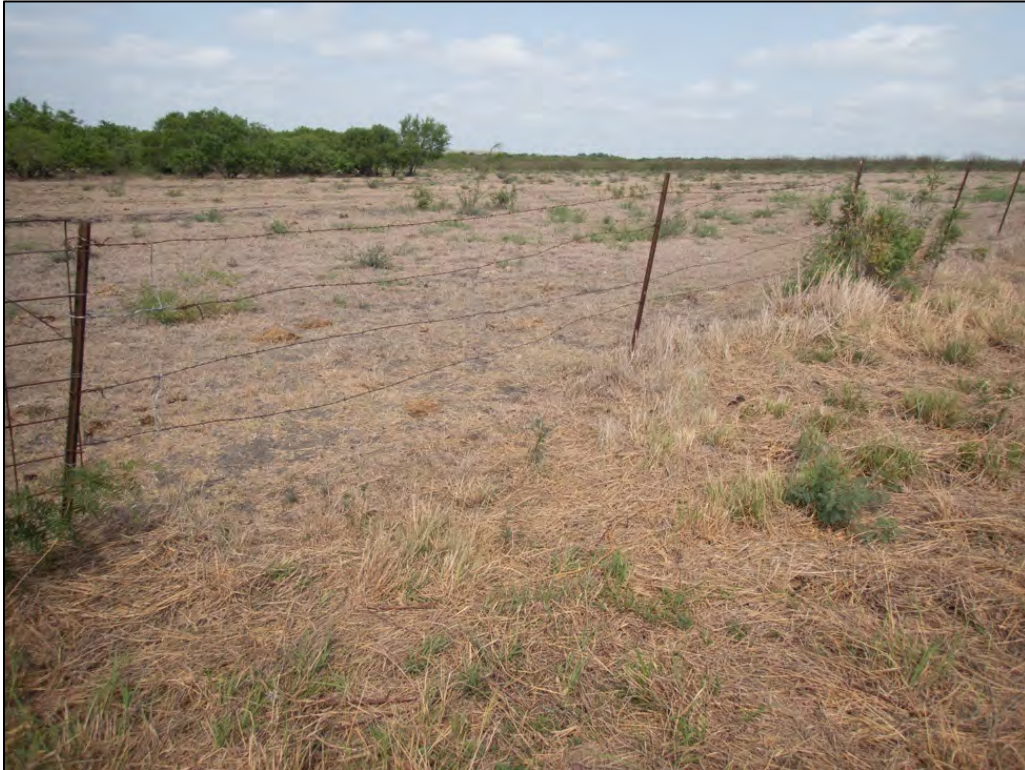
PL-1. Rusted and Damaged Fence Line

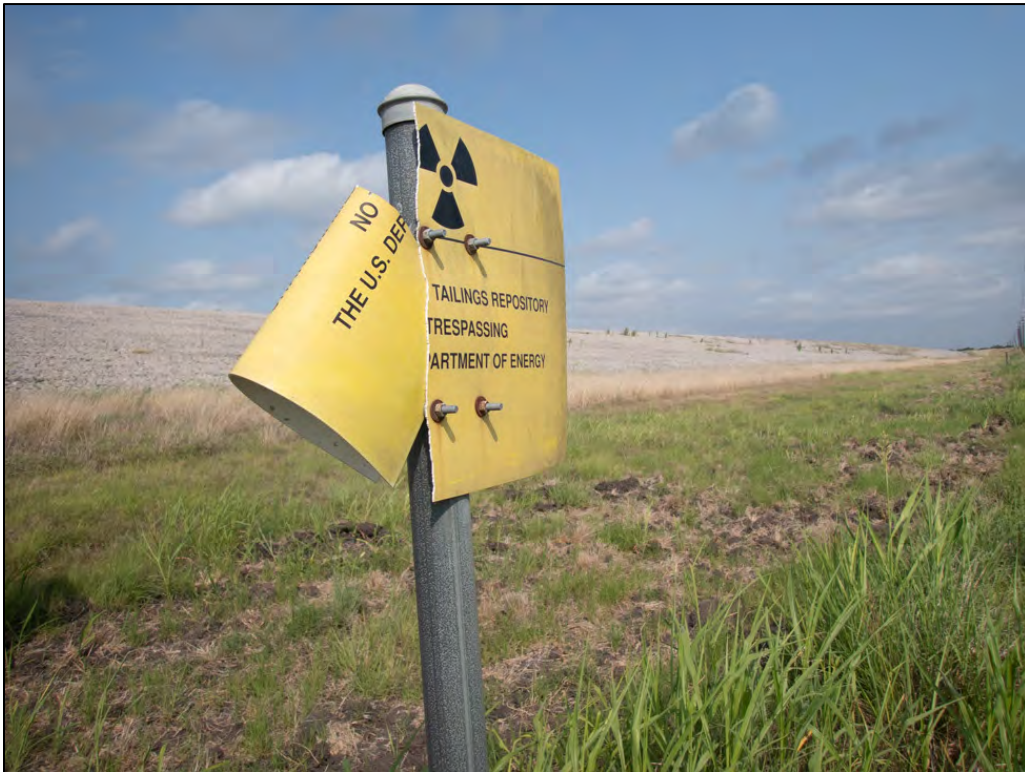
PL-2. Broken Perimeter Sign P62

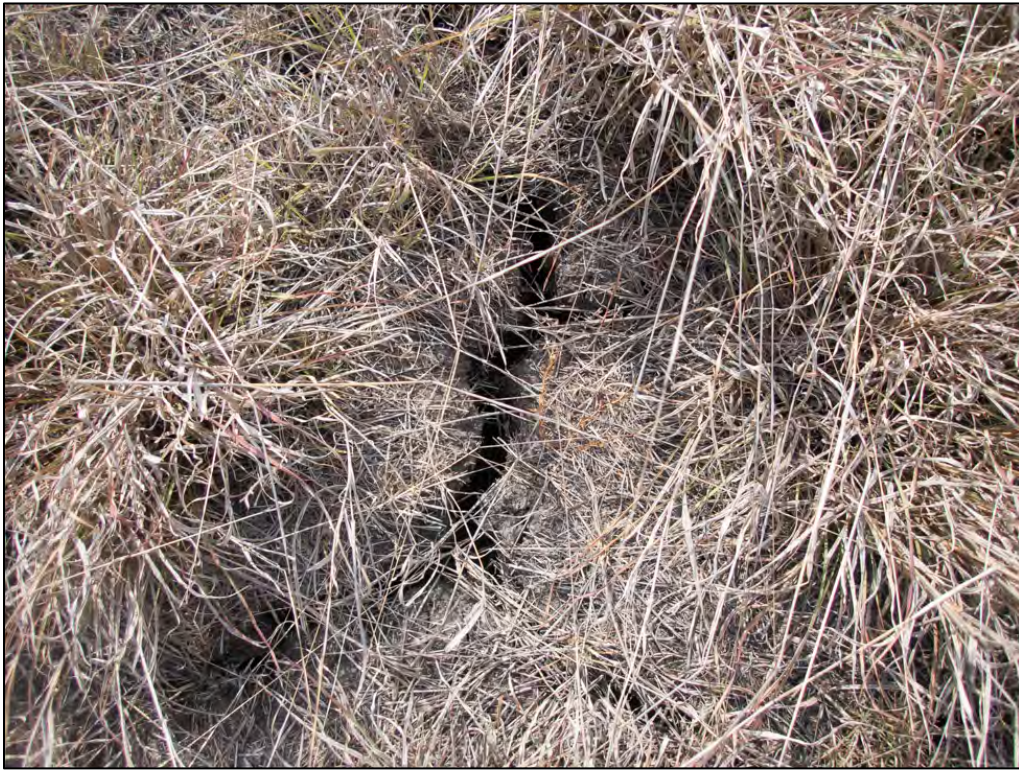
PL-7. Soil Desiccation Cracks on Top Slope of Disposal Cell

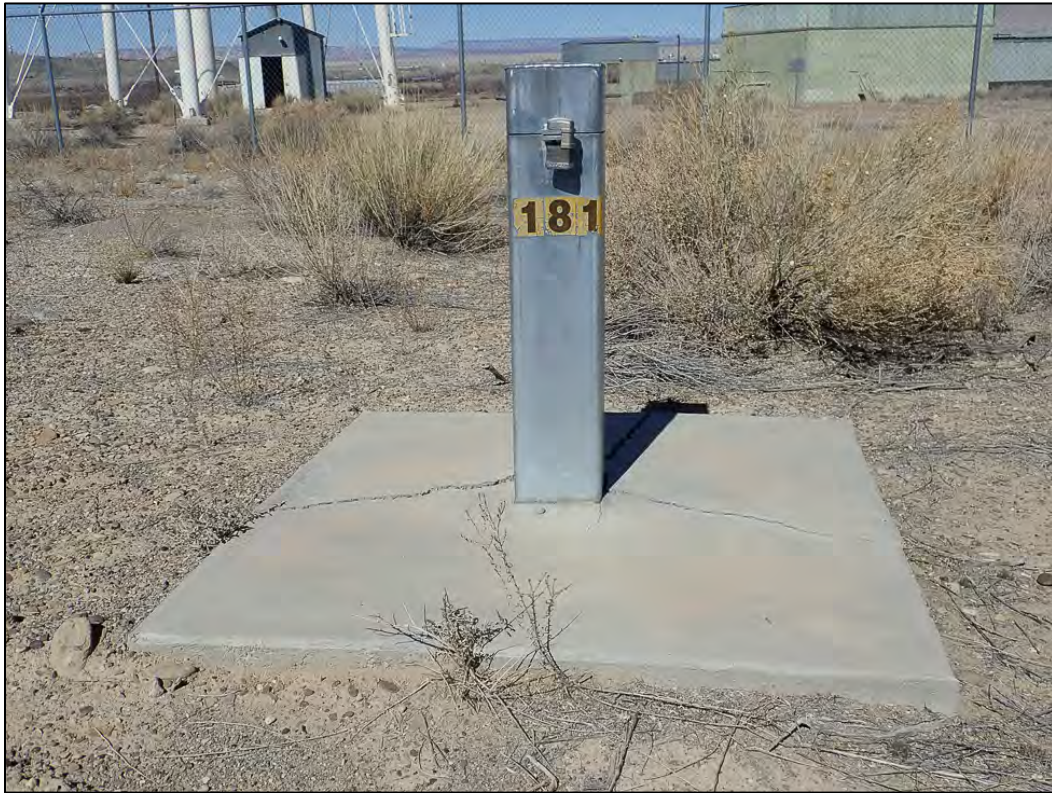
PL-7. Cracked Concrete Around Monitoring Well 0181 (Onsite) and Abandoned Mill Buildings (Offsite)

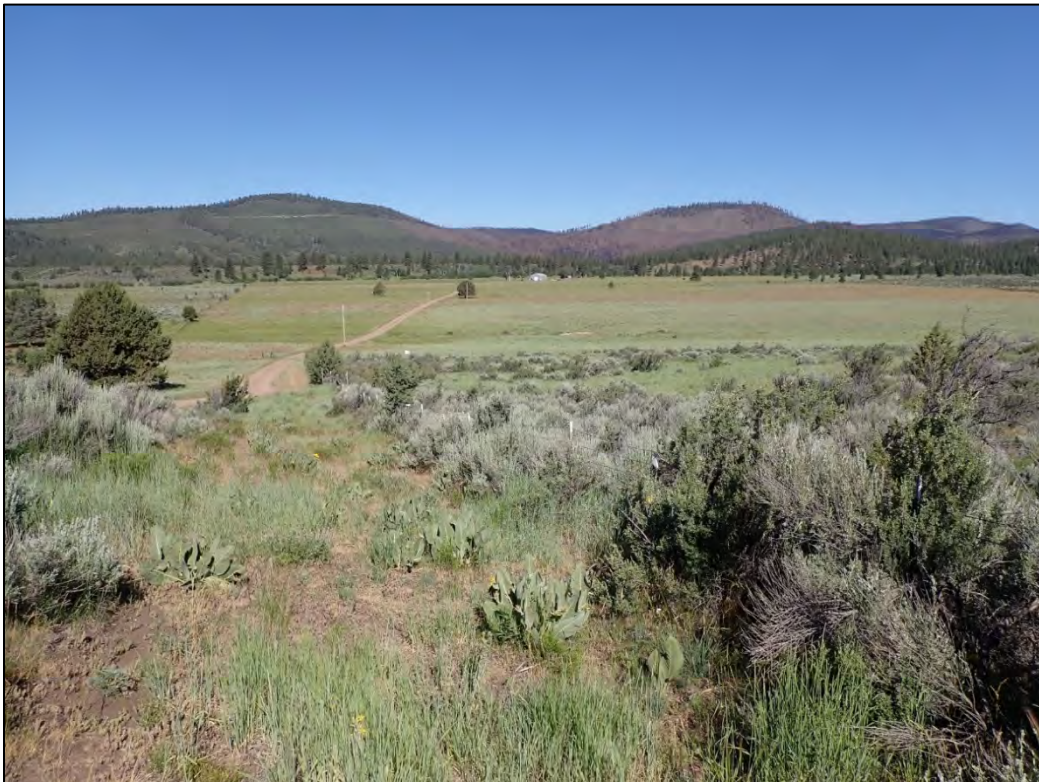
PL-11. Southern Fence Line with Cougar Peak Fire Burn Scar in Distance

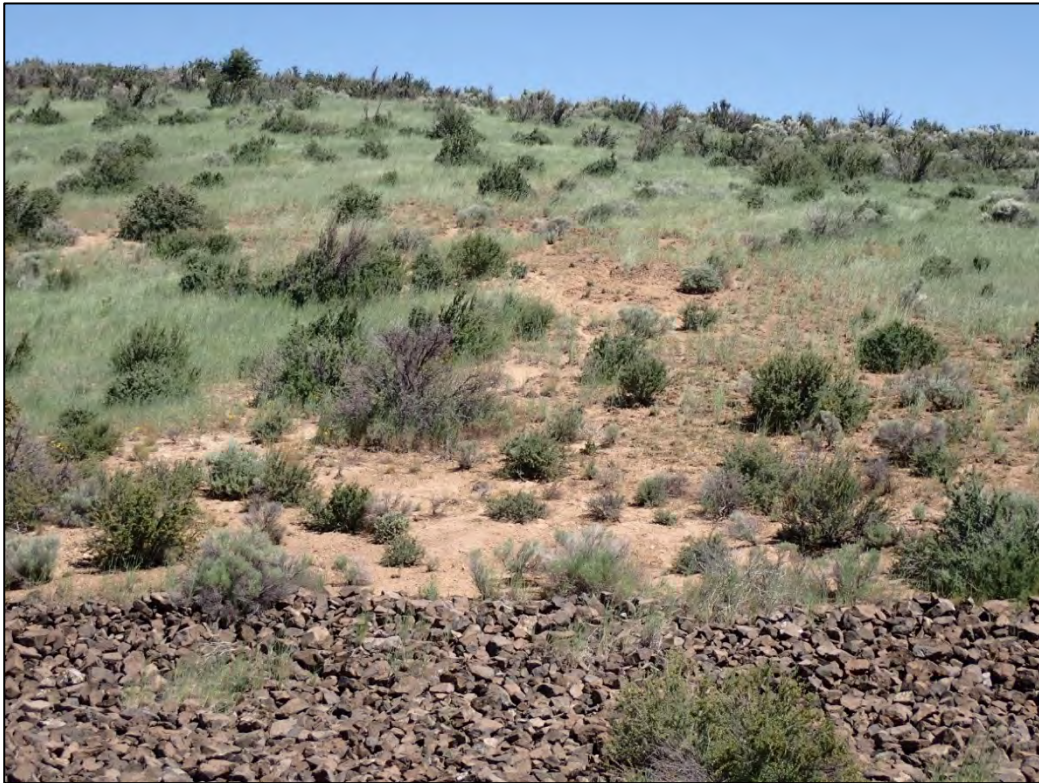
PL-12. Erosional Features on North Slope of Disposal Cell

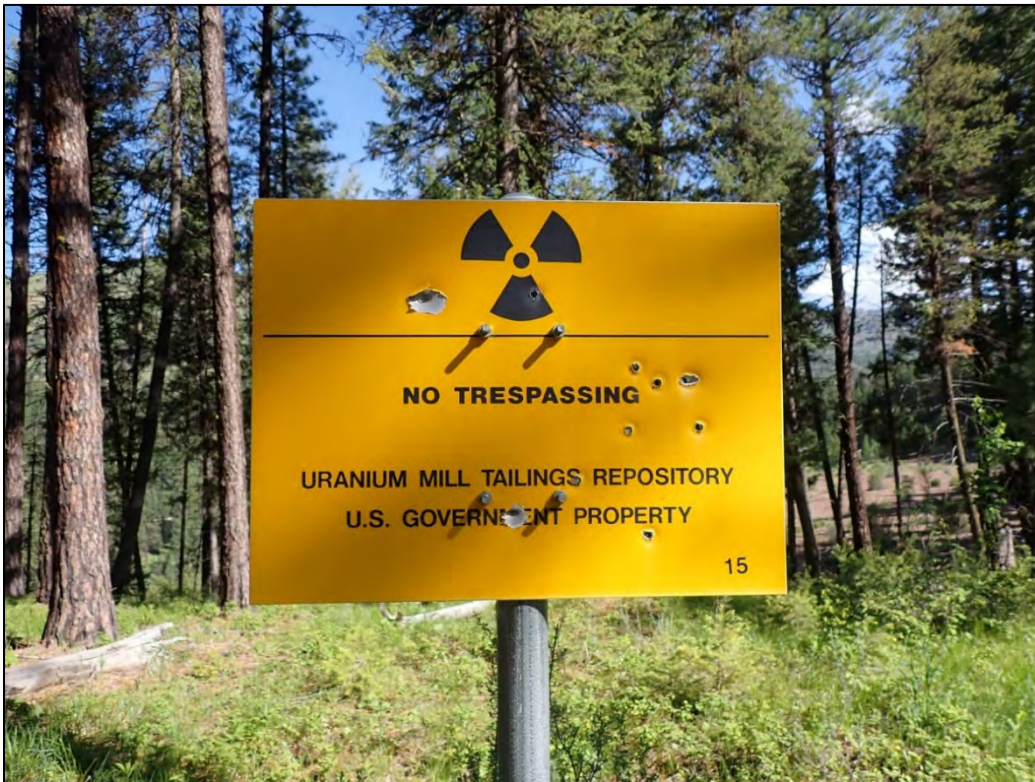
PL-2. Perimeter Sign P15 with Bullet Damage

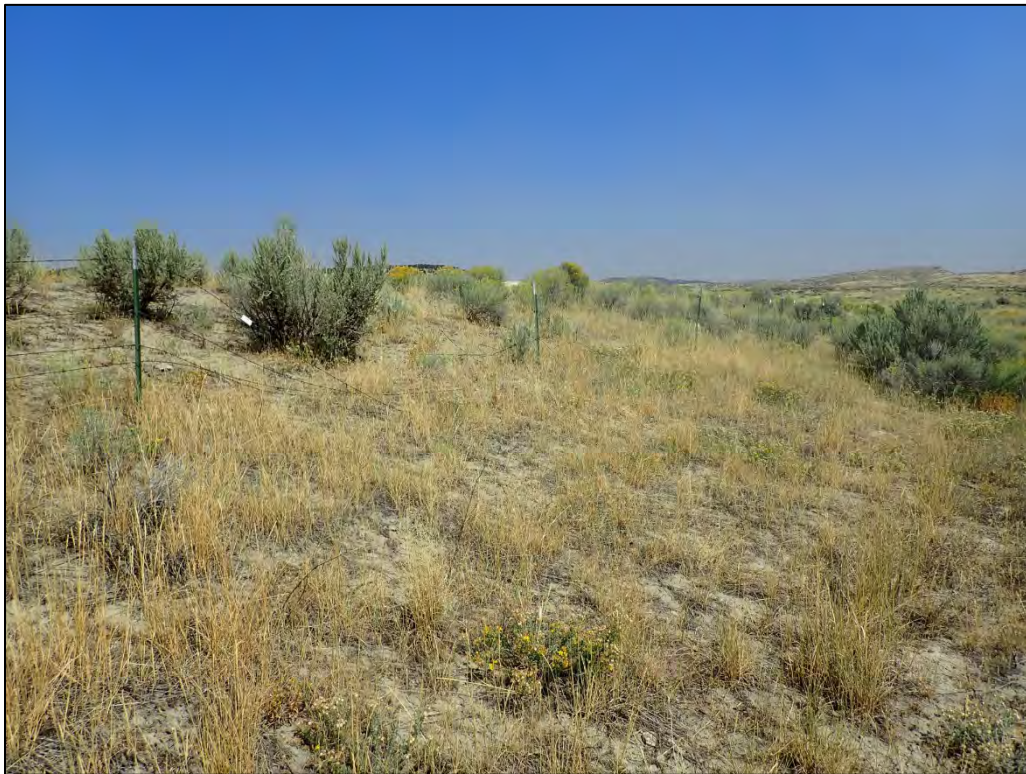
PL-2. Damaged Fence near Perimeter Sign P1

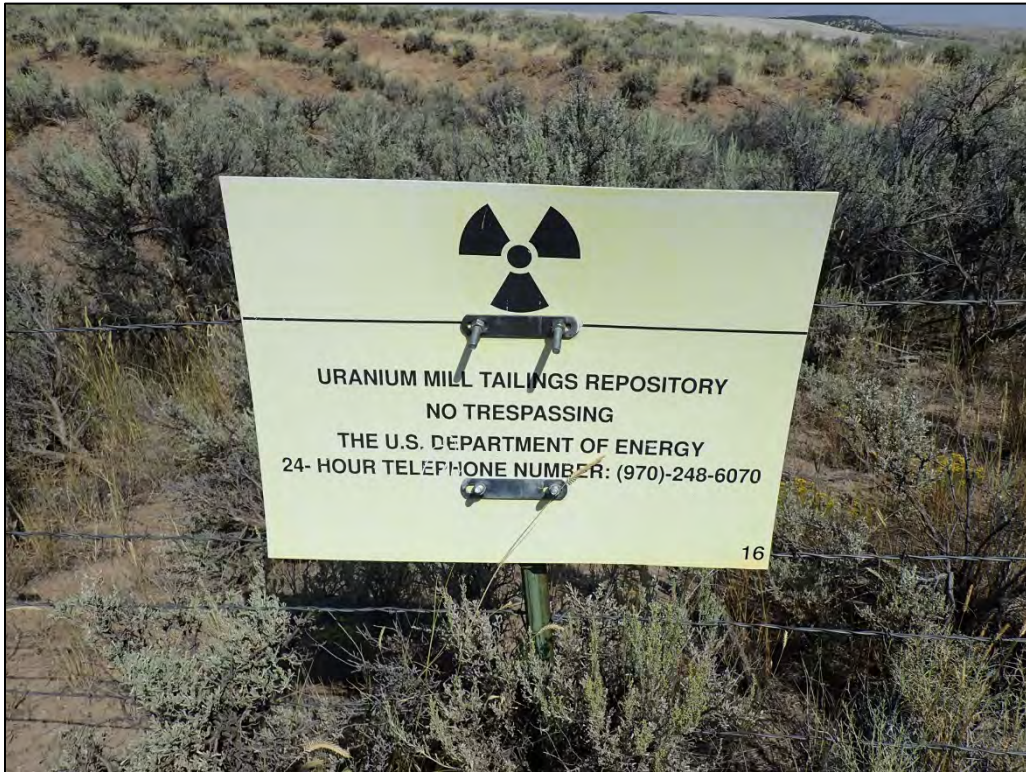
PL-3. Faded Perimeter Sign P16 to Be Replaced

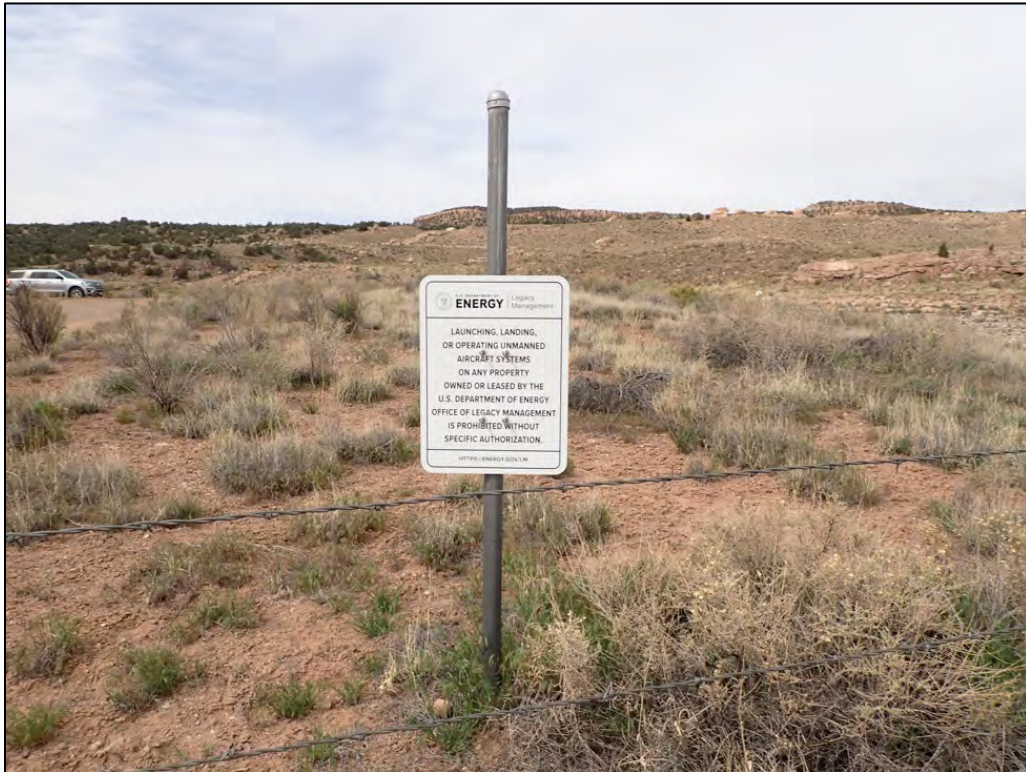
PL-1. Entrance Area with Missing Entrance Sign

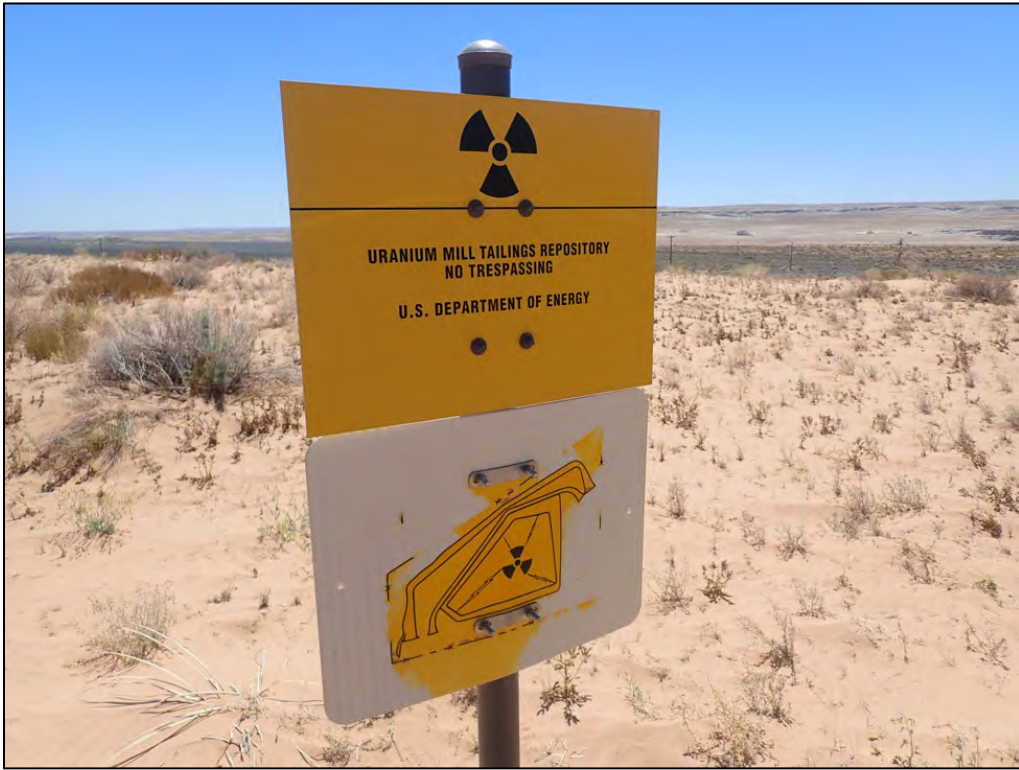
PL-5. Perimeter Sign P7; Pictorial Sign Damaged
