APPENDIX F

GROUP 7 2008 WASTE DEBRIS SURVEY RESULTS

**Table F-1
Waste Debris Areas - RFI Group 7
Santa Susana Field Laboratory**

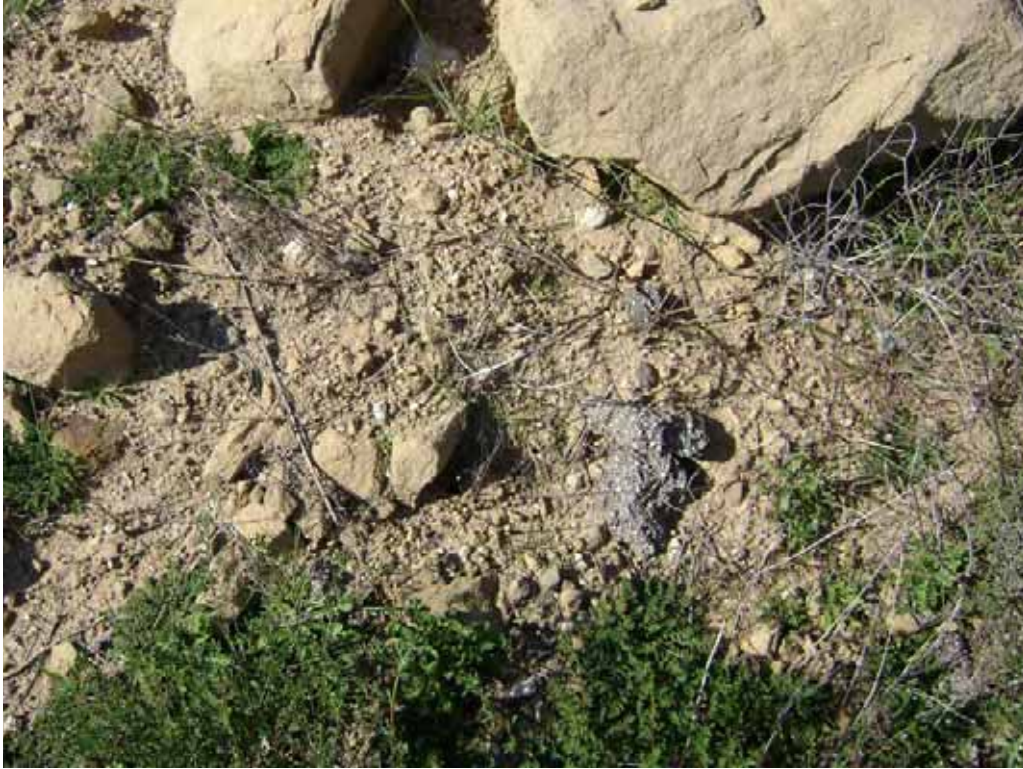
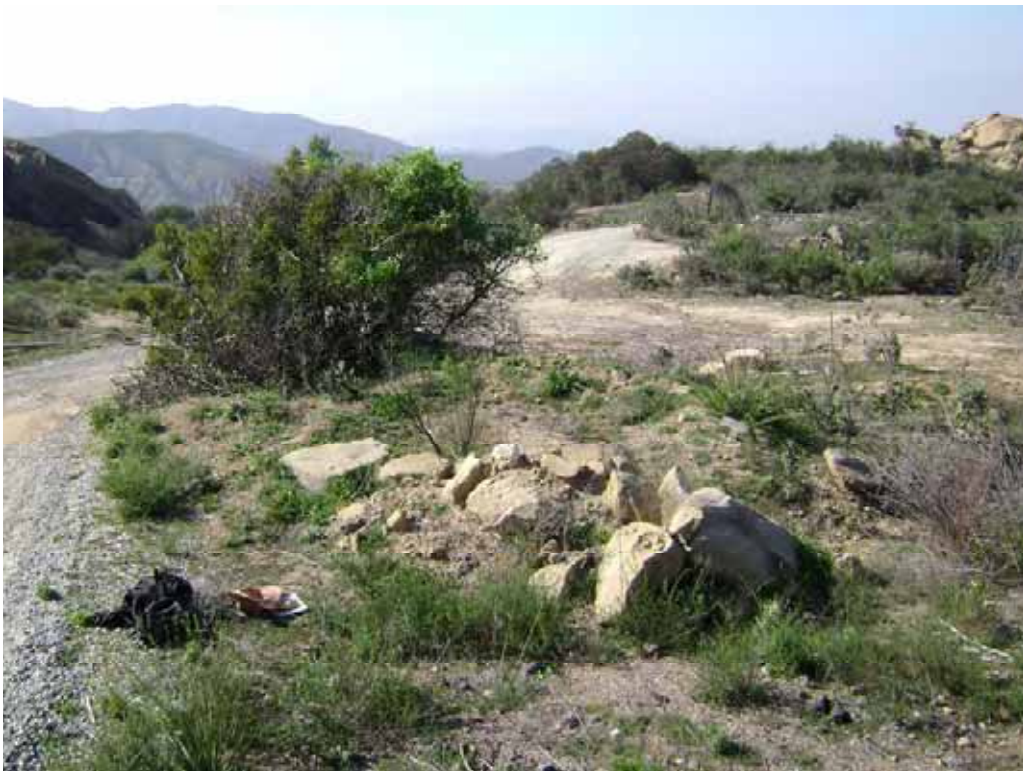
Debris ID: CH2-G07-1011

| Waste Debris Area Identifier | Date of Discovery | Description | Estimated Debris Area Size (sq. ft.) | Map Grid Number ¹ | Coordinates ² | | Status ³ | Comments |
|---|---|--|---|---|---|---|---|---|
| CH2-G07-1011 | 2/13/2008 | Soil pile with intermixed concrete and asphalt debris. | 753 | H04 | 267743.441 | 1784962.075 | Not Removed | |

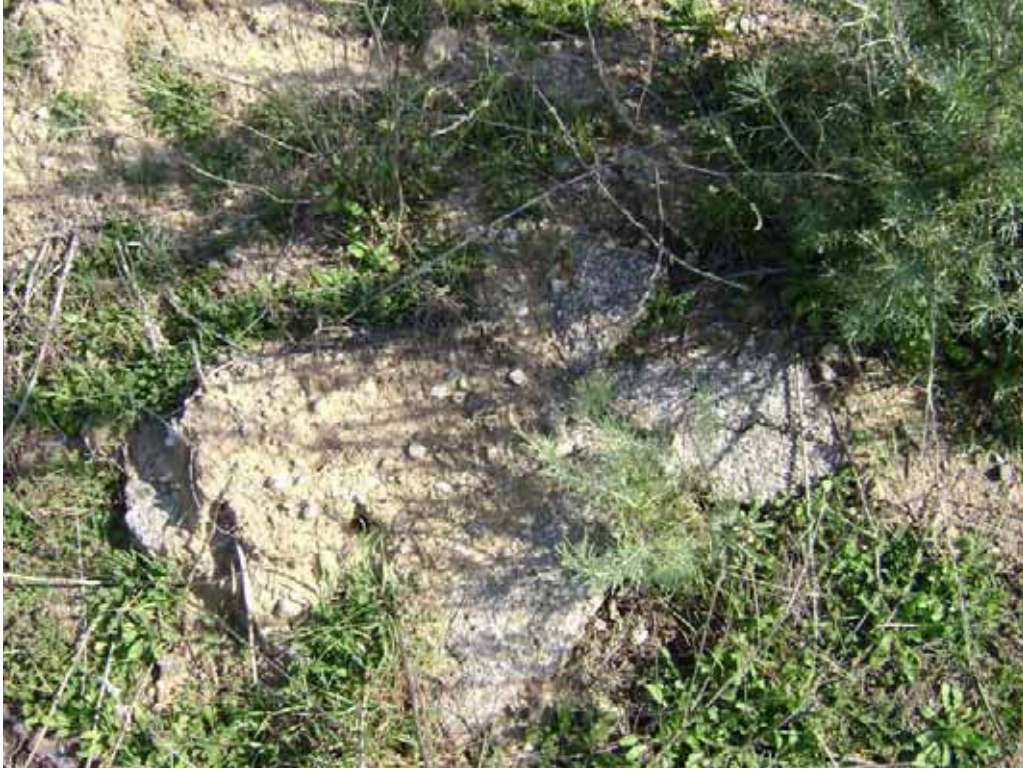
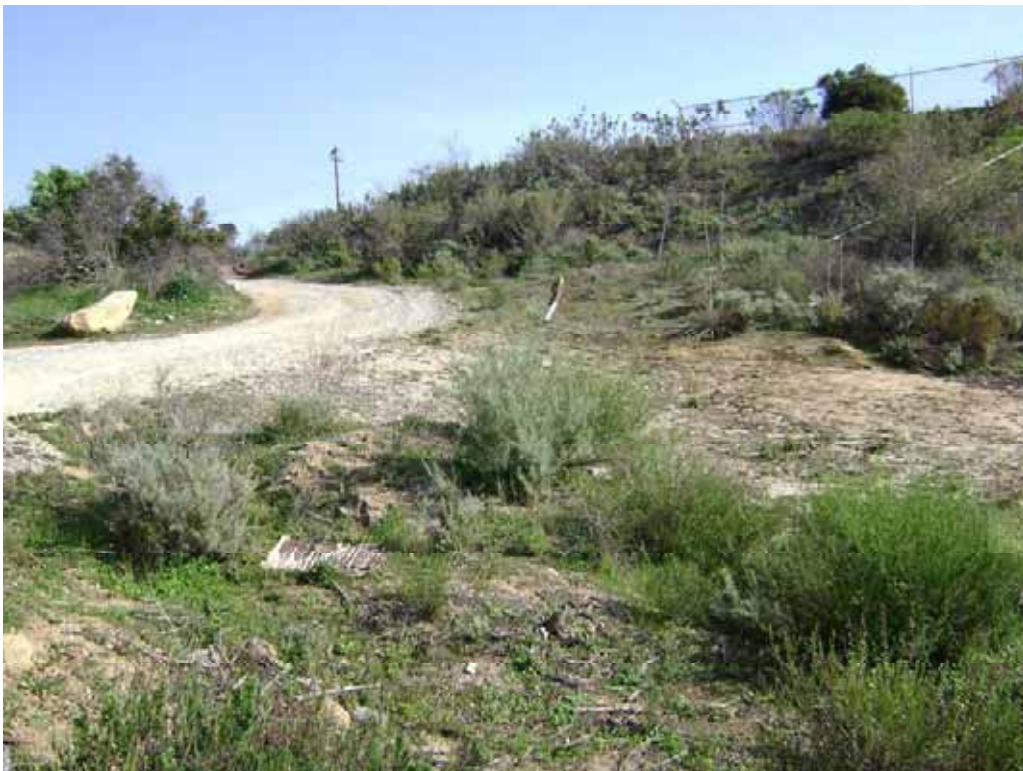
Debris ID: CH2-G07-1012

| Waste Debris Area Identifier | Date of Discovery | Description | Estimated Debris Area Size (sq. ft.) | Map Grid Number ¹ | Coordinates ² | | Status ³ | Comments |
|---|---|--|---|---|---|---|---|---|
| CH2-G07-1012 | 2/13/2008 | Soil pile with intermixed asphalt debris. | < 100 | H04 | 267739.333 | 1784866.766 | Not Removed | |

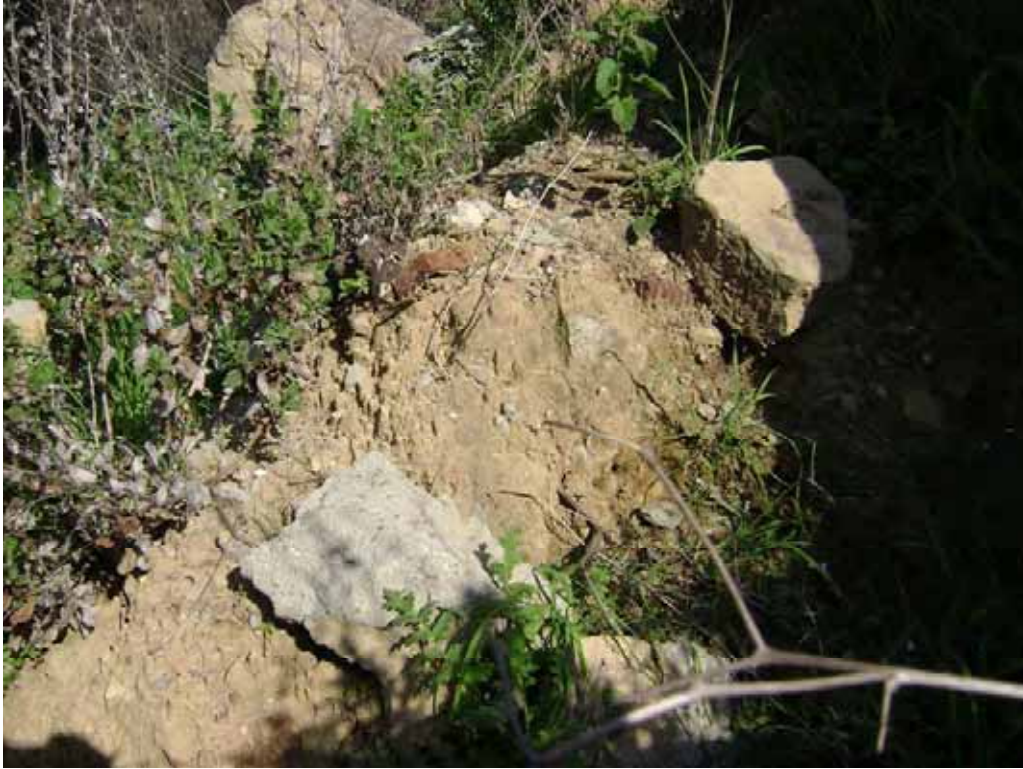
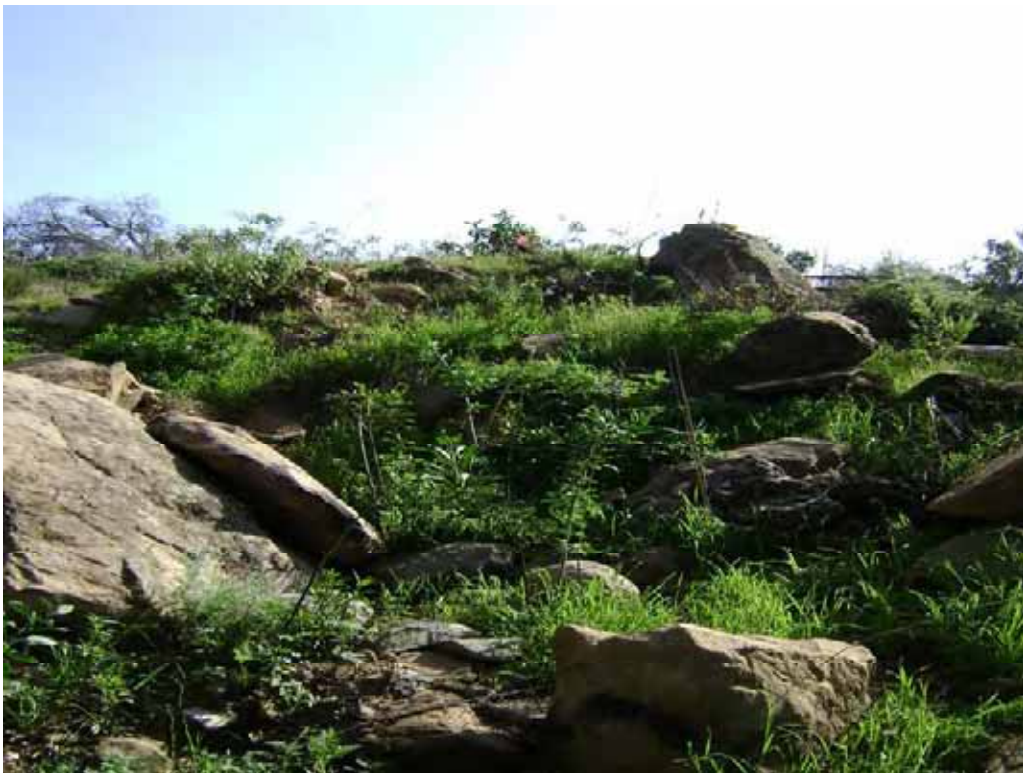
Debris ID: CH2-G07-1013

| Waste Debris Area Identifier | Date of Discovery | Description | Estimated Debris Area Size (sq. ft.) | Map Grid Number ¹ | Coordinates ² | | Status ³ | Comments |
|---|---|--|---|---|---|---|---|---|
| CH2-G07-1013 | 2/13/2008 | Soil pile with intermixed concrete, asphalt and metal debris. | 1,357 | H04 | 267956.460 | 1784947.948 | Not Removed | |

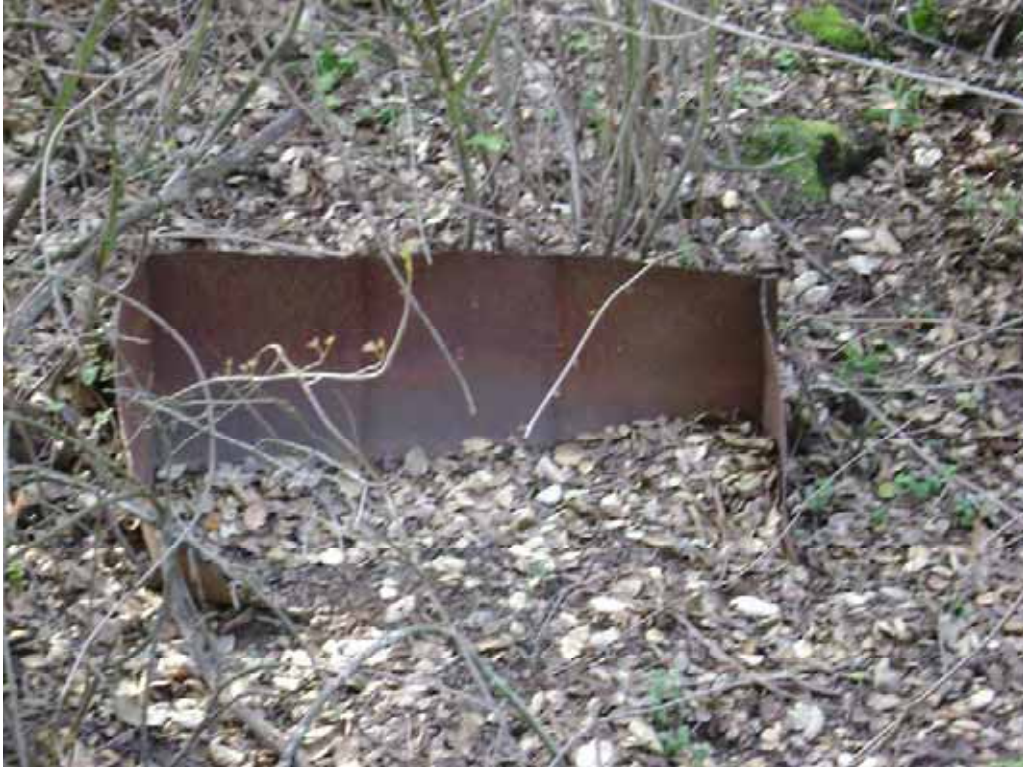
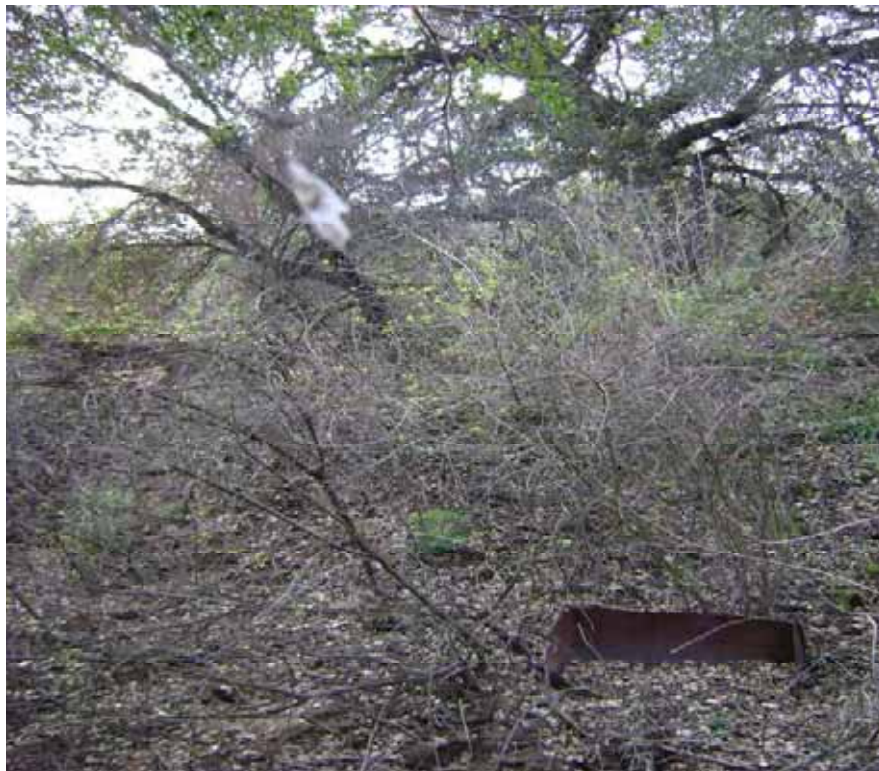
Debris ID: CH2-G07-1014

| Waste Debris Area Identifier | Date of Discovery | Description | Estimated Debris Area Size (sq. ft.) | Map Grid Number ¹ | Coordinates ² | | Status ³ | Comments |
|---|---|--|---|---|---|---|---|---|
| CH2-G07-1014 | 2/13/2008 | 55-gallon drum cut in half lengthwise and partially filled with soil. | < 100 | H04 | 267999.989 | 1784933.755 | Not Removed | |

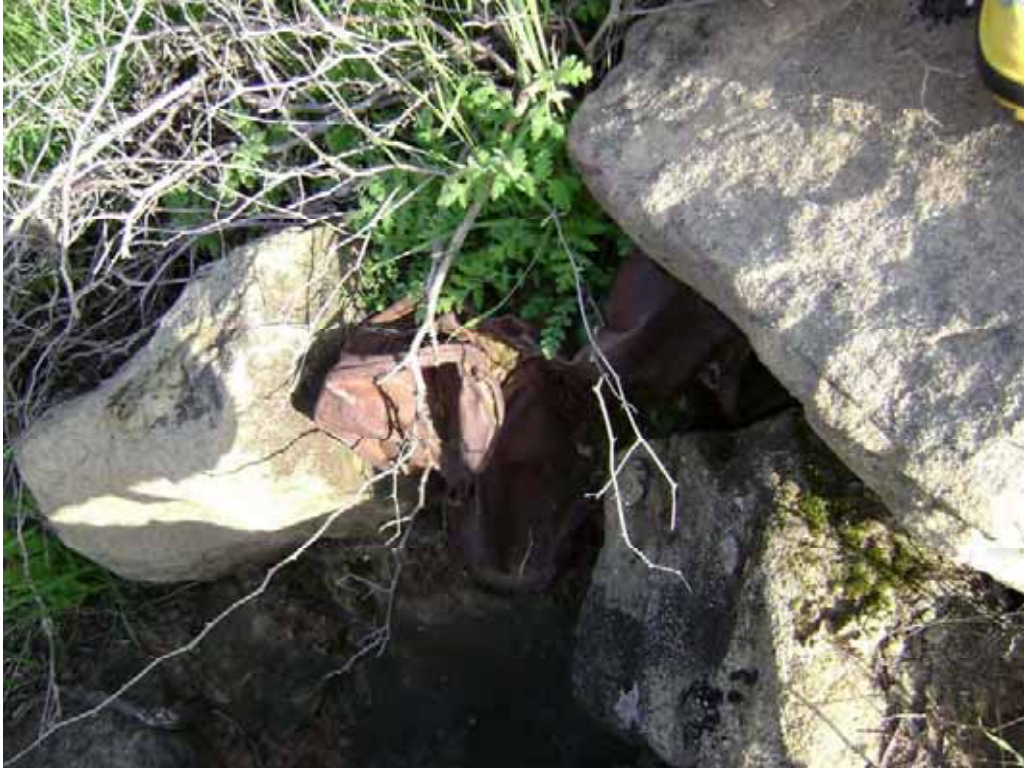
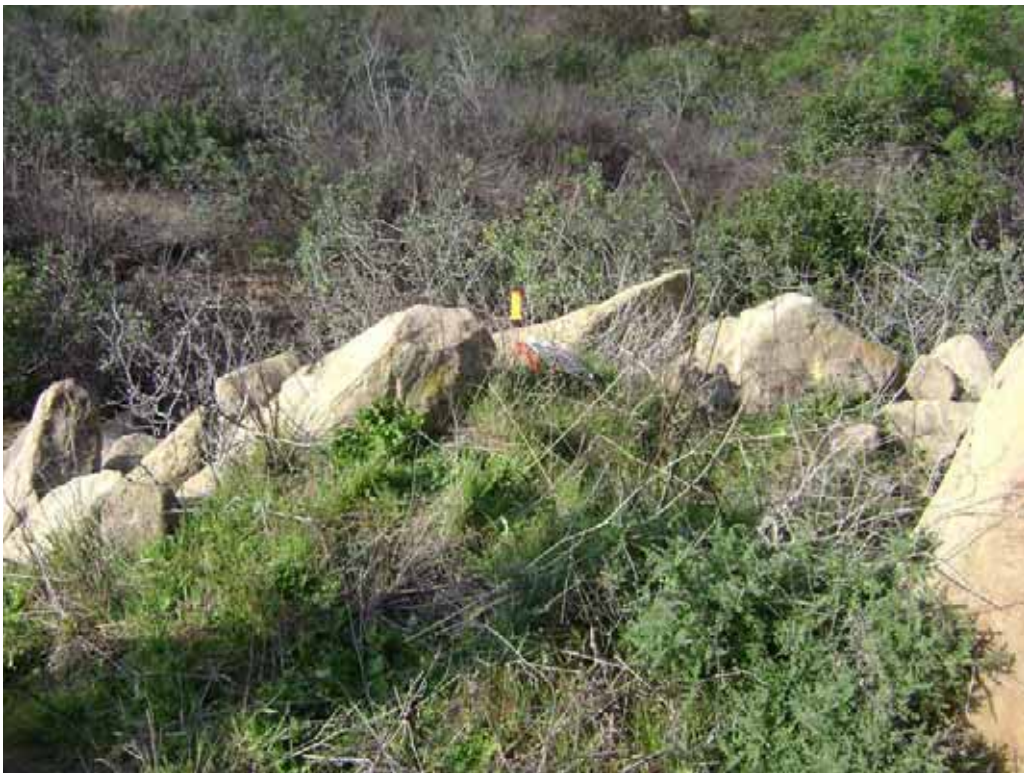
Debris ID: CH2-G07-1015

| Waste Debris Area Identifier | Date of Discovery | Description | Estimated Debris Area Size (sq. ft.) | Map Grid Number ¹ | Coordinates ² | | Status ³ | Comments |
|---|---|--|---|---|---|---|---|---|
| CH2-G07-1015 | 2/13/2008 | Two crushed 5-gallon metal containers within a soil pile intermixed with asphalt and concrete. | < 100 | H04 | 267591.433 | 1784685.332 | Not Removed | |

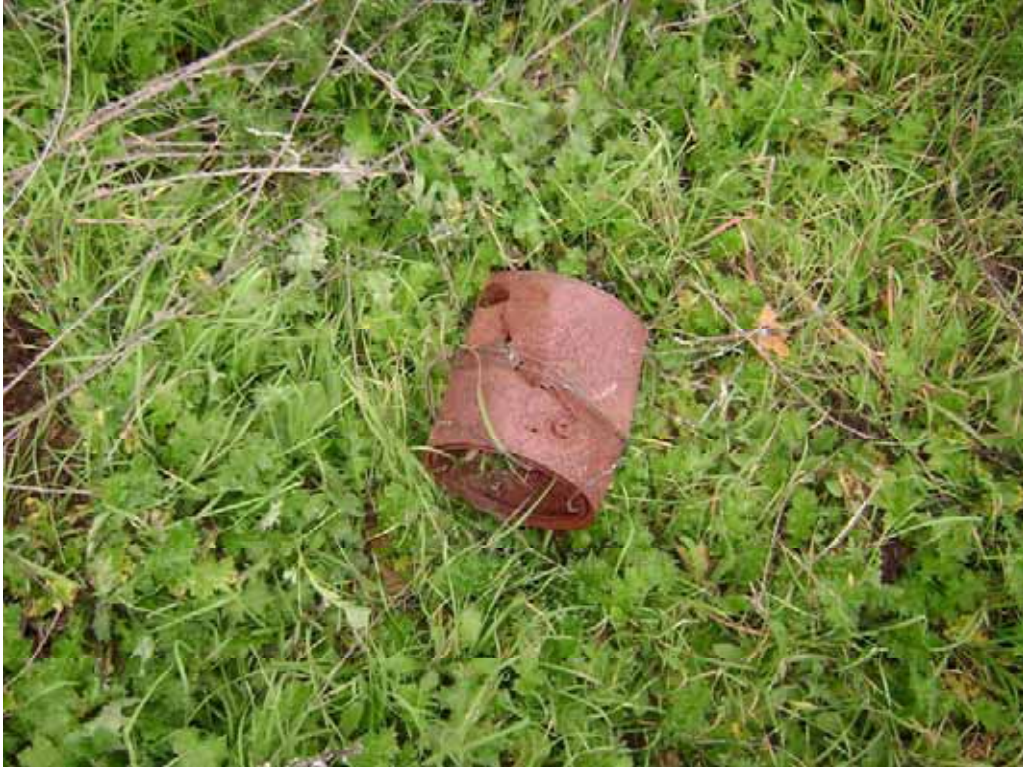
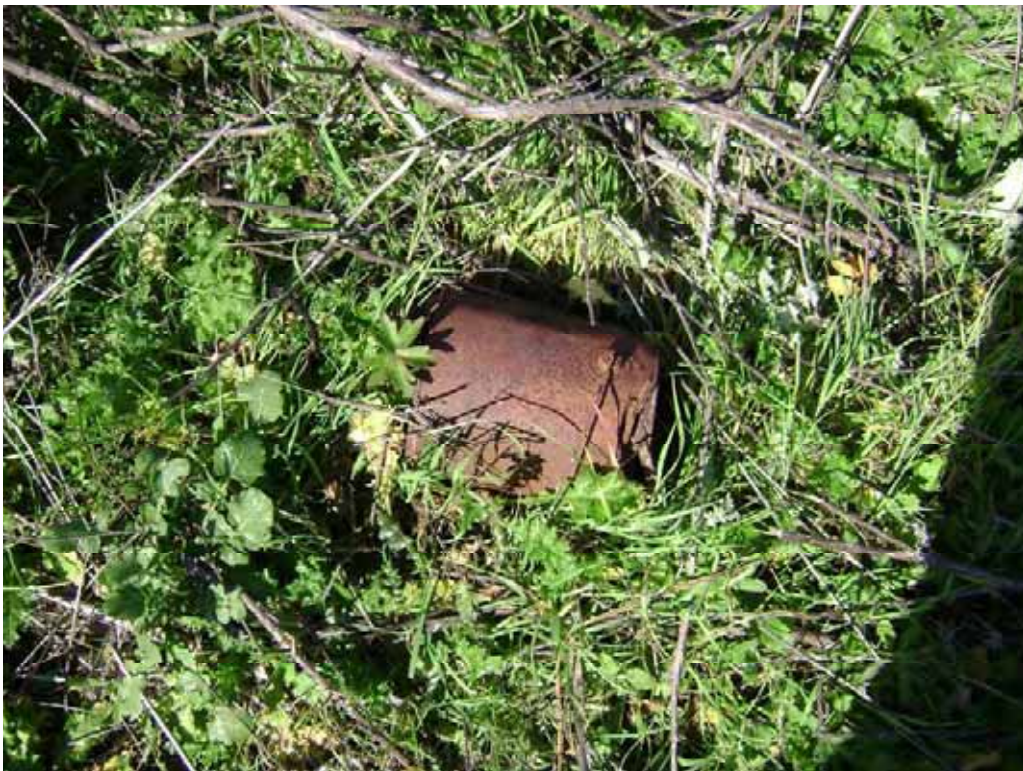
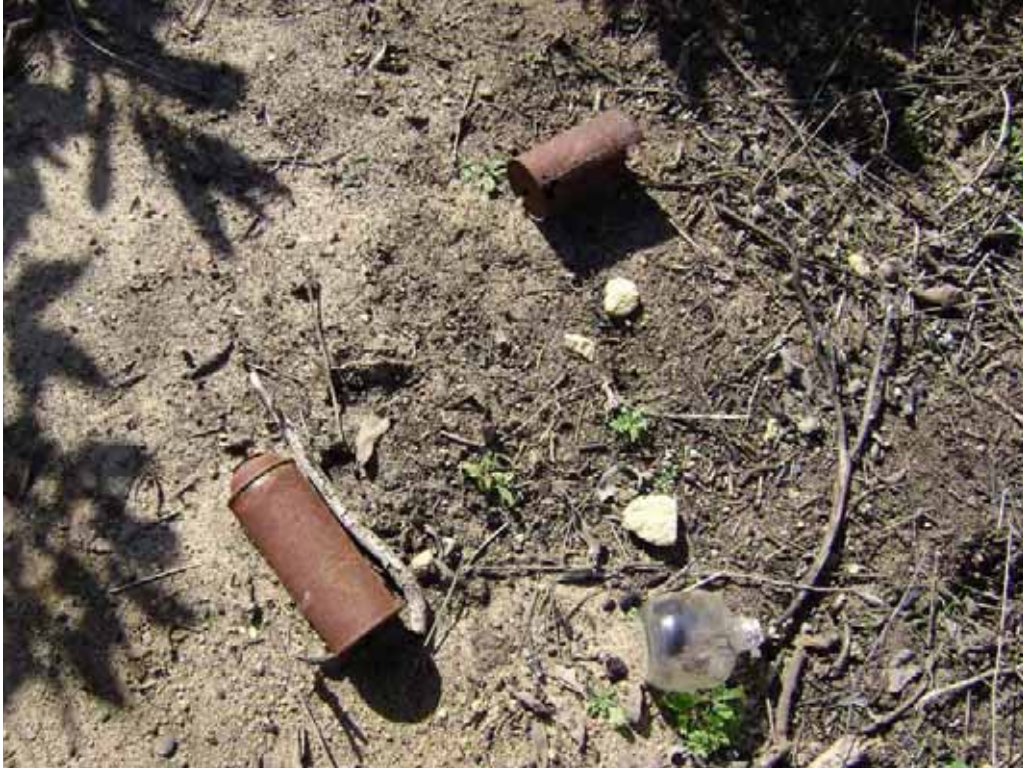
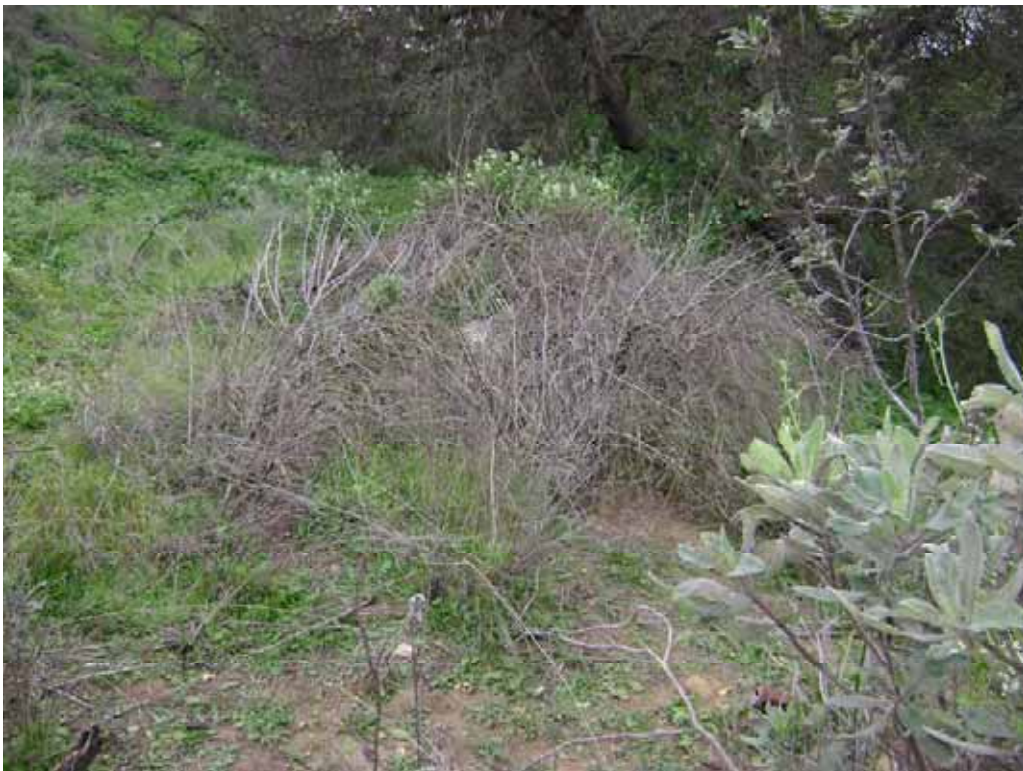
Debris ID: CH2-G07-1016

| Waste Debris Area Identifier | Date of Discovery | Description | Estimated Debris Area Size (sq. ft.) | Map Grid Number ¹ | Coordinates ² | | Status ³ | Comments |
|---|---|--|---|---|---|---|---|---|
| CH2-G07-1016 | 2/13/2008 | Soil pile intermixed with spray paint cans (empty), ceramic insulators with filaments attached, concrete and scrap metal. | 2,458 | H04 | 267521.646 | 1784594.467 | Not Removed | |

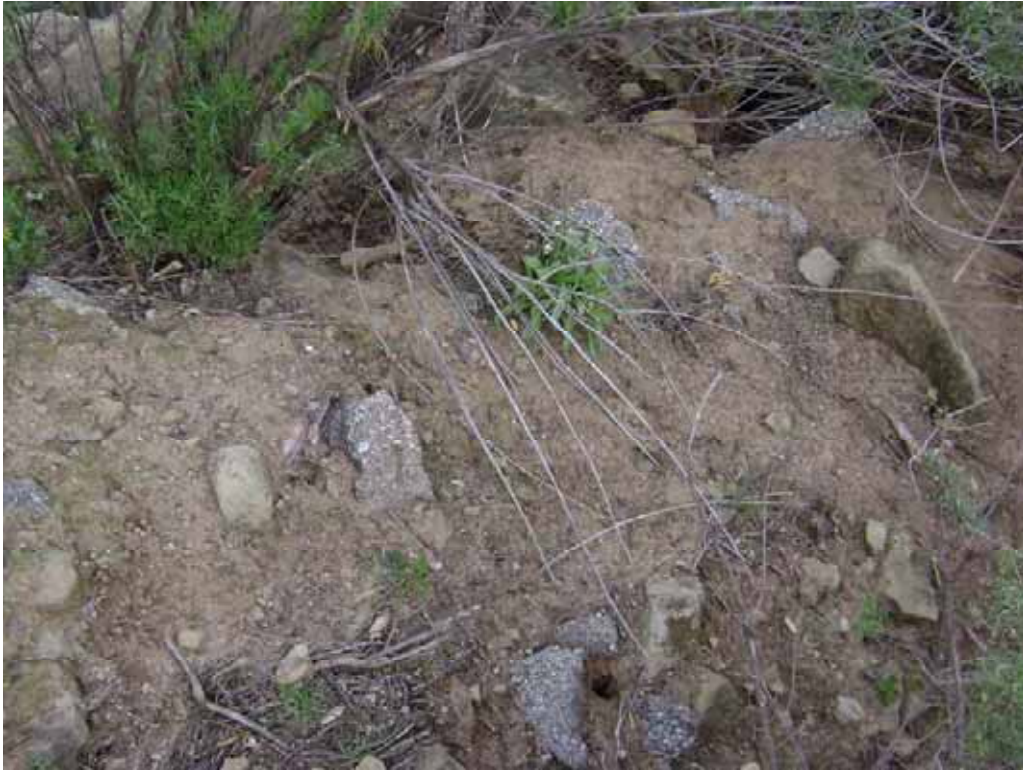
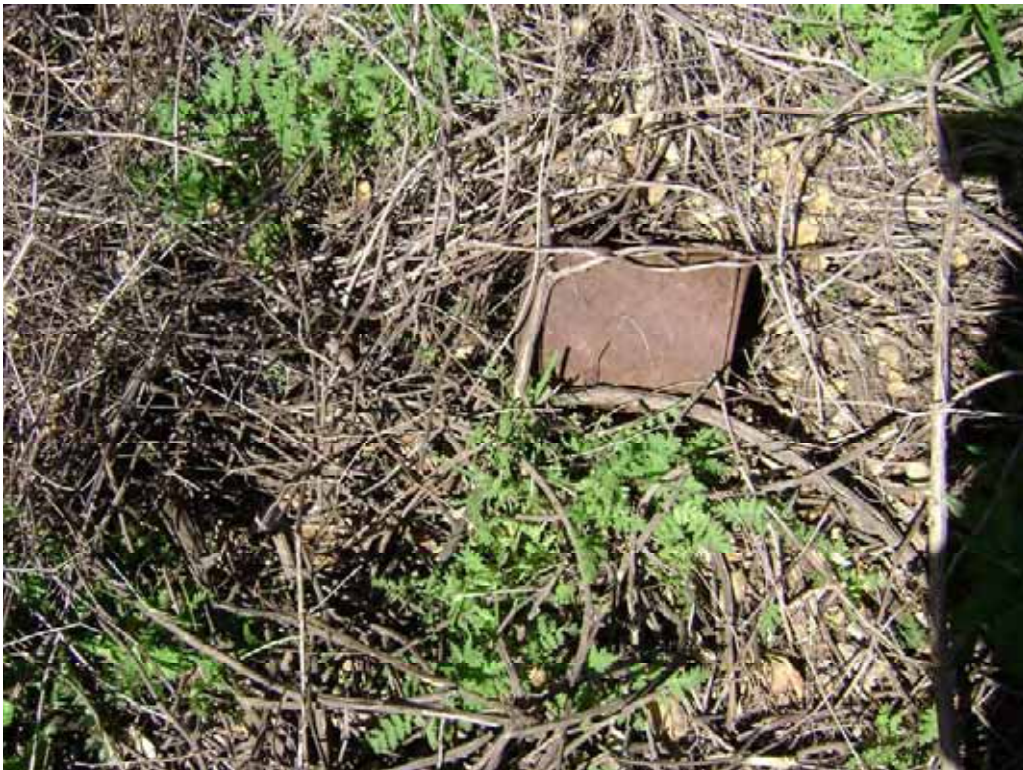
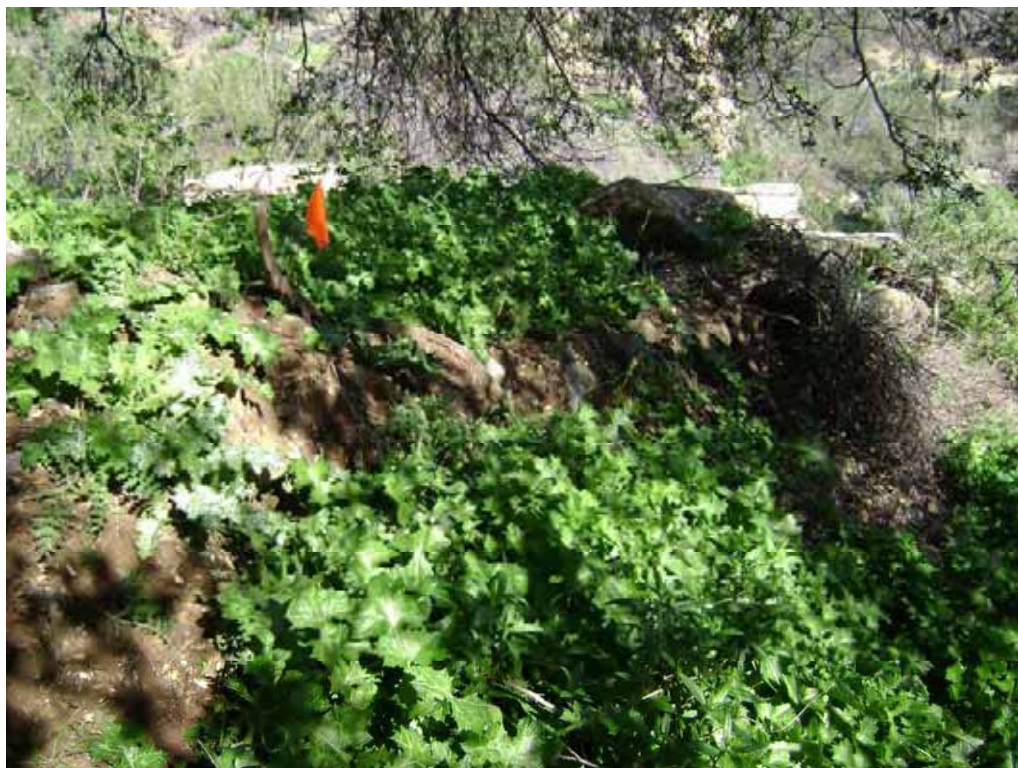
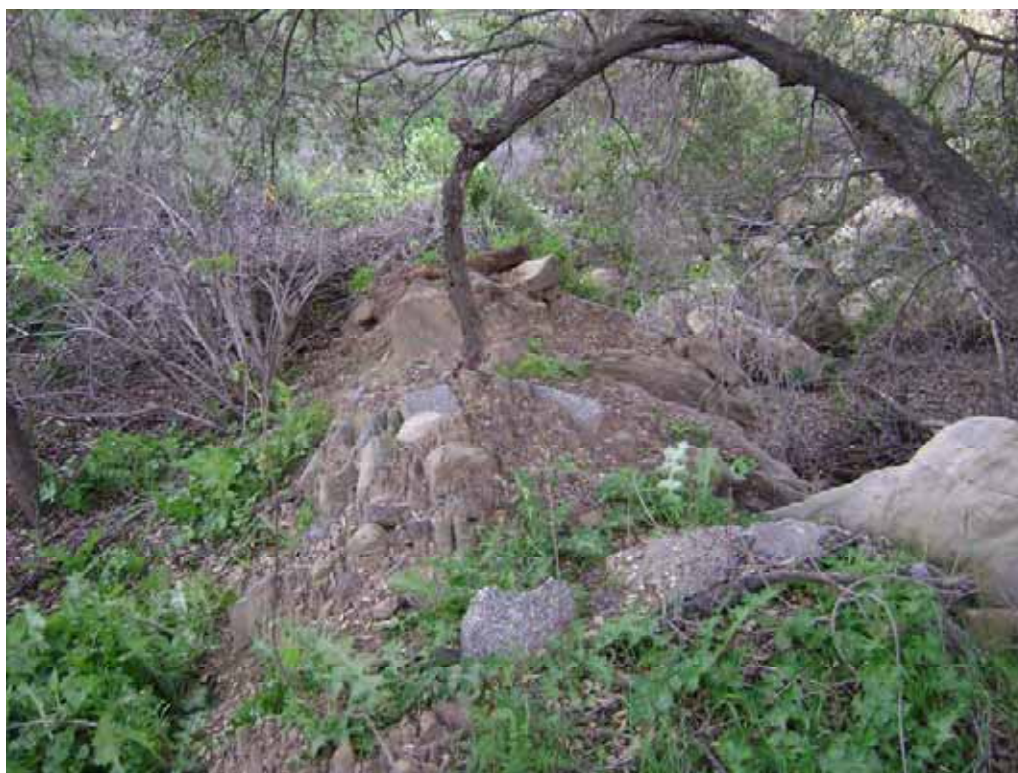
Debris ID: CH2-G07-1017

| Waste Debris Area Identifier | Date of Discovery | Description | Estimated Debris Area Size (sq. ft.) | Map Grid Number ¹ | Coordinates ² | | Status ³ | Comments |
|---|---|--|---|---|---|---|---|---|
| CH2-G07-1017 | 2/14/2008 | Soil pile intermixed with concrete, asphalt, one paint can (empty), and scrap metal in a long narrow pile. | 2,866 | H04 | 267466.181 | 1784505.061 | Not Removed | |

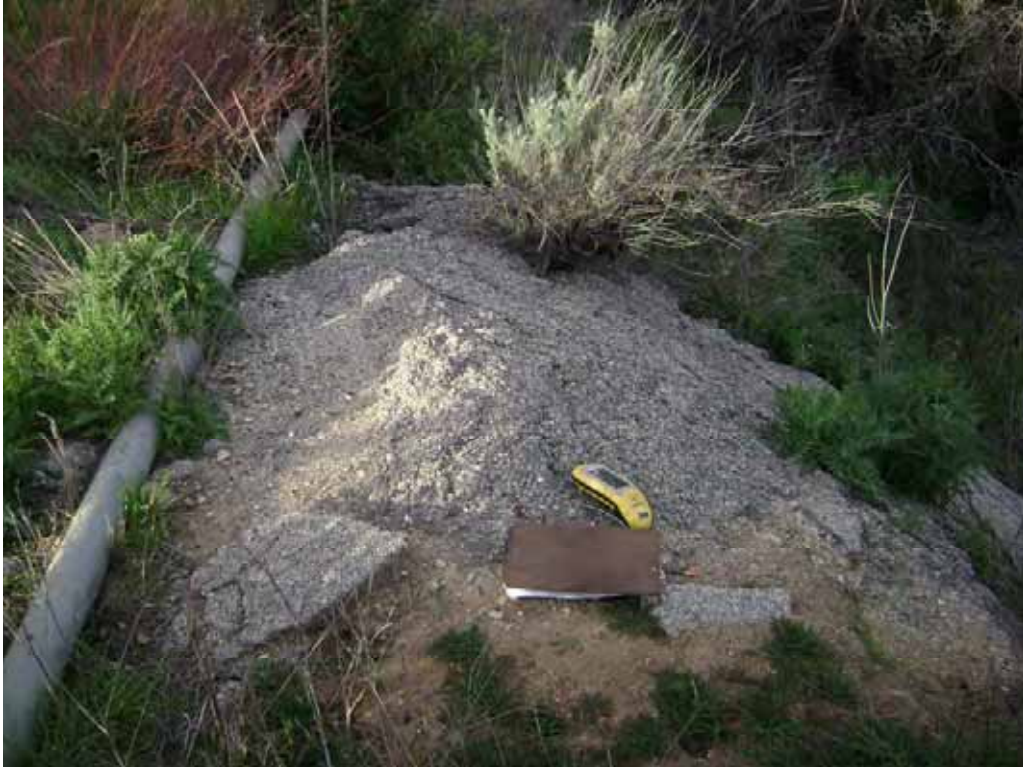
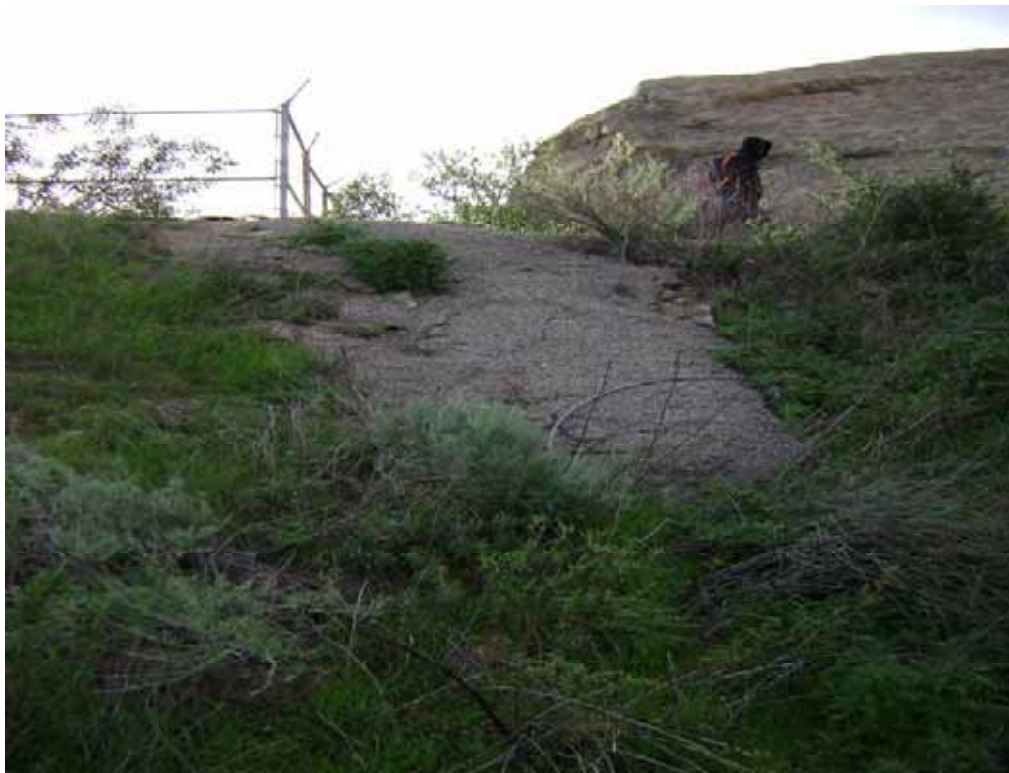
Debris ID: CH2-G07-1018

| Waste Debris Area Identifier | Date of Discovery | Description | Estimated Debris Area Size (sq. ft.) | Map Grid Number ¹ | Coordinates ² | | Status ³ | Comments |
|---|---|--|---|---|---|---|---|---|
| CH2-G07-1018 | 2/14/2008 | Soil pile with intermixed asphalt material on hillside. | < 100 | H04 | 267360.928 | 1784443.688 | Not Removed | |

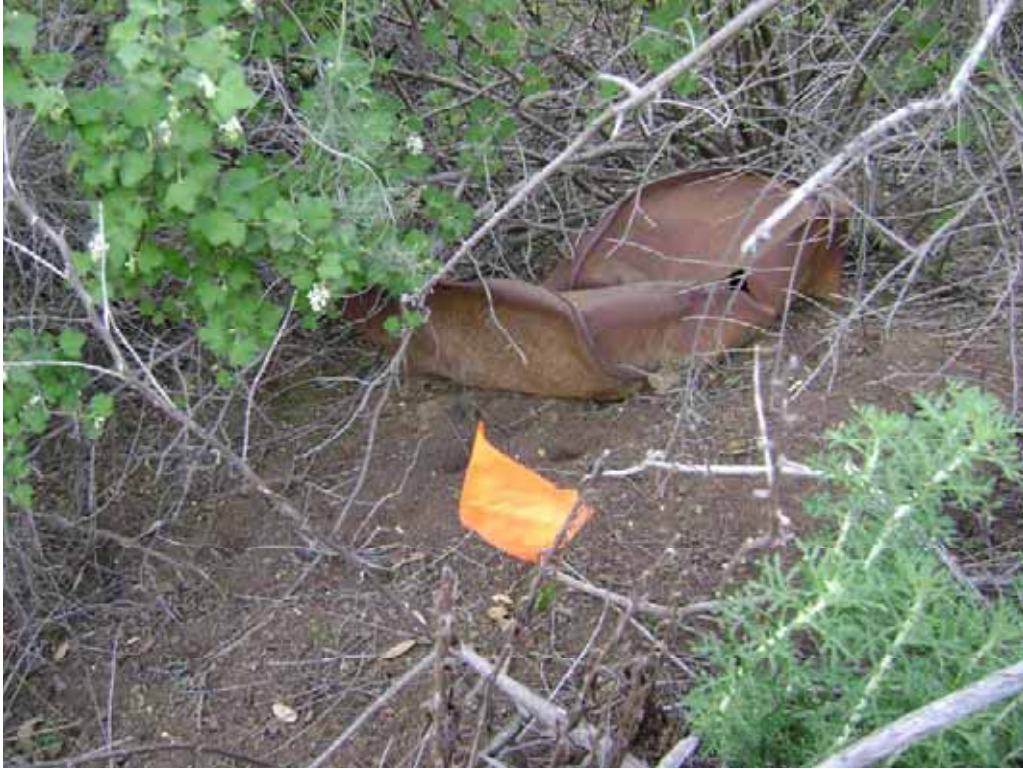
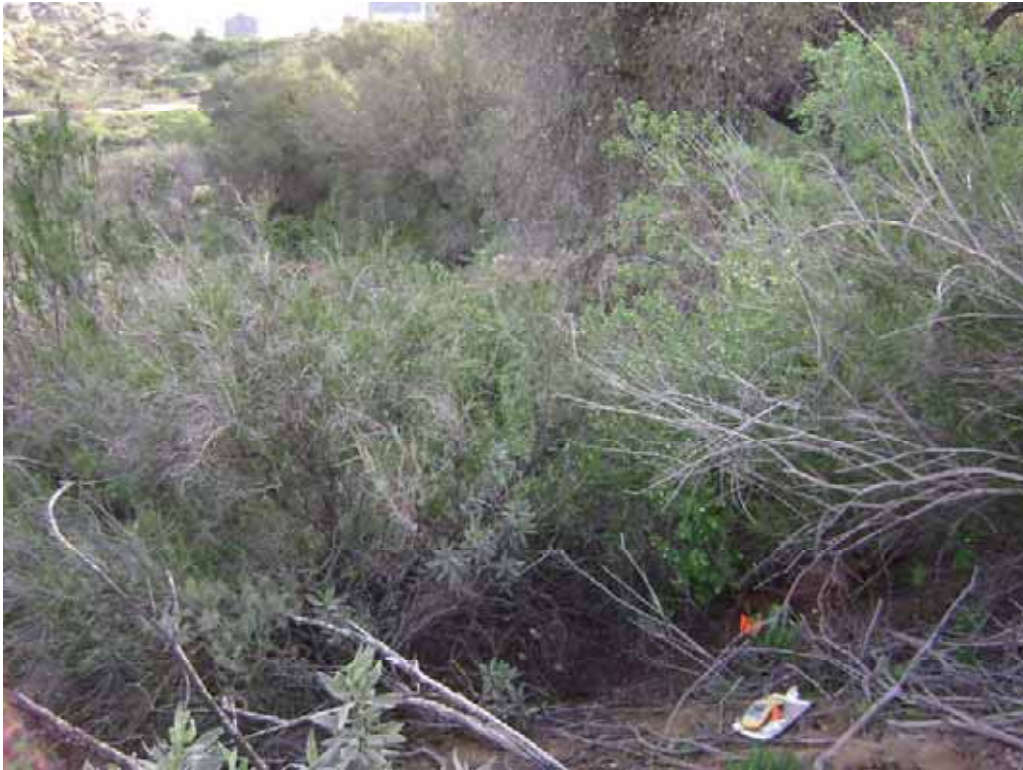
Debris ID: CH2-G07-1019

| Waste Debris Area Identifier | Date of Discovery | Description | Estimated Debris Area Size (sq. ft.) | Map Grid Number ¹ | Coordinates ² | | Status ³ | Comments |
|---|---|--|---|---|---|---|---|---|
| CH2-G07-1019 | 2/14/2008 | Crushed 55-gallon drum (empty) found within dense vegetation. | < 100 | H04 | 267471.643 | 1784411.669 | Not Removed | |

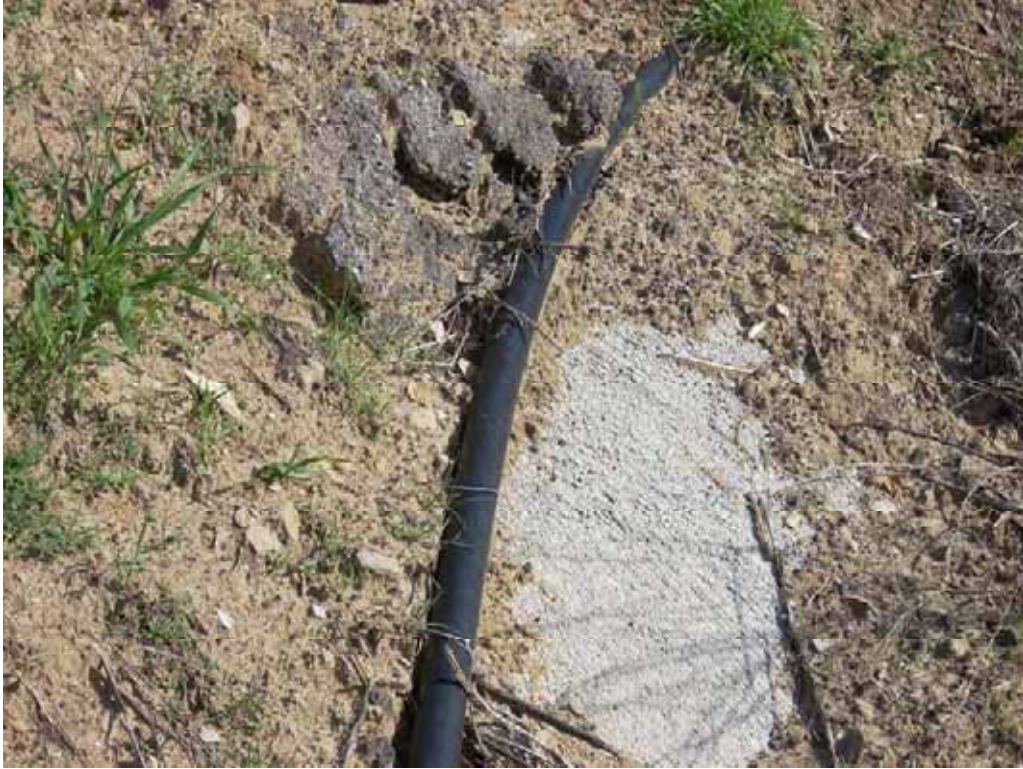
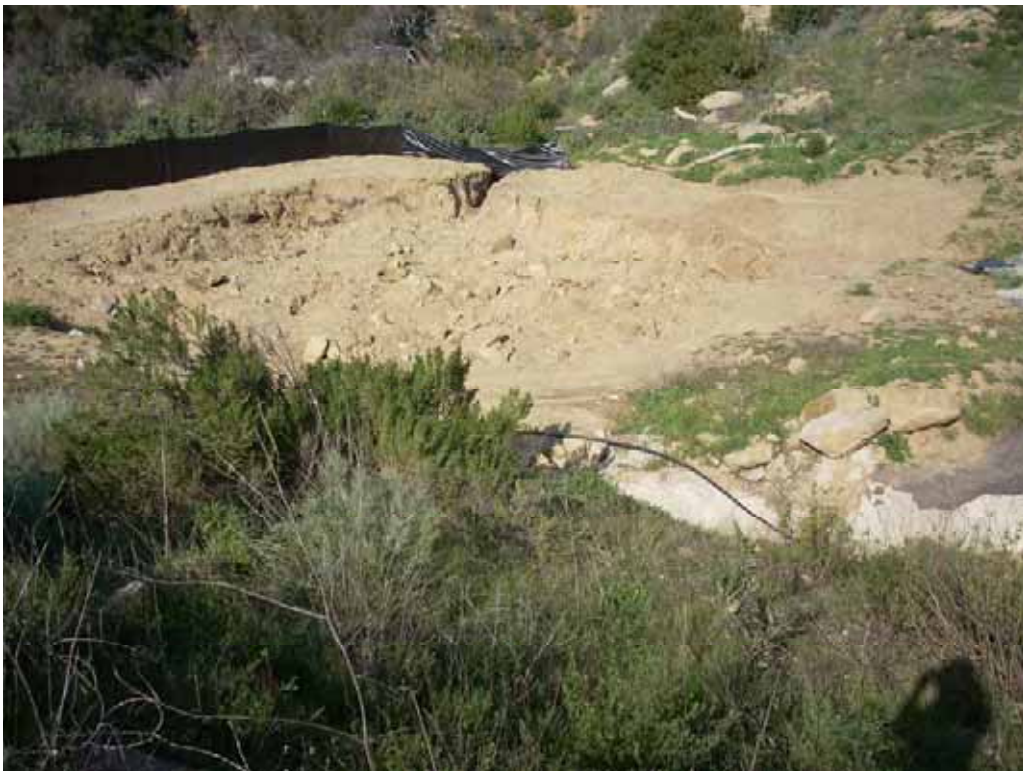
Debris ID: CH2-G07-2043

| Waste Debris Area Identifier | Date of Discovery | Description | Estimated Debris Area Size (sq. ft.) | Map Grid Number ¹ | Coordinates ² | | Status ³ | Comments |
|---|---|--|---|---|---|---|---|---|
| CH2-G07-2043 | 2/13/2008 | Debris in and around open excavation (appears to be former Building 4614 location). Debris includes concrete, asphalt, metal pipes and fence posts. | 10,087 | H05 | 267806.923 | 1785051.844 | Not Removed | |

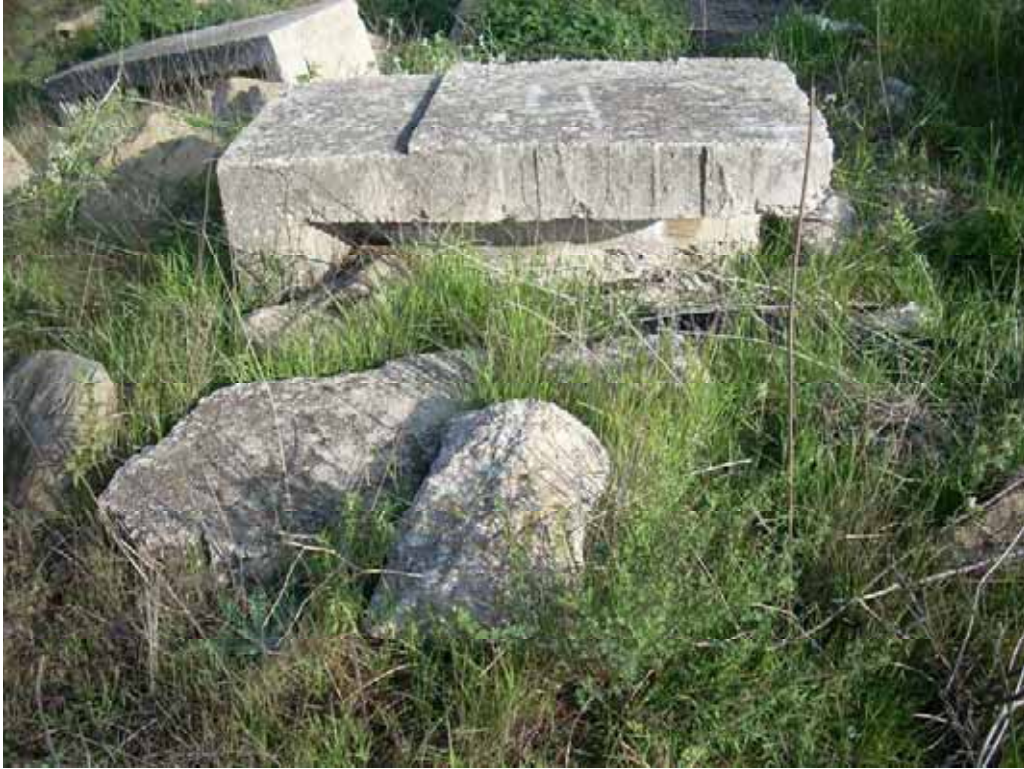
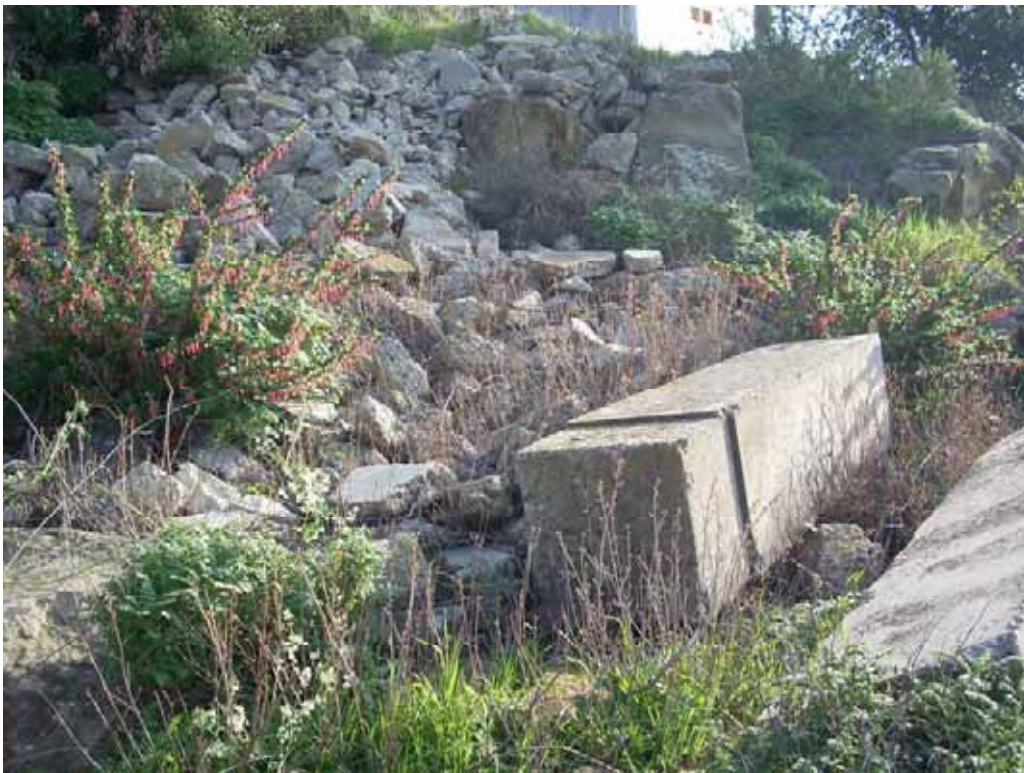
Debris ID: CH2-G07-2044

| Waste Debris Area Identifier | Date of Discovery | Description | Estimated Debris Area Size (sq. ft.) | Map Grid Number ¹ | Coordinates ² | | Status ³ | Comments |
|---|---|--|---|---|---|---|---|---|
| CH2-G07-2044 | 2/13/2008 | Large concrete blocks and smaller broken pieces of concrete. | < 100 | H05 | 267955.263 | 1785232.657 | Not Removed | |

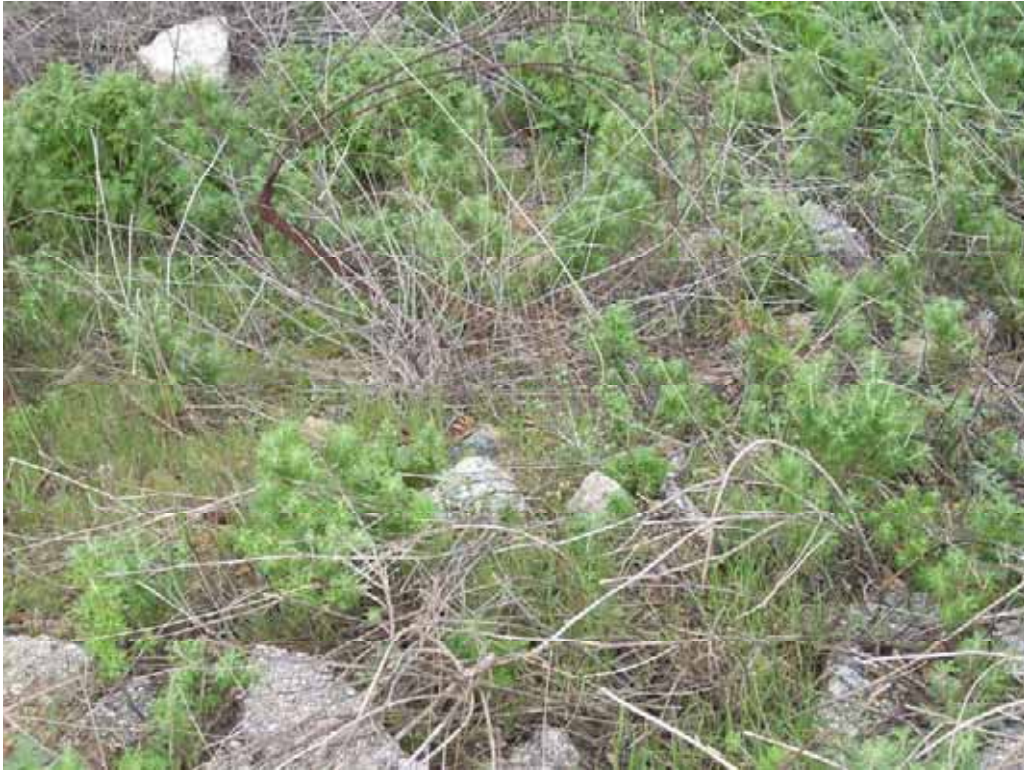
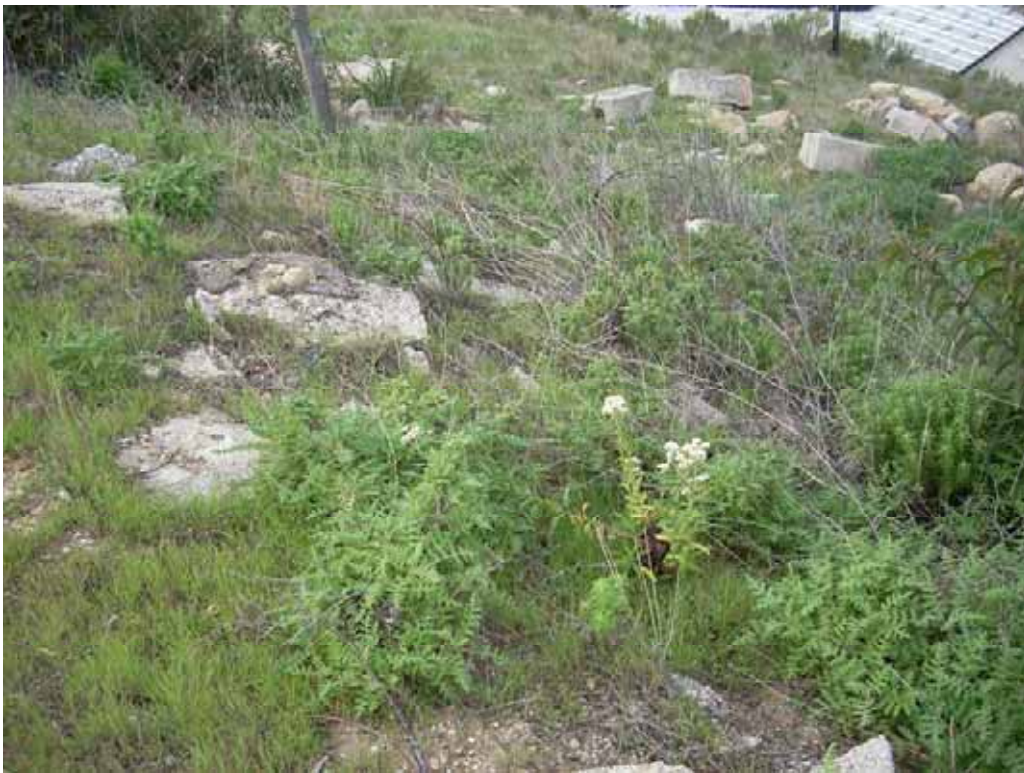
Debris ID: CH2-G07-2045

| Waste Debris Area Identifier | Date of Discovery | Description | Estimated Debris Area Size (sq. ft.) | Map Grid Number ¹ | Coordinates ² | | Status ³ | Comments |
|---|---|--|---|---|---|---|---|---|
| CH2-G07-2045 | 2/13/2008 | Asphalt and metal wire down slope from Building 4075. | < 100 | H05 | 267926.986 | 1785257.783 | Not Removed | |
