APPENDIX F

GROUP 7 2008 WASTE DEBRIS SURVEY RESULTS

**Table F-1
Waste Debris Areas - RFI Group 7
Santa Susana Field Laboratory**

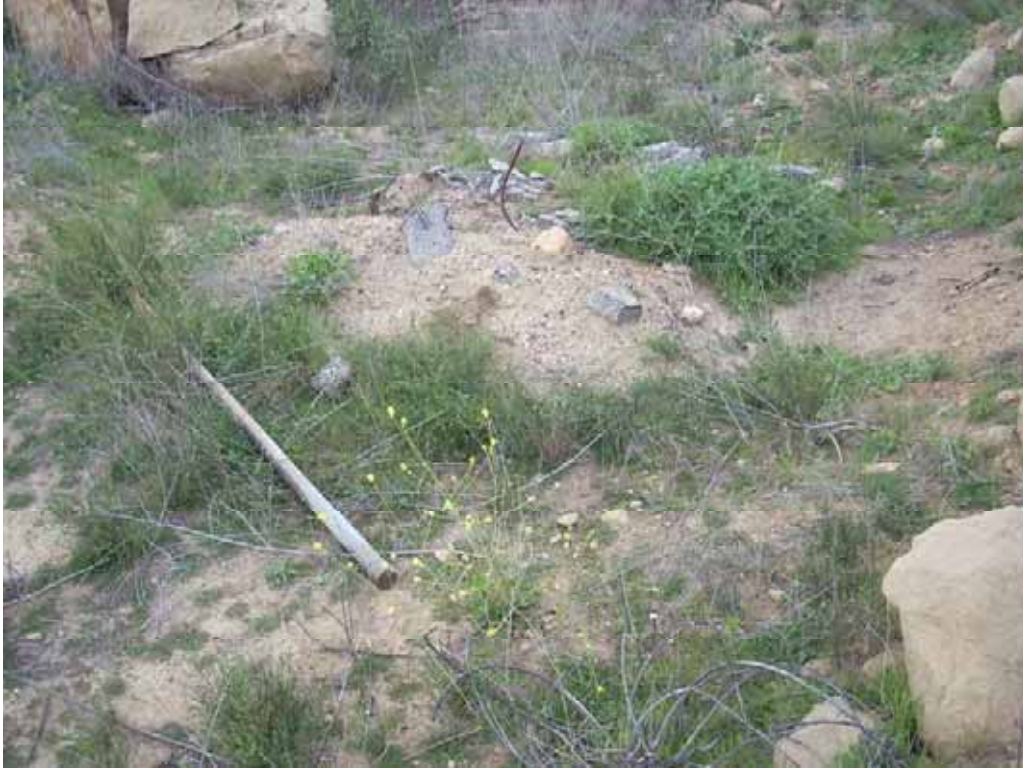
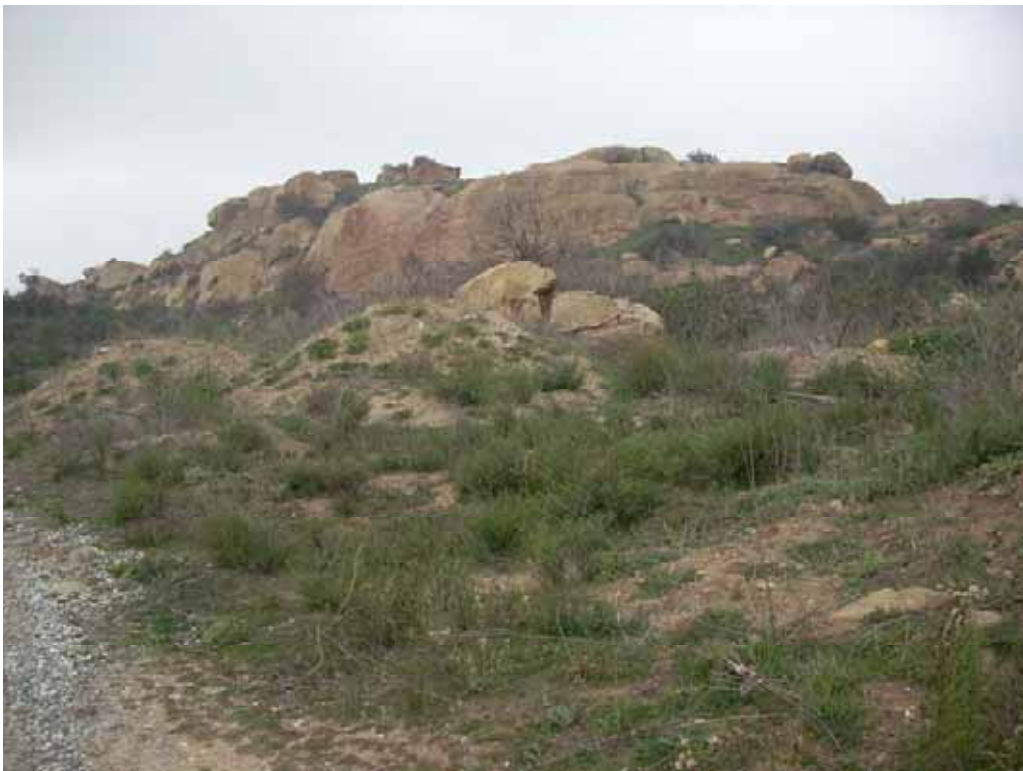
Debris ID: CH2-G07-2046

| Waste Debris Area Identifier | Date of Discovery | Description | Estimated Debris Area Size (sq. ft.) | Map Grid Number ¹ | Coordinates ² | | Status ³ | Comments |
|---|---|--|---|---|---|---|---|---|
| CH2-G07-2046 | 2/13/2008 | Soil piles intermixed with asphalt, concrete, metal pipes and scrap metal. | 1,805 | H05 | 267725.409 | 1785012.642 | Not Removed | |

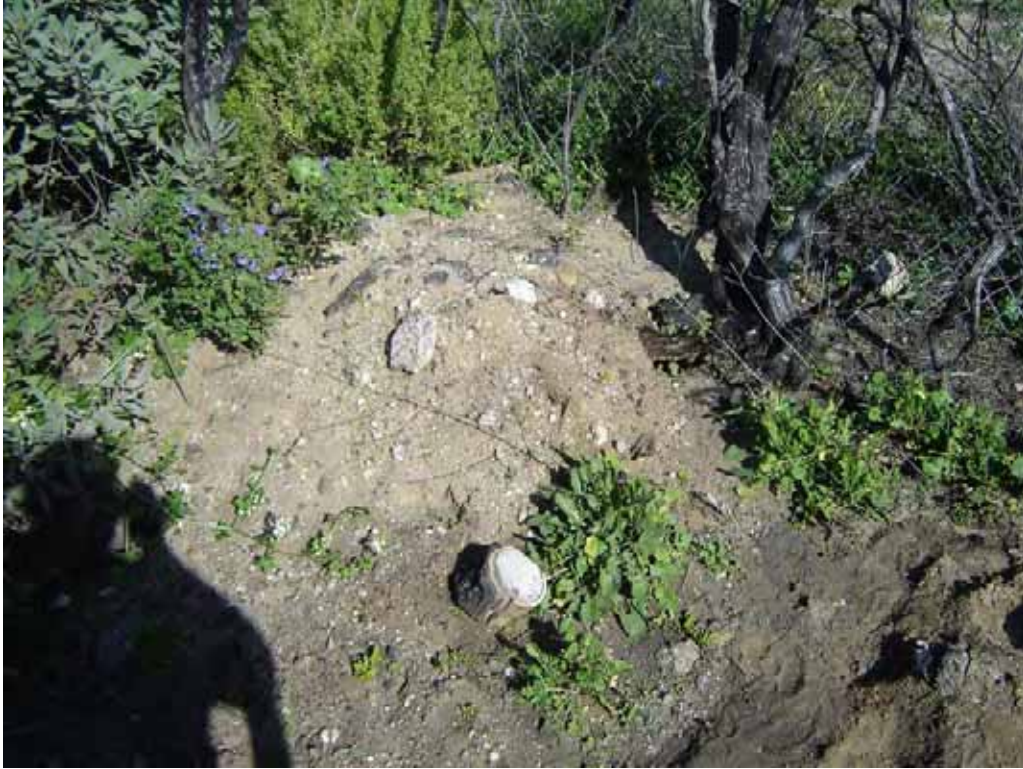
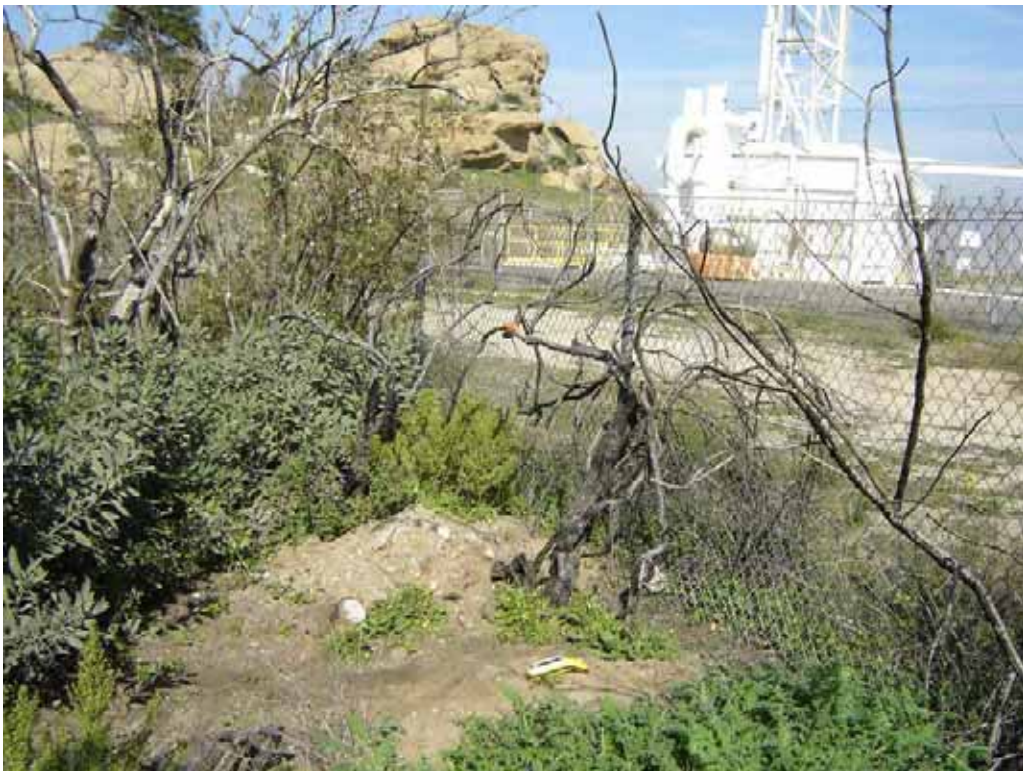
Debris ID: CH2-G07-3020

| Waste Debris Area Identifier | Date of Discovery | Description | Estimated Debris Area Size (sq. ft.) | Map Grid Number ¹ | Coordinates ² | | Status ³ | Comments |
|---|---|--|---|---|---|---|---|---|
| CH2-G07-3020 | 2/13/2008 | Two approximately 4-ft x 4-ft soil piles intermixed with concrete, asphalt debris and a 6-inch length of Schedule-40 PVC filled with concrete. Small topographic low (approximately 2 ft deep) with broken glass present is situated between soil piles. | < 100 | I05 | 268124.854 | 1785840.307 | Not Removed | |

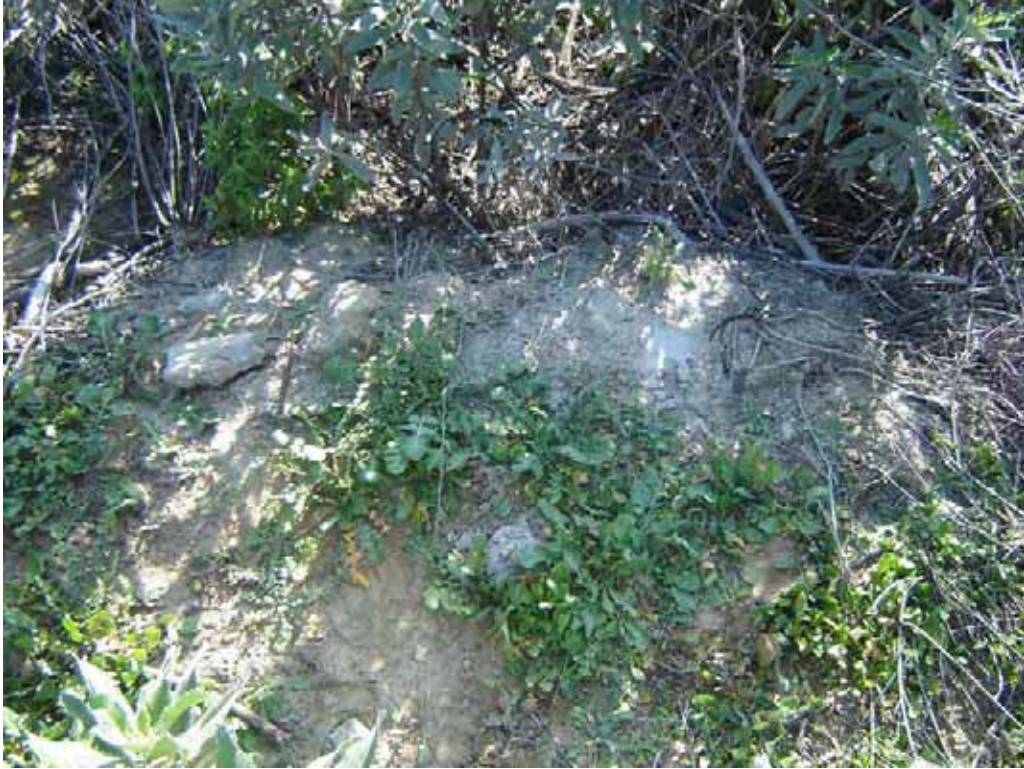
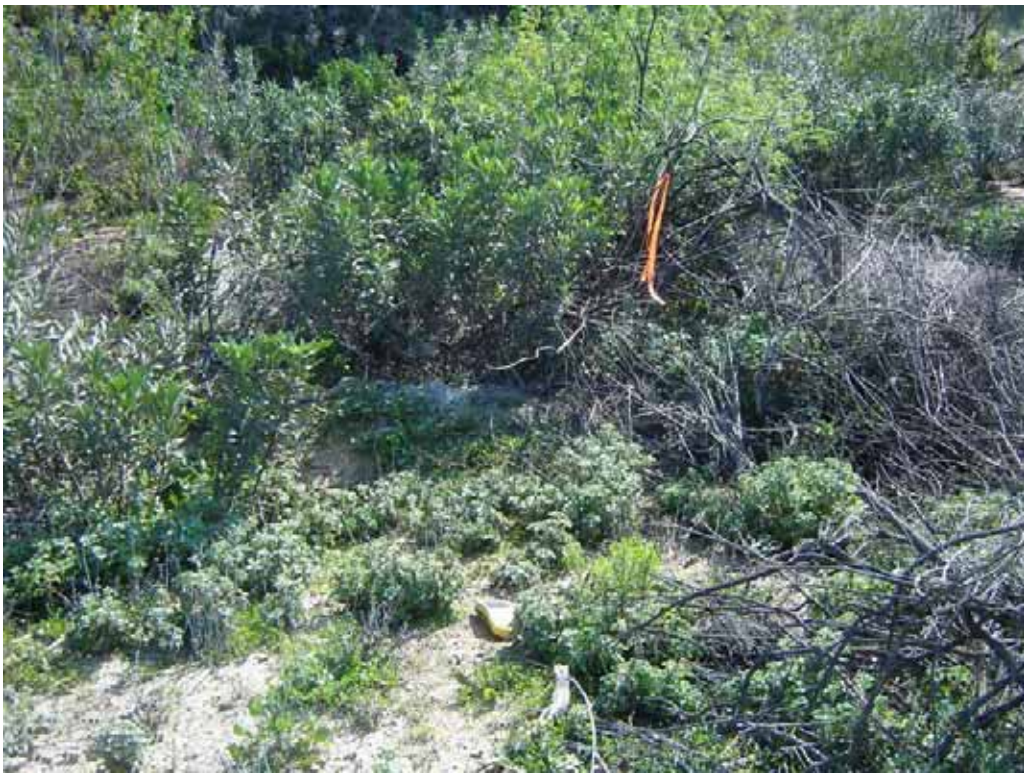
Debris ID: CH2-G07-3021

| Waste Debris Area Identifier | Date of Discovery | Description | Estimated Debris Area Size (sq. ft.) | Map Grid Number ¹ | Coordinates ² | | Status ³ | Comments |
|---|---|--|---|---|---|---|---|---|
| CH2-G07-3021 | 2/13/2008 | Approximate 3-ft x 5-ft soil pile intermixed with broken pieces of concrete and grey crumbling substance (possibly grout from | < 100 | I05 | 268183.366 | 1785781.046 | Not Removed | |

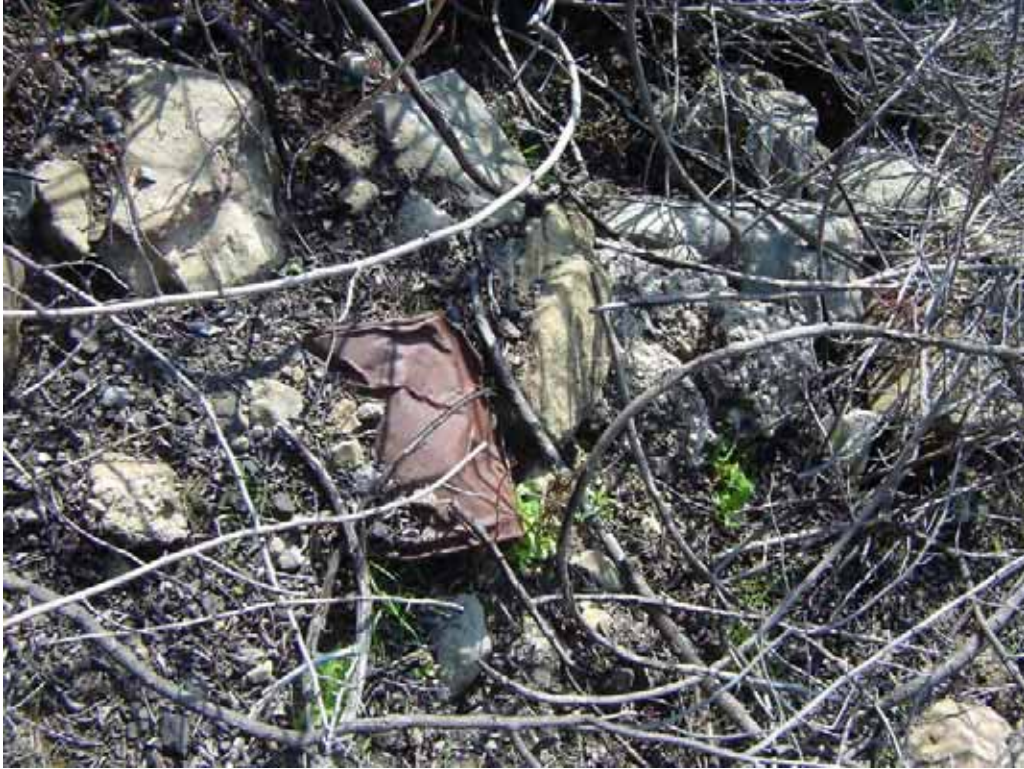
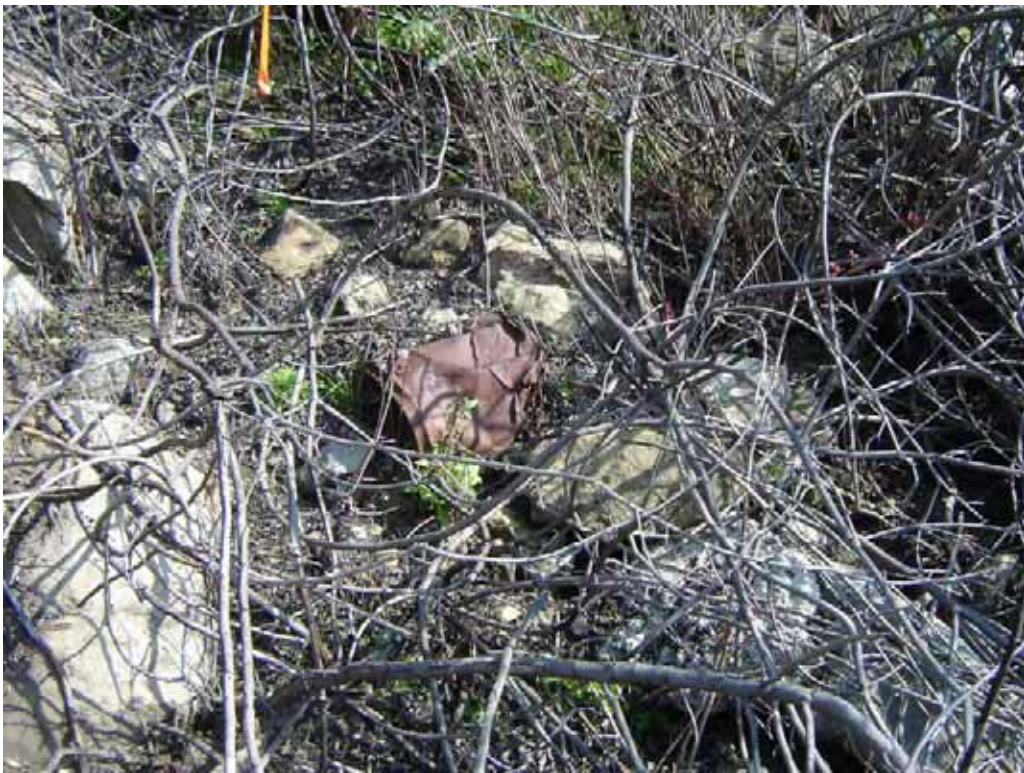
Debris ID: CH2-G07-3022

| Waste Debris Area Identifier | Date of Discovery | Description | Estimated Debris Area Size (sq. ft.) | Map Grid Number ¹ | Coordinates ² | | Status ³ | Comments |
|---|---|--|---|---|---|---|---|---|
| CH2-G07-3022 | 2/13/2008 | Two 2.5 gallon cans (empty) with wire handles (possible paint cans), scrap metal, concrete and asphalt debris. | < 100 | I05 | 268027.093 | 1785654.995 | Not Removed | |

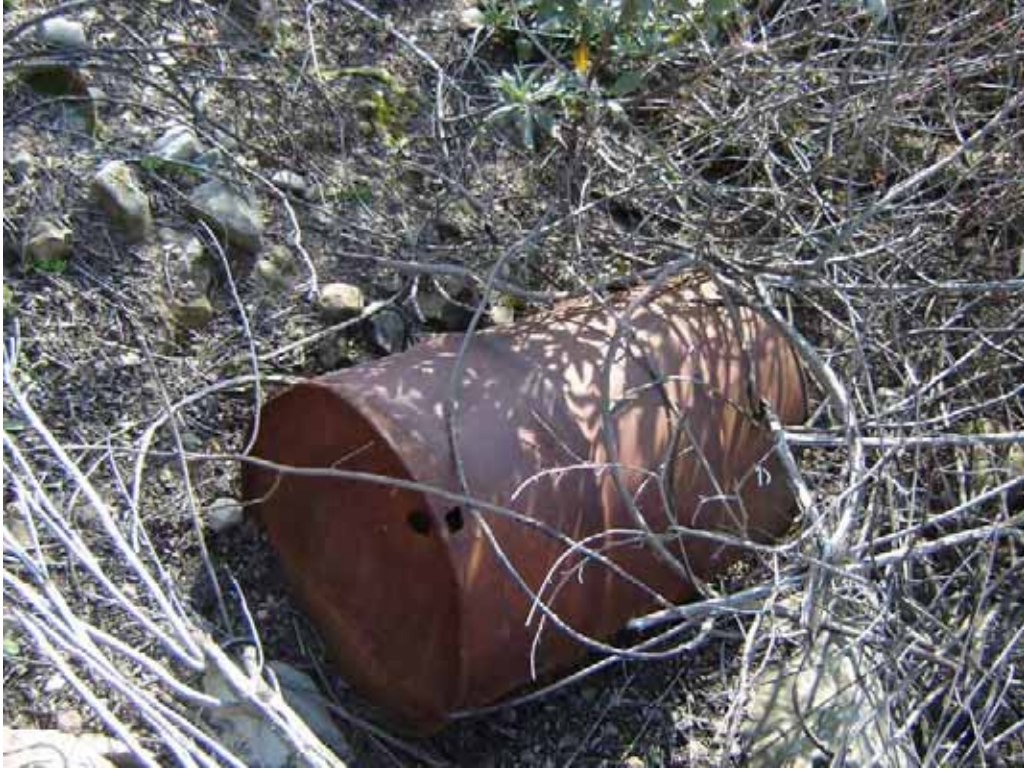
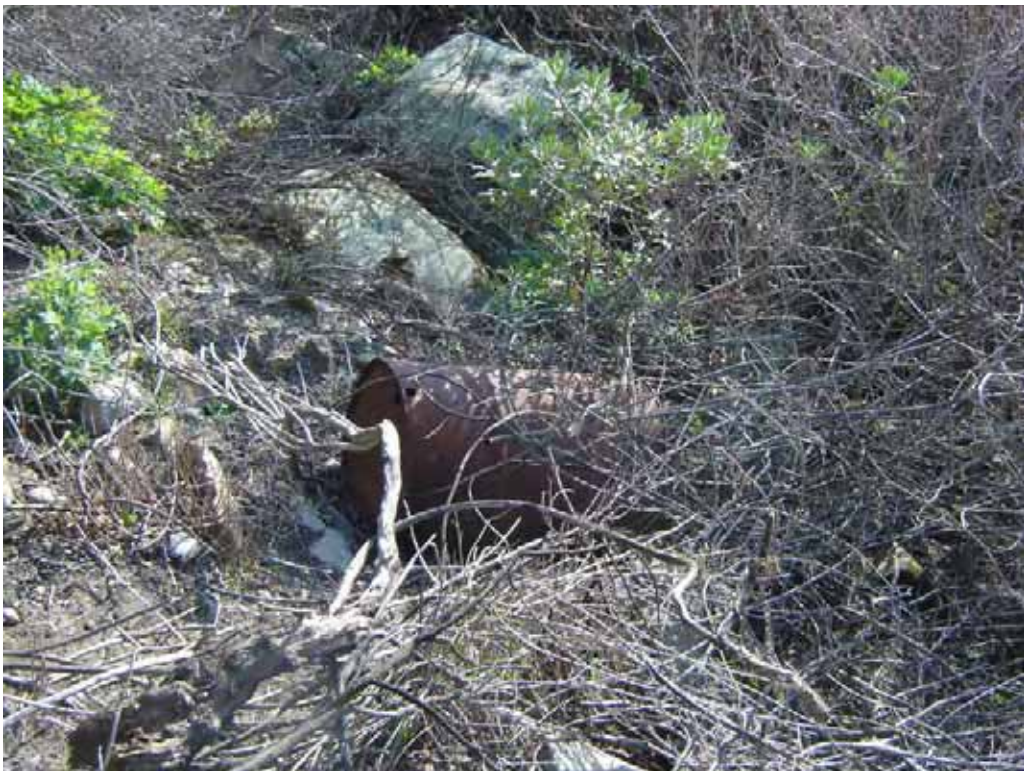
Debris ID: CH2-G07-3023

| Waste Debris Area Identifier | Date of Discovery | Description | Estimated Debris Area Size (sq. ft.) | Map Grid Number ¹ | Coordinates ² | | Status ³ | Comments |
|---|---|--|---|---|---|---|---|---|
| CH2-G07-3023 | 2/13/2008 | 55-gallon drum (empty) with holes punched into side and bottom. | < 100 | I05 | 268063.617 | 1785727.157 | Not Removed | |

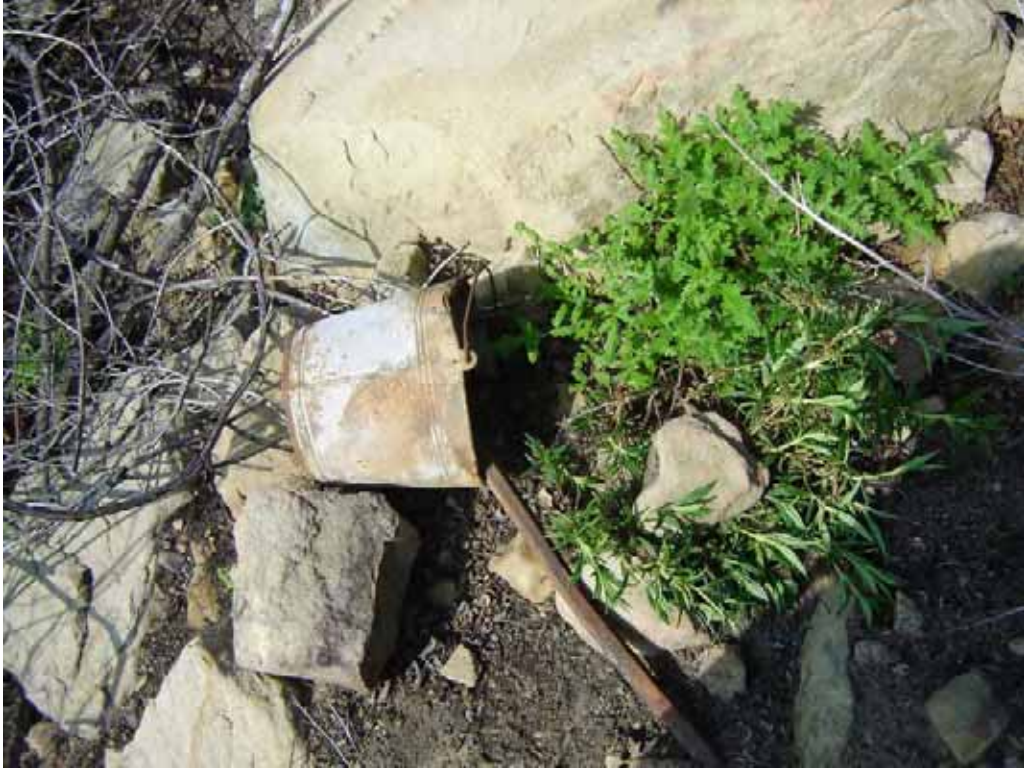
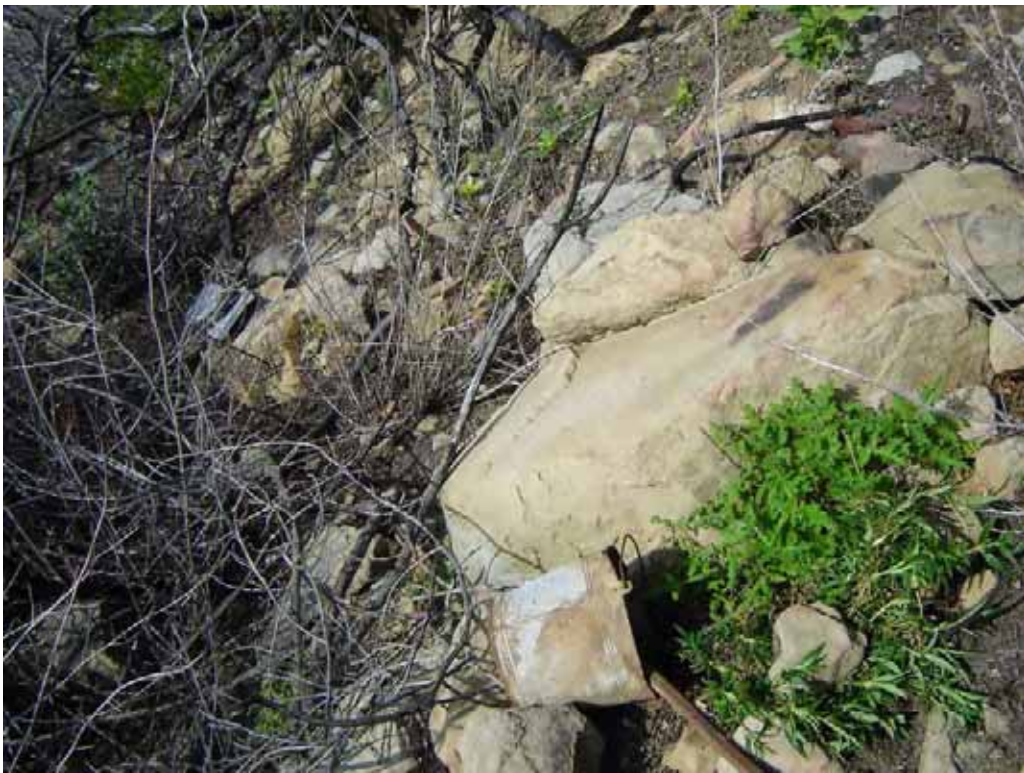
Debris ID: CH2-G07-3024

| Waste Debris Area Identifier | Date of Discovery | Description | Estimated Debris Area Size (sq. ft.) | Map Grid Number ¹ | Coordinates ² | | Status ³ | Comments |
|---|---|--|---|---|---|---|---|---|
| CH2-G07-3024 | 2/13/2008 | One 2-gallon galvanized steel bucket (empty), metal rod, and small piece of sheet metal. | < 100 | I05 | 268108.109 | 1785723.254 | Not Removed | |

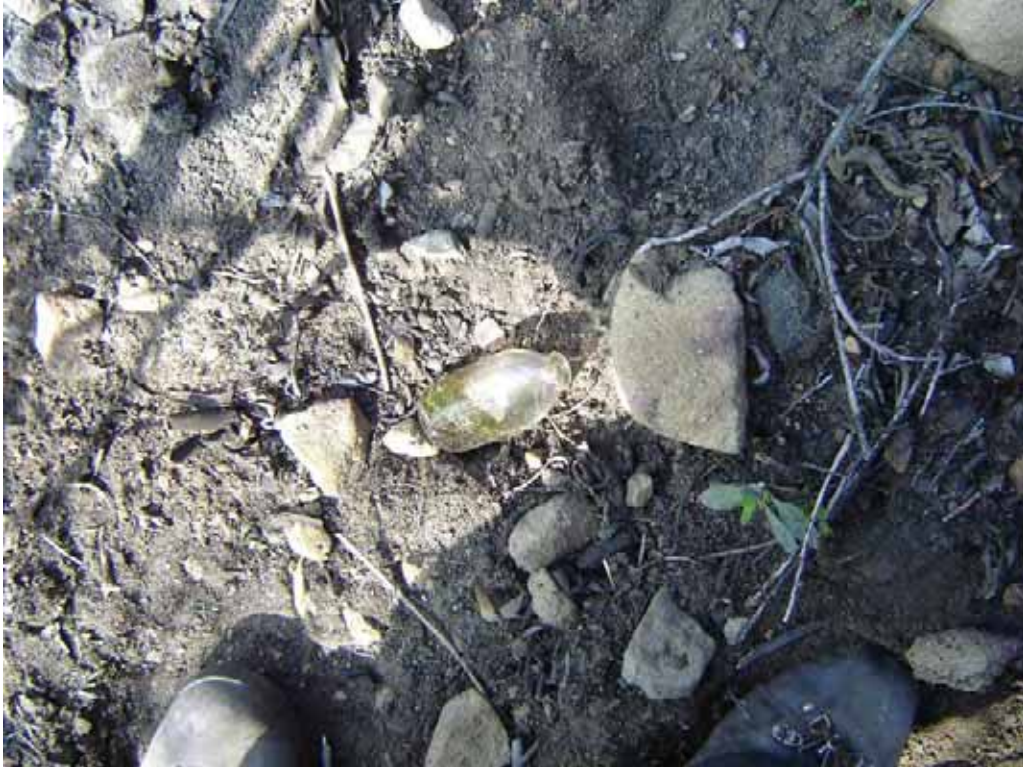
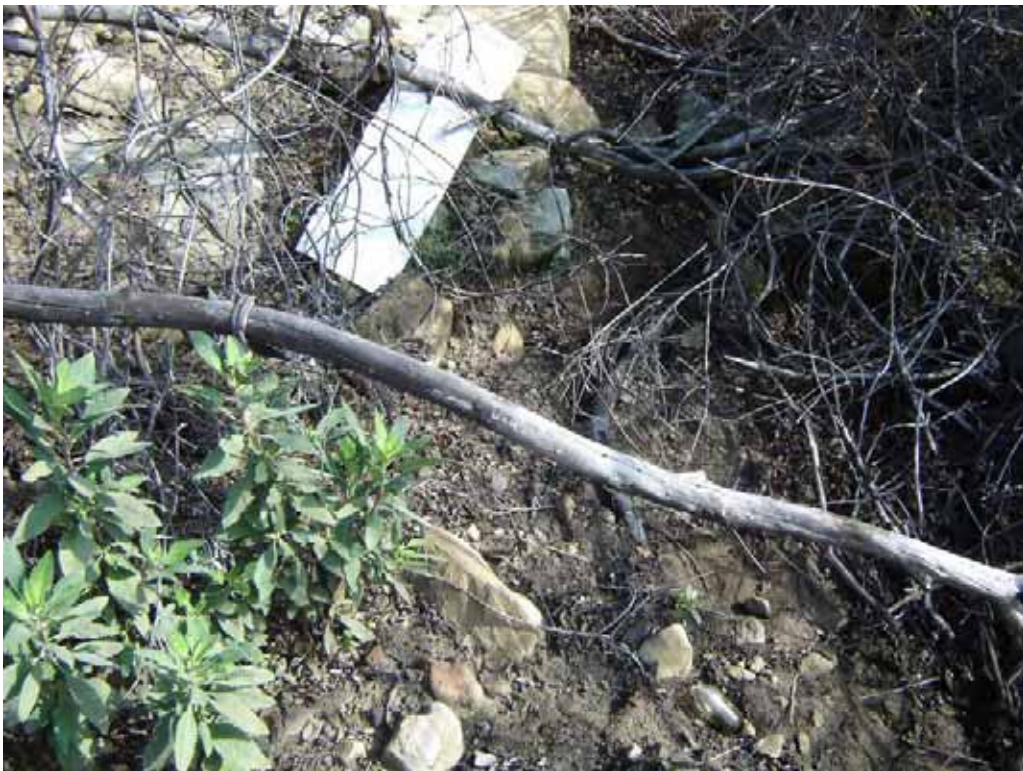
Debris ID: CH2-G07-3025

| Waste Debris Area Identifier | Date of Discovery | Description | Estimated Debris Area Size (sq. ft.) | Map Grid Number ¹ | Coordinates ² | | Status ³ | Comments |
|---|---|--|---|---|---|---|---|---|
| CH2-G07-3025 | 2/13/2008 | One approximately 250-ml unidentified glass bottle half-filled with water. 1-ft x 3-ft piece of aluminum sheet metal. | < 100 | I05 | 268120.129 | 1785712.370 | Not Removed | |

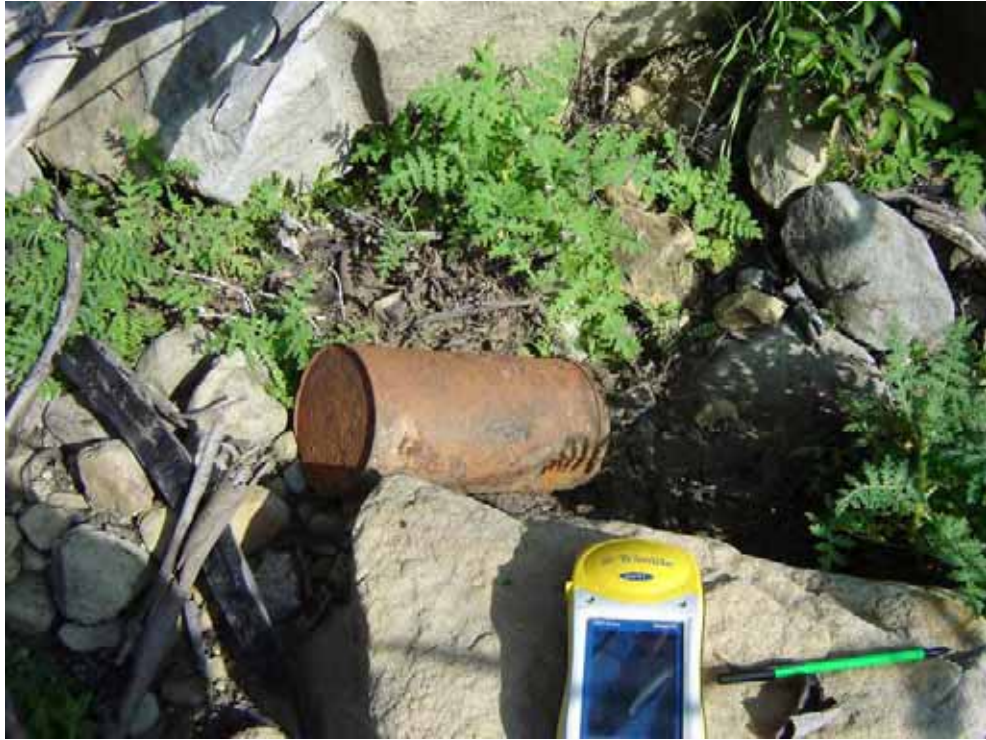
Debris ID: CH2-G07-3026

| Waste Debris Area Identifier | Date of Discovery | Description | Estimated Debris Area Size (sq. ft.) | Map Grid Number ¹ | Coordinates ² | | Status ³ | Comments |
|---|---|---|---|---|---|---|---|---|
| CH2-G07-3026 | 2/13/2008 | Approximately 12-inch long, 6-inch diameter metal container (possibly filled with concrete), and broken pieces of concrete on down slope from former Building 4133 location. | < 100 | I05 | 268136.535 | 1785714.810 | Not Removed | |

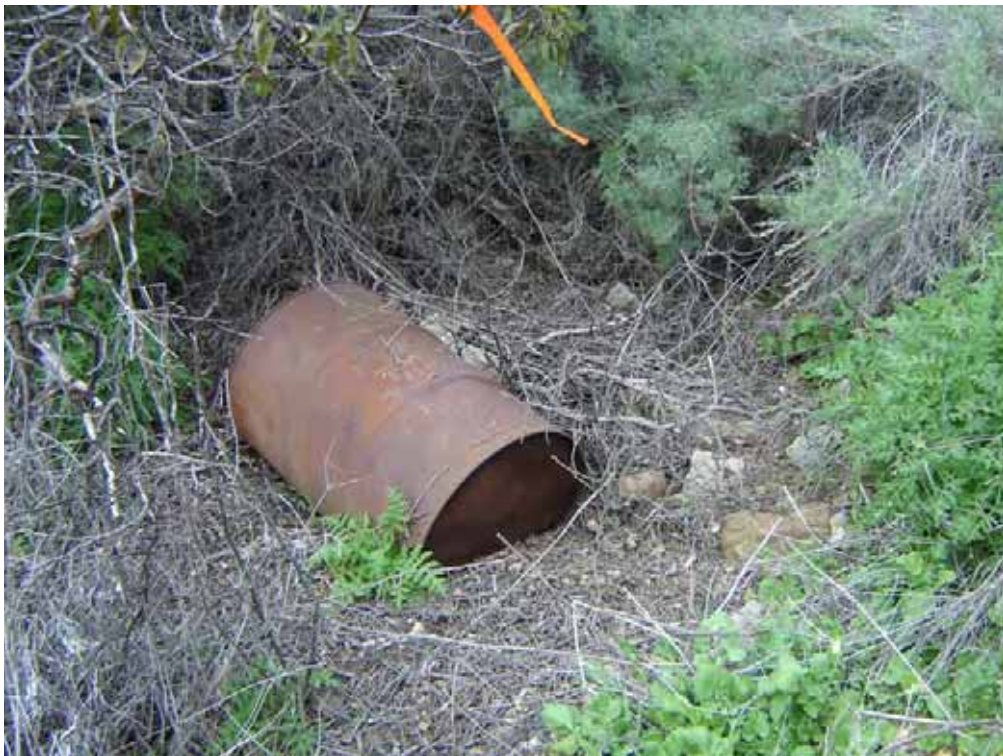
Debris ID: CH2-G07-3027

| Waste Debris Area Identifier | Date of Discovery | Description | Estimated Debris Area Size (sq. ft.) | Map Grid Number ¹ | Coordinates ² | | Status ³ | Comments |
|---|---|---|---|---|---|---|---|---|
| CH2-G07-3027 | 2/13/2008 | 55-gallon drum (empty) located down slope from former Building 4133. | < 100 | I05 | 268184.364 | 1785687.598 | Not Removed | |

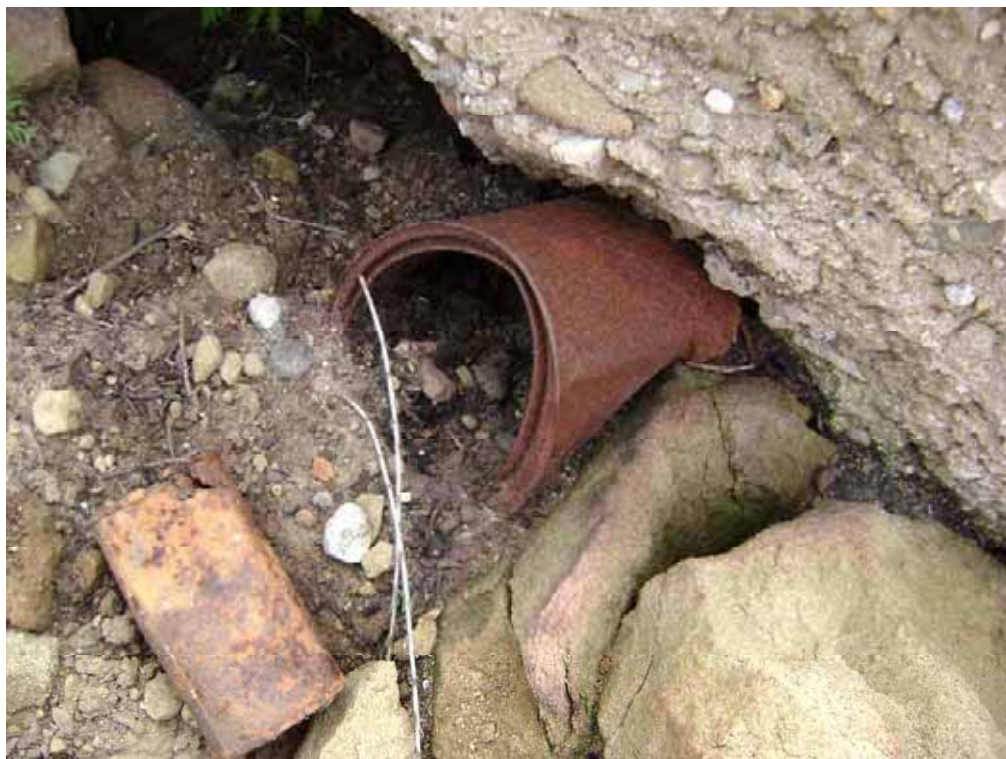
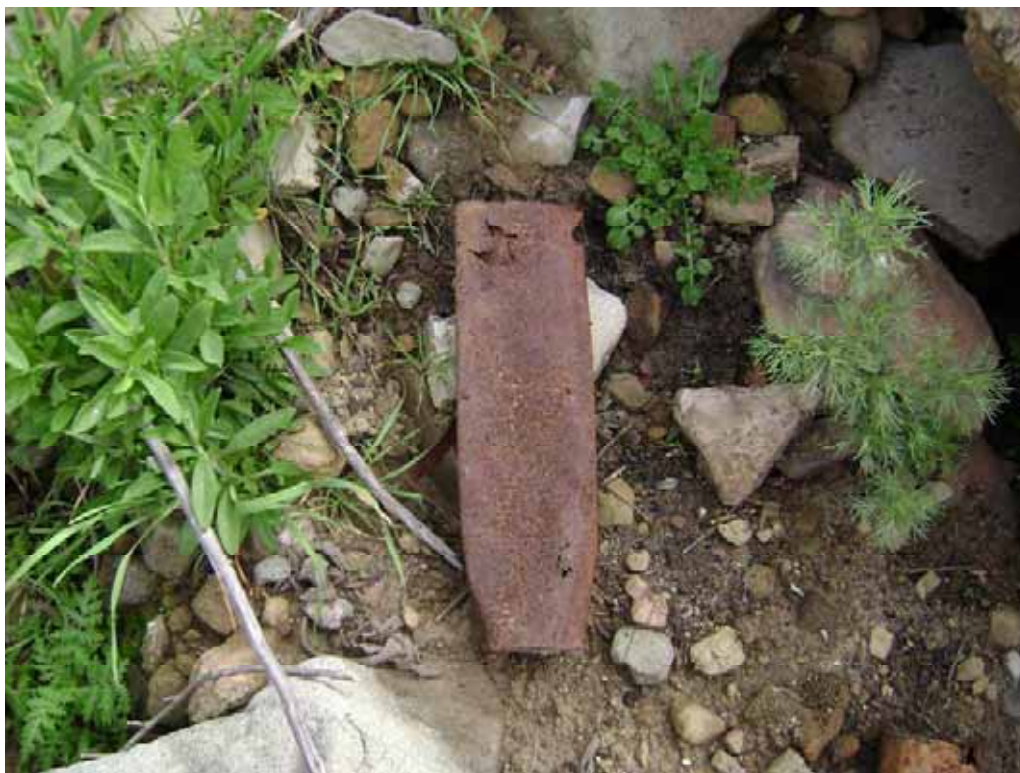
Debris ID: CH2-G07-3028

| Waste Debris Area Identifier | Date of Discovery | Description | Estimated Debris Area Size (sq. ft.) | Map Grid Number ¹ | Coordinates ² | | Status ³ | Comments |
|---|---|---|---|---|---|---|---|---|
| CH2-G07-3028 | 2/13/2008 | One 1-gallon paint can, one 12-oz. can, and one approximately 30 oz. can (all containers are empty) located down slope from former Building 4133 location. | < 100 | I05 | 268148.841 | 1785712.562 | Not Removed | |

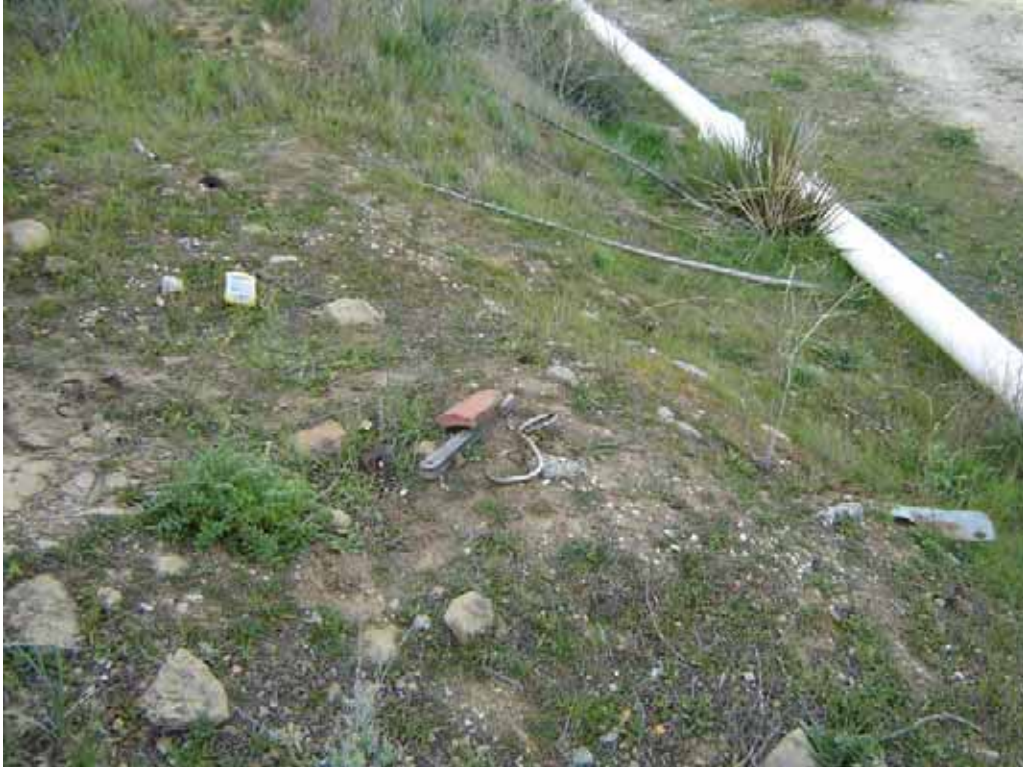
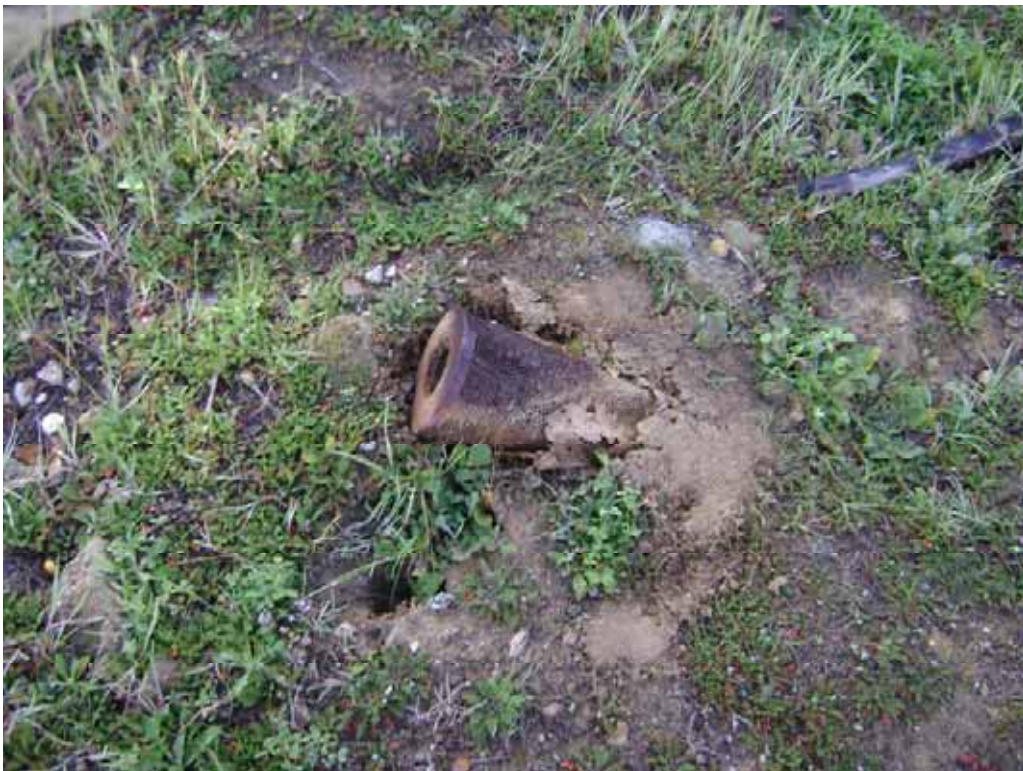
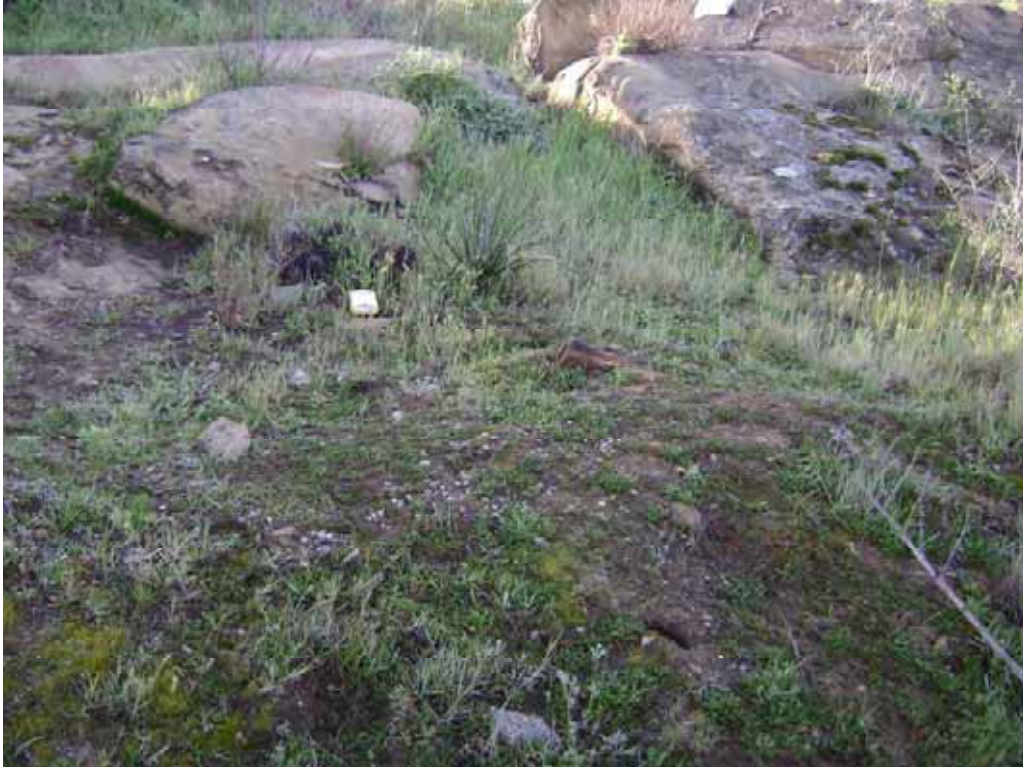
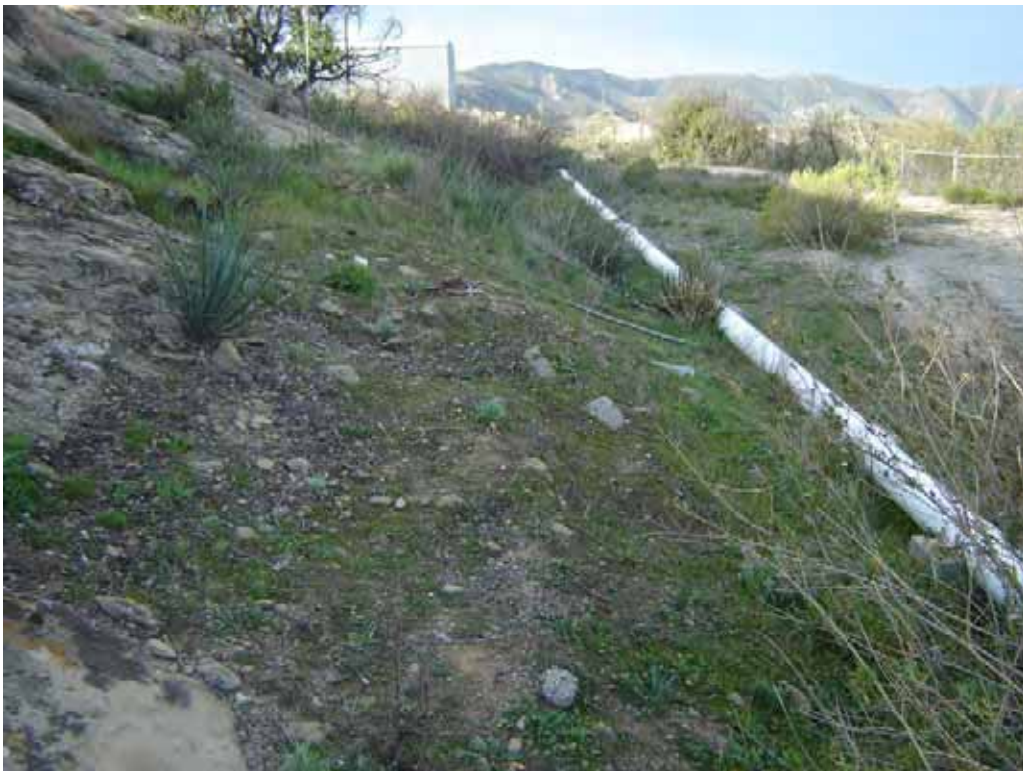
Debris ID: CH2-G07-3029

| Waste Debris Area Identifier | Date of Discovery | Description | Estimated Debris Area Size (sq. ft.) | Map Grid Number ¹ | Coordinates ² | | Status ³ | Comments |
|---|---|---|---|---|---|---|---|---|
| CH2-G07-3029 | 2/14/2008 | Two soil piles intermixed with concrete, asphalt, clay pipe, stainless steel tubing (approximately 18-in long, 1/4-in diameter), metal bracket, and a cylindrical equipment air filter. | < 100 | I05 | 268102.276 | 1785949.981 | Not Removed | |

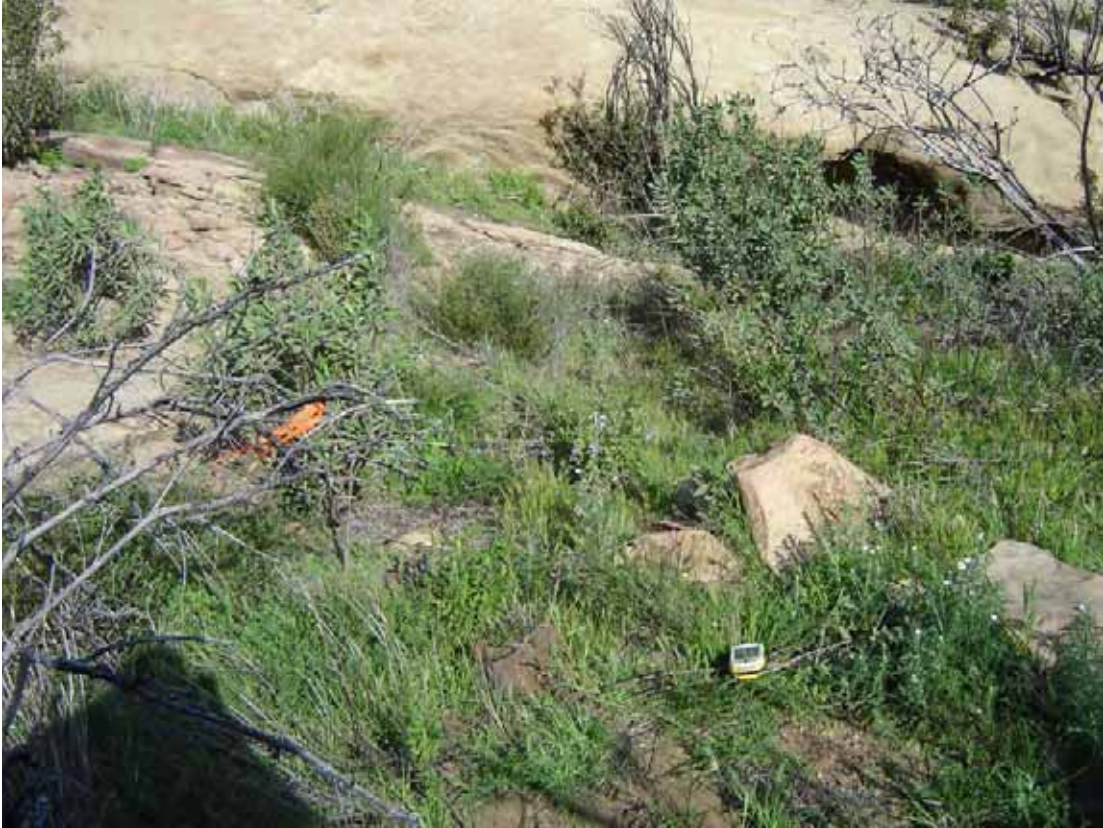
Debris ID: CH2-G07-3030

| Waste Debris Area Identifier | Date of Discovery | Description | Estimated Debris Area Size (sq. ft.) | Map Grid Number ¹ | Coordinates ² | | Status ³ | Comments |
|---|---|---|---|---|---|---|---|---|
| CH2-G07-3030 | 2/14/2008 | Approximately 0.5-gallon rectangular metal container (paint thinner type; empty). | < 100 | I05 | 268576.897 | 1785828.803 | Not Removed | |
