**SEWER INSPECTION DOCUMENTATION LOGS**

**Sewer Line and Manhole Locations  
Group 7 Reporting Area  
SANTA SUSANA FIELD LABORATORY**

Sewer/Manhole Inventory Log  
 Manhole Number: B-11  
 Santa Susana Field Laboratory, Ventura County, California

Sewer/Manhole Inventory Log  
 Manhole Number: B-12  
 Santa Susana Field Laboratory, Ventura County, California

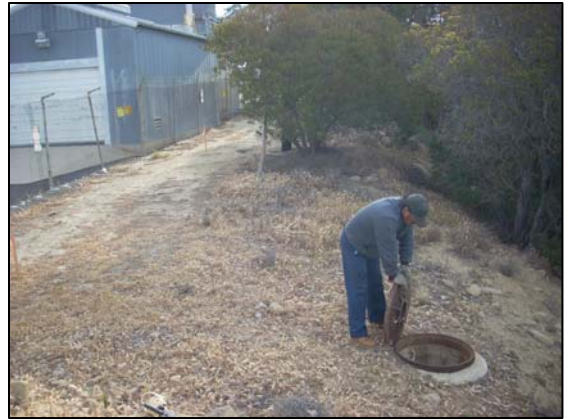
Photo 1. Manhole B-11 viewed from the north.

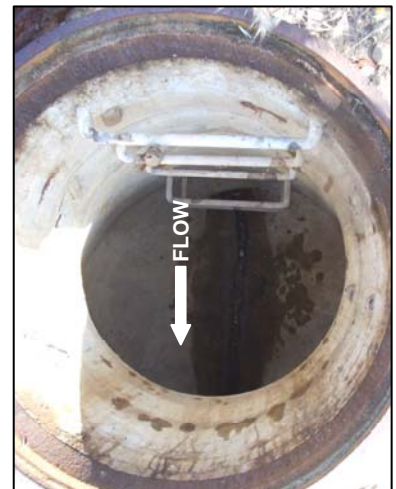
Status: Active  
 Sedimentation: None  
 Fluids/solids present: Fluids present; no solids  
 Pipe condition: Good, intact  
 Manhole condition: Good, minor rust, intact

Photo 2. View inside Manhole B-11. Minor rust was observed on metal surfaces. The vitreous clay sewer pipe remains in good condition.

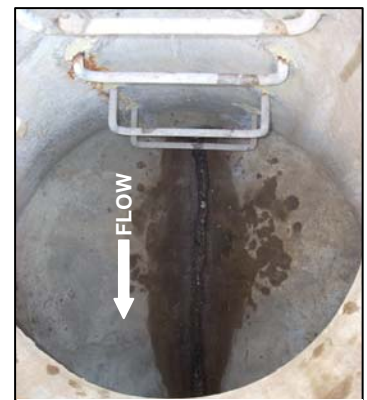
Flowing water at time of inspection; no detection above background on multigas meter.

Photo 3. Close up view inside Manhole B-11.

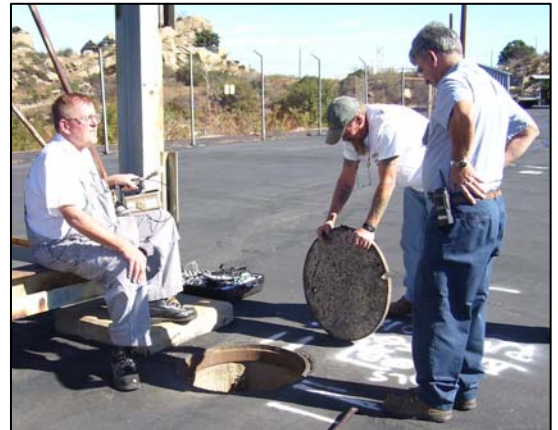
Photo 1. Manhole B-12 viewed from the southwest.

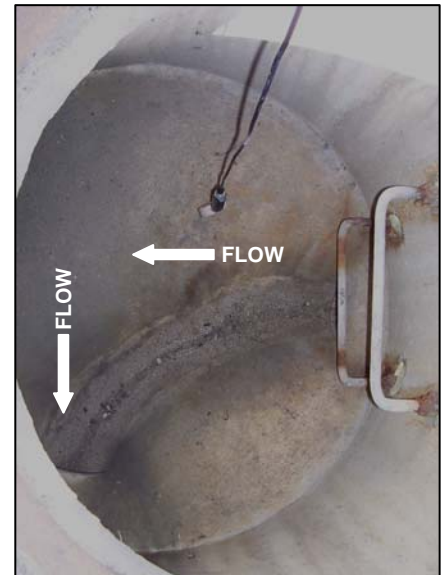
Status: Active  
 Sedimentation: None  
 Fluids/solids present: Fluids present; no solids  
 Pipe condition: Good, intact  
 Manhole condition: Good, minor rust, intact

Photo 2. View inside Manhole B-12. Minor rust was observed on metal surfaces. The vitreous clay sewer pipe remains in good condition.

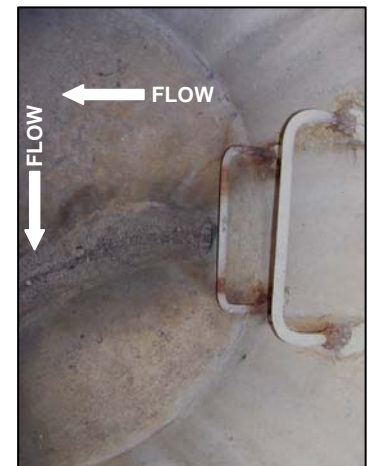
Flowing water at time of inspection; no detection above background on multigas meter.

Photo 3. Close up view inside Manhole B-12.
