# 2023 Annual Site Inspection and Monitoring Report for Uranium Mill Tailings Radiation Control Act Title I Disposal Sites

March 2024

Legacy  
Management

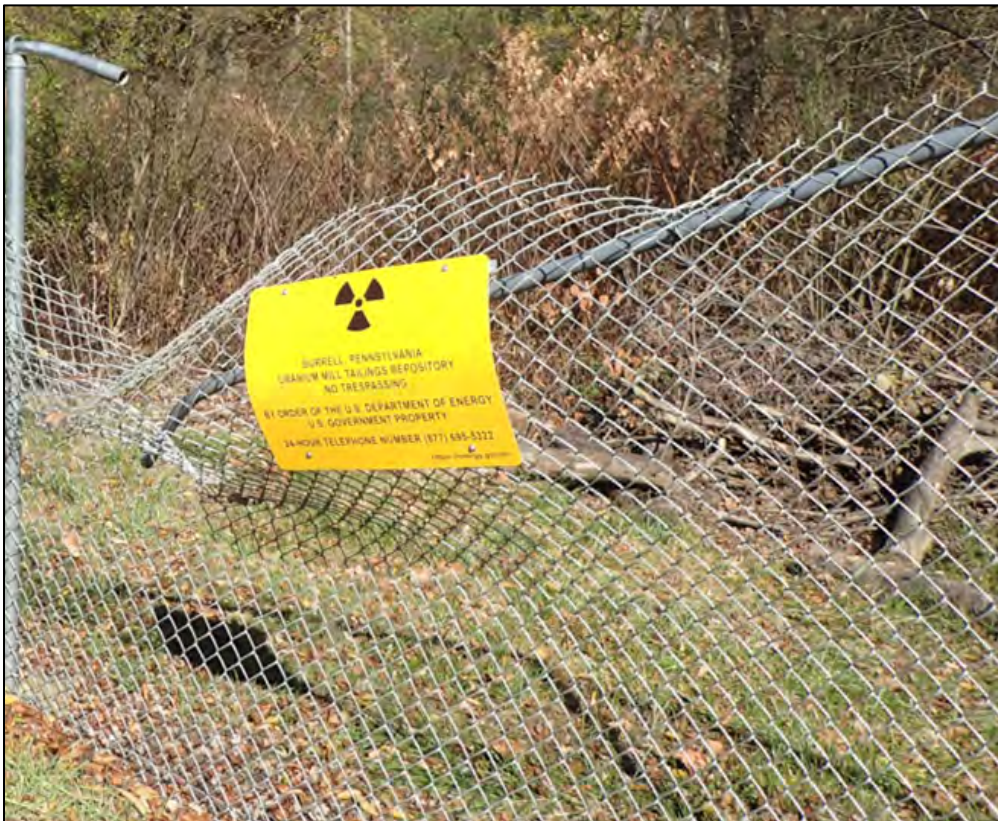
A chainlink security fence encloses the disposal cell and drainage features. The site herbicide subcontractor keeps the fence line clear of vegetation, which should prolong the life of the security fence (PL-1). In 2023, trees felled by strong winds damaged the fence. The top rail of the fence was separated in three areas, which compromised the integrity of the fence (PL-2). Repairs to this area were completed following the inspection. Other trees felled by strong storms have bent the upper rail of the fence along the southern boundary, but the fence remains serviceable, and repairs are not required at this time.

*PL-2. Fence Damage*

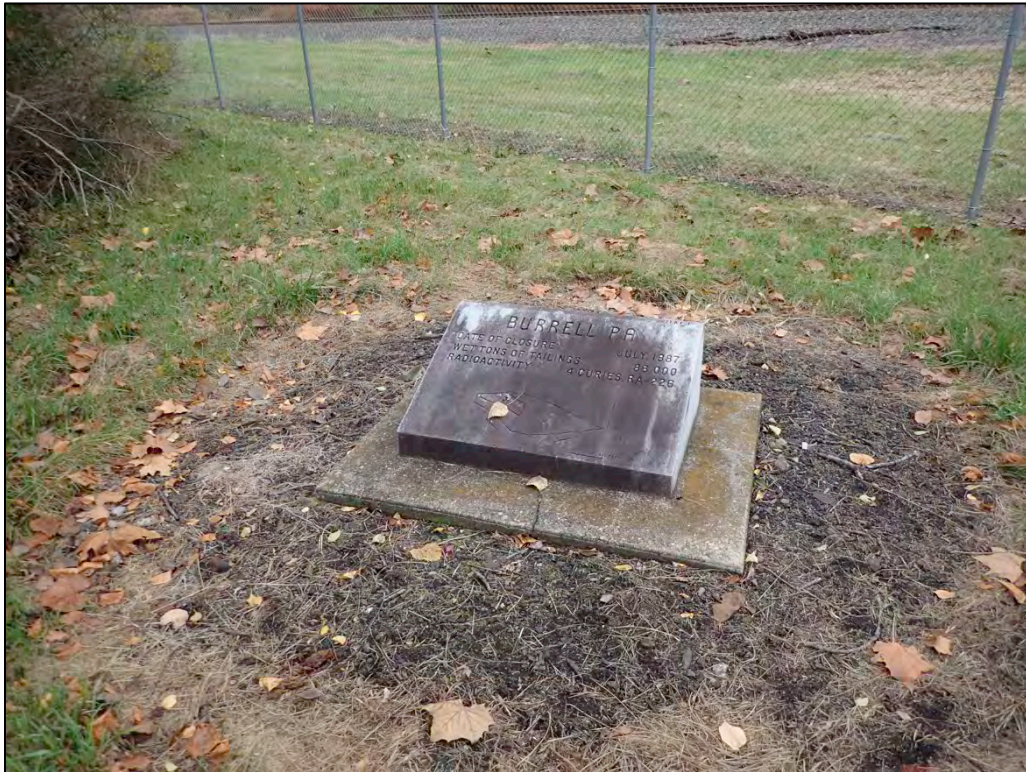
The site has one granite site marker just inside the main entrance gate. The concrete pad is cracked but remains functional. The surface of the marker is stained but remains legible (PL-3). No maintenance needs were identified.

*PL-3. Site Marker*

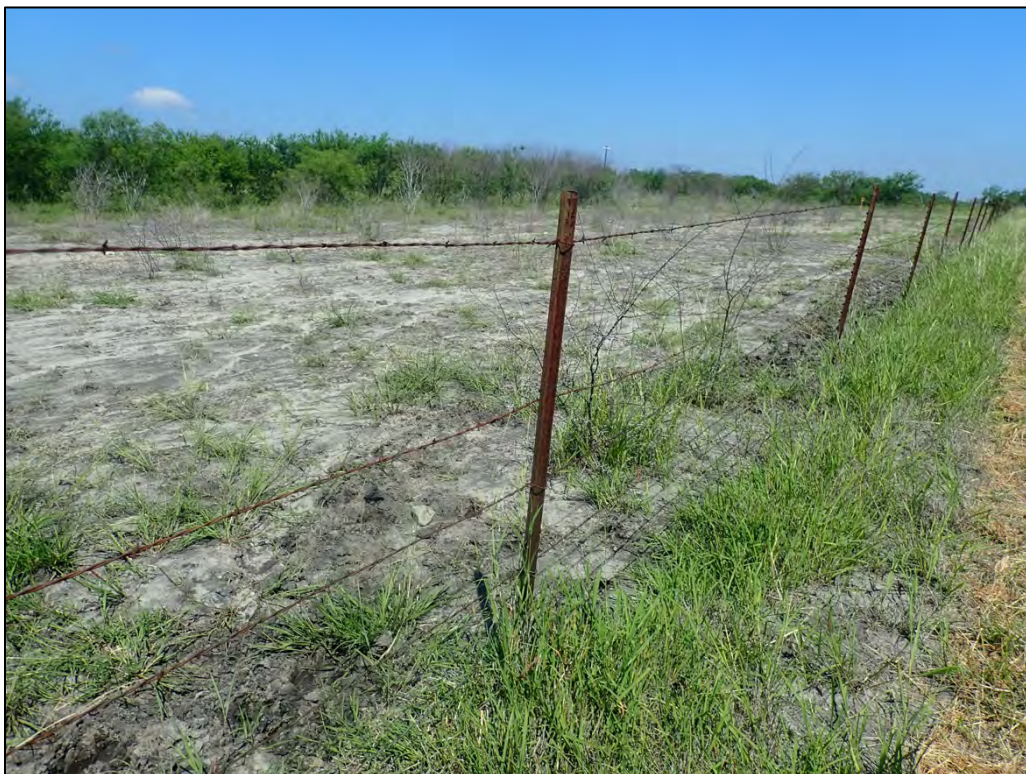
*PL-1. Rusting Fence Line*

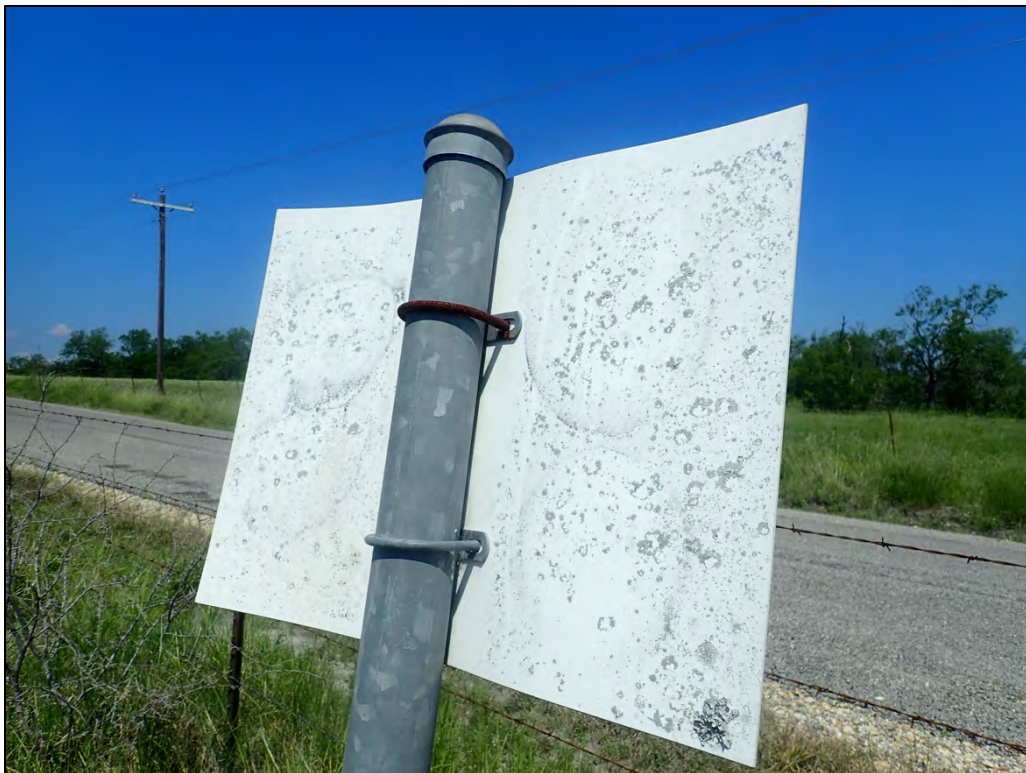
*PL-2. Perimeter Sign P38 with Bent Post*

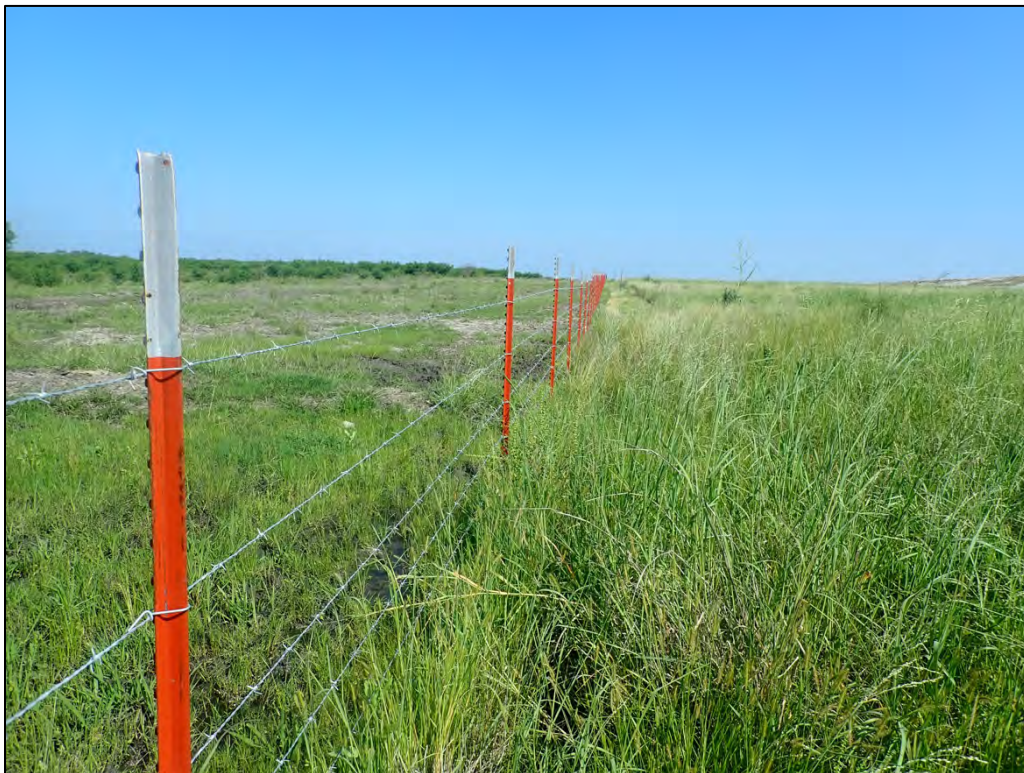
*PL-4. Repaired Fence Line Between Survey Monument SM-3 and Perimeter Sign P18*

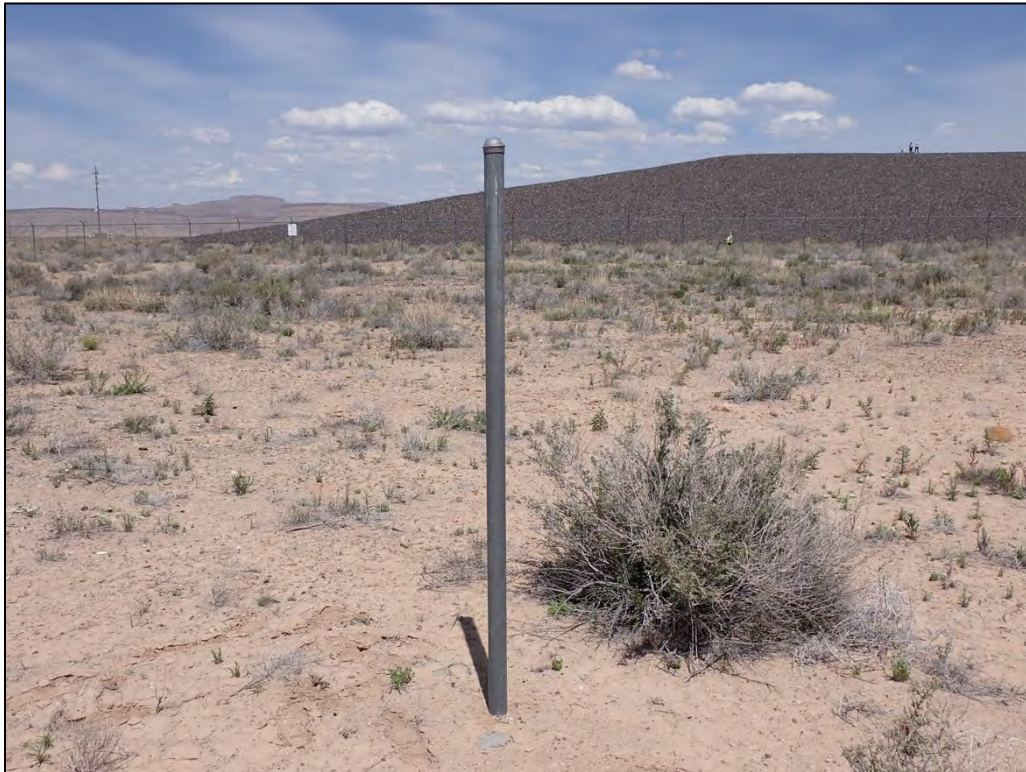
*PL-3. Perimeter Sign P2 Missing*

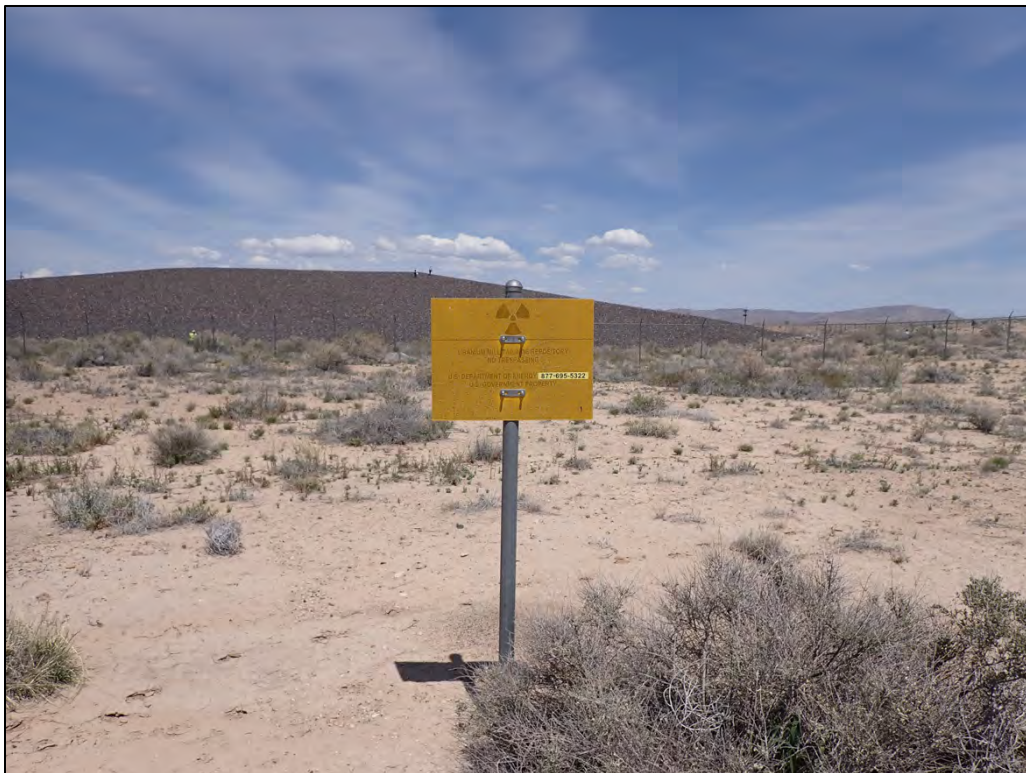
*PL-4. Faded Perimeter Sign P1*

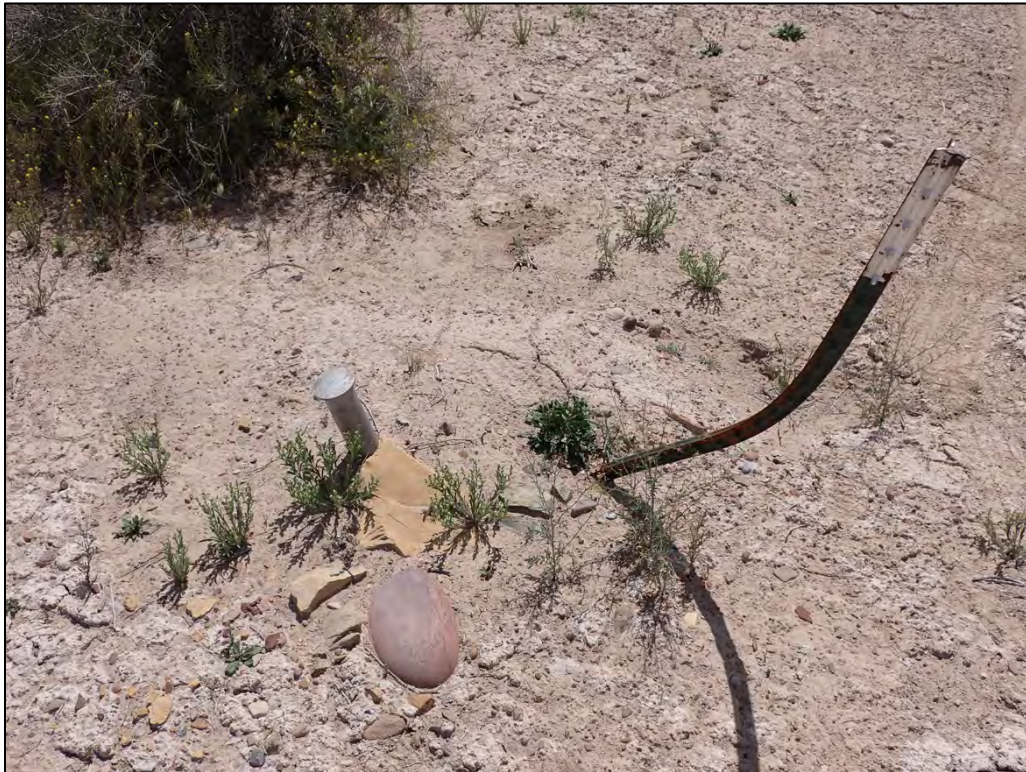
*PL-5. Boundary Monument BM-5 is Damaged but Stable*

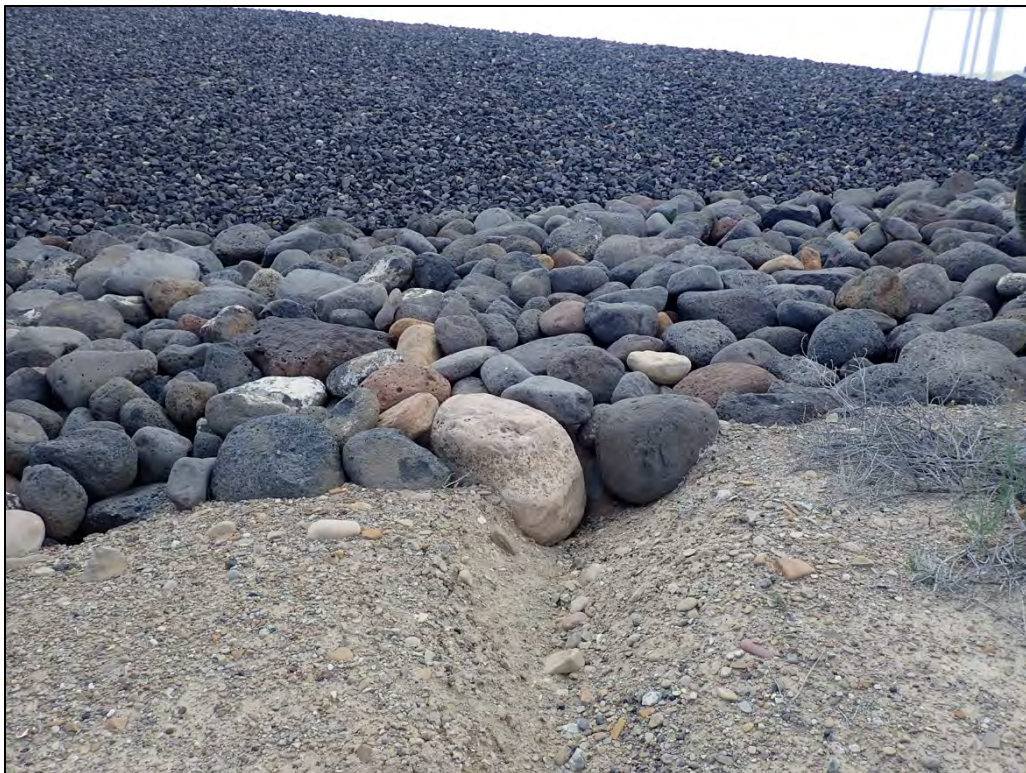
*PL-6. Rill Running into Toe Drain near North Corner of Disposal Cell*

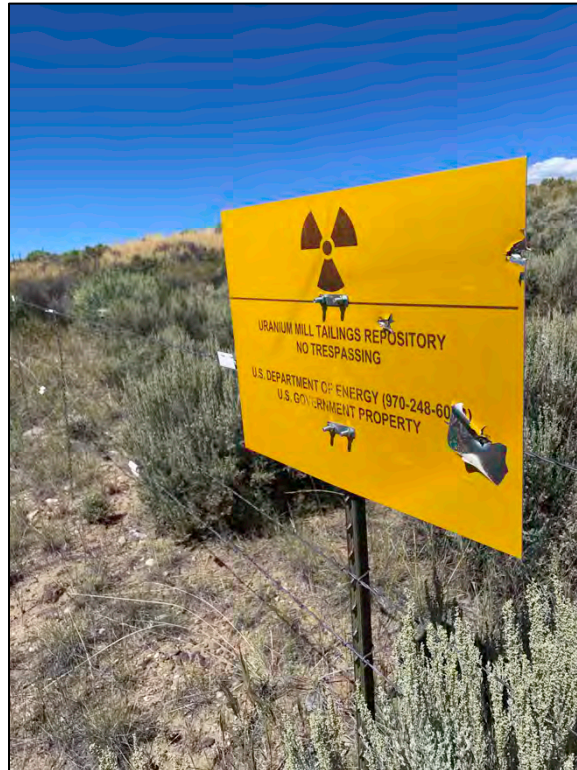
*PL-1. Perimeter Sign P40 with Bullet Holes*

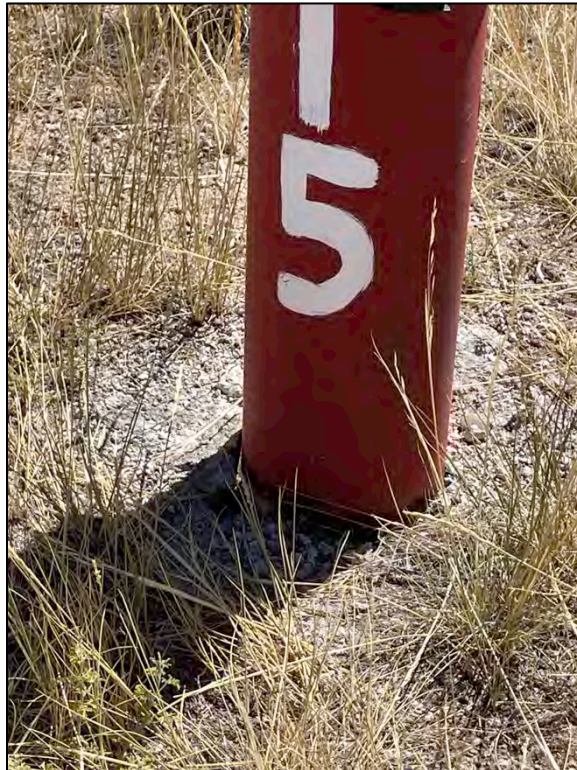
*PL-5. Monitoring Well 0715 with Concrete Spalling at Base*

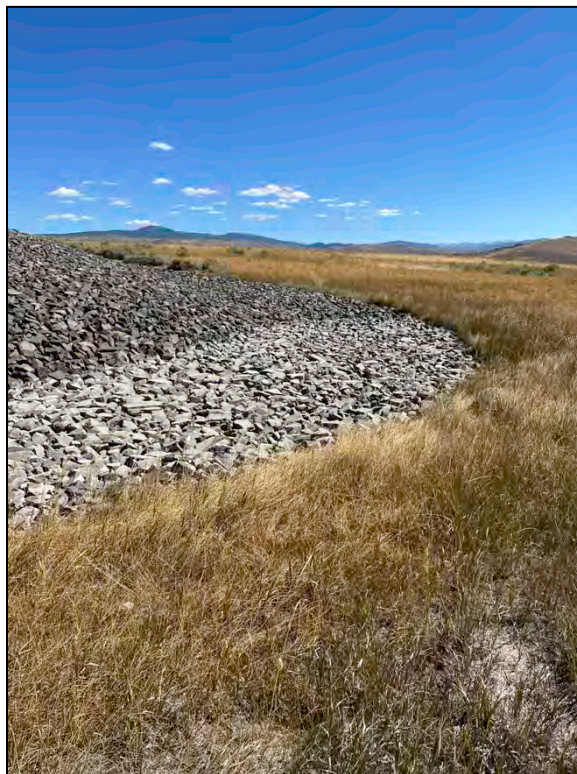
*PL-6. Evidence of Water Accumulation on Southeast Toe of Disposal Cell*

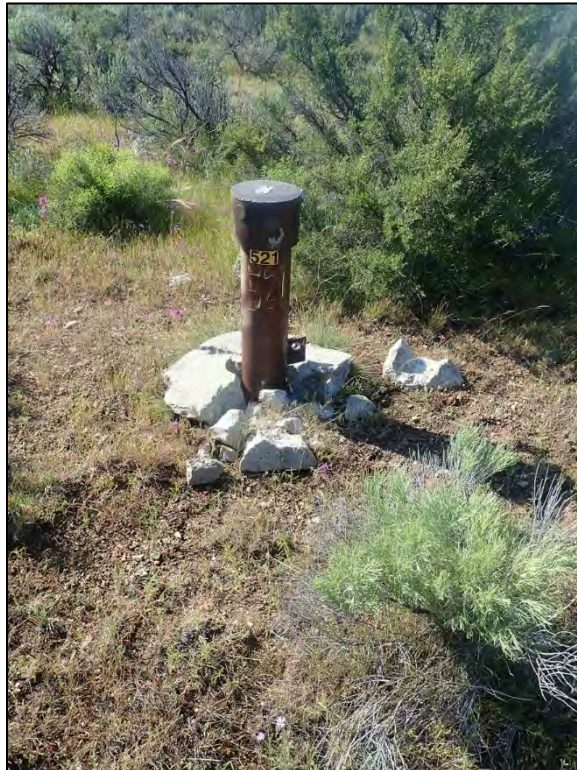
*PL-9. Well 0521 with Cracked Concrete Base*

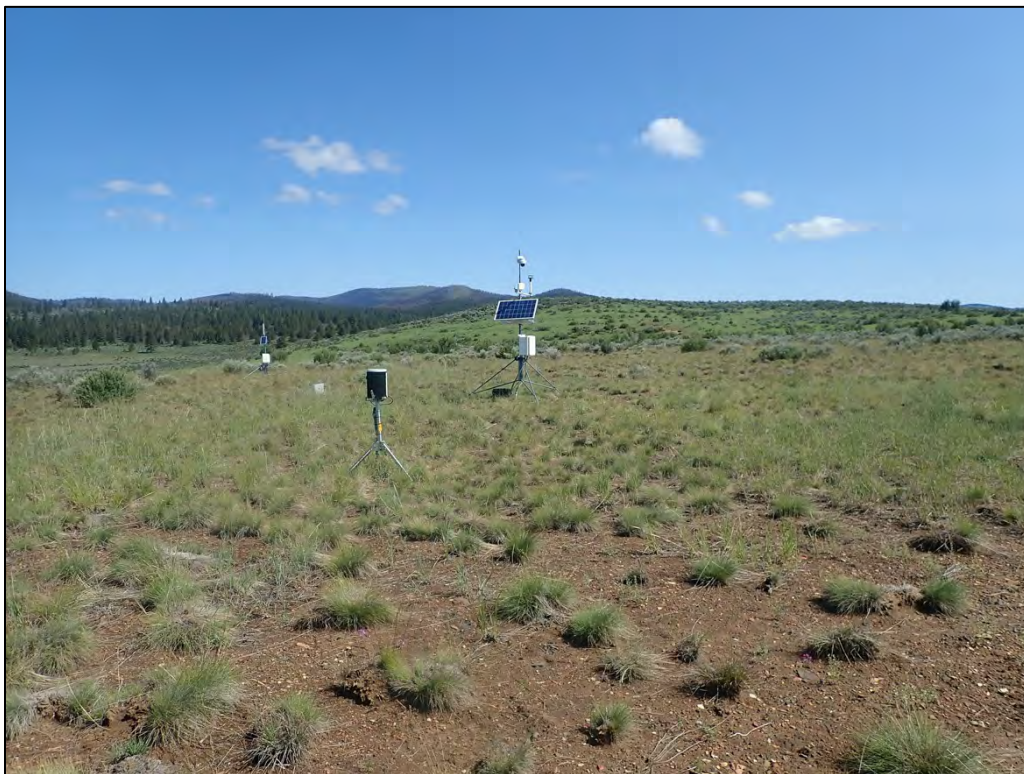
*PL-10. Sparse Vegetation near SOARS Station on Top of Cell*

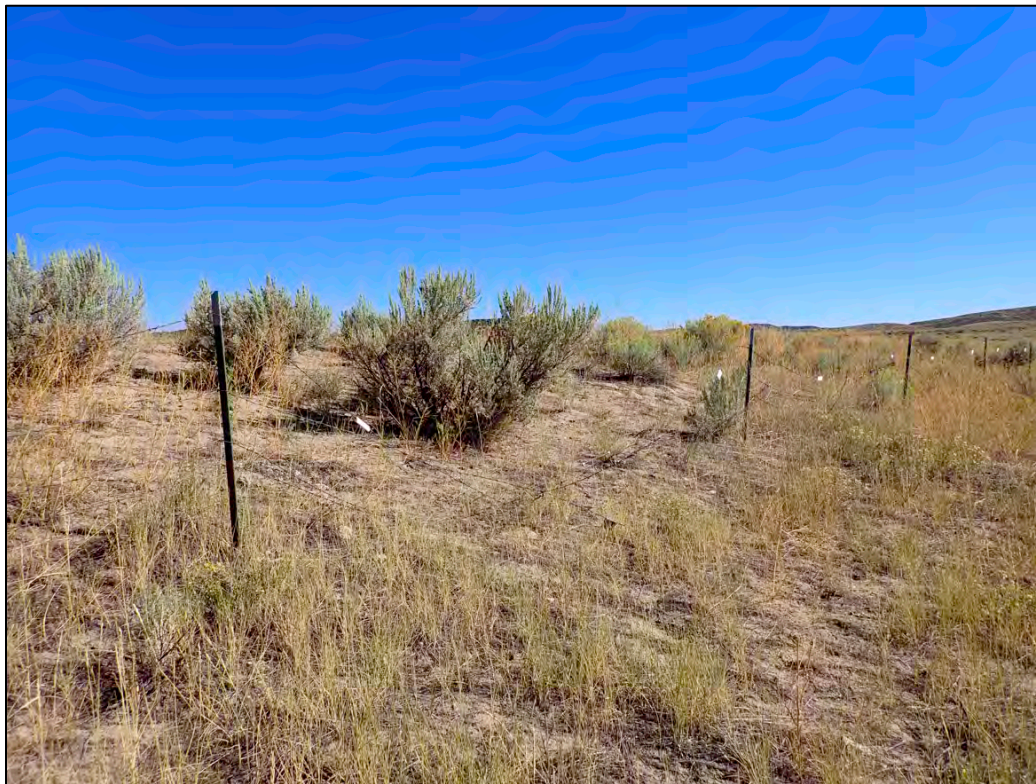
*PL-2. Fence Damage near Entrance Sign*

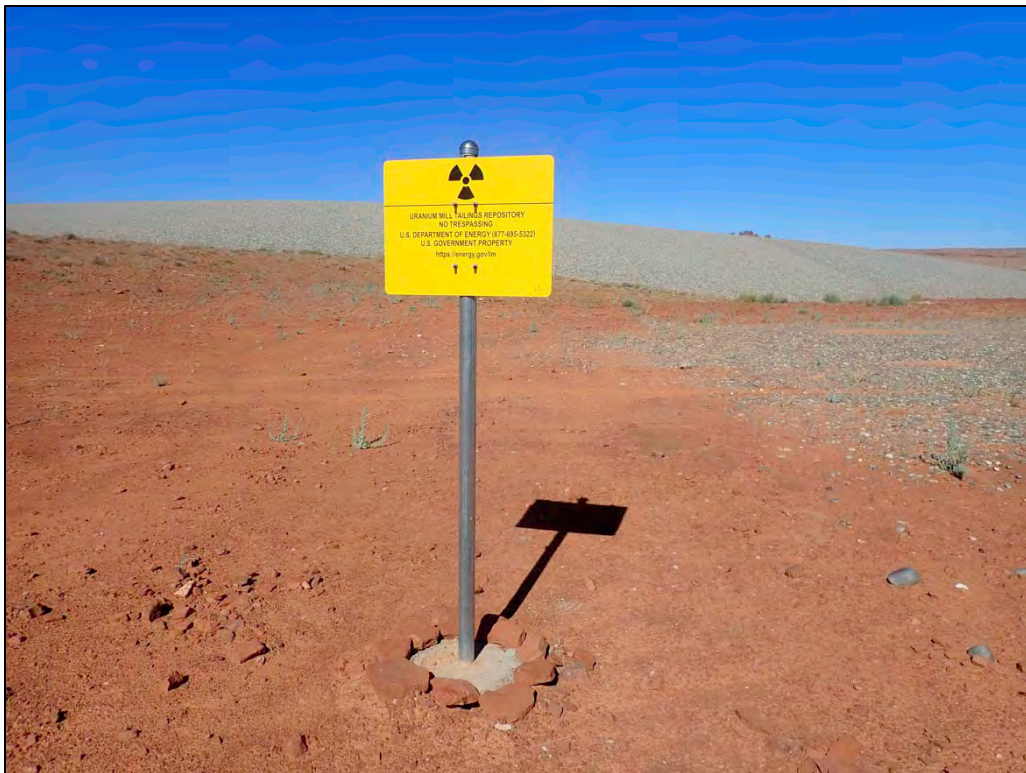
*PL-4. Perimeter Sign P15 Missing Lower Sign*

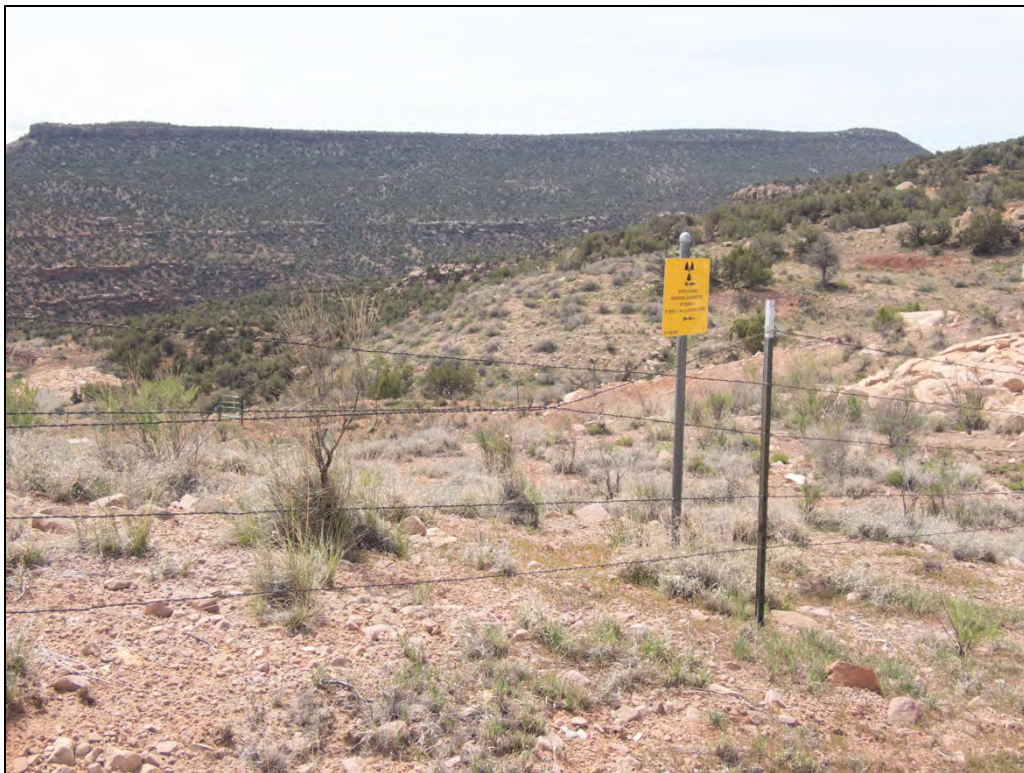
*PL-2. Broken Fence Strand at Northwest Corner of Site near Perimeter Sign P21*

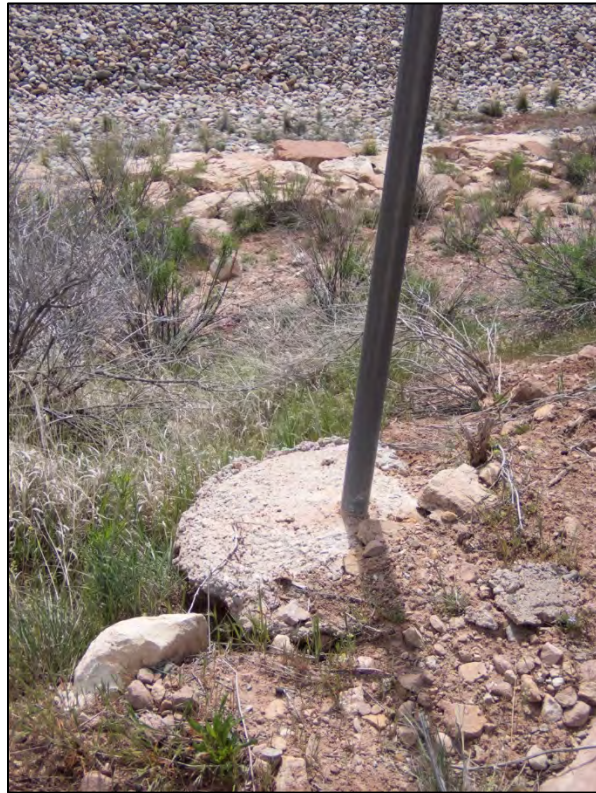
*PL-3. Erosion Around Concrete Base of Perimeter Sign P22*

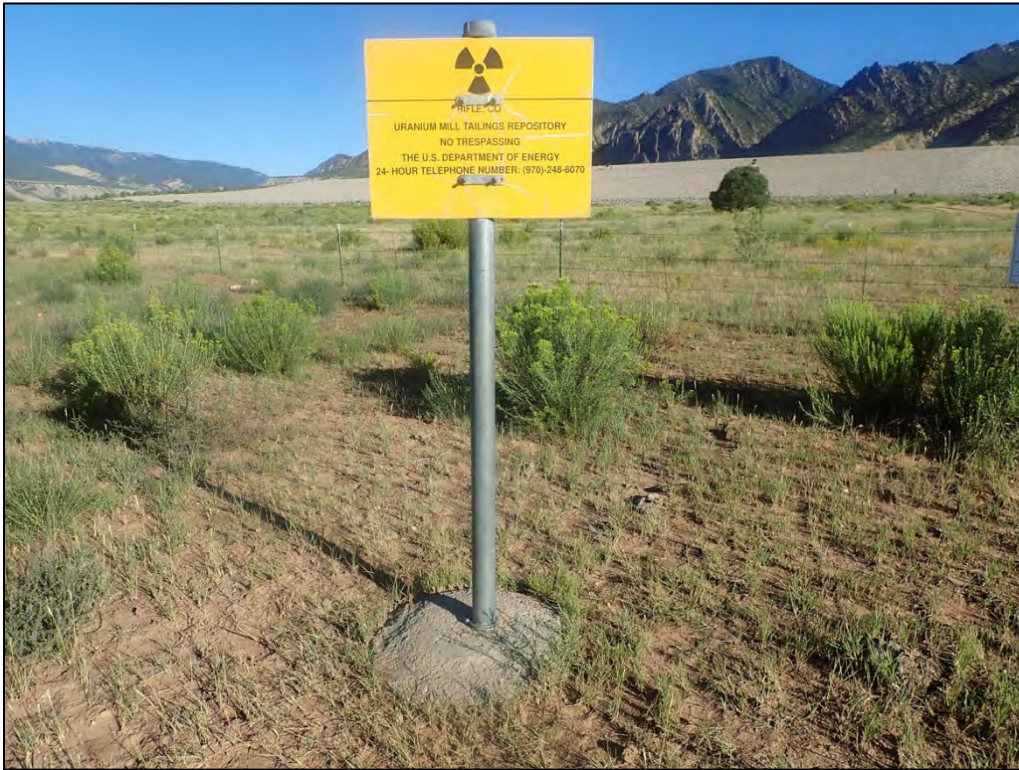
*PL-1. Entrance Sign, Cracked and Faded but Legible*

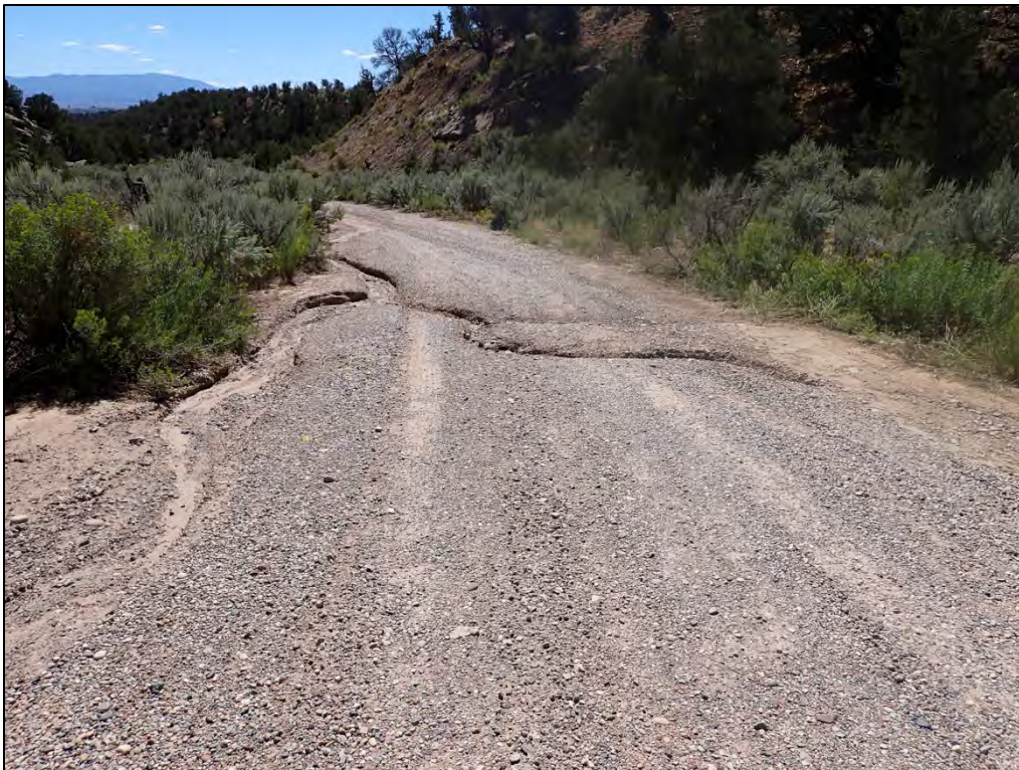
*PL-2. Rutting and Erosion Along Access Road*

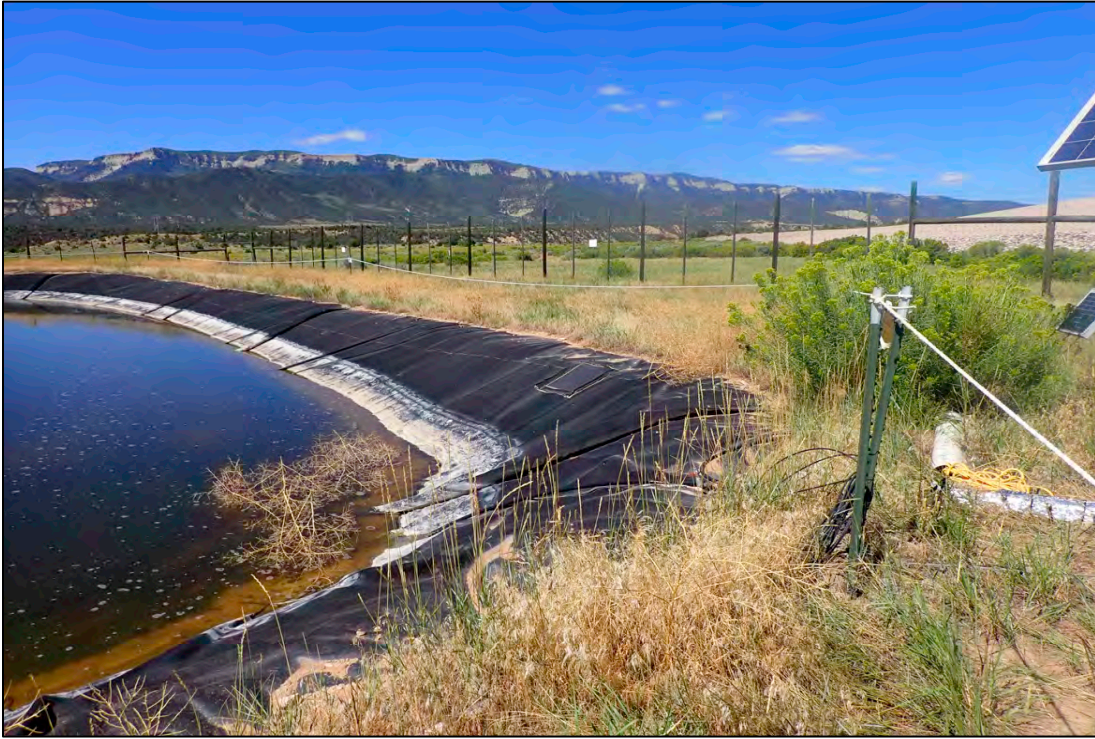
*PL-7. Evaporation Pond Liner with Repair Patch on Northern Corner*

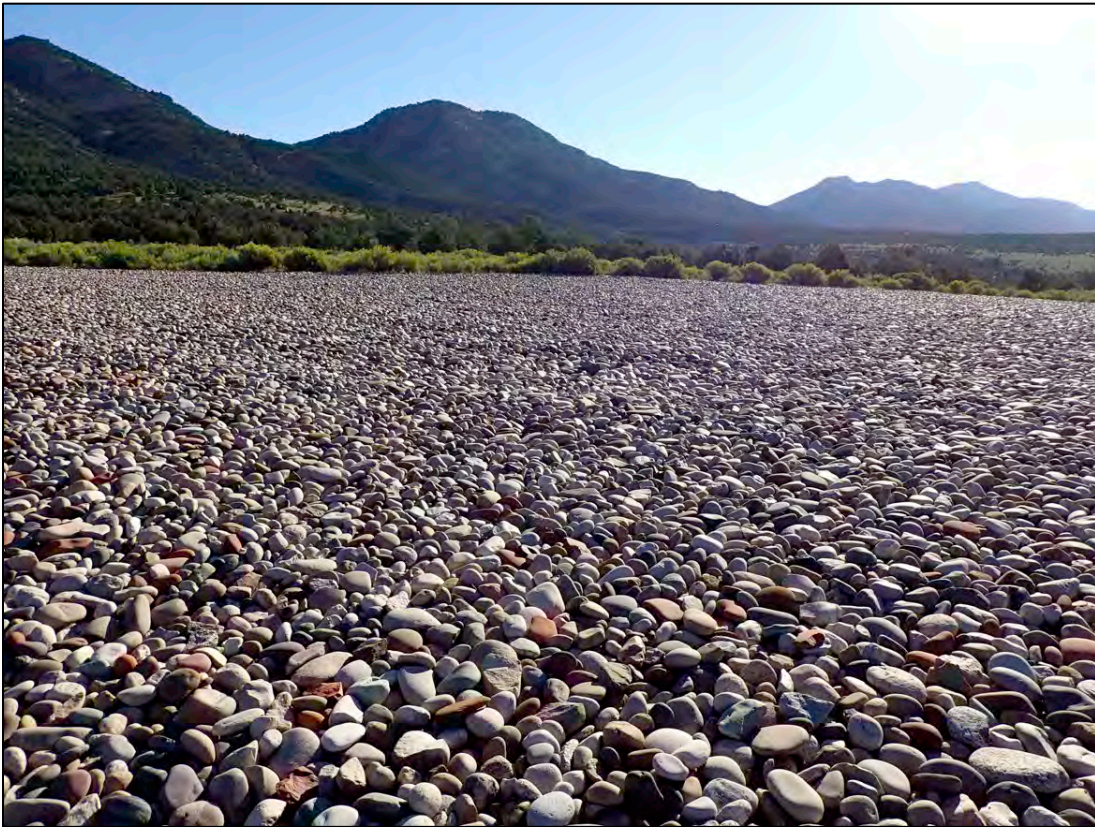
*PL-8. Depression on Top Slope in Southeast Area of Disposal Cell*

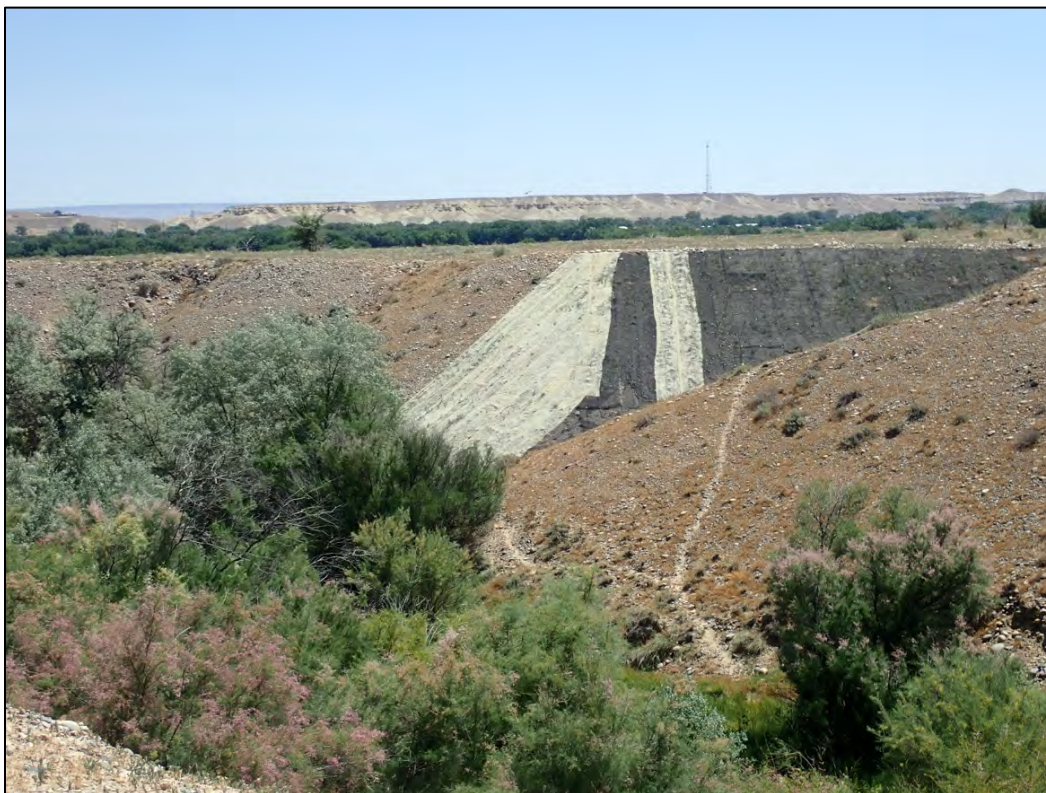
*PL-7. Repaired Erosion Control Fabric*
