# Operating Experience Summary

OES 2025-03

April 2025

## Electrocution Hazard: A Near Fatal Reminder of Electrical Safety

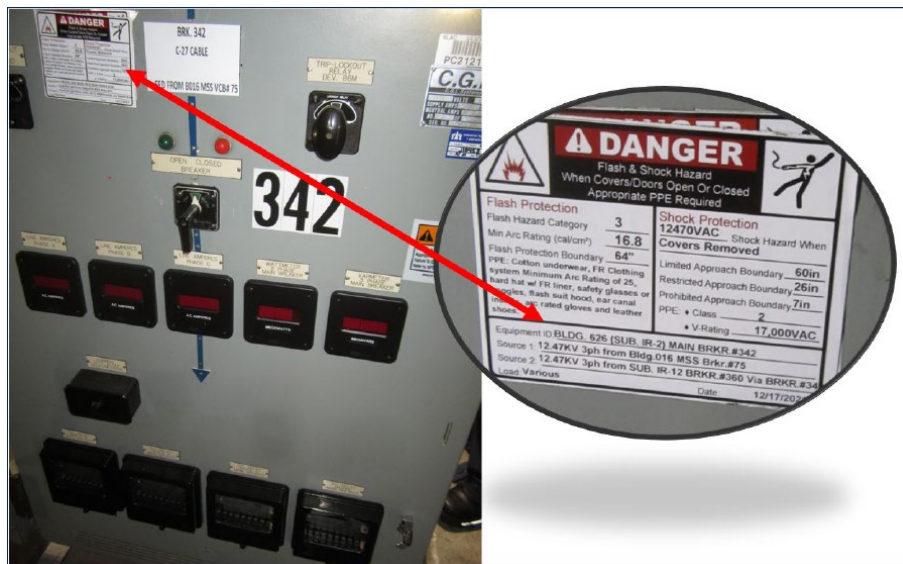
Figure 1

HVE1 and HVE2 then proceeded to rack out BRK342 and apply a lock to its associated racking mechanism. At this point, HVE2 noticed the BRK342 arc flash label applied to the front of the switchgear listed two separate sources supplying power (see **Figure 1**). HVE2 voiced their concerns to HVE1, who was at the back of the switchgear, stating that the label indicated BRK75 was one of the two power sources supplying BRK342. However, HVE1 did not acknowledge or respond to HVE2. No clarification or follow up discussions were held on this issue between HVE1 and HVE2.

- ✓ Critical communication efforts initiated by HVE2 regarding the information listed on the BRK342 arc flash label, and the indications that SS-B was still energized as brought up by HVE4, were ignored.

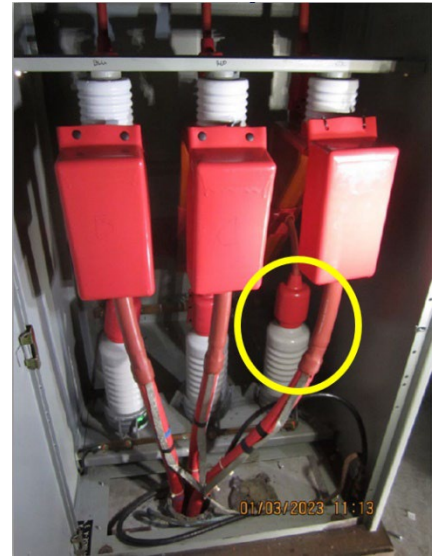
**Figure 2**

While HV-3 was staging the grounding hook, HVE1 came in-between them and the cubicle, fully opened the door, reached into the switchgear, and lifted an insulation boot off the top of phase "A" surge arrester (see **Figure 2**), exposing a bolted connection energized to ground. However, since they removed the insulation boot with their left hand while holding on to the grounded cubicle enclosure with their right hand, electricity flowed across their upper chest from the phase "A" connection to the cubicle enclosure.

HVE3 noticed HVE1 reach in, lift the insulation boot, and immediately go into a tight contraction, being unable to release. With no rescue equipment pre-staged or available nearby, and no time to get help, HVE3 grabbed HVE1's raincoat tail and forcefully yanked HVE1 out of the energized cubicle. This action interrupted the shock current and HVE1 fell unconscious to the floor with serious injuries to their hands and face.
