# Operating Experience Summary

OES 2025-04

## Ironworker Near Fatal Fall: A Preventable Tragedy

### Translating Investigations into Prevention & Learning

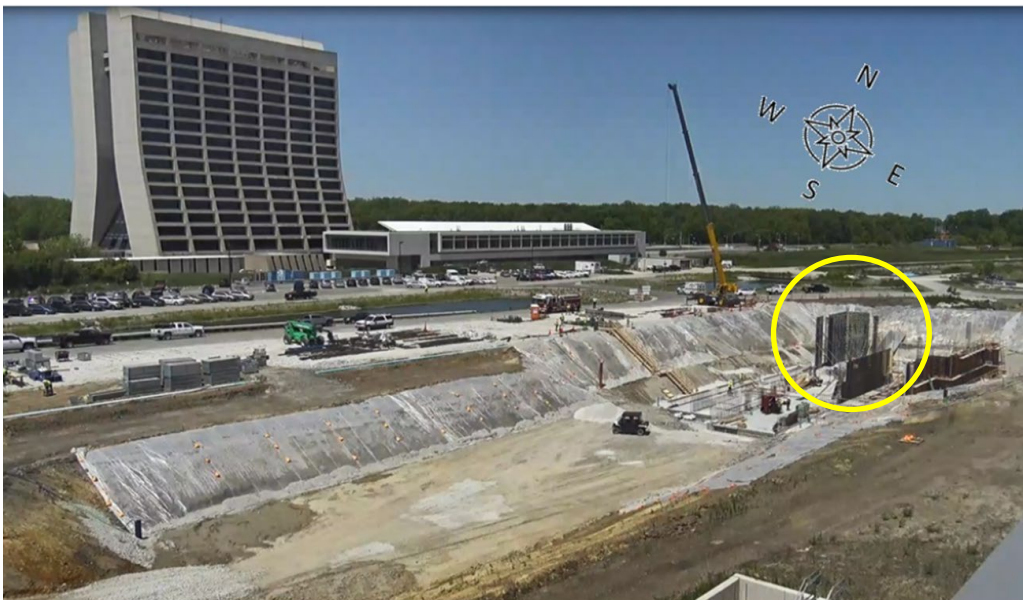
**Figure 2: PIP-II Construction Site**

The formwork assembly for the northwest corner of the PIP-II structure commenced on May 24, 2023, and continued into May 25, 2023 (see **Figure 2**).

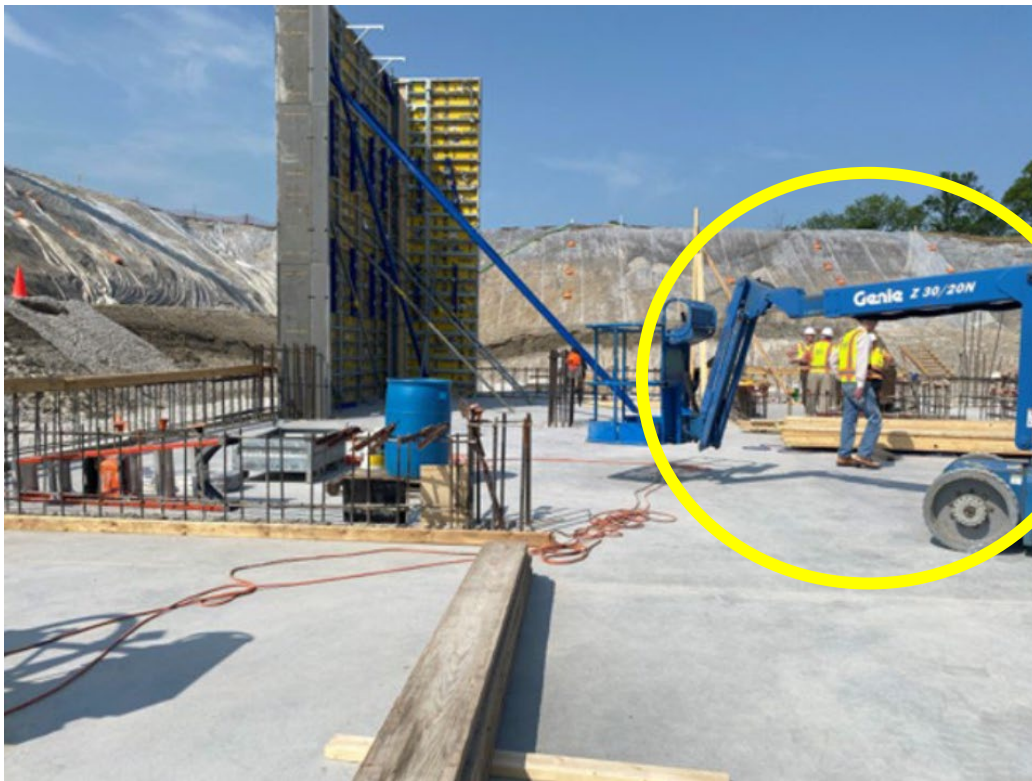
**Figure 3: Aerial lift (Genie®)**

Though other carpenters and ironworkers had used an available aerial lift (Genie®) in the days prior to the accident (see **Figure 3**), nobody, including IW1, elected to use the Genie® for this specific work evolution that day.

- ✓ The PSC failed to submit a revised SSSP to the prime contractor and was neither challenged nor stopped from working.
- ✓ The aerial lift previously used by ironworkers was available but not used for the activity on May 25, 2023.
- ✓ Oversight personnel and field supervisors failed to recognize that employees had a poor awareness and/or poor compliance with requirements when working at heights.
- ✓ IW1 was assigned the task of climbing the formwork when several options to reduce the risk of the work activity were available (ladder, aerial lift, radios).
