## Accident Investigation Report

# Construction Worker Injury at the Surplus Plutonium Disposition Project at the Savannah River Site

October 14, 2025

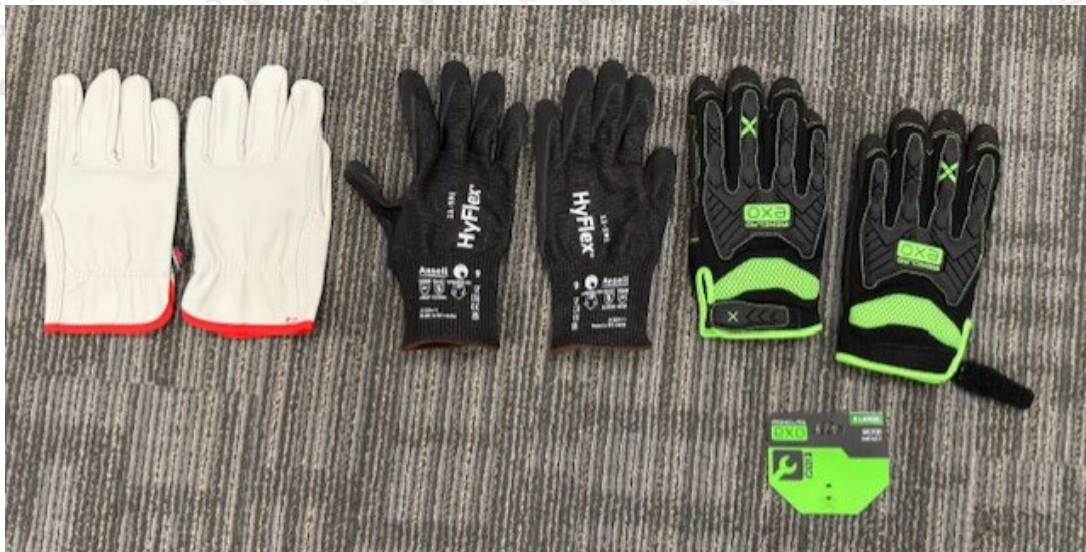
At the time of the accident, the worker was wearing HyFlex 11-591 gloves, which offer puncture resistance but are not compatible with rotating equipment hazards. Figure 2.2-1 depicts the gloves available to IW1 on the day of the event. The drill bit involved was 39-3/8 inches in length and operated at full rotational speed when the entanglement occurred.

**Figure 2.2-1: Close-up of Gloves Available for Drilling Operations**

(Left, leather non-puncture resistant gloves historically used;  
Center, HyFlex 11-591 gloves used by IW1 on day of event; Right, anti-vibration gloves)

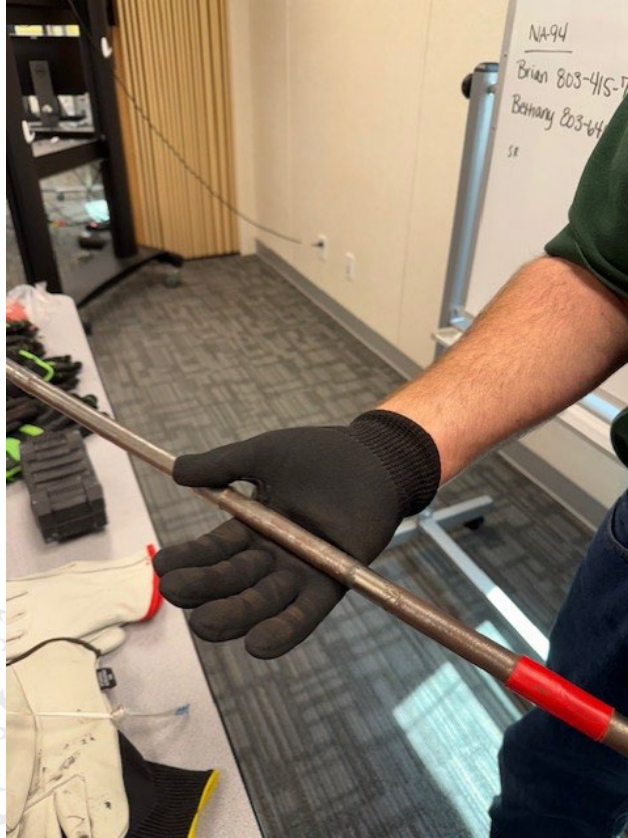
Figure 2.2-2: Example of Horizontal Guiding of Drill Bit with HyFlex 11-591 Gloves

Workers requested shorter drill bits and safer equipment but none were provided before the accident. PPE substitution to use HyFlex 11-591 gloves addressed puncture hazards but increased the risk of entanglement by increasing grip on the rotating bit.

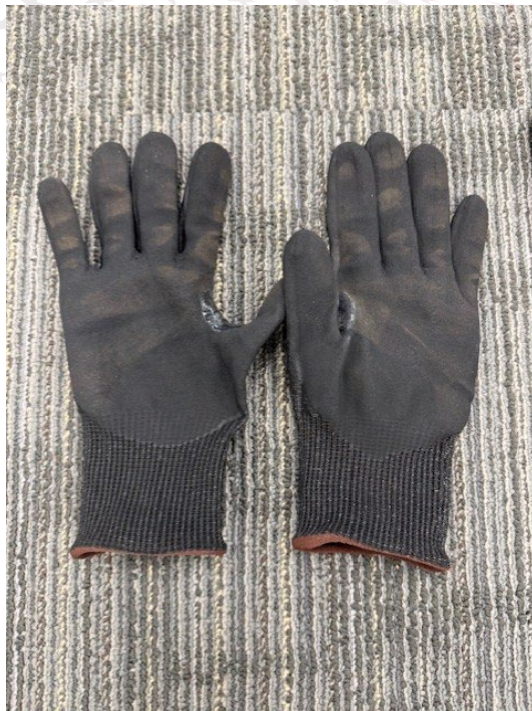
Figure 2.2-3: Palm of HyFlex 11-591 Gloves

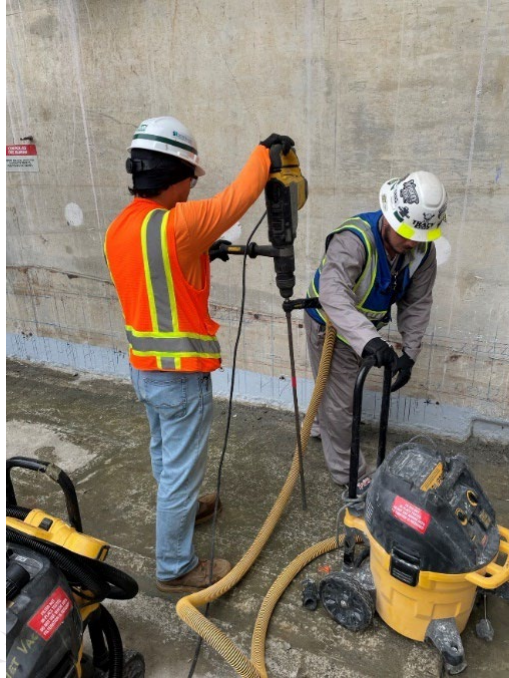
The SRNS Approved WO 02137123-01, *HEPA Building Slab Install SPD-(Y744)*, did not identify all hazards associated with horizontal concrete drilling. The only hazards documented in the AHA and JHA were standard hazards such as silica, noise, penetration checks, and electrical hazards. Hazards directly relevant to drilling operations – including rotating-bit entanglement, glove compatibility, loose clothing, miscommunication, and heat stress – were not identified or analyzed. Under SRNS Procedure 8Q 122 R.18, *Hazard Analysis Process*, Section 5.3.1, hazard identification is required for work activities, work location and environment, and co-located work. This requirement was not met, as hazards associated with the work and co-worker activities were not consistently analyzed in accordance with the procedure.

**Figure 3.2-1: Longer Drill Bit with Silica Control**

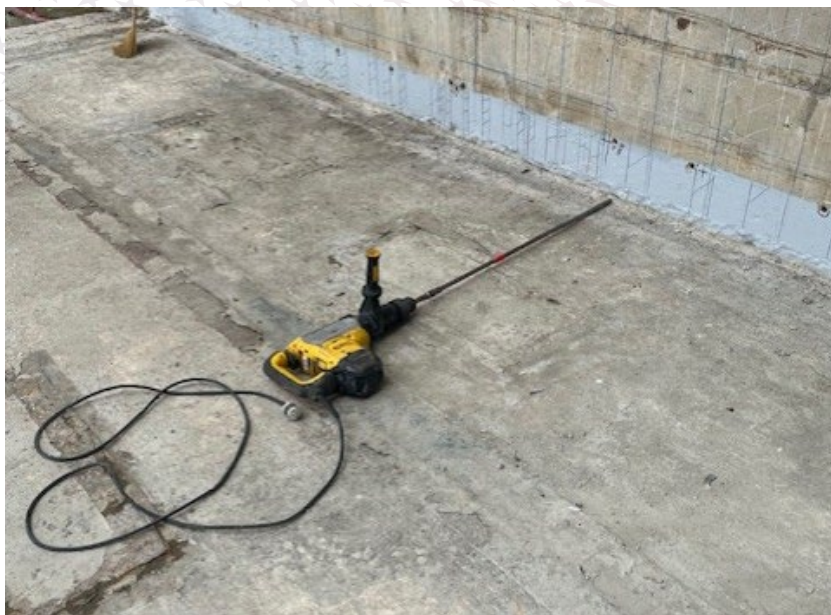
The drills used had speed controls ranging from one (slowest) to seven (fastest). Workers reported that the drills were always operated at the highest setting. By the time of the accident, over 150 holes had been drilled using this practice without SRNS construction management identifying the hazard. Time Out Authority was available but not exercised, and the Employee Concerns Program (ECP) was unused despite near misses and long-standing worker concerns about less than safe drilling methods.

**Figure 3.2-2: Longer Drill Bit for Horizontal Concrete Dowel Drilling**

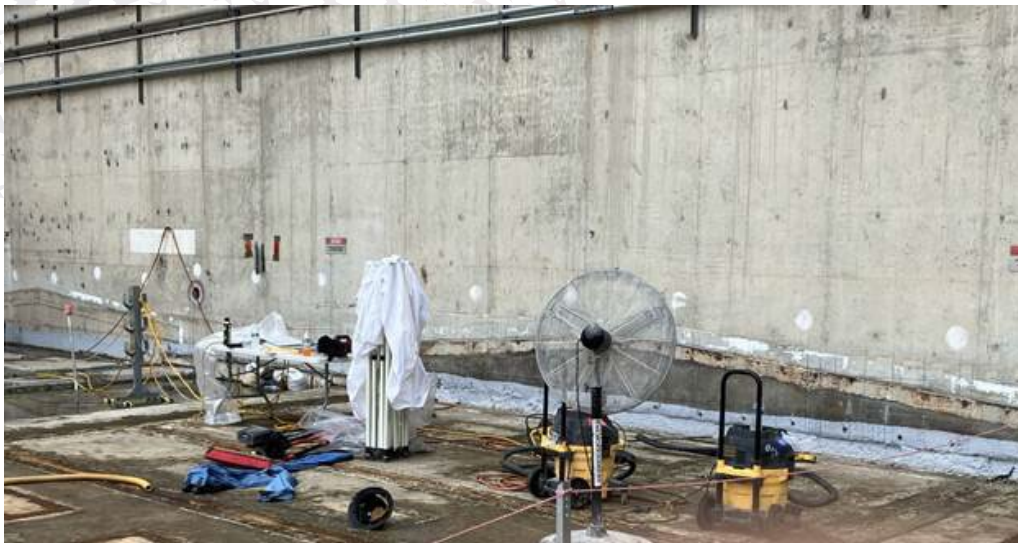
At the time of the accident, drilling was being conducted outside along the north wall of the K-Area reactor building next to the hatches that were historically used to access heat exchangers for the K-Area reactor. The general area was called the “handball court” area by workers (see Figure 3.2-3). The workday started with attending a Pre-Job Briefing to discuss daily activities and the STARRT card requirements. All ironworkers placed initials on the STARRT card to acknowledge they reviewed and marked all potential hazards, PPE, and required safety controls. In addition, the initials acknowledged all comments had been addressed and they understood their duty to stop/call a Time Out if a less than safe condition was identified.

When drilling restarted for the emplacement holes in June 2025, a shorter drill bit was used in the process for a limited number of emplacement holes. The shorter bit allowed a single person to conduct the entire drilling process. The shorter bit could establish a pilot hole so the longer drill bit could be inserted to drill the emplacement hole to required depth. Soon after the restart of drilling inside the building in June 2025, the shorter drill bits became clogged and could not be used. The ironworkers attempted on multiple occasions to obtain replacement shorter bits, but their requests were not fulfilled until after the accident occurred.

**Figure 3.2-3: Outside Work Location (Handball Court) for Emplacement Holes**

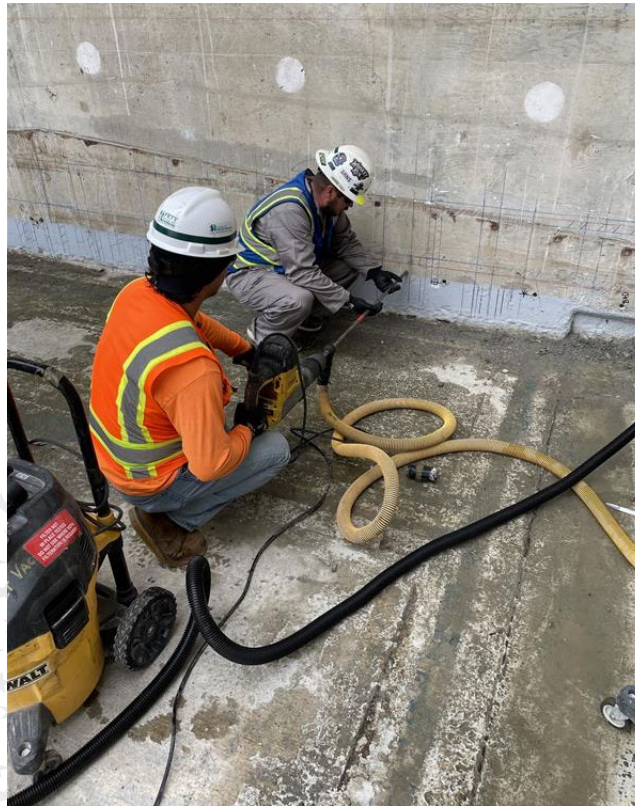
The rotational hazard or energy transfer potential of the drill or bit was not addressed in the WO. It only appeared once in the STARRT card of the day of the accident stating: “Hazard: Rotating equipment,” and “Control: Keep hands clear.” This control was insufficient given the work conditions. Due to the unavailability of shorter drill bits and the inherent challenge for a single individual to safely initiate an emplacement hole with the longer bits (i.e., establish the “initial bite”), ironworkers developed an improvised

two-person workaround. This process involved a drill operator (Driller) and a horizontal drill bit Supporter, as depicted in Figure 3.2-4.

**Figure 3.2-4: Reenactment of Ironworker Hand Guiding Horizontal Drill Bit**

The “initial bite” refers to successful engagement of the drill bit with the concrete surface without slipping or “walking.” Masonry drill bits, characterized by a non-cutting flat spot (web or chisel point) on the tip, tend to skid across the surface until the outer cutting edges engage. Interviews with the ironworkers indicated that the drill’s speed adjustment dial, ranging from one (slowest) to seven (fastest), was never used; and operations consistently occurred at the highest speed setting.

Interviews with the ironworkers revealed that some would use the palms of their hands to stabilize the horizontal drill bit while it was rotating. Journeymen attested that open-hand support was the established common practice. The accident suggests that even a slight grasping or contact with the rotating bit while wearing HyFlex 11-591 gloves

Alternative safe methods, such as drilling pilot holes, using guide blocks, or reducing drill speed, were not incorporated into the WO or enforced. SRNS construction management oversight failed to detect or correct this practice, despite hundreds of holes being drilled in this manner.
