U.S. DEPARTMENT  
*of* **ENERGY**

Office of  
Science

# Accident Investigation of the July 1, 2026, Brookhaven National Laboratory Forklift Accident Resulting in a Serious Pedestrian Injury

October 2026

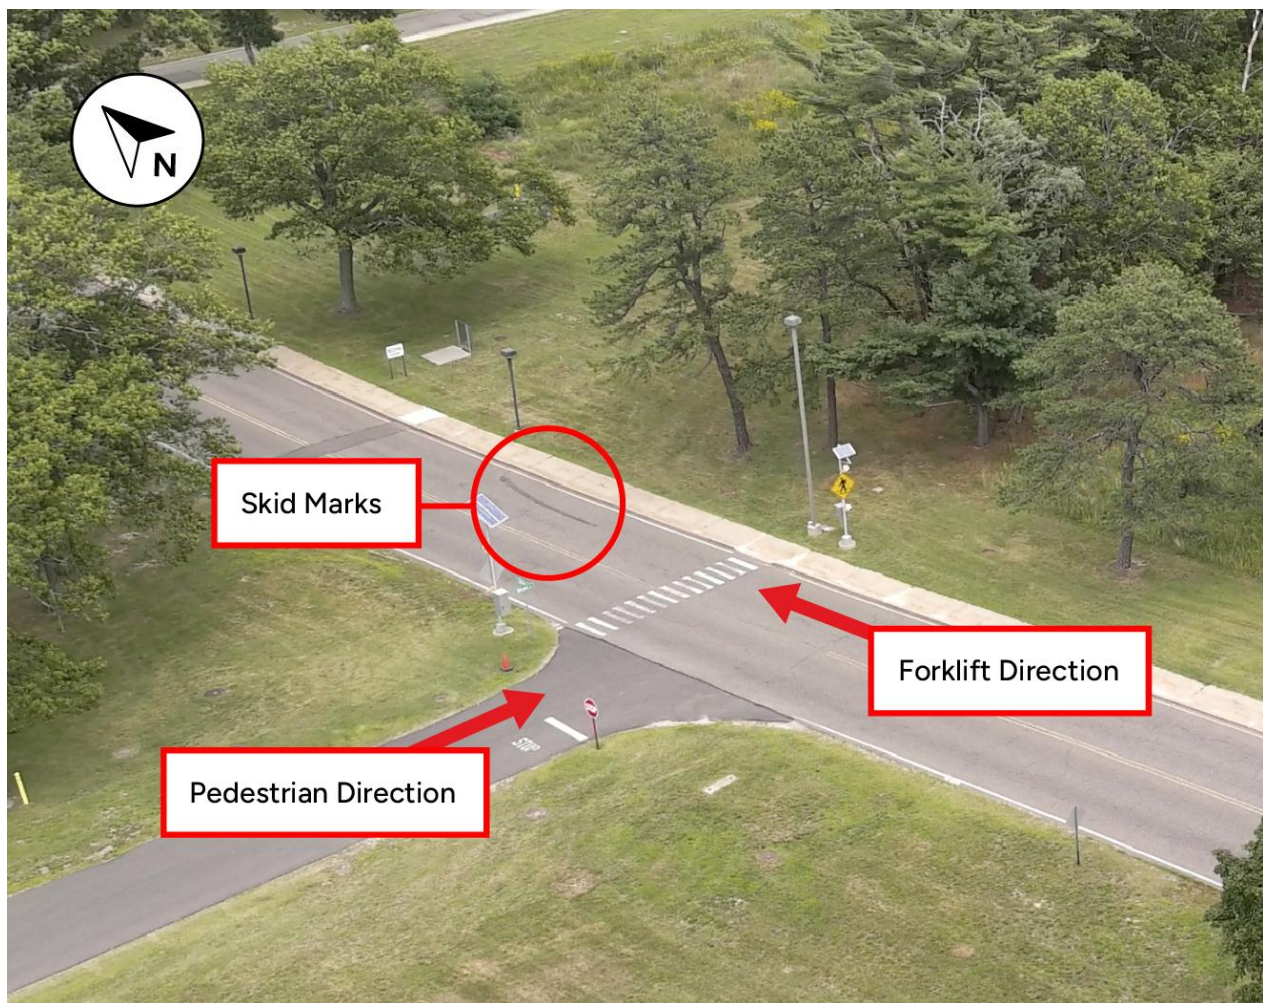
There is no stop sign at the crosswalk for traffic on Upton Road. However, continuous caution lights identify the crosswalk (as shown in Figure 6).

Figure 6: Overhead view of crosswalk and signage at Mitchell Lane and Upton Road intersection; skid marks are circled. (BNL drone footage from accident re-creation on July 14, 2026. To reflect the scene the day of the accident, the image was digitally altered by removing police vehicles and additional crosswalk signage BNL placed after the accident.)

Based on this accident, the Board notes that **the crosswalk configuration and signage were ineffective to alert the Forklift Operator to the Pedestrian's presence (Contributing Cause 9)**. Specifically, the sign alerting Upton Road drivers to the crosswalk at Mitchell Lane flashes continuously, regardless of whether a pedestrian is in the crosswalk. In addition, Mitchell Lane, the road that leads from Curie House to the crosswalk, does not have a sidewalk. This compels pedestrians to walk either in grass or on the road. The Board noted that BNL had not conducted a safety engineering analysis to evaluate roads, signage, crosswalks, and pedestrian interactions across the laboratory.

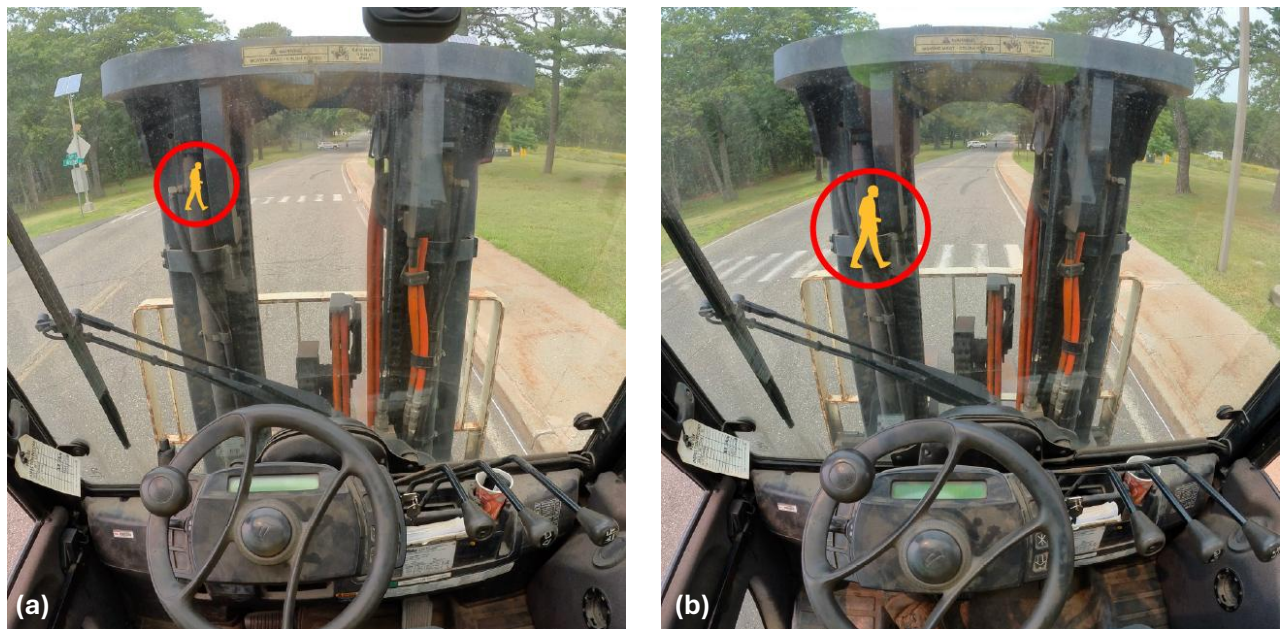
- **Visibility and Equipment Design Limits:** The forklift involved in the accident weighed 15,560 pounds and was equipped with 72-inch-long forks, the longest forks this model of forklift is allowed to use. Although the forklift was regularly maintained, recently serviced, and free of mechanical deficiencies, its design inherently limits operator visibility. **Visual obstruction due to the forklift's left mast, the speed of the forklift, and the speed of the Pedestrian resulted in continuous occlusion of the Pedestrian (Contributing Cause 6)**, as illustrated in Figure 10. This obscured the Pedestrian during the critical window when the Pedestrian was in the crosswalk. BNL did not identify or mitigate these equipment-specific hazards.

Figure 10: View from an operator's perspective while in forklift. Images depict continuous occlusion of pedestrian (circled) in the crosswalk at (a) approximately 3 seconds before impact and (b) less than 1 second before impact (from accident re-creation on July 14, 2026).
