U.S. DEPARTMENT  
*of* **ENERGY**

# Accident Investigation of the July 1, 2026, Brookhaven National Laboratory Forklift Accident Resulting in a Serious Pedestrian Injury

October 2026

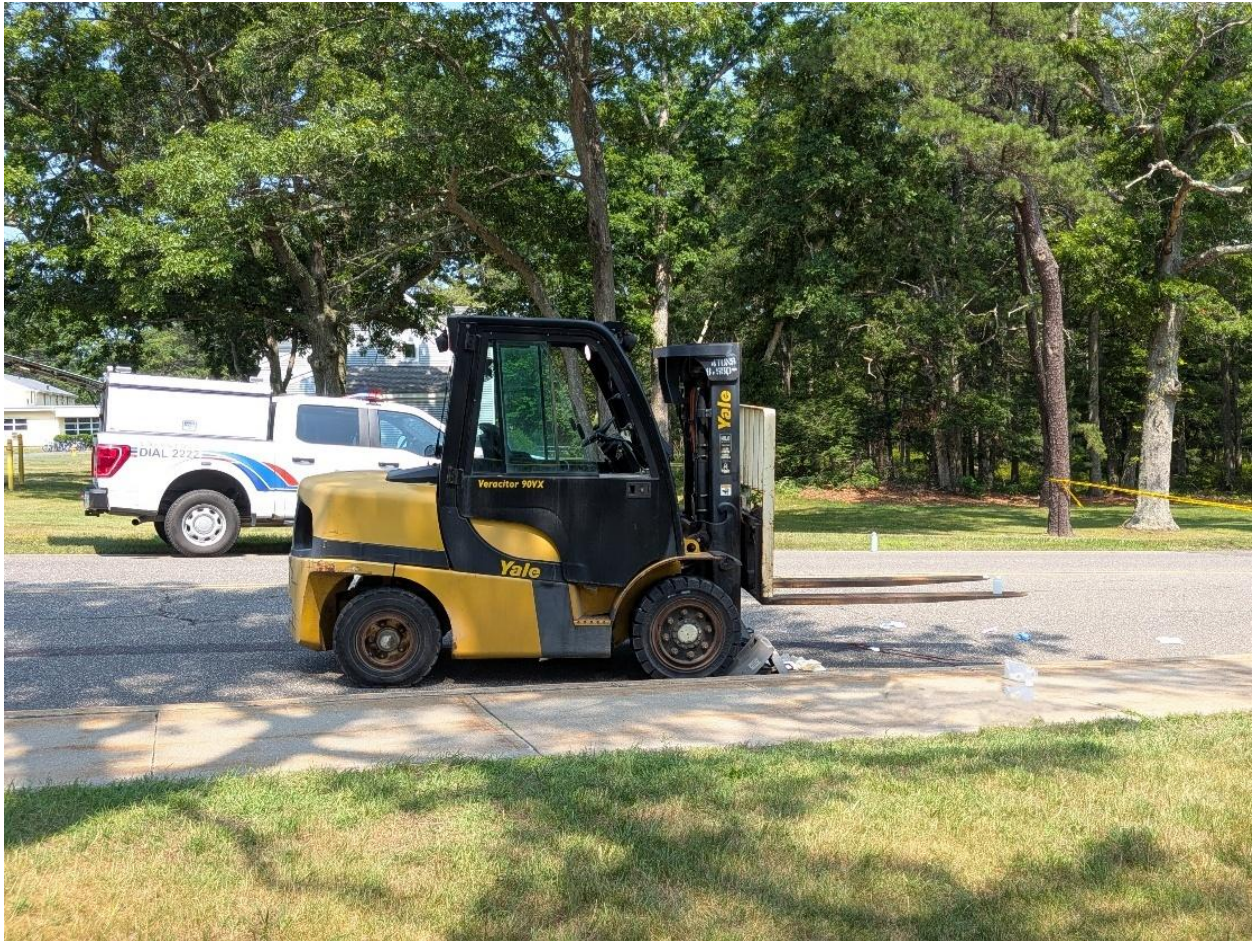
Figure 2: Forklift parked after the accident; the AIB digitally removed the Pedestrian's personal items from this image and the similar image on the report's cover.

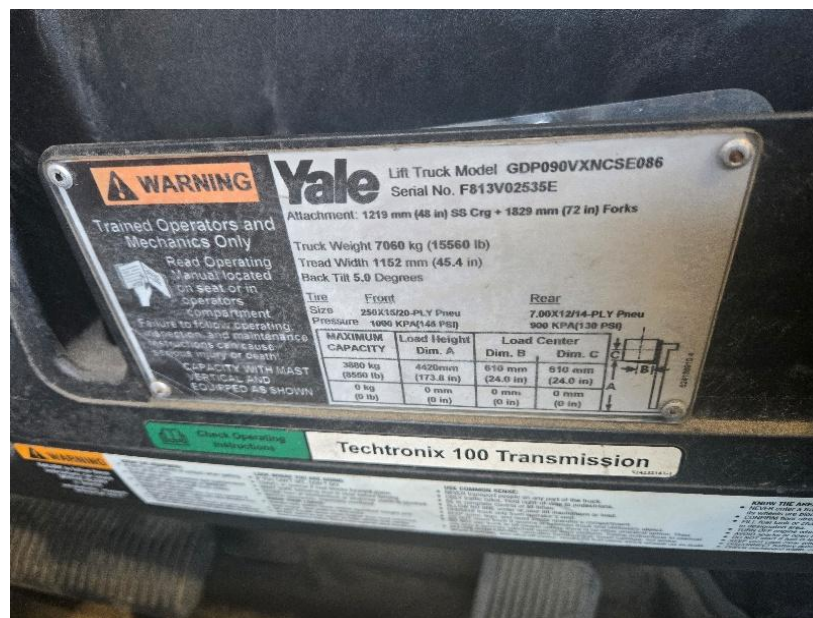
Figure 3: Forklift data plate.

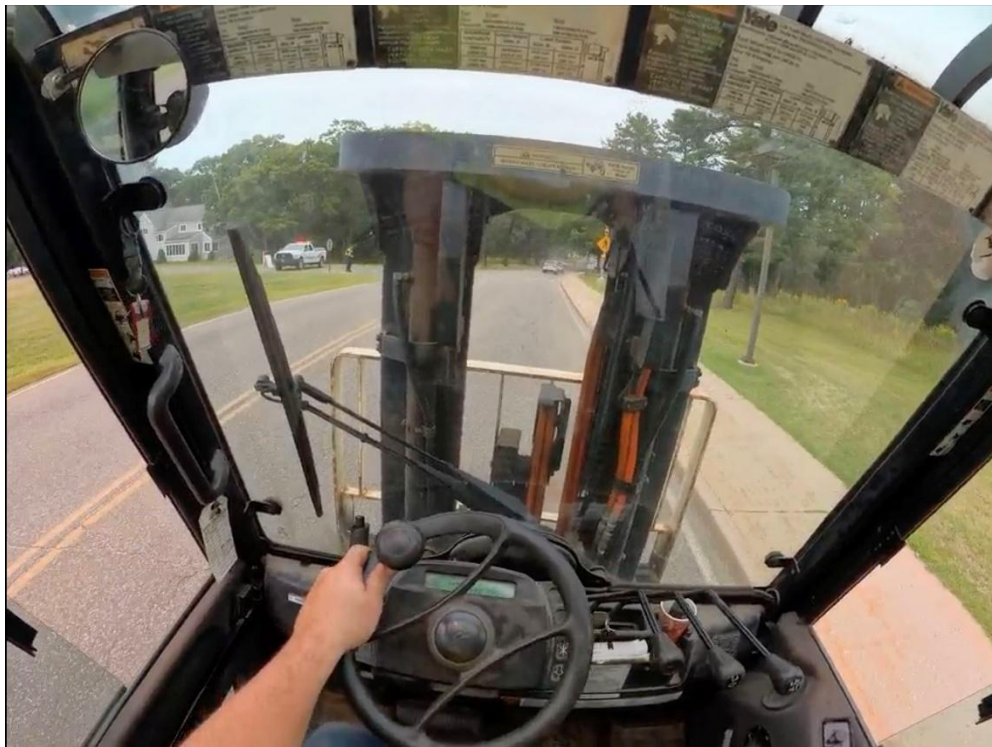
The Forklift Operator drove northbound on Upton Road, a two-lane road with a double yellow line separating the north and southbound lanes, at a speed of approximately 10 MPH with the forks approximately 8–10 inches off the ground, a standard driving configuration for forklifts with no payload (see Figure 4 for depiction of Forklift Operator's view). The vehicle speed limit for the road is 30 MPH; however, the maximum speed of this forklift is about 10–11 MPH.

Figure 4: First-person view from the forklift involved in the accident approaching the crosswalk where the accident took place. (The image is a screen capture from first-person video recorded during the accident re-creation on July 14, 2026.)

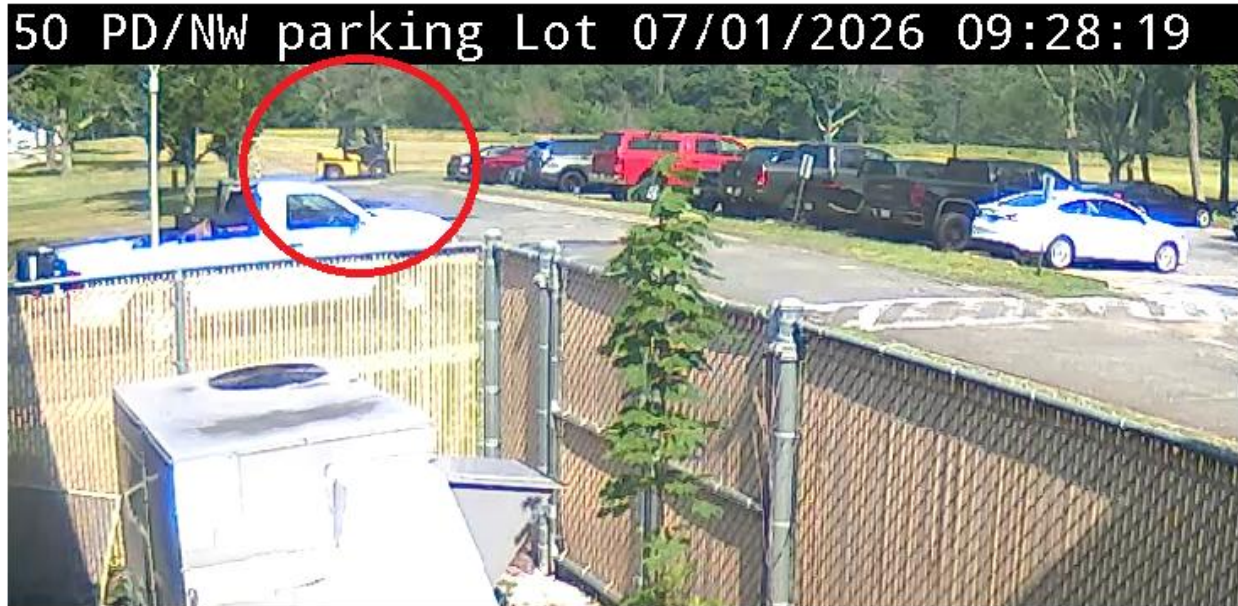
The forklift passed the BNL Police Headquarters (Building 50), which is approximately 1,000 feet from the crosswalk at Upton Road and Mitchell Lane, at 9:28 a.m. (Figure 5). At least three vehicles (operated by Driver 1, Driver 2, and Driver 3) passed the forklift between the BNL police station and the crosswalk by crossing the double yellow lines on Upton Road. Two additional vehicles (operated by Driver 4 and Driver 5) were following behind the forklift.

Figure 5: Forklift passed the BNL police station at 9:28 a.m. (BNL Police Headquarters camera; red circle added to photo to highlight forklift.)

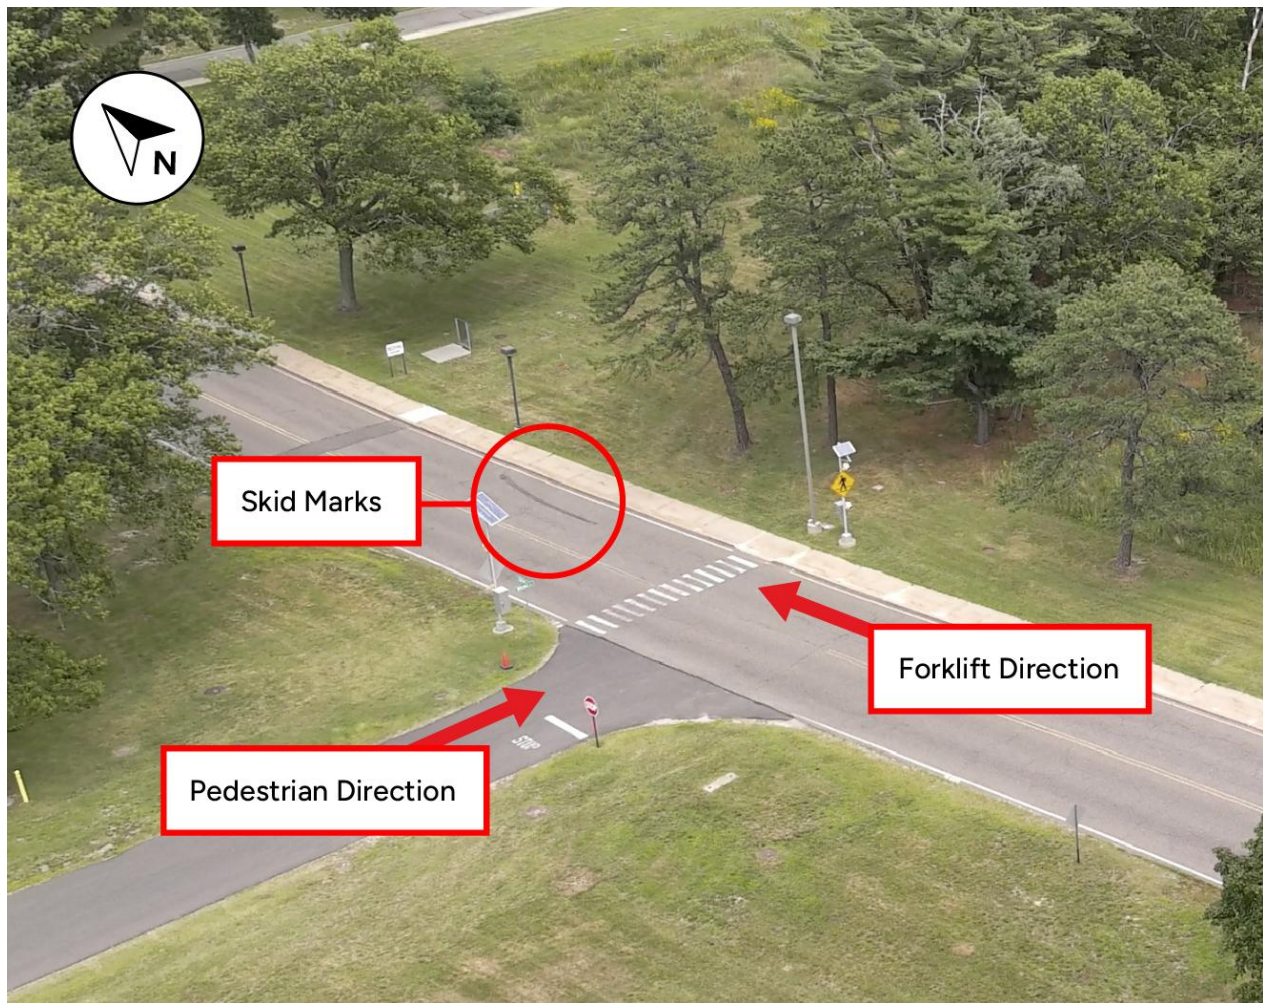
There is no stop sign at the crosswalk for traffic on Upton Road. However, continuous caution lights identify the crosswalk (as shown in Figure 6).

Figure 6: Overhead view of crosswalk and signage at Mitchell Lane and Upton Road intersection; skid marks are circled. (BNL drone footage from accident re-creation on July 14, 2026. To reflect the scene the day of the accident, the image was digitally altered by removing police vehicles and additional crosswalk signage BNL placed after the accident.)

Based on this accident, the Board notes that **the crosswalk configuration and signage were ineffective to alert the Forklift Operator to the Pedestrian's presence (Contributing Cause 9)**. Specifically, the sign alerting Upton Road drivers to the crosswalk at Mitchell Lane flashes continuously, regardless of whether a pedestrian is in the crosswalk. In addition, Mitchell Lane, the road that leads from Curie House to the crosswalk, does not have a sidewalk. This compels pedestrians to walk either in grass or on the road. The Board noted that BNL had not conducted a safety engineering analysis to evaluate roads, signage, crosswalks, and pedestrian interactions across the laboratory.

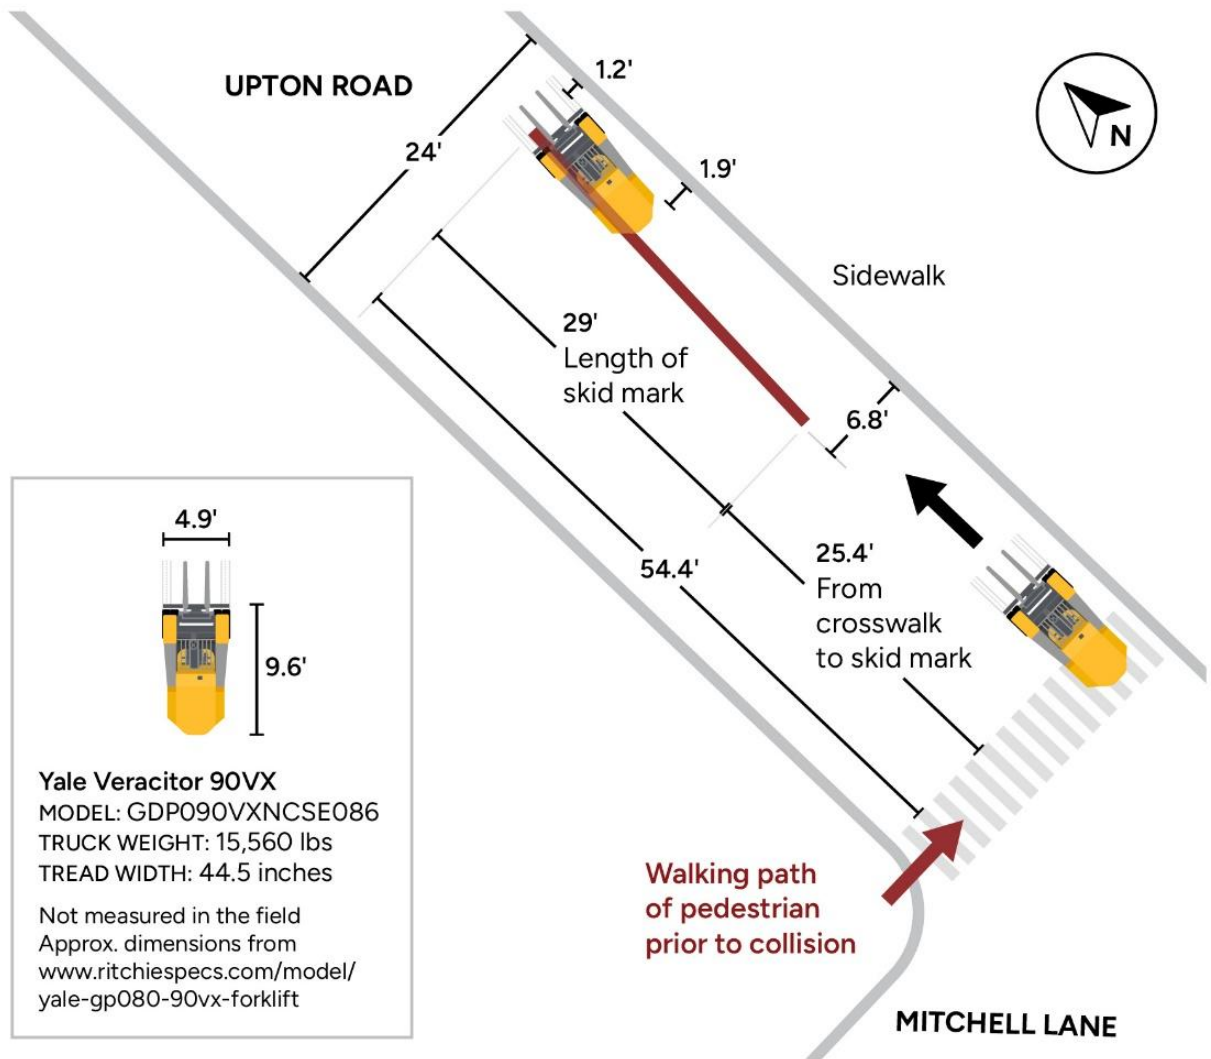
The Forklift Operator did not immediately recognize that the forklift hit the Pedestrian and did not start braking until seeing the Pedestrian on the ground. As the Forklift Operator braked, the truck's left front tire left a visible 29-foot-long skid mark before coming to a complete stop 54 feet past the crosswalk. The skid mark began 25.4 feet past the crosswalk. The one visible skid mark was from the left front tire. See Figure 7 for a detailed diagram of the accident.

Figure 7: Diagram of forklift braking after impact, from BNL ES&H measurements.

AIB brake testing reenactments repeatedly showed the same one-tire skid-mark pattern observed at the accident site. The AIB could not determine why the left tire left a distinct skid mark, while the right tire did not.

However, the AIB determined that the brakes and tires were serviceable and performed to standard expectations, and the one visible skid mark was not an indication of any mechanical deficiency.

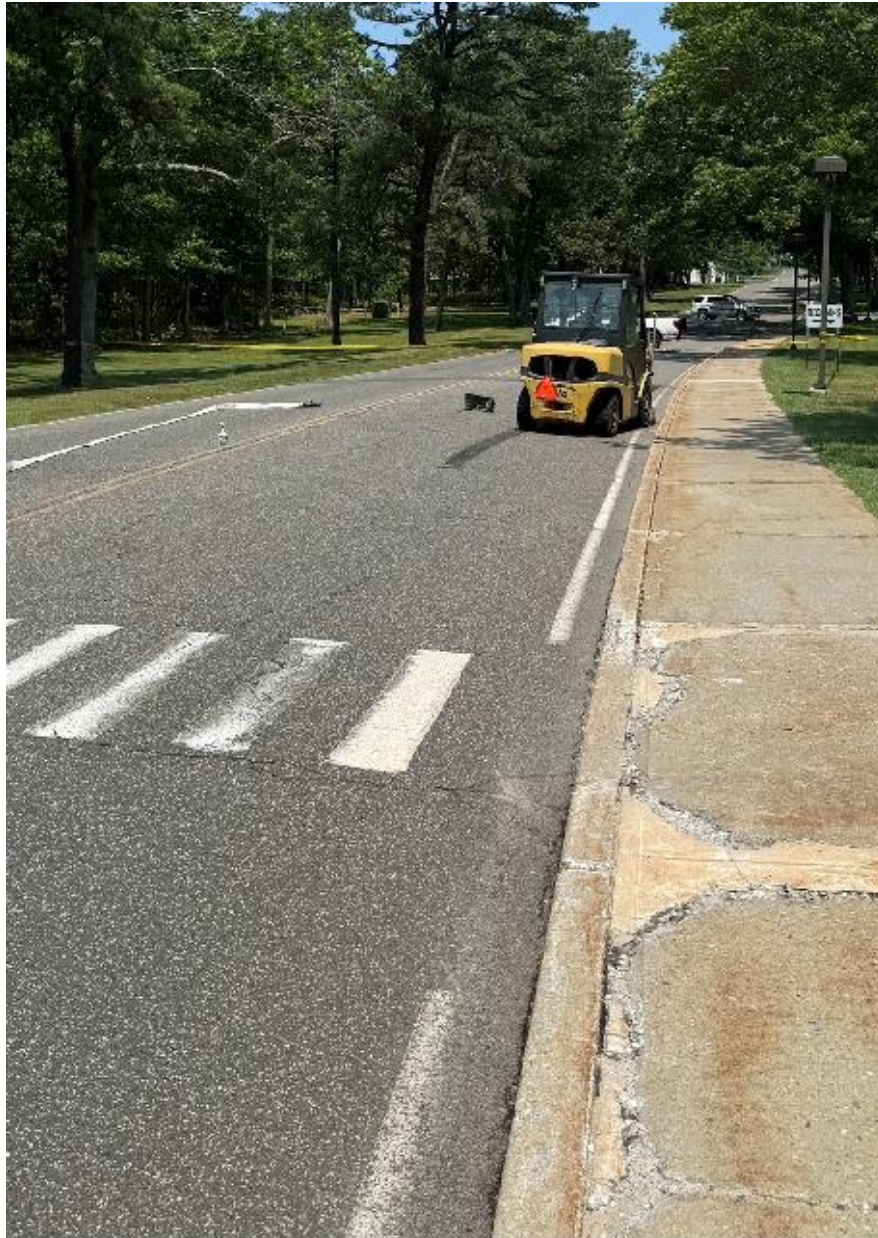
The Pedestrian was trapped and pushed along the ground in front of the forklift tires. The Board cannot determine whether the Pedestrian was initially struck, thrown forward in the roadway, and then pushed against the road for 29 feet, or if the Pedestrian was under the forklift for all 54 feet from the crosswalk to the end of the skid mark. The Board concludes that the Pedestrian was trapped between the forklift carriage, forks, and the asphalt road and pushed along the road for at least 29 feet but no more than 54 feet. After the vehicle stopped, the Forklift Operator raised the forks and backed up the forklift (as shown in Figure 8).

Figure 8: Photo of forklift and skid mark on July 1, 2026 (courtesy of BNL).

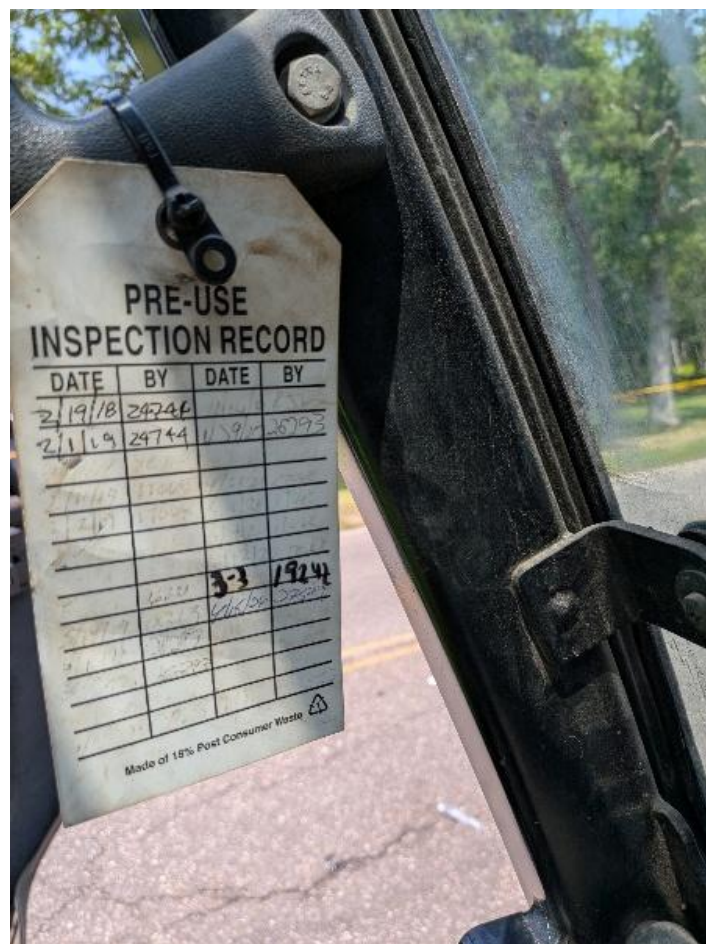
- **Pre-Use Inspections:** On the day of the accident, the Forklift Operator failed to document the required daily pre-use inspection of the forklift. The local paper-tag logging system lacked independent verification or supervisory checks. This allowed the daily inspection tag to remain without updates since April 18, 2026, as shown in Figure 9. Further, this procedural noncompliance occurred without supervisory or management intervention. The AIB assesses that the forklift was in good working order at the time of the accident. Therefore, the failure to complete or document the inspection did not directly impact the accident, but it does demonstrate an important instance of noncompliance with BNL requirements; it also calls into question BNL’s compliance with the Occupational Safety and Health Administration (OSHA) requirement to examine industrial trucks at least daily before placing them in service (1910.178(q)(7)).

Figure 9: Forklift pre-use inspection tag after the accident on July 1, 2026.

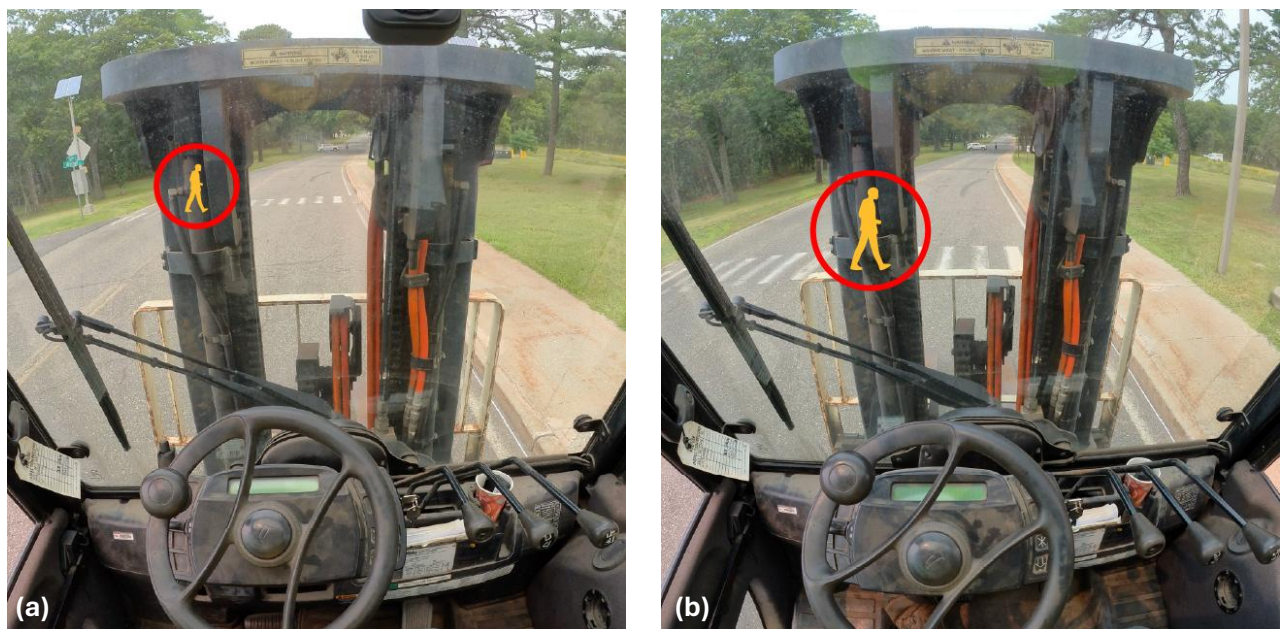
- **Visibility and Equipment Design Limits:** The forklift involved in the accident weighed 15,560 pounds and was equipped with 72-inch-long forks, the longest forks this model of forklift is allowed to use. Although the forklift was regularly maintained, recently serviced, and free of mechanical deficiencies, its design inherently limits operator visibility. **Visual obstruction due to the forklift's left mast, the speed of the forklift, and the speed of the Pedestrian resulted in continuous occlusion of the Pedestrian (Contributing Cause 6)**, as illustrated in Figure 10. This obscured the Pedestrian during the critical window when the Pedestrian was in the crosswalk. BNL did not identify or mitigate these equipment-specific hazards.

Figure 10: View from an operator's perspective while in forklift. Images depict continuous occlusion of pedestrian (circled) in the crosswalk at (a) approximately 3 seconds before impact and (b) less than 1 second before impact (from accident re-creation on July 14, 2026).

- **Engineering Controls and Safety Features:** The forklift lacked additional available safety technologies such as a pre-use inspection ignition interlock system; warning, directional, and/or safety lights; enhanced frontal visibility cameras; proximity sensors; pedestrian and presence-detection systems; audible alerts; or automatic braking. Without any engineering or administrative controls on the forklift, BNL relied almost entirely on the Forklift Operator's skill to operate the forklift safely in the presence of pedestrians. **The forklift did not have additional installed safety features that could have alerted the Forklift Operator or Pedestrian prior to the collision (Contributing Cause 5).**
