Plugging of Exhaust Gas Recirculation Coolers

Michael J. Lance, John M.E. Storey, C. Scott Sluder, Samuel A. Lewis Sr., and Hassina Bilheux
Oak Ridge National Laboratory

October 19th, 2012

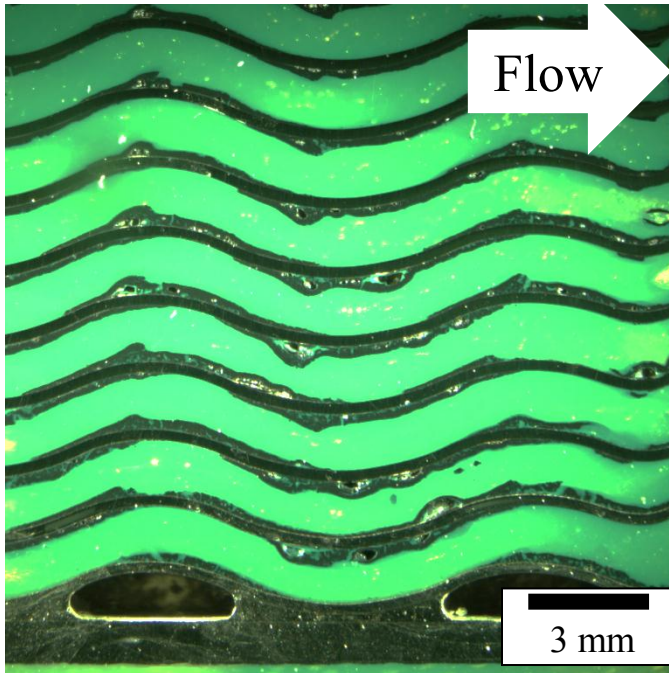
Stabilized Effectiveness Loss

- Deposits reduce cooling effectiveness, but do not typically restrict gas flow.
- Low-density, low-K, powdery deposit.
- May be mitigated by changes in cooler geometry or engine operation.

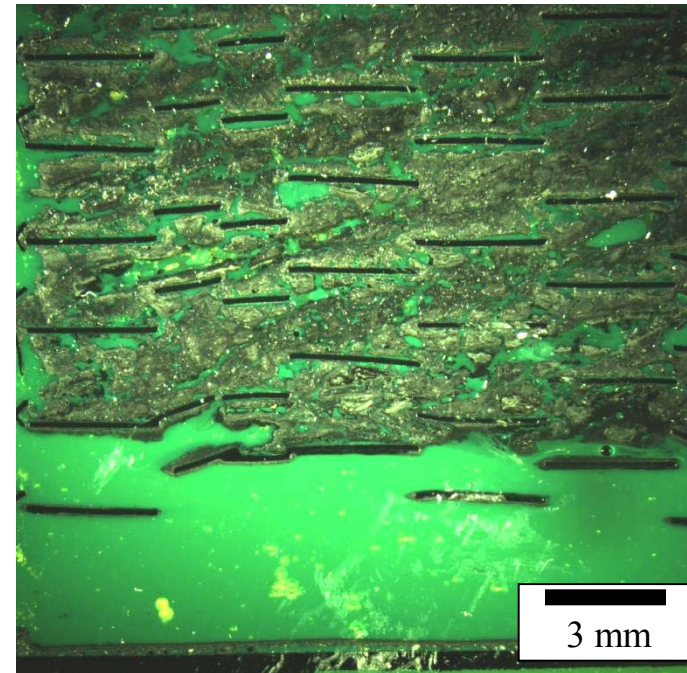
Loss of Flow (Plugging)

- Deposits form plugs strong enough to occlude gas passages.
- Usually evidence of large hydrocarbon influence.
- Lacquer-like or tar-like consistency.

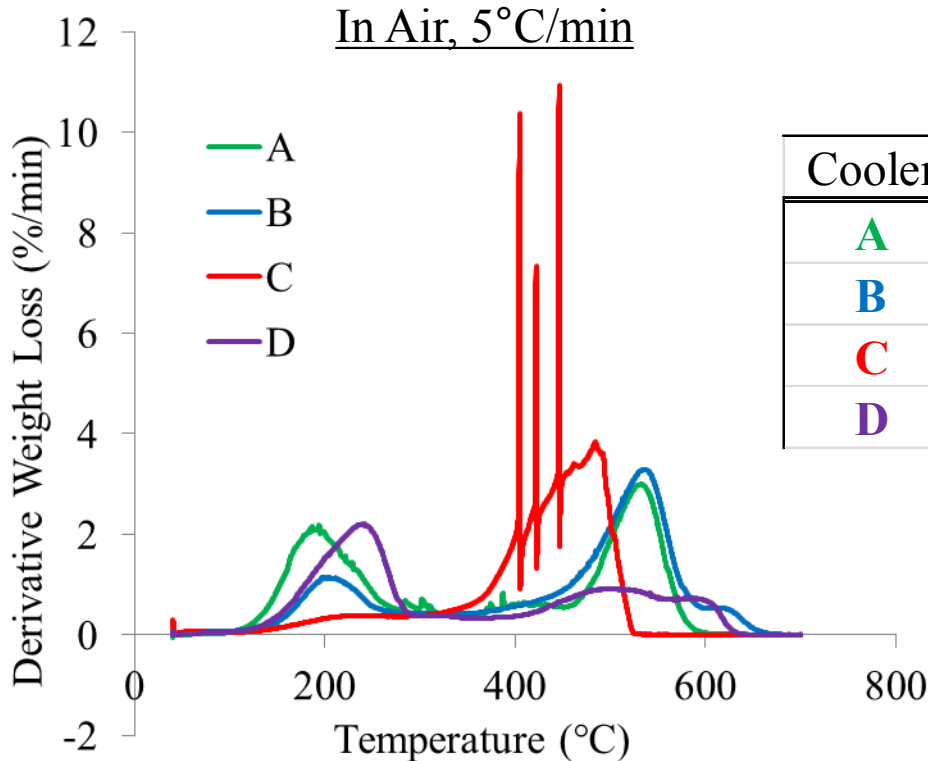
Thermogravimetric Measurements

Cooler	Volatile	Ash	Description
A	78%	0%	Shiny Brittle Lacquer
B	55%	1%	Lacquer and soot
C	26%	8%	Dry, Crumbly
D	59%	13%	Oily, wet

- Coolers A & B were both lacquer-like and had the lowest ash content.
- Cooler C burned at a low temperature and showed exothermic spikes during oxidation.
- Cooler D was very wet and oily and contained the most ash.

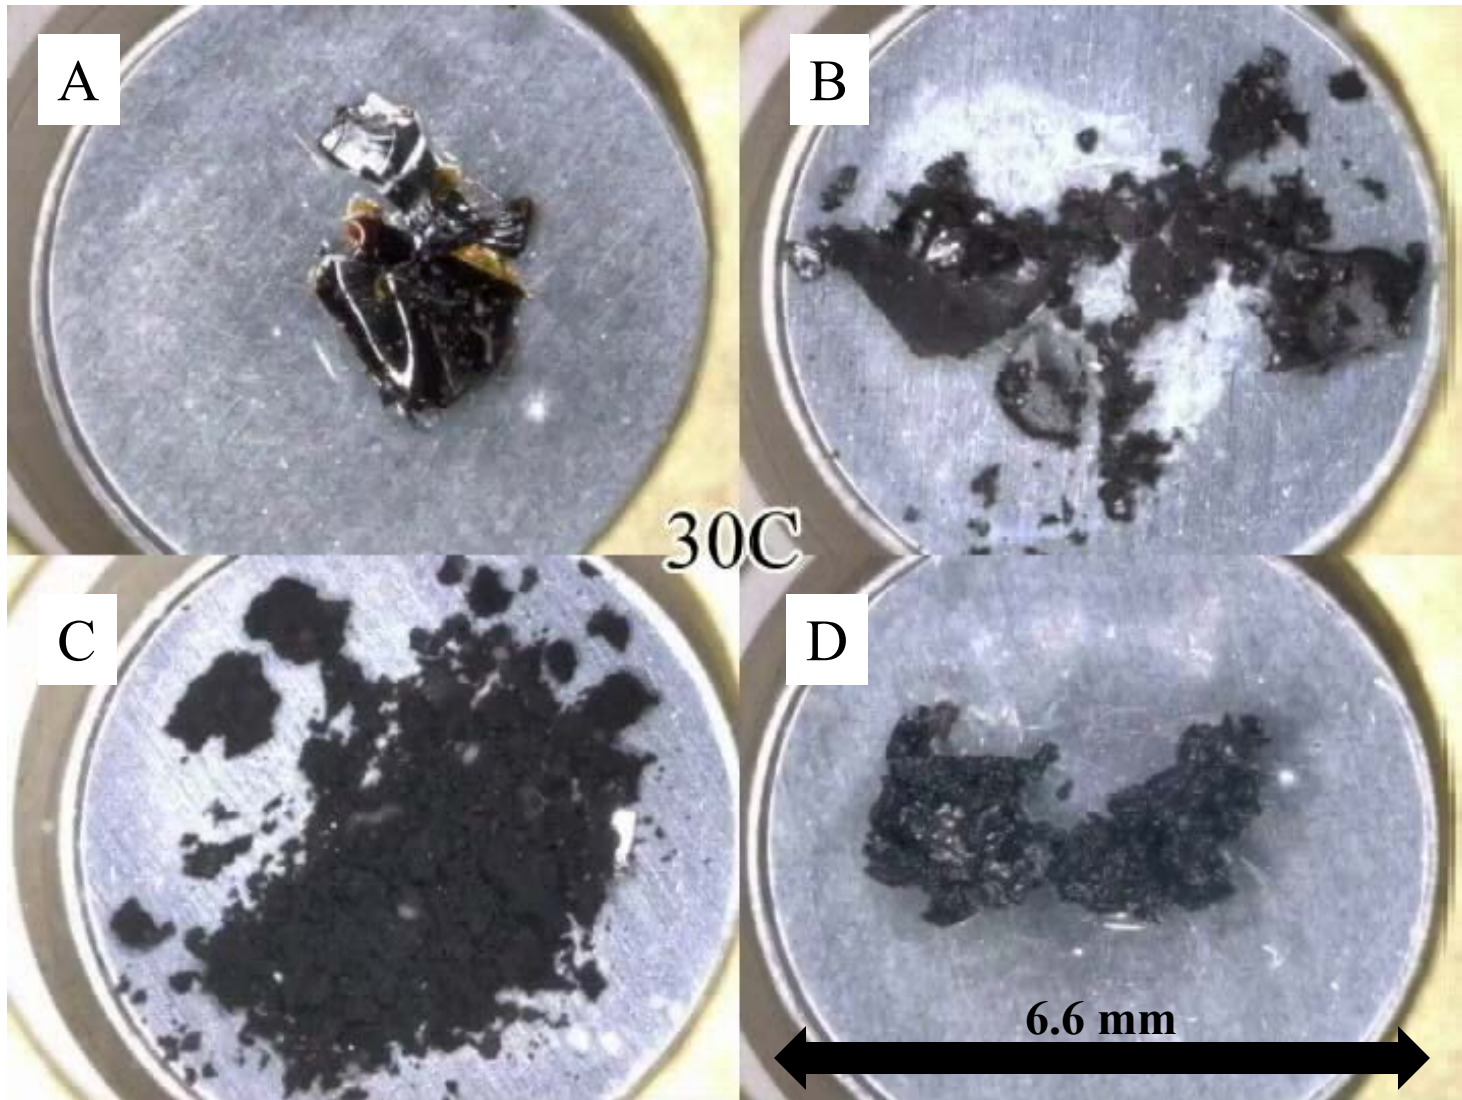
Videos Taken While Heating in Air are Useful for Visualizing Deposit Behavior at High Temperatures

- Cooler D was soot mixed with oil.

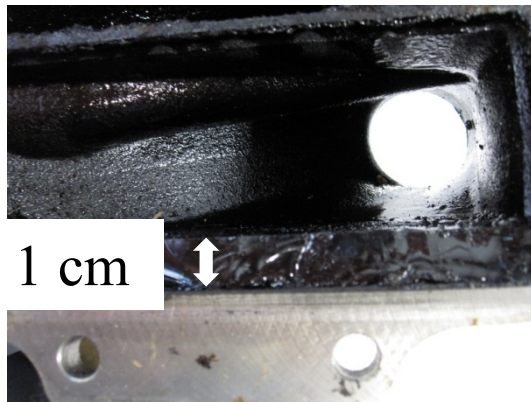
Outlet Diffuser

Cooler A: Deposit Flowed and Boiled During Use

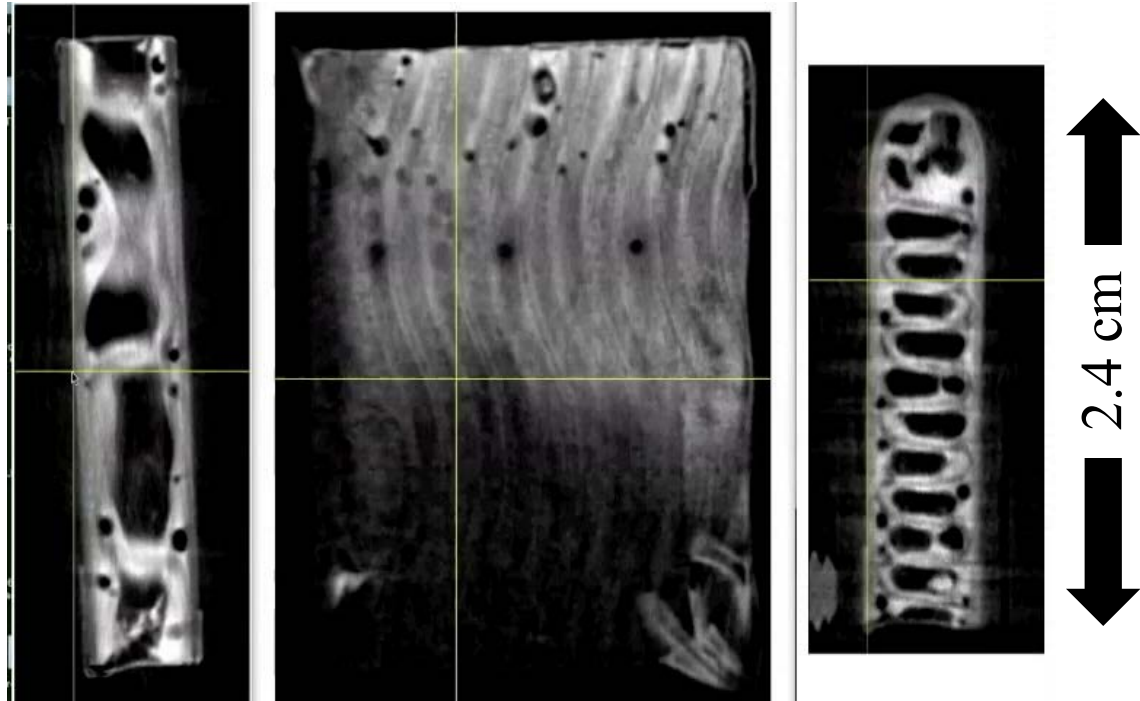
Neutron Tomography

- Industry Representative:
 - “This particular test was an extremely severe EGR valve sticking test. The EGR valve and throttle were forced open, the engine ran at low idle, and timing was retarded by 7 degrees.”
- Bubbles in the deposit were observed using neutron tomography.

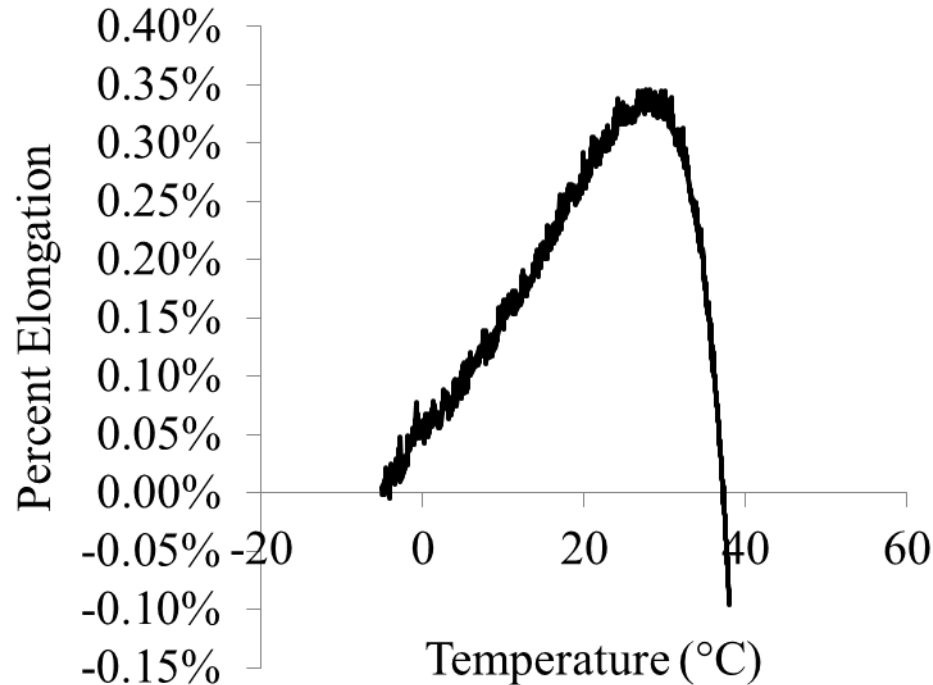
Thermo-Mechanical Analysis (TMA)

Cooler A: Lacquer Deposit Starts to Soften around Room Temperature

- Density = 1.2 g/cm^3
 - More similar to a polymer than fuel or oil.
- Thermal Conductivity = 0.11 W/mK

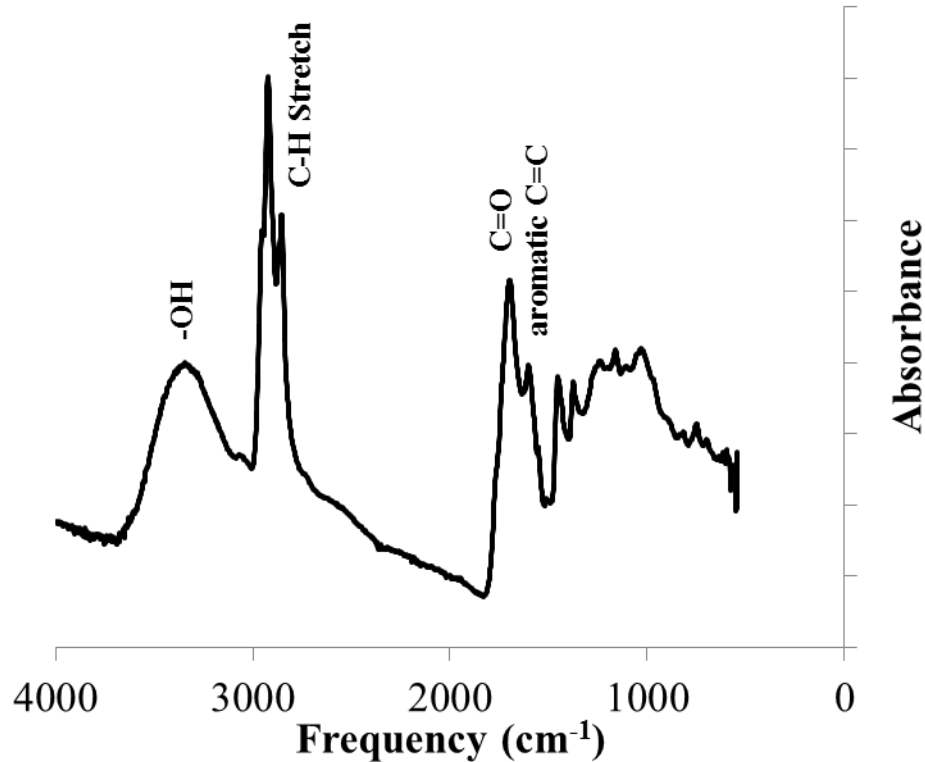
Fourier Transform Infrared (FT-IR) Spectroscopy of Cooler A Showed the Presence of Oxygen-containing Hydroxyl and Carboxyl Groups

- X-ray Photoelectron Spectroscopy (XPS) showed 15 at% oxygen and 0.5 at% nitrogen.

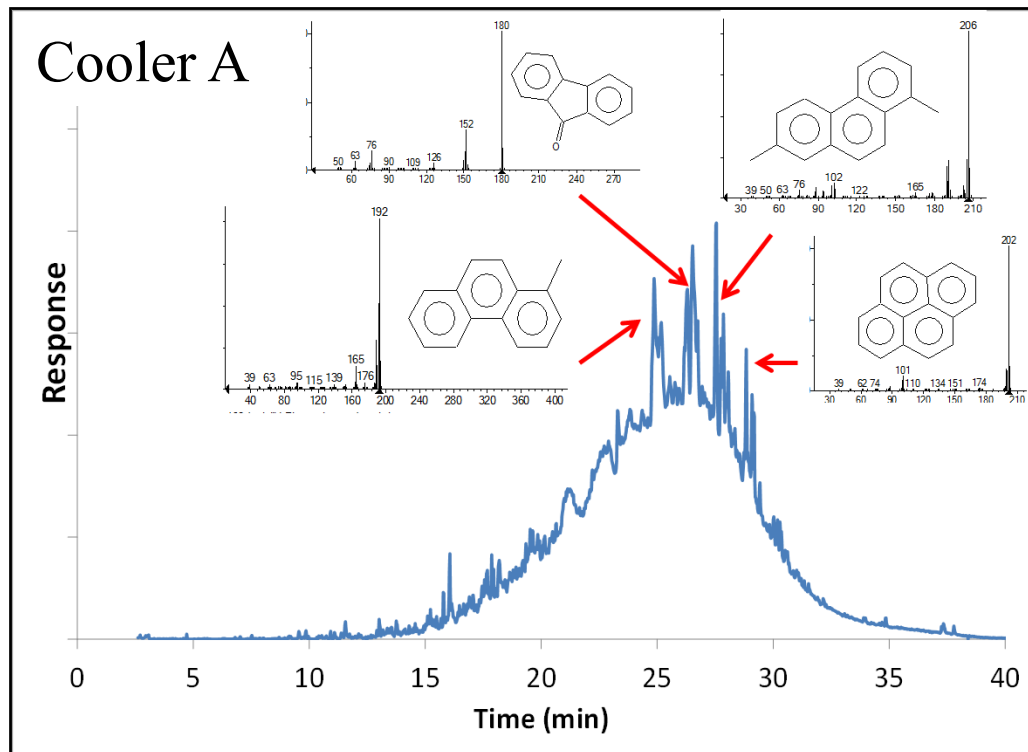
Pyrolysis GC-MS was used to Determine Lacquer Chemistry

- Peaks are variants of 2 to 4 ring PAHs and oxygenated PAHs with a narrow range of melting/boiling points.
- Cooler B contained 3 to 5 ring PAHs.
- Paraffinic fuel or oil peaks are not present.
- Deposit chemistry was representative of PM collected from low temperature combustion regimes – “proto-soot” compounds that have not lost all of the hydrogen necessary to form particulate carbon.

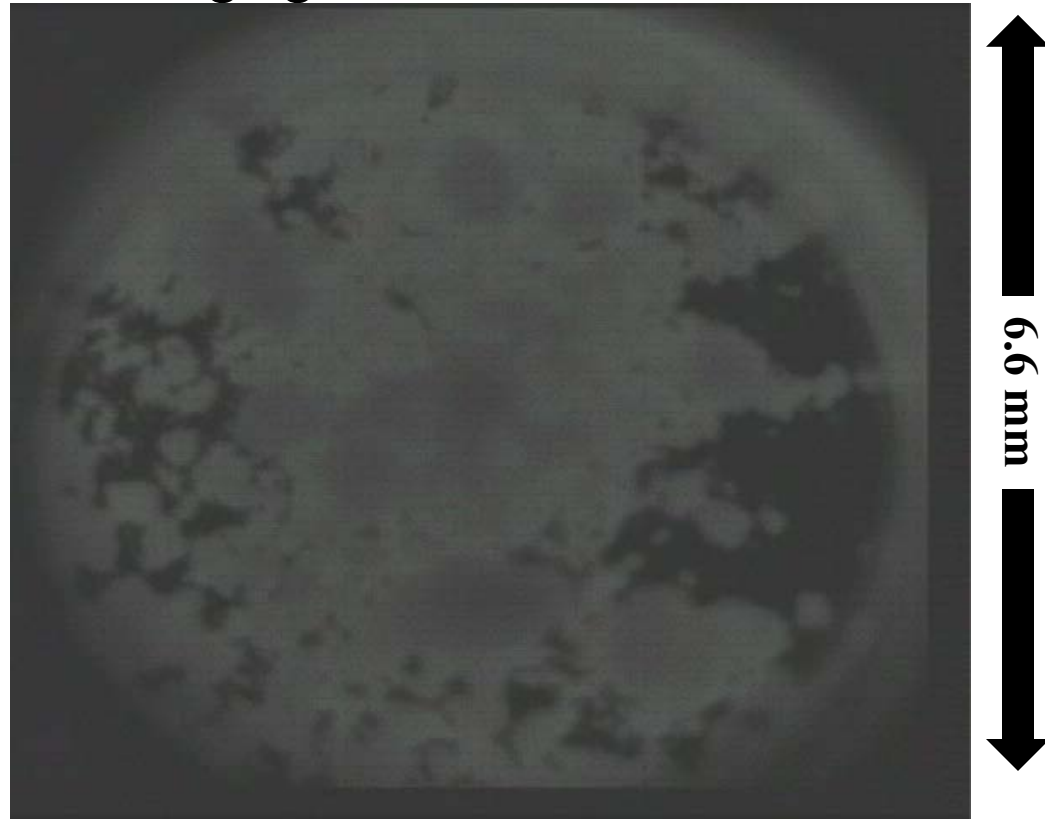
IR Imaging from 500 to 700°C in Air

Cooler C Deposit Contained Oxygenated Species

- An infrared camera revealed local heterogeneous oxidation likely caused by oxygenated PAHs feeding the combustion.
- Contained similar HC species to coolers A and B but at far lower concentrations and more dispersed by soot.
- Soot may be hindering the gas-liquid phase reaction that produces lacquer.
