**National Nuclear Security Administration  
Sandia Site Office**

**Type B Accident Investigation**

**Employee Injured when Rocket Motor  
Unexpectedly Fired on October 9, 2008  
at the Sandia National Laboratories  
Technical Area III Sled Track**

**November 2008**

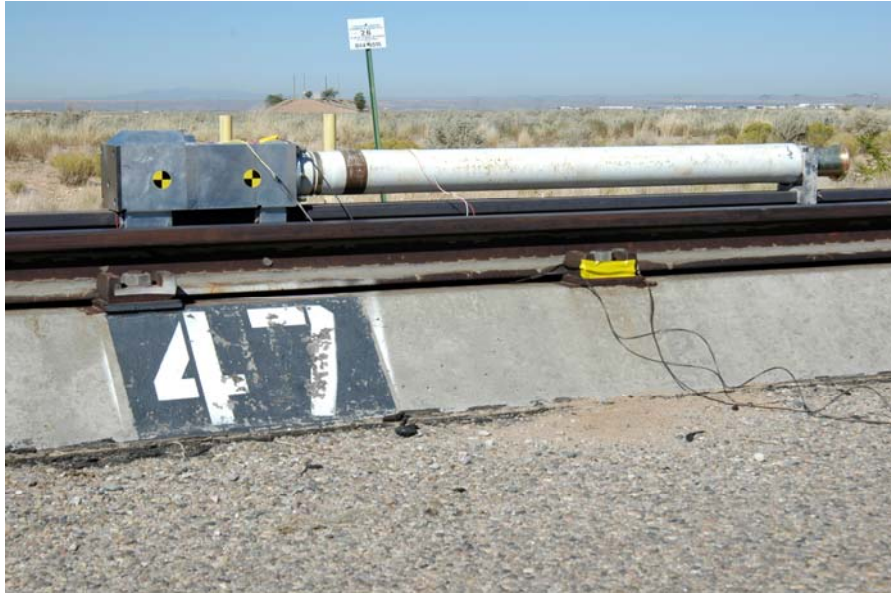
Figure 2-1. Representative rocket motor and test package

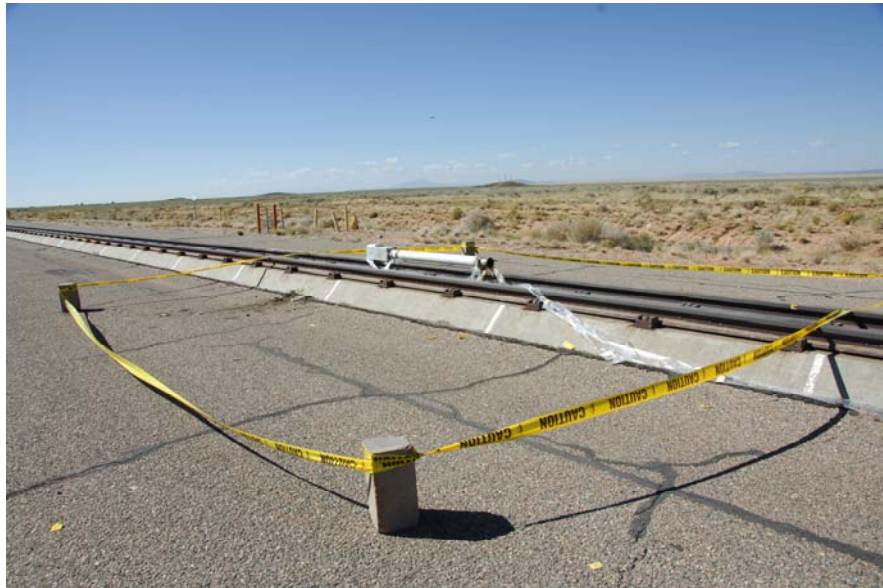
Figure 2-2. Position of rocket and test package after accident

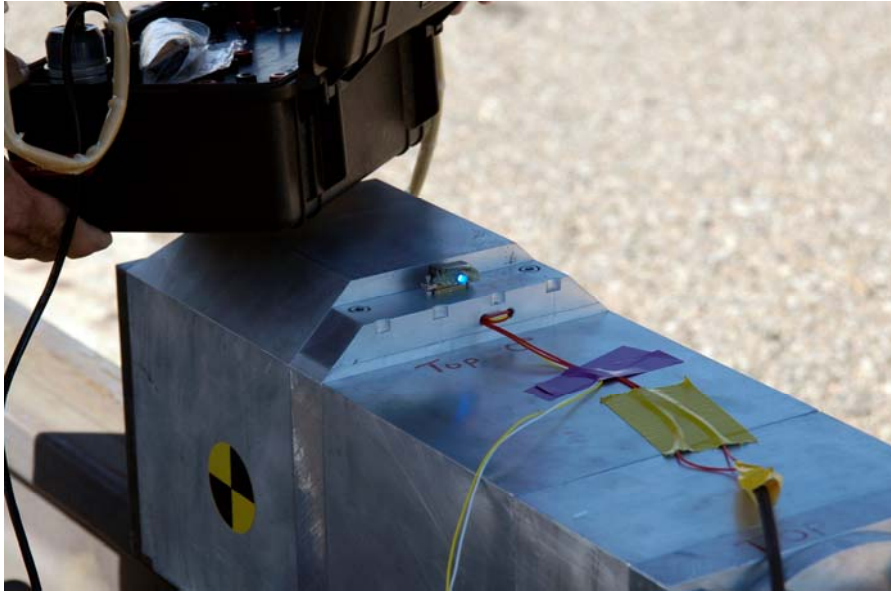
Figure 2-3. HiCapPen with LED module installed and illuminated

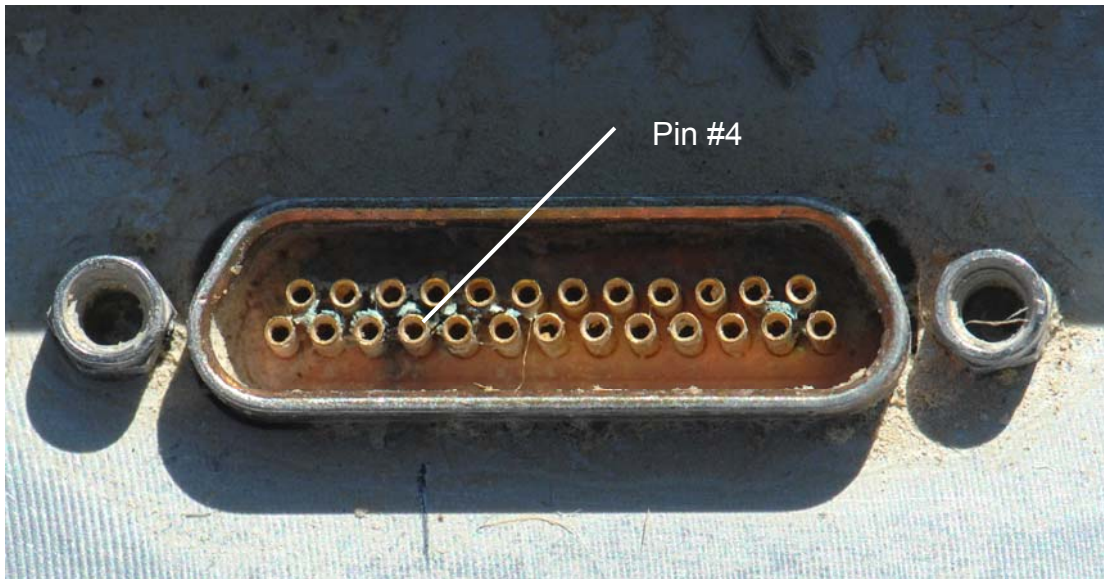
Figure 2-4. Post accident MDM25 connector

Microscopic photography of the female MDM25 connector confirmed a black mark at the base of the pin connected to the HiCapPen battery (See Figure 2-4). Pin #4 on the female MDM25 connector, by design, was connected directly to the HiCapPen battery in order to energize the LED (See Figure 2-3). The output of the HiCapPen battery was 10.8 volts and the battery was not current limited. The TAT concluded that the energy source that caused the rocket ignition was a short at Pin #4 that occurred when

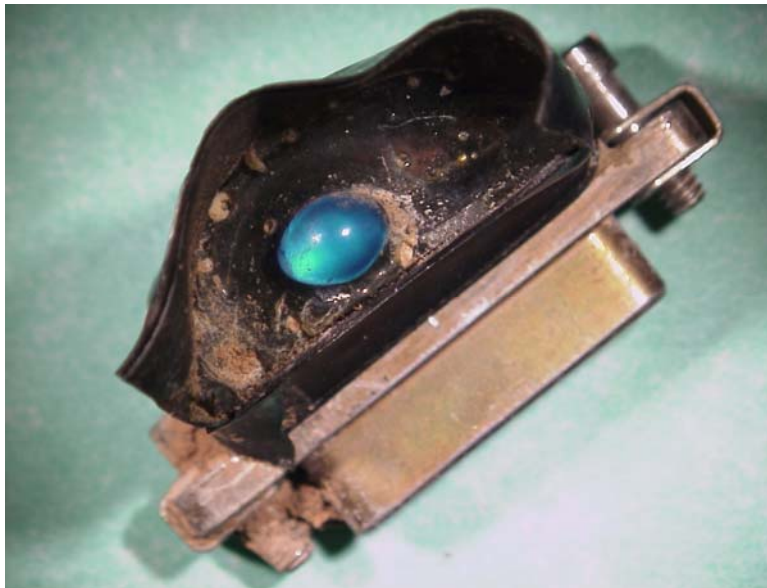
Figure 2-5. Post accident LED module with black electrical tape

A search for the LED module was not initiated until the Board was assured that all other physical evidence and measurements had been taken. On October 30, 2008, a search team found the LED module (See Figure 2-5) approximately 250 feet north of Station 47 and approximately 60 feet east of the rocket sled track. Black electrical tape had been wrapped around the LED module (See Figure 2-5). The purpose of the tape was to shield the LED from sunlight in order to more effectively see the status of the LED

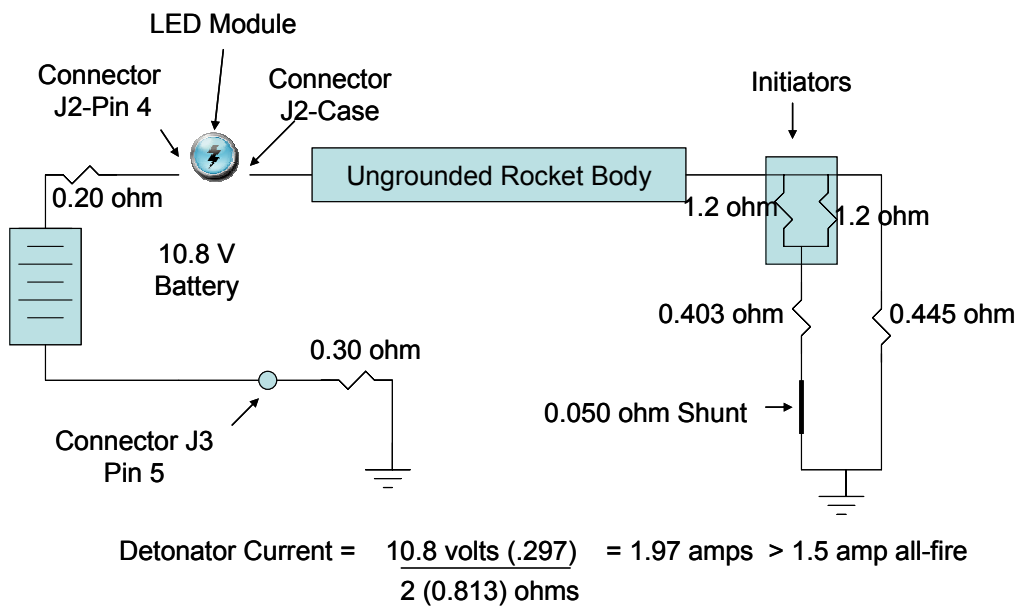
Figure 2-6. TAT Schematic Analysis

the male and female MDM25 connectors came in contact. From the TAT analysis of the circuit schematic (See Figure 2-6), they discovered a circuit configuration that would have caused the energy from the short to flow from the MDM25 female connector, through the test sled body, and through the rocket igniter.

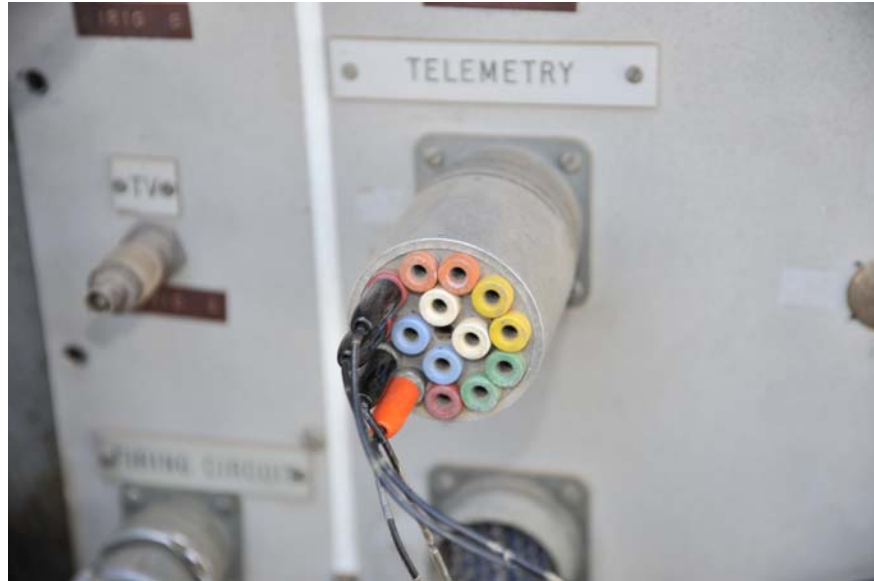
Figure 2-7. HiCapPen connection to sled track side box

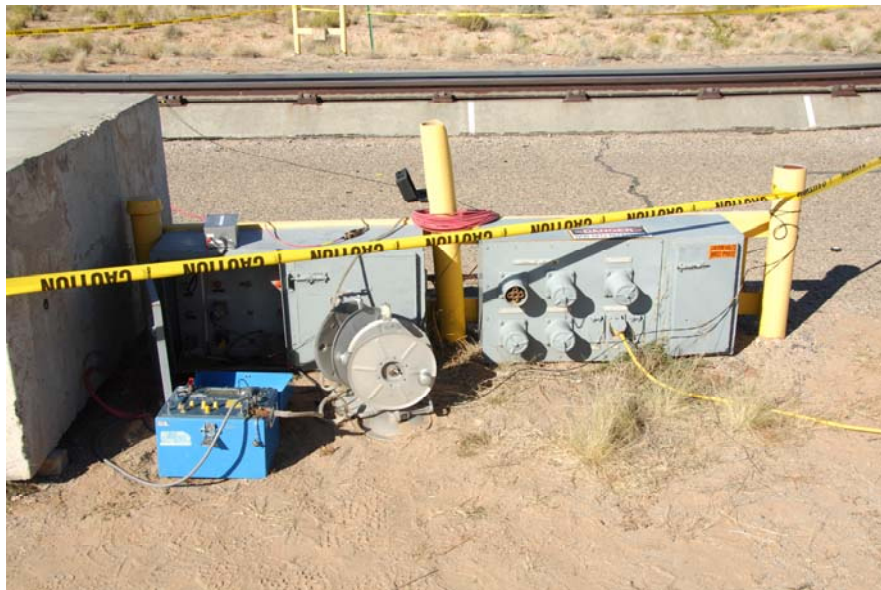
Figure 2-8. Post accident sled track side box

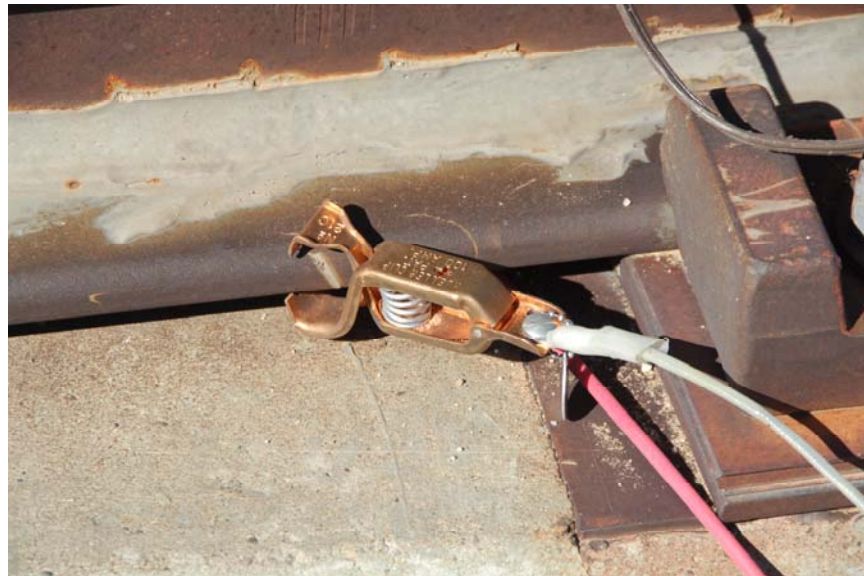
Figure 2-9. Post accident wiring to sled track (note oxidation on track rails)

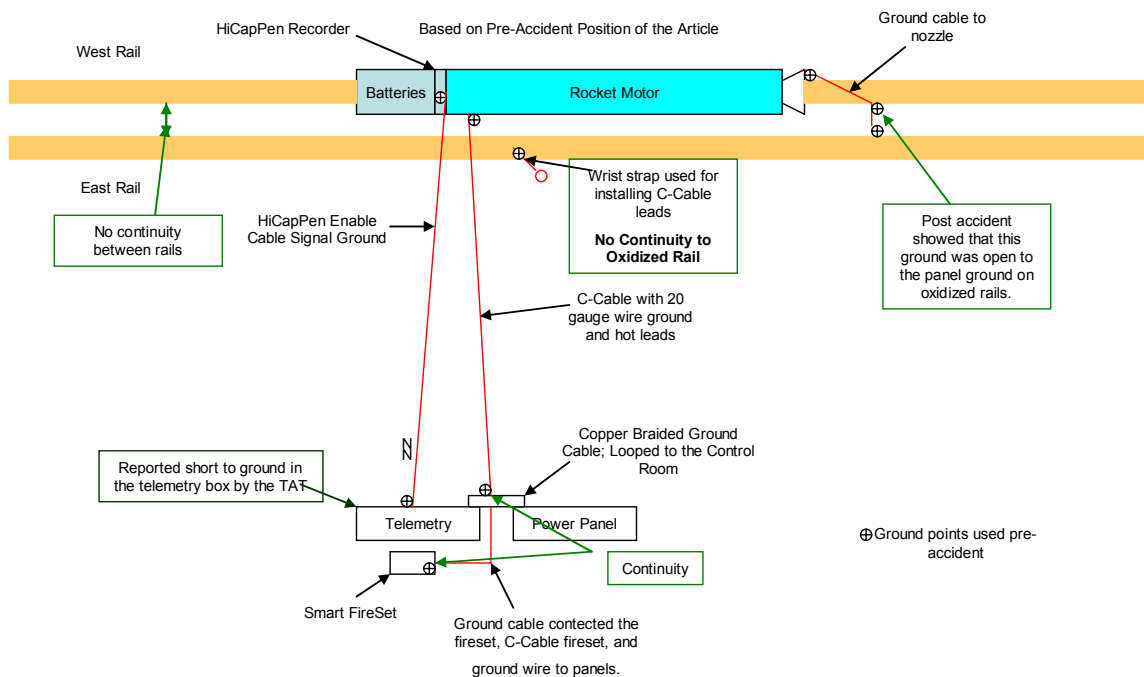
Figure 2-10. Pre-accident grounding connections (Board reconstruction)

the accident scene and found an unexpected earth ground in the telemetry sled side box which later analysis showed contributed to the ignition of the rocket (See Figure 2-10).
