**U.S. Department of Energy
Portsmouth/Paducah Project Office**

Type B Accident Investigation Report

**THE JULY 12, 2007
FORKLIFT AND PEDESTRIAN ACCIDENT
AT
THE PADUCAH GASEOUS DIFFUSION PLANT**

April 2008

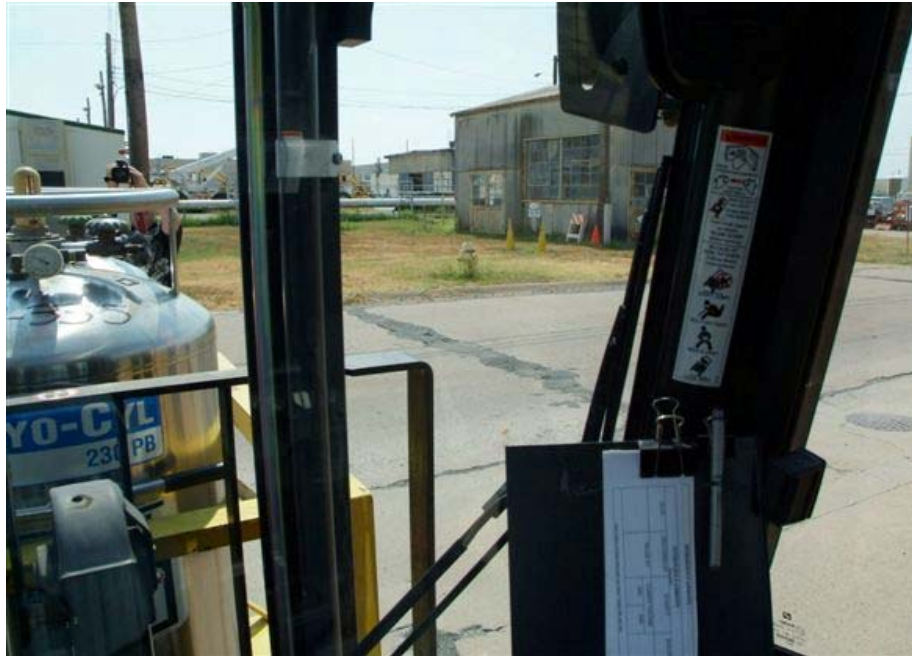
The forklift mast when tilted backwards decreases the width of the window of visibility between the mast and the windshield support column, window frame, and windshield wiper. A photo of the right side of the forklift was taken to demonstrate the full extent of the blind spot created by the combination of the roll cage post, door, windshield, wiper, and clipboard. Related photos are shown in Figures 2.3-3 through 2.3-5. In Figure 2.3-3, there was an individual standing approximately 10 feet away who could not be seen by the driver.

Figure 2.3-3. Inside the Forklift Cab Showing Field of View Impairment From the Windshield Wiper, the Post, and Door Frame

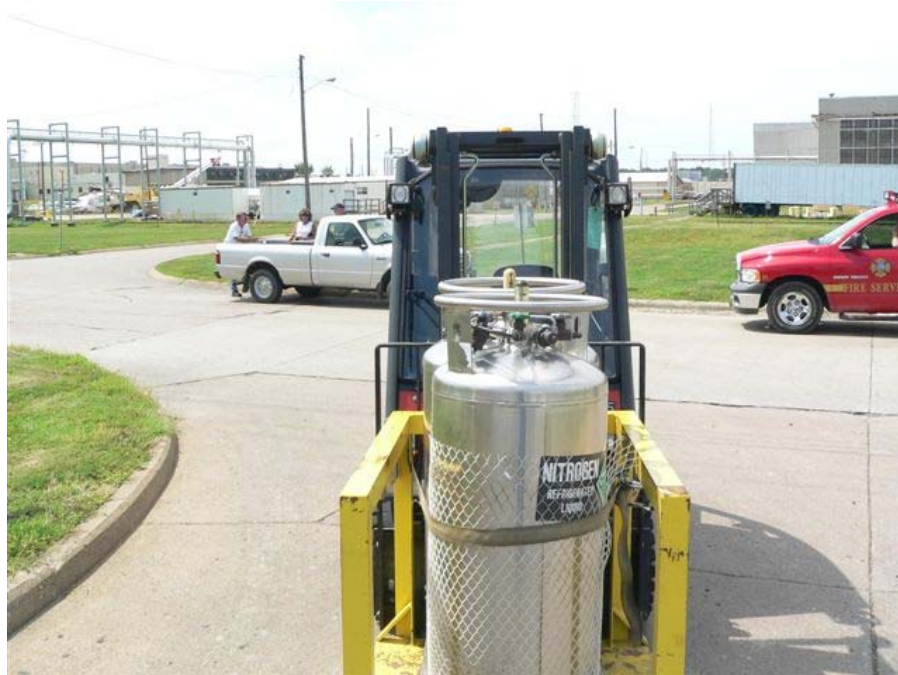
Figure 2.3-4. Front View of Forklift Showing Mast Pillars and Roll Cage Post

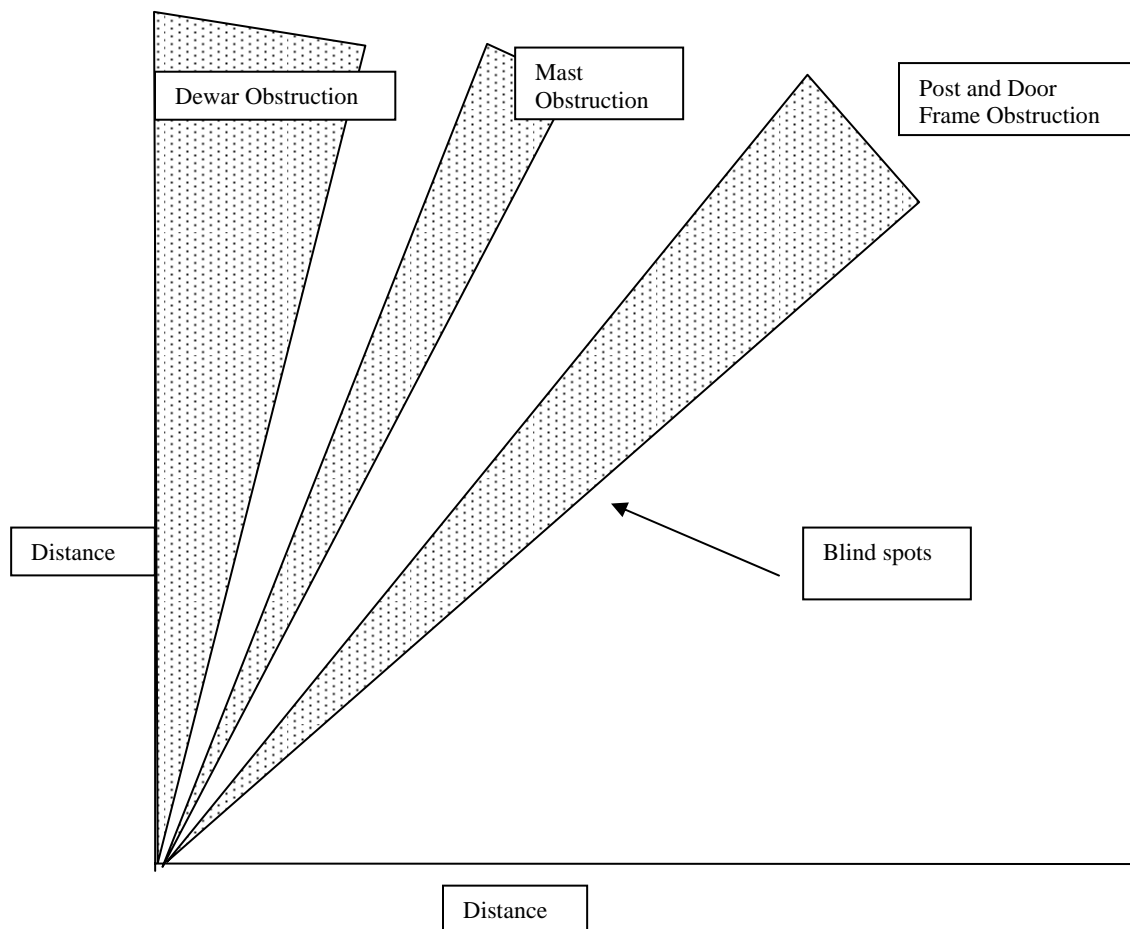
The forklift visibility issue discussion in section 2.3.2 indicates that the driver had a field of view impairment located at approximately 38 degrees from the driver's point of view. Further analysis by the Board revealed the blind spot from the forklift design created a field of view impairment which extended from approximately 31 degrees to 44 degrees to the right of the path of travel. Figure 3.3.2-1 represents obstructions to the driver's field of vision from the dewars, the forklift mask, and the post and door frame.

Figure 3.3.2-1. Driver's Field of View From Forklift Seat

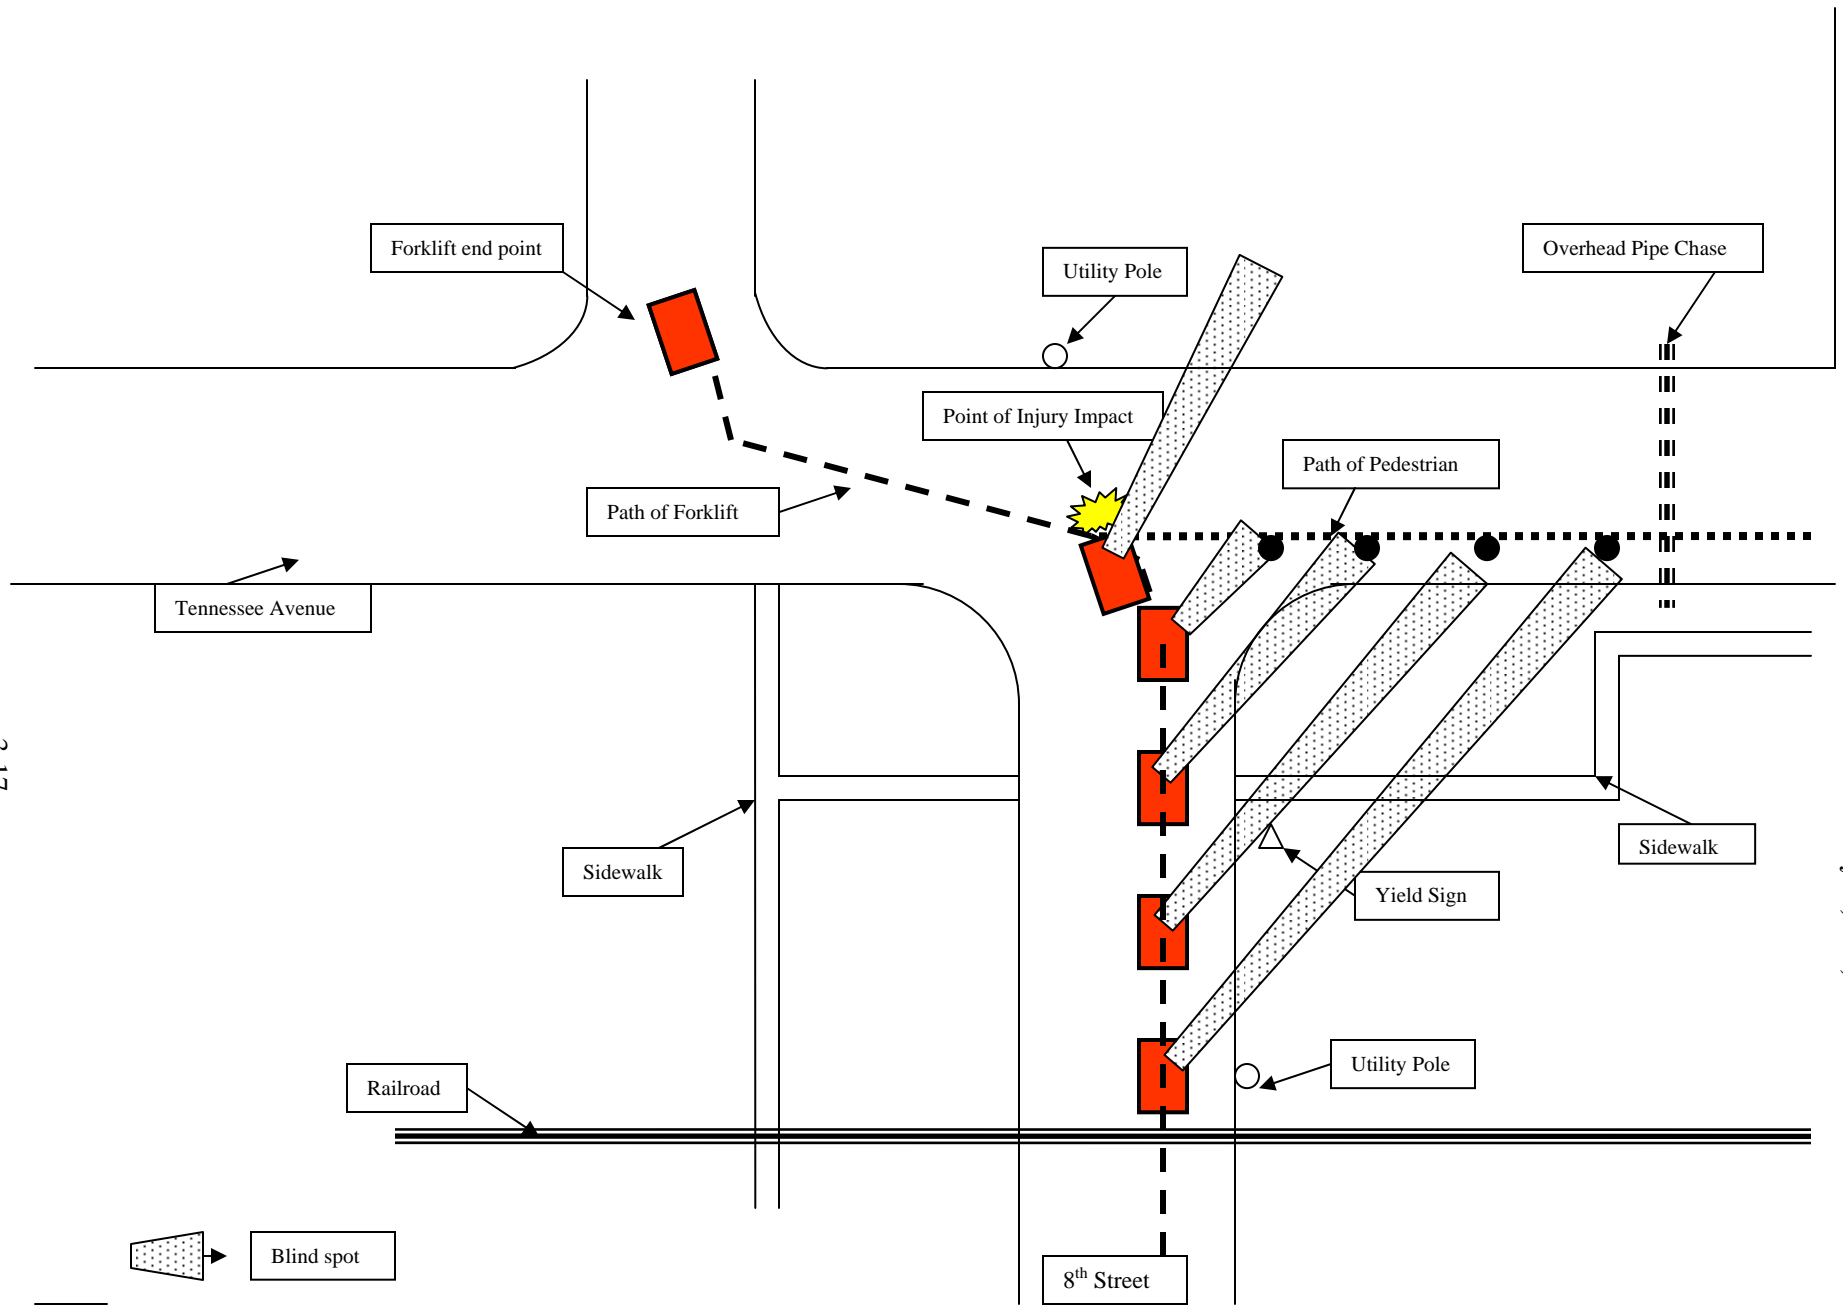
Since the driver and the pedestrian were both maintaining a constant direction of travel and the same relative speed, the Board concludes (if the driver did not physically move to look around the field of view impairment) that the driver could have looked to the right several times and not observed the pedestrian until seconds before the collision. A graphical representation of this possibility is shown below in Figure 3.3.2-2.

Figure 3.3.2-2. Pedestrian Masked by the Forklift Blind Spot
