Type B
Accident Investigation Board Report
On the February 25, 2009
Abdominal Injury
To a Passenger in an Electric Cart
Waste Isolation Pilot Plant
Carlsbad, New Mexico

April 2009

U.S. Department of Energy
Carlsbad Field Office

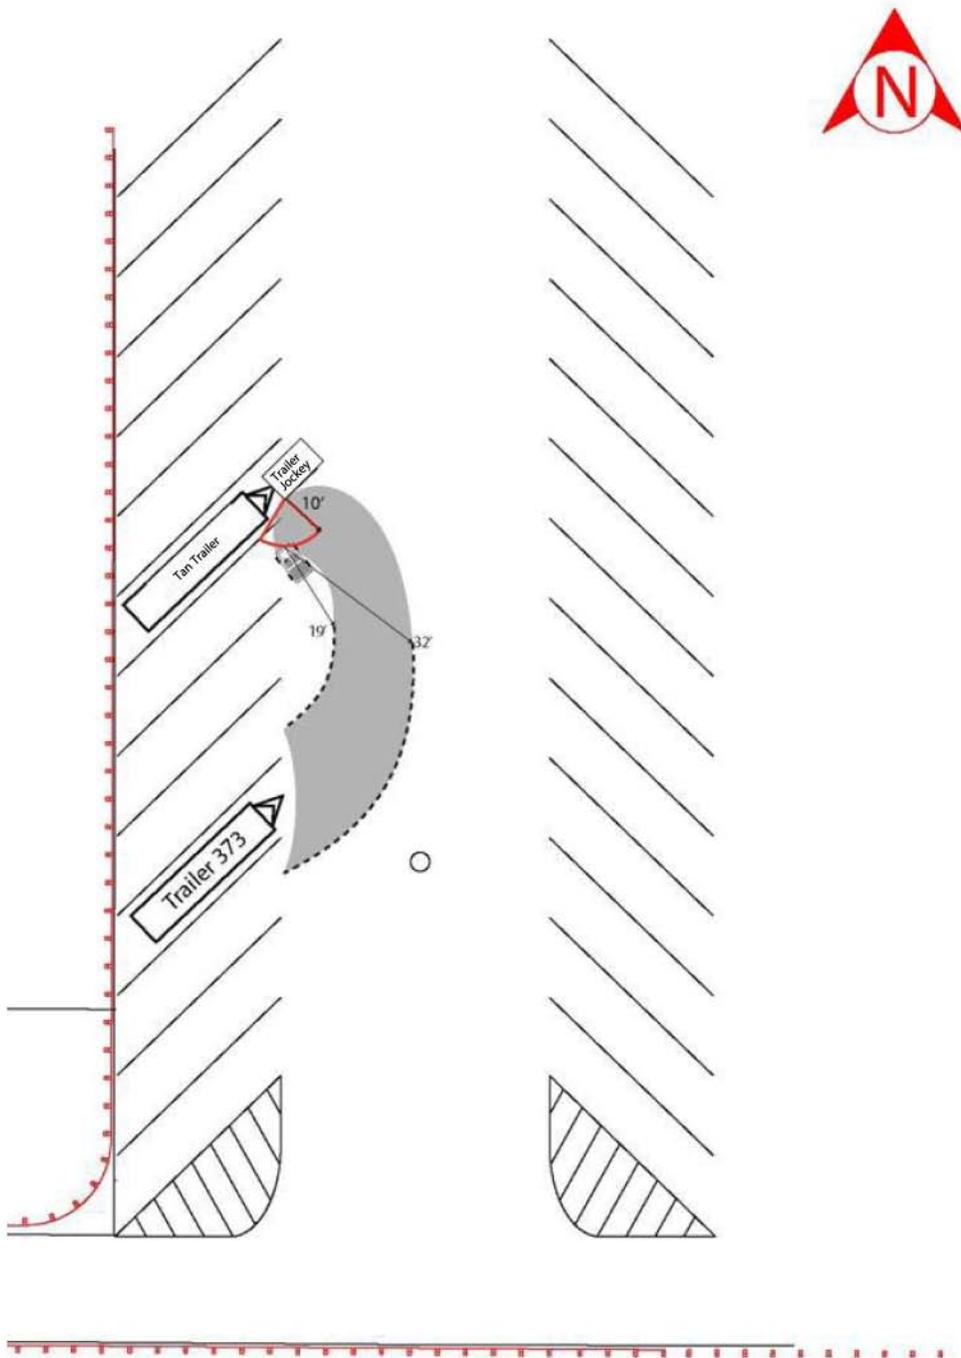
Figure 3: Schematic of the Accident Scene

The Electric Cart Driver then returned to the electric cart and backed up approximately 6 feet from the trailer jockey. The Electric Cart Driver made a looping turn to the right to travel to Trailer 373, which was four spaces to the south. An illustration of these activities is found in Figure 3. When completing the looping turn, the Electric Cart Driver was heading straight onto Trailer 373, as illustrated in the figure. About 6 feet from the trailer, the Electric Cart Driver attempted to stop the cart by pressing the brake pedal. The electric cart slowed, but the accelerator seemed to stick and

A couple of seconds later, the Electric Cart Driver was able to push the electric cart back approximately 2 feet. After the electric cart was pushed back, the Front Seat Passenger exited the electric cart. The Passenger complained of pain, stumbled, and fell onto the parking lot area. The Electric Cart Driver noted the Front Seat Passenger was having difficulty breathing and the Rear Seat Passenger, a trained Mine Rescue Responder, began primary medical care.

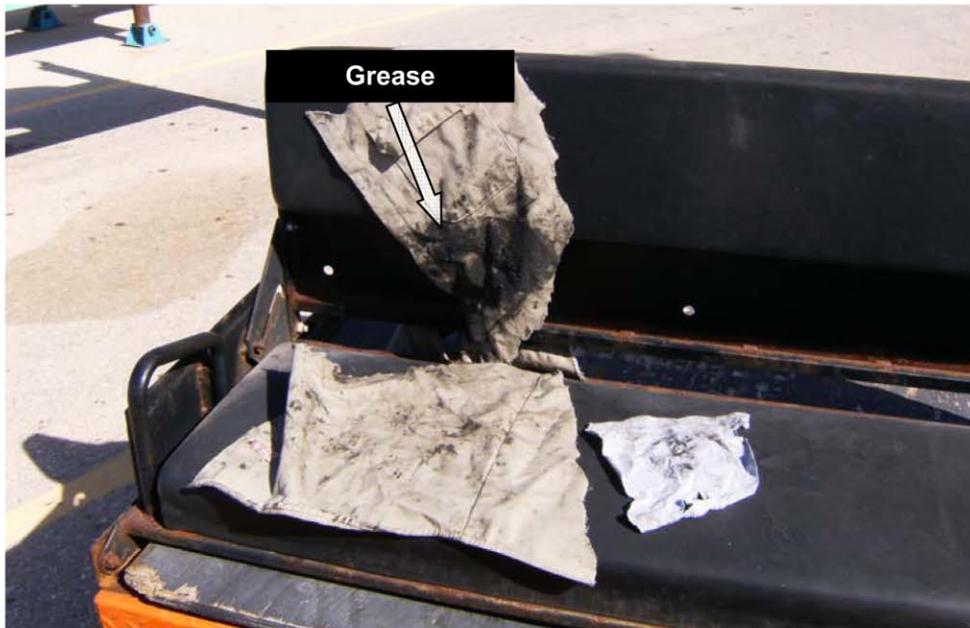
Figure 5: Shirt Worn by Injured Worker (cut/torn as part of primary medical care)

Figure 5 shows the injured worker's shirt, with grease marks just below the front pocket resulting from being pressed against the light bar.

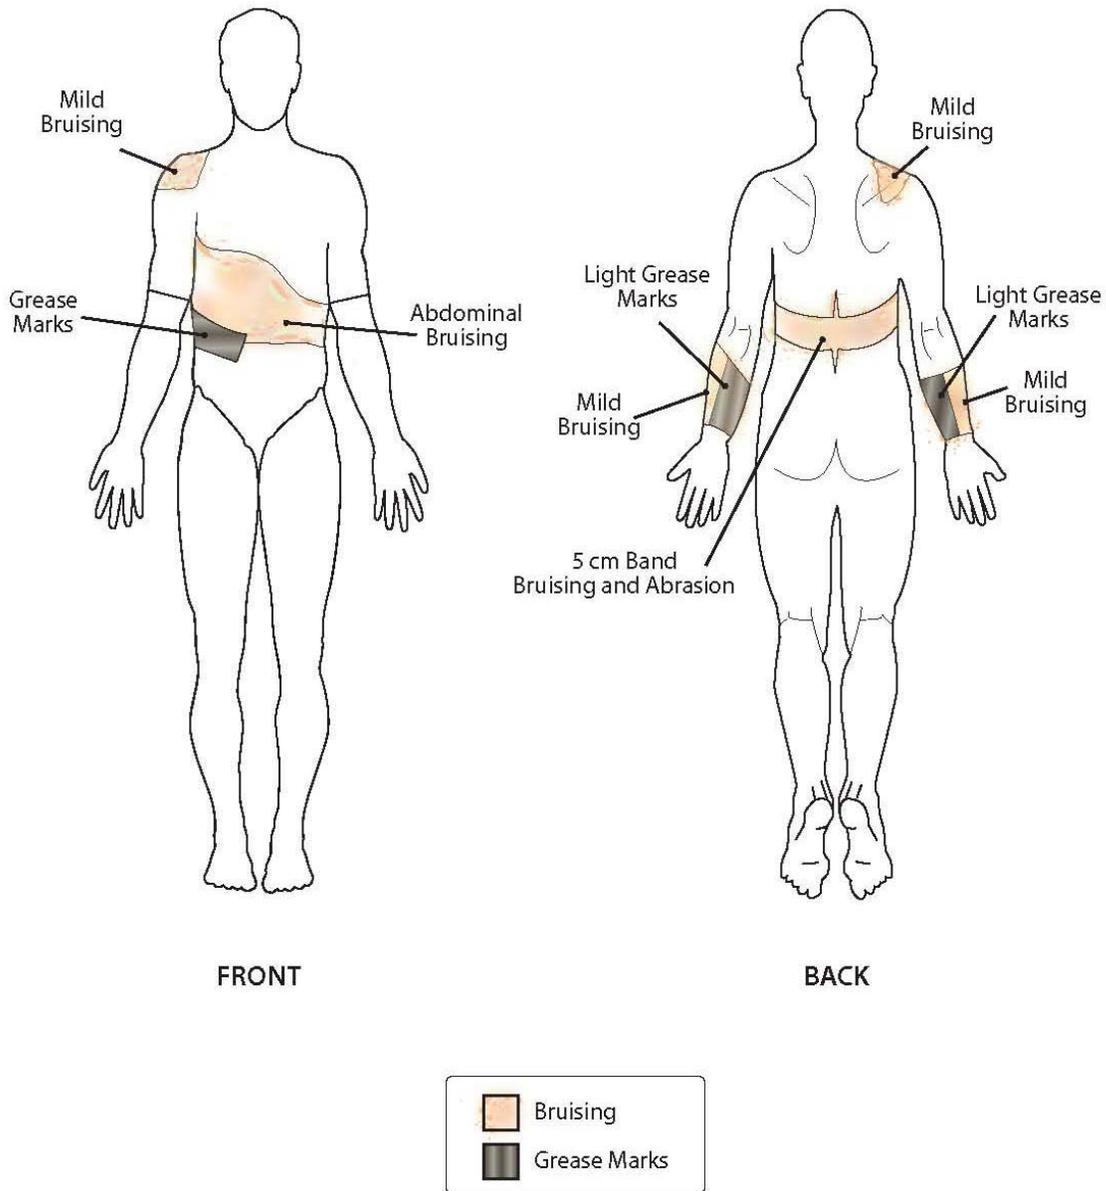
Figure 6: Schematic of Passenger's Injuries

As an immediate action, the WTS management requested that the site nurse, a Waste Handling Manager, and a Human Resources representative be present at the Carlsbad Medical Center to provide case management services for the injured worker and to serve as an interface between the medical staff, the injured worker, and the injured worker's family. The site nurse contacted the WTS Occupational Physician to provide information on the accident and the condition of the injured worker. When the injured worker was transferred to Lubbock, the site nurse traveled to and remained at the hospital for the first three days after the accident. During the entire hospitalization, a WTS manager remained in Lubbock to interface with the injured worker and the family and to support all of their needs. The site nurse prepared the schematic in Figure 6, which shows the bruising and red marking on the injured worker's torso.

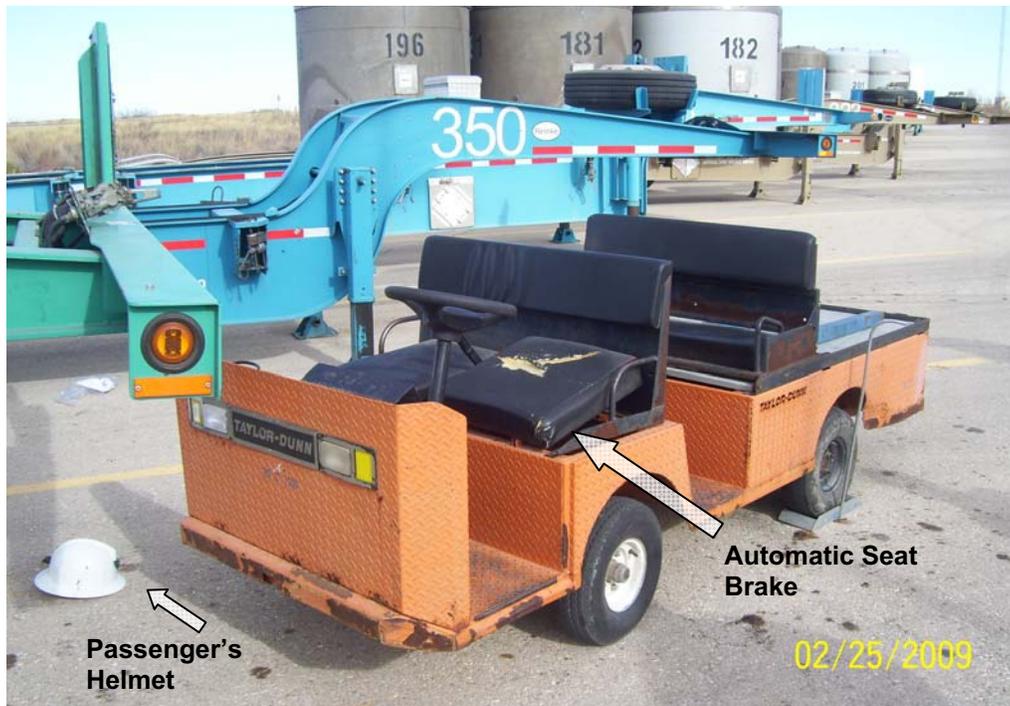
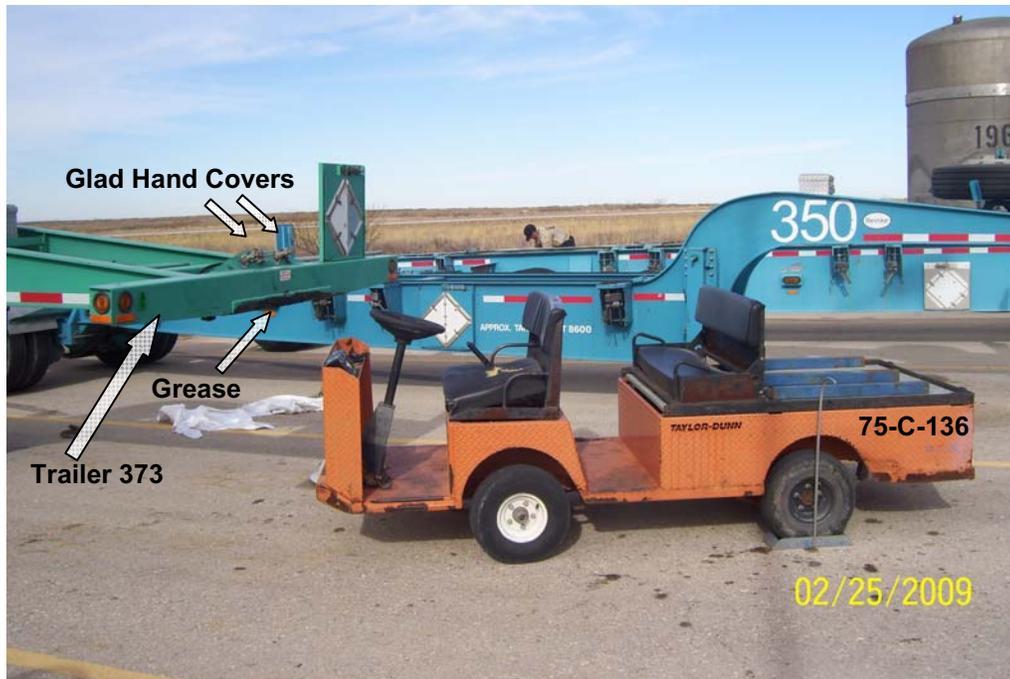
The electric cart involved in the accident, 75-C-136, was a Taylor Dunn Model B0-210 36 Burden Master. This electric burden and personnel carrier, shown in Figures 7 and 8, was obtained in 1999. There are about 143 electric carts on the site, with approximately 50 operated on the surface. Some of the units have a cab and cowl configuration; however, 75-C-136 did not have the cab and cowl option. Without that option, the electric cart can potentially travel under any protruding loads or, in this case, a TRUPACT trailer. This type of electric cart presents a potential hazard for any obstacle that is 45 inches or higher.

Figure 7: Taylor-Dunn Cart Involved in Accident (showing angle related to trailer)

Figure 8: Taylor-Dunn Cart Involved in Accident (from the front of the trailer)

After the accident, the WTS investigation was able to reproduce the reported slipping/clicking sound and jerking of the electric cart, as described by the Electric Cart Driver and Passengers. This was found by applying the brake and activating the accelerator at the same time. Based on this test, it was confirmed that depressing the accelerator can override the braking system on Electric Cart 75-C-136.

The chain drive of Electric Cart 75-C-136 was subsequently inspected and it was found that the chain was loose on the gear drive and could not be adjusted. WTS replaced the chain, the brakes, and the steering column top bearing on Electric Cart 75-C-136, and repeated the above electric cart tests on April 1, 2009. The results of these tests identified that the electric cart came to a complete stop when the cart was accelerating at low, medium, and high speeds and the brake was engaged. Based on information provided by the manufacturer, "The brake performance is not changed by a misadjusted or worn out drive chain. Additionally, the drive cannot develop any more torque with a misadjusted or worn out drive chain than with a correctly maintained drive chain. The truck [sic] would not lurch due to a misadjusted or worn out drive chain if the brake pedal is held firm."

<p>The Board concludes that the combination of the accelerator being depressed and the existing conditions of Electric Cart 75-C-136 (loose drive chain and worn brake linings) resulted in an override of the braking system.</p>
--

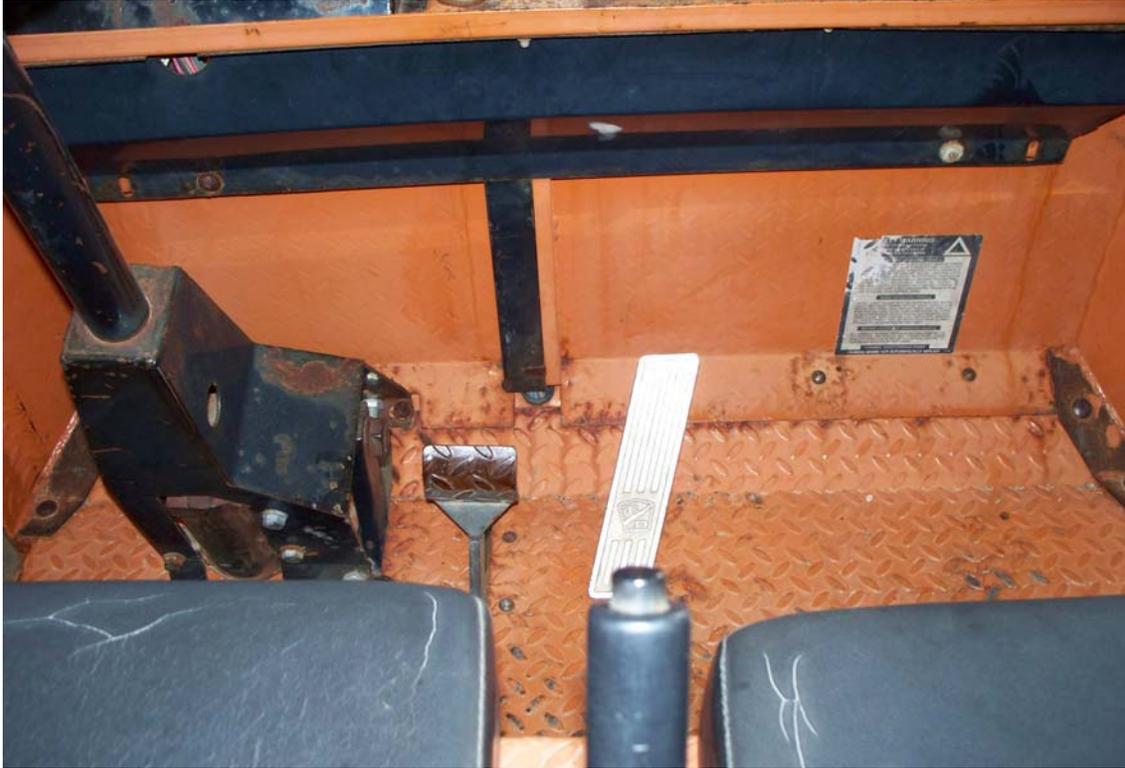
Figure 9: Cart Accelerator Pedal

One design feature of the electric cart is that the accelerator pedal extends off-center into the passenger's foot area. The electric cart width is 42 1/2 inches and the bottom of the pedal is located on the passenger's side, 19 1/2 inches from the edge of the passenger's side. The top of the pedal extends further into the passenger's side. In discussions, many of the workers stated they have witnessed and even placed their own foot on the accelerator pedal while riding as passengers in the electric carts. However, this information was not brought formally to management prior to this accident. Figure 9 is photo of the pedal arrangement in the electric carts.

The Board concludes that the designed location of the electric cart accelerator pedal contributed to the accident.

Conclusions	Judgments of Need
<p>The designed location of the electric cart acceleration pedal contributed to the accident.</p>	<p>WTS needs to install the manufacturer's approved retrofit for the electric cart accelerator to prevent inadvertent engagement by the passenger.</p>
<p>Maintenance of the electric carts did not include the periodic drive chain adjustment, as well as the semi-annual and annual maintenance items established by the manufacturer.</p> <p>The combination of the accelerator being depressed and the existing conditions of Electric Cart 75-C-136 (loose drive chain and worn brake linings) resulted in an override of the braking system.</p>	<p>WTS needs to incorporate and implement the manufacturer's recommendations in the maintenance and servicing of the electric carts.</p>
<p>A Job Hazard Analysis has not been performed for surface electric cart use and, as a result, the appropriate controls were not implemented.</p> <p>Spotter activities were not analyzed for the hazards associated with the task to ensure appropriate controls were implemented, and were performed for some 34 months past the WTS documented endpoint.</p> <p>Overall implementation of Integrated Safety Management Systems for the use of electric carts was insufficient.</p>	<p>WTS needs to enhance its job hazard process to analyze task-level activities based on a formal risk-based approach, as a part of its Integrated Safety Management System program.</p> <p>WTS needs to evaluate the continued need for the spotter activities. (This Judgment of Need is consistent with the WTS recommendation from its initial investigation.)</p>
