July 2009

DOE/RL-2009-83

Type B Accident Investigation Report

**Washington Closure Hanford, LLC
Employee Fall Injury on July 1, 2009,
at the 336 Building, Hanford Site,
Washington**

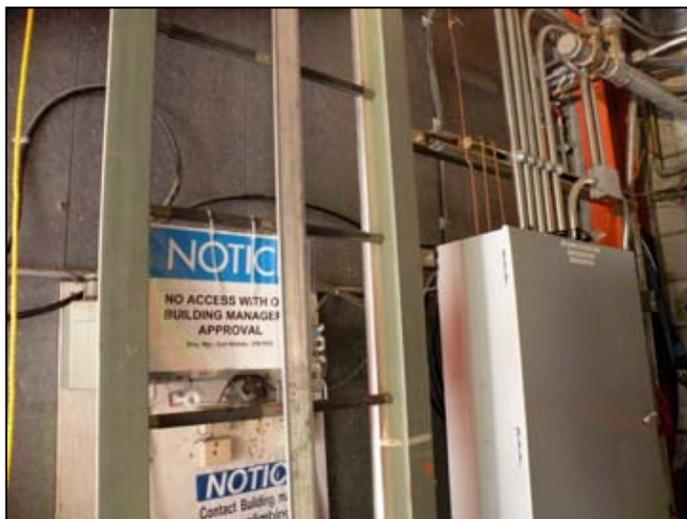
Figure 2-1. Ladder and center rail for engineered ladder safety device attachment

The 50-ft. high bridge crane catwalk is accessed by a vertical steel ladder with a midpoint platform 25 feet from the floor. The ladder also contains an engineered center safety fall protection rail. On June 29, WCH safety and engineering staff performed an evaluation of the ladder structural integrity. WCH safety staff briefly attempted to locate the engineered ladder safety devices that would fit the pre-existing center safety restraint rail, but were unsuccessful. Lacking these safety restraint devices, WCH safety staff decided to utilize two 50-ft. retractable fall restraint devices for climbing the ladder. They discussed areas suitable for fall protection anchors with the structural engineer and the building's horizontal structural beams were determined to be acceptable.

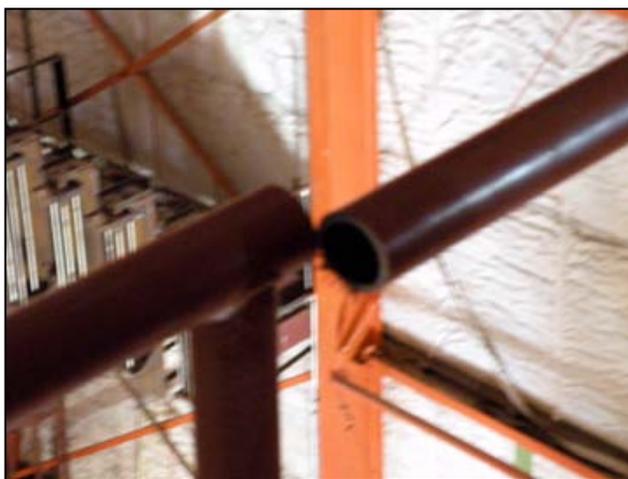
Figure 2-4. Cut guardrail

At this point the three workers on the catwalk (Rigger 3, Millwright 1, and Millwright 2) and the one worker present on the ground (Rigger 2) believed all of the work was complete except for cutting the guardrail, intended to be the last activity. A rope was tied to the guardrail to prevent it from falling after being cut. At approximately 9:17 a.m. Millwright 2 exited the catwalk through the hatch. He expected Millwright 1 to follow him down and the hatch remained open. While Millwright 2 was descending the ladder, Rigger 3 remained on the catwalk and began cutting the catwalk guardrail, using a cordless band saw.

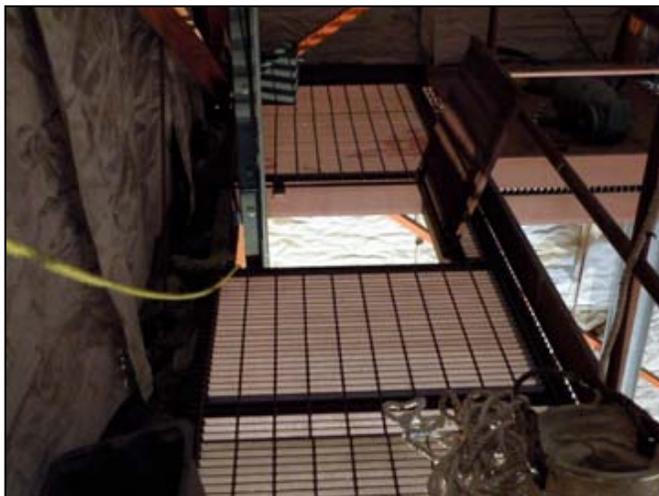
At approximately 9:33 a.m. Millwright 1 fell through the open hatch. During his fall he struck the guardrail on the midpoint platform and then fell the remaining distance to the concrete floor, a total height of about 50 feet.

Figure 2-6. Facing west on the catwalk with the hatch open

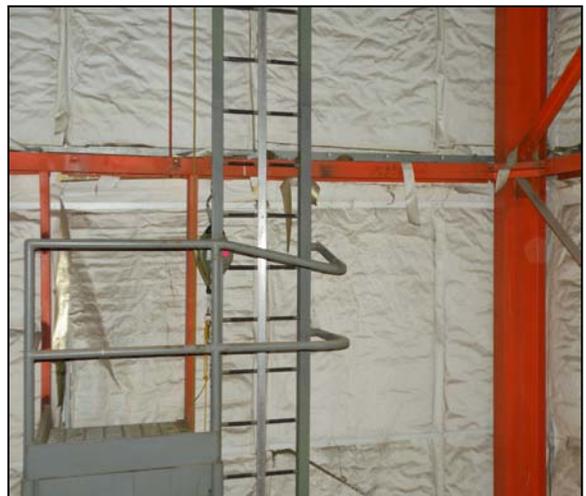
Figure 2-7. Bent guardrail on the midpoint platform where Millwright 1 hit during fall

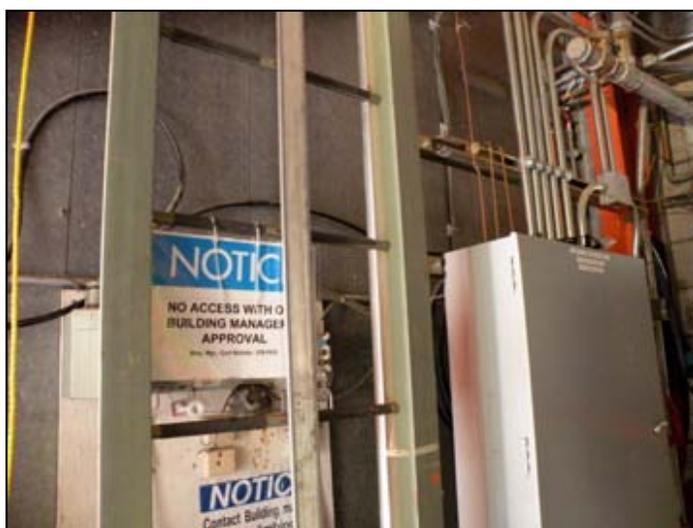
Figure 3-1. Ladder center rail for ladder safety device attachment

The ladder had an engineered ladder safety system; however, the PSRs only made a cursory attempt to locate the device. Contributing to the failure to obtain the safety device was determined to be an unfamiliarity of the Planner and PSRs regarding WCH's facility transition process. The Board was able to locate and obtain the engineered ladder safety device (Sellstrom/RT 2000 Climb-Rite) in less than an hour. Not using this device exacerbated control of the catwalk hatch since the retractable lanyards that were used rubbed on the hatch when it was in a closed position.

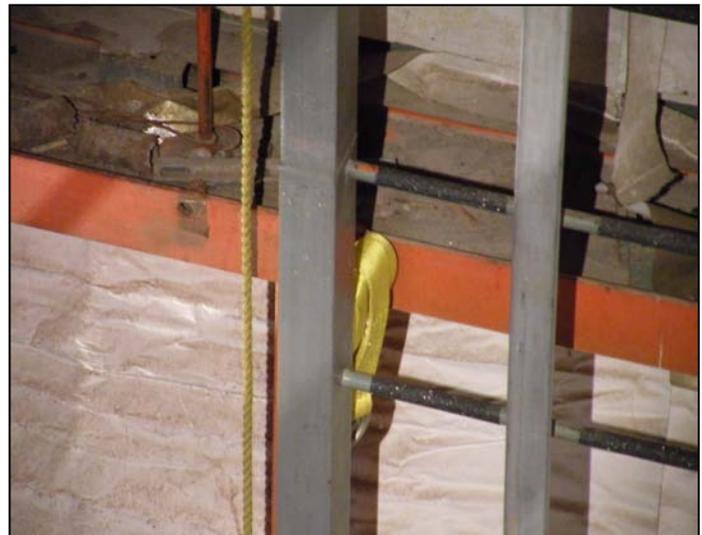
Figure 3-3. Lower anchorage at midpoint platform

(d)(15)(ii) require certification from a qualified person (such as a structural engineer) if the employer is not certain that the selected anchorage point is capable of supporting 5,000 pounds and independent of any anchorage being used to support or suspend platforms. After the accident the structural engineer evaluated the installed anchorage points that were used and determined they were adequate.

- Softeners were not used to protect the anchorage devices (beam straps) from the sharp and abrasives edges of the flat iron and cross bracing. WCH's FPP, SH -1-3.5, Section 6.4.1(2) requires the use of softeners for lifelines, but does not discuss anchorage attachments. MSA, the manufacturer of the anchorage connector straps, recommends avoiding sharp edges and abrasive surfaces.

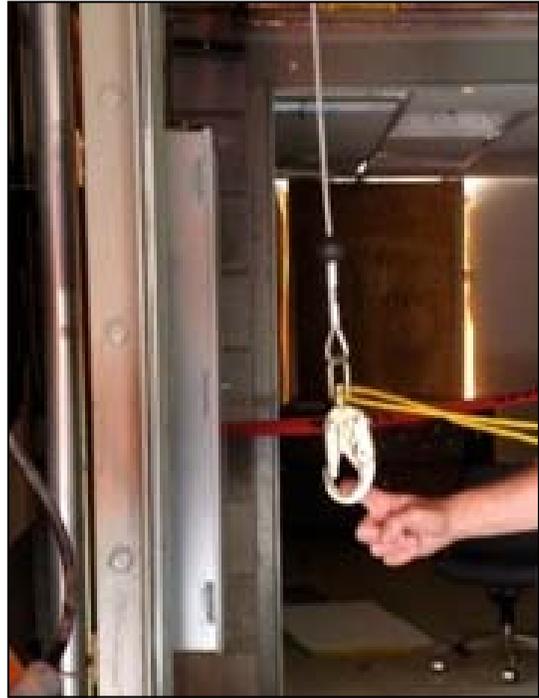
- During the installation of the retractable fall protection for the ladder, the rigger used a 6-ft. lanyard and tied off to the midpoint platform guardrail. In addition, the 336 Work Supervisor/300 Area D4 Superintendent directed the last worker on the catwalk to cut the guardrail and be tied off one section back from the cut. When the scope of work changed to include chaining the bridge crane, neither the rigger nor the millwright had lanyards, so they opted to stand back from the cut rail. The OSHA fall protection standard 29 CFR 1926.502(d)(23) does not allow personal fall arrest systems to be attached to guardrails.

Figure 3-4. Retractable lanyard and hook
