SUBJECT: **FORWARDING OF AN ACCIDENT INVESTIGATION REPORT ON A PERSONNEL
INJURY AT BETTIS ATOMIC POWER LABORATORY - PITTSBURGH,
PENNSYLVANIA**

Type B Accident Investigation Board Report

**Personal Injury Accident at the
Bettis Atomic Power Laboratory
February 17, 2004**

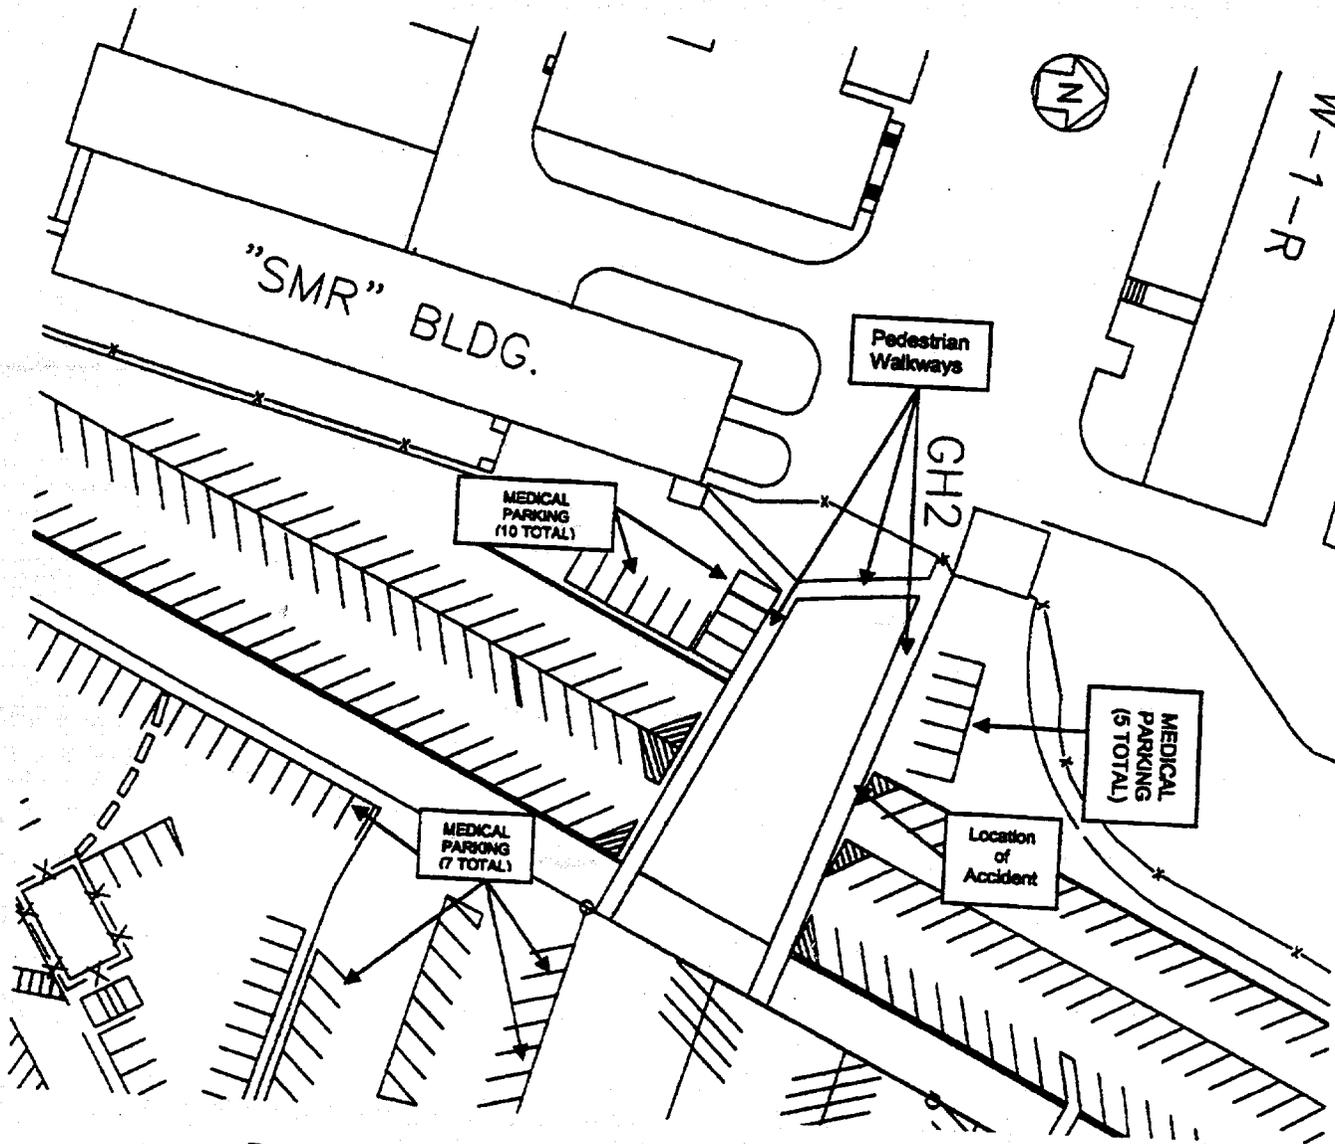
FIGURE 2

Pedestrian Walkways and Parking Areas Near Gate 2.

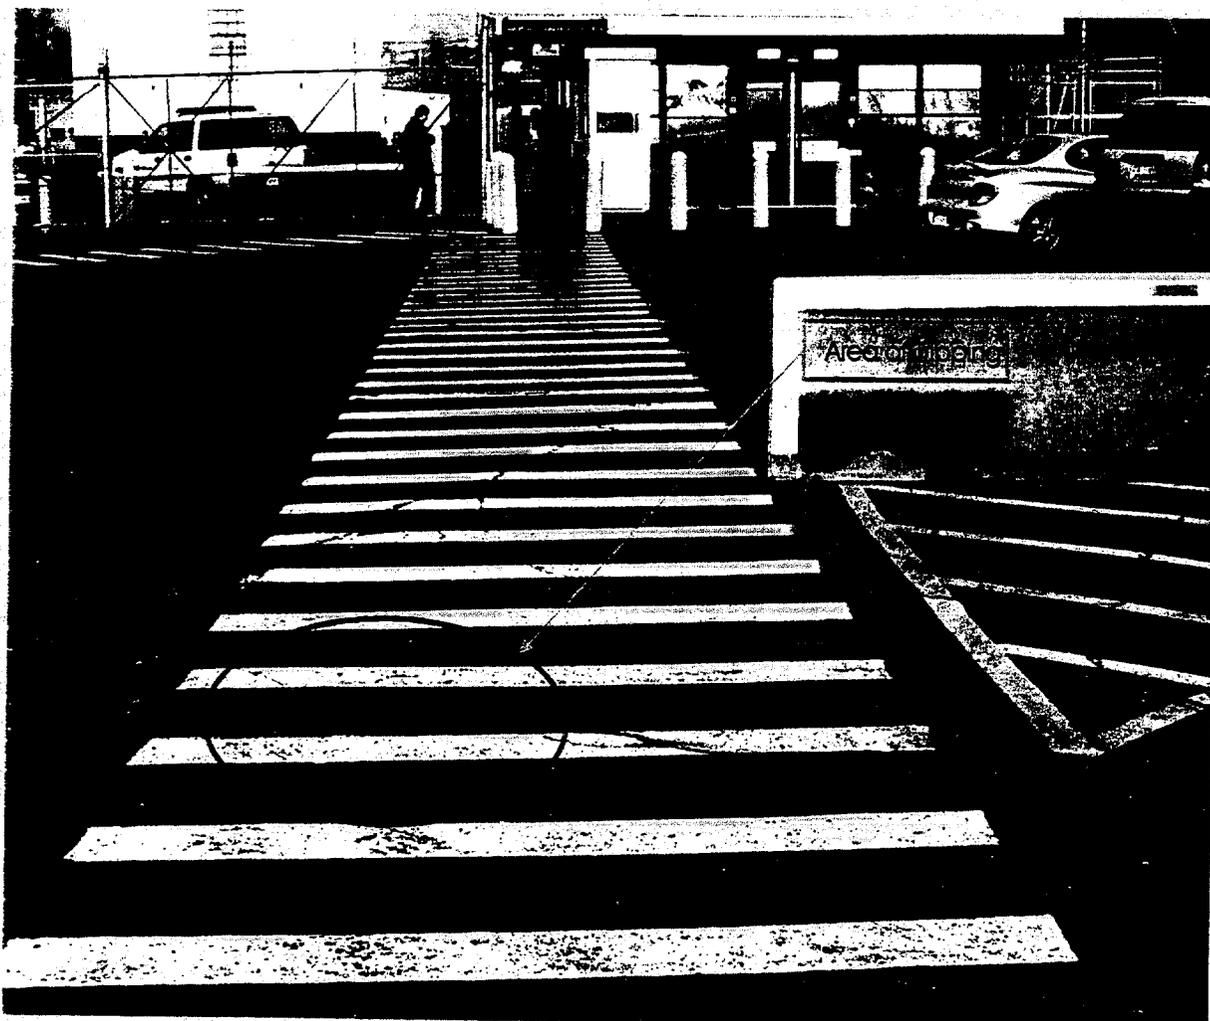
FIGURE 3

Figure 3 - Photograph taken March 9, 2004 showing pedestrian walkway approaching Gate 2 looking west.

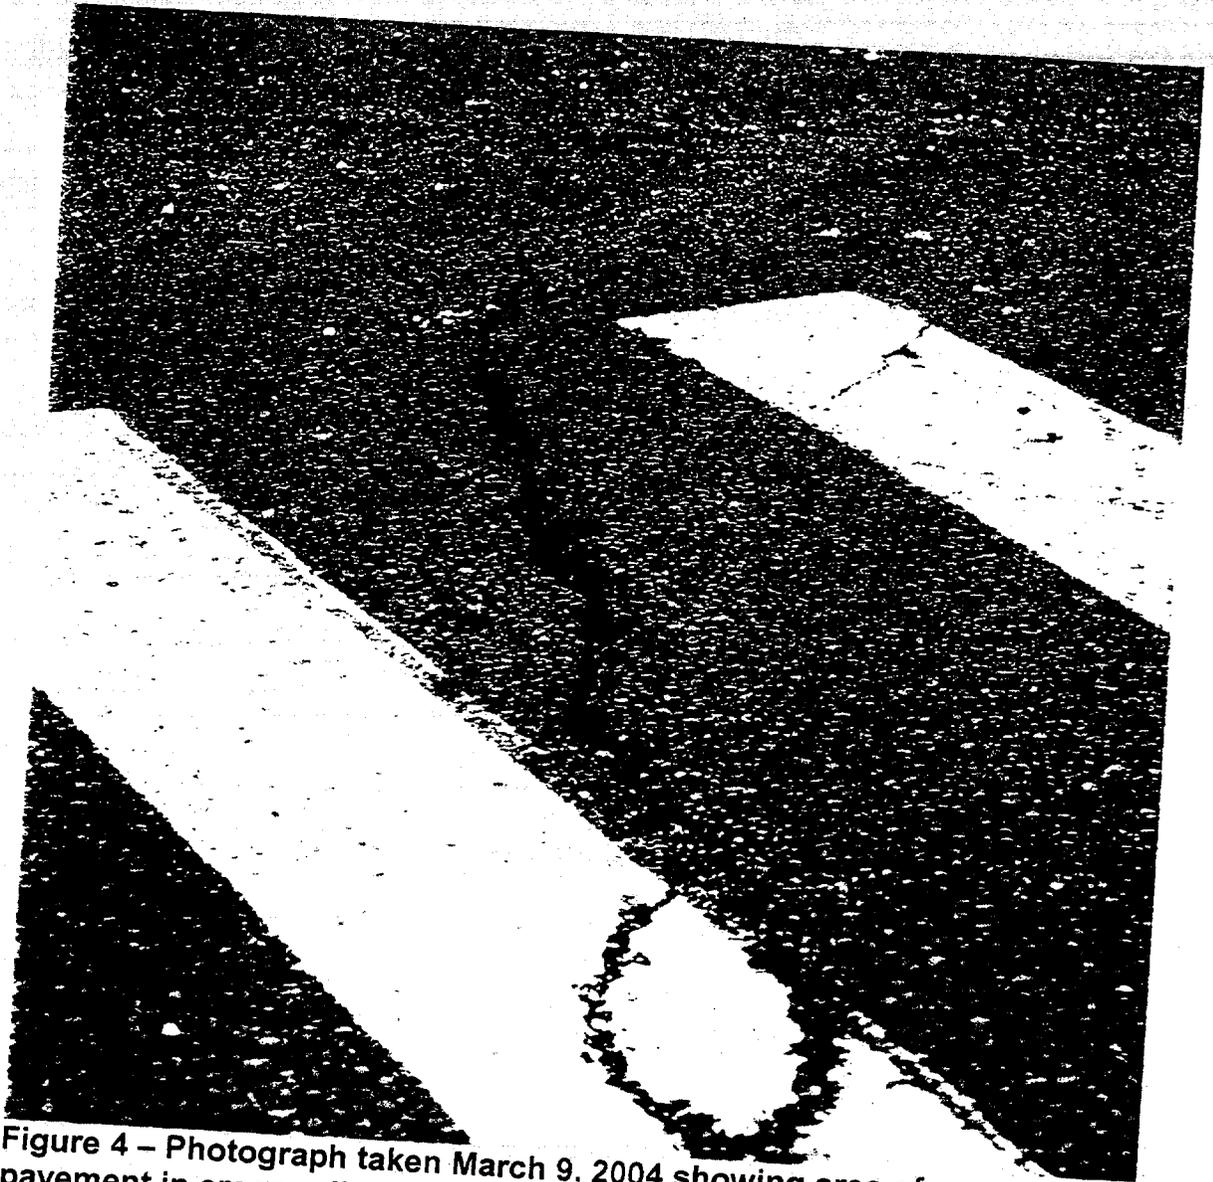
FIGURE 4

During the course of the investigation, the Investigation Board took additional measurements of the pavement at the accident site and observed at least a ½-inch displacement. The Investigation Board observed that the walkway outside Gate 2 where the accident occurred had extensive cracks and evidence of heaving in addition to the crack where the employee tripped (see Figures 3, 4, and 5). Pedestrian traffic at the accident site was not restricted. After Bettis was notified of the Type B accident investigation, the area involved was not cordoned off and entry denied to all personnel except those directly involved in mitigating the event and/or placing the scene in a stable condition.

- A vertical displacement at least ½-inch in a pedestrian walkway existed without edge treatment. The walkway is a UFAS accessible route since it connects parking access aisles for parking spaces that are reserved for individuals with medical disabilities. The UFAS states that changes in level for ground surfaces in accessible routes between ¼-inch and ½-inch shall be beveled with a slope no greater than 1:2.
- BBI did not limit access where a potential safety hazard existed.

Figure 4 – Photograph taken March 9, 2004 showing area of uneven pavement in crosswalk where employee tripped and fell near Gate 2.

- Action should be taken to seal or overlay existing cracks that measure more than ¼-inch vertically to reduce tripping hazards.
- Cracks measuring more than ¼-inch horizontally should be sealed adequately to reduce the introduction of water to the pavement sub-base.
- A more definitive pedestrian walkway with barriers could be designated and maintained to keep the walkway free of tripping hazards.

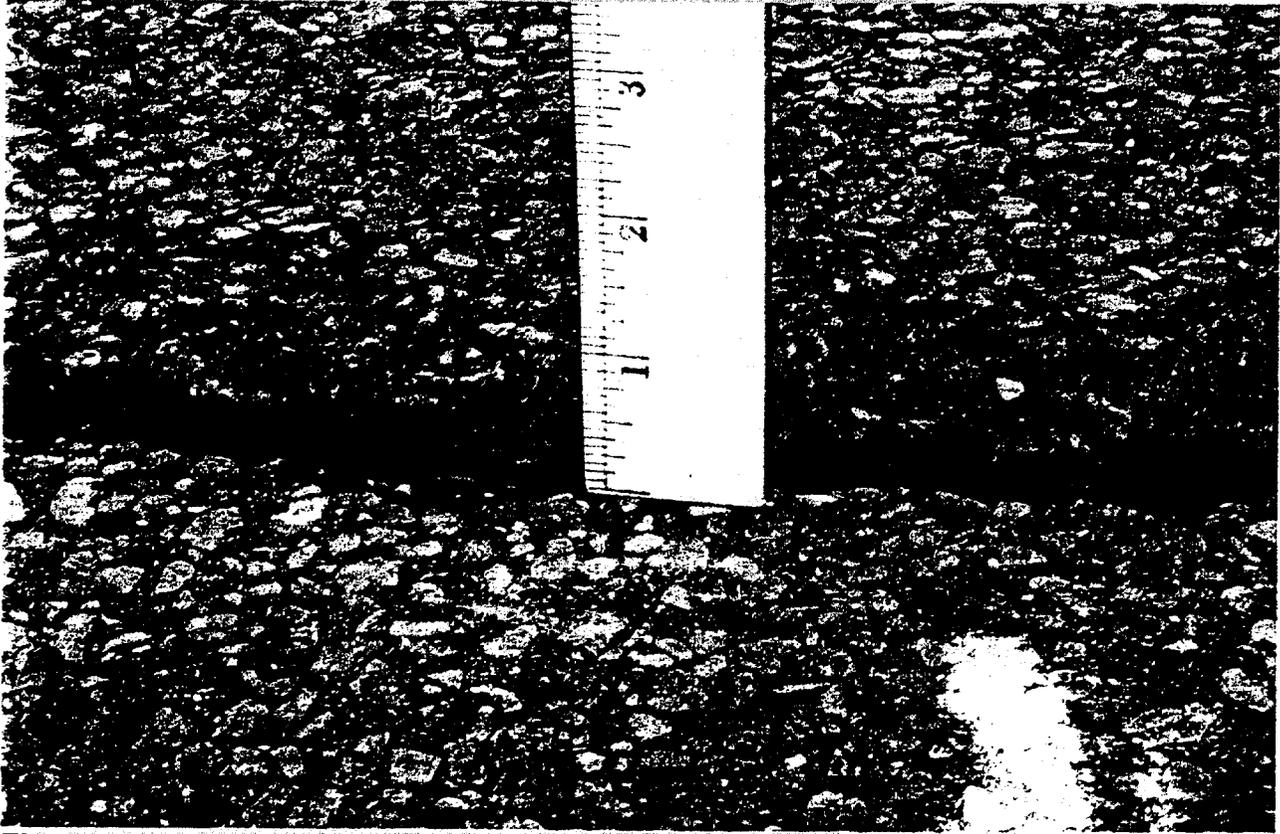
FIGURE 5

BBI Safety Engineering first inspected the accident site a week after the accident when the accident had become OSHA recordable. Safety Engineering observed a vertical displacement of approximately ¼-inch at the site where the accident occurred and their assessment was that no further action was needed and considered that there was no safety issue. BBI management did not critique the event. Section II of Bettis Management Guide 505 (Unplanned Event Reporting System) defines an occupational injury requiring hospitalization as an unplanned event requiring investigation.

Figure 5 – Photograph taken March 11, 2004 showing area of heaved pavement highlighting area of vertical displacement > 1/4-inch.
