Re: Type B Accident Investigation Board Report

**Type B
Accident Investigation Board Report
On the August 25, 2004
Head Injury to Miner
Waste Isolation Pilot Plant
Carlsbad, New Mexico**

On August 25, 2004, an employee of Washington TRU Solution, LLC (WTS) sustained a head injury when he was struck by a C-clamp and rope attachment that broke loose from a piece of metal vent line that was being dragged. This occurred as part of the development and recovery of an existing drift for underground disposal of waste at the Waste Isolation Pilot Plant (WIPP).

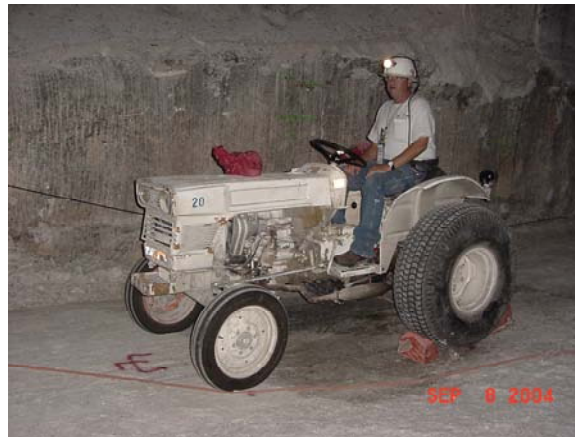
Figure 4: Kubota Tractor

Mine Operations employees in the worksite area recognized the Kubota tractor was inadequate to pull heavier metal vent line sections, because the tractor lost traction in

the loose salt and uneven haulage surface. Mine operations employees intended to use the LHD, which was included in the work package, in place of the Kubota tractor. Workers also realized the nylon rope being used had been severely abraded (Figure 5) by being wrapped around the vent line and dragged on the rough floor. Because the rope was abraded when moving the first vent line, a discussion was held among workers under the brow. Some concerns were expressed, but it was decided to attach rope using a C-clamp rather than the timber hitches as on the first vent line. Employees did not utilize stop work.

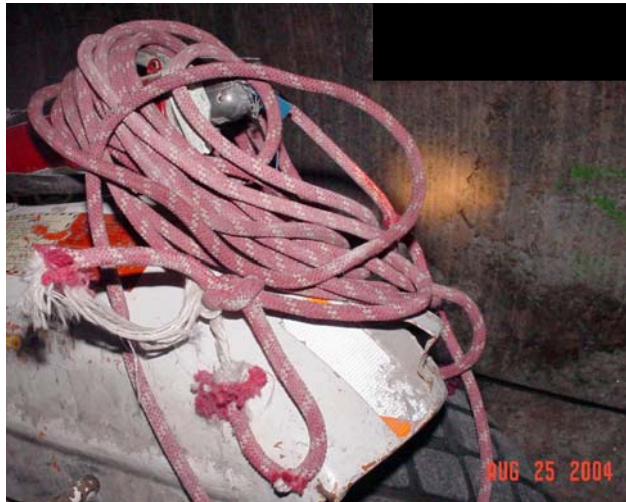
Figure 5: Rope used to pull Vent Line 1

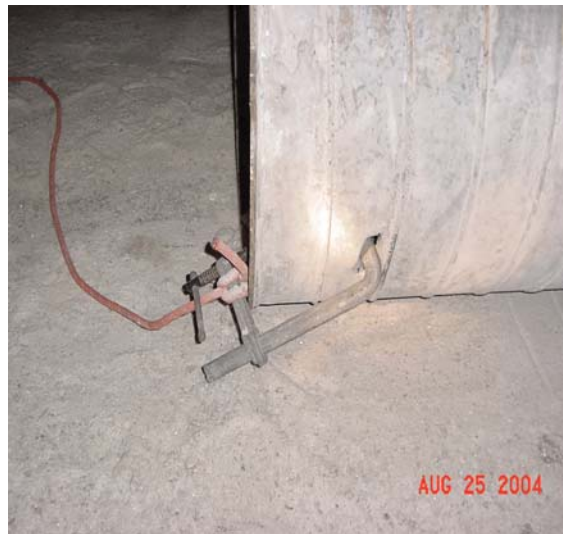
Figure 7: C-clamp still attached to Vent Line 3

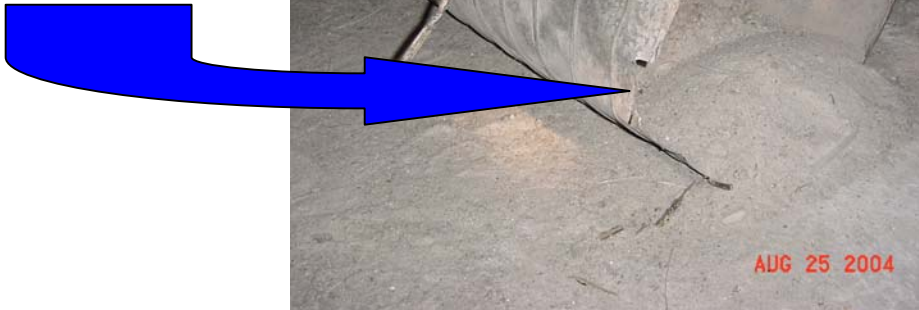
Hole in Vent Line 4

During the pull, E1 was standing at the south end of Vent Line 3. E1 warned Employee 7 (E7) to move away from the rope used for pulling Vent Line 4. At about the same time, Vent Line 4 began to dig into the floor, and E9 saw the C-clamp begin to rip out of the end of Vent Line 4.

Figure 9: End of Vent Line 4

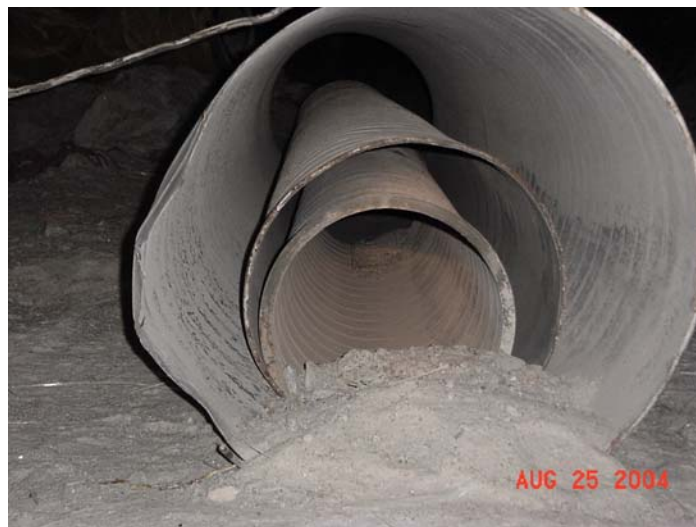
Figure 10: Inside Vent Line 4

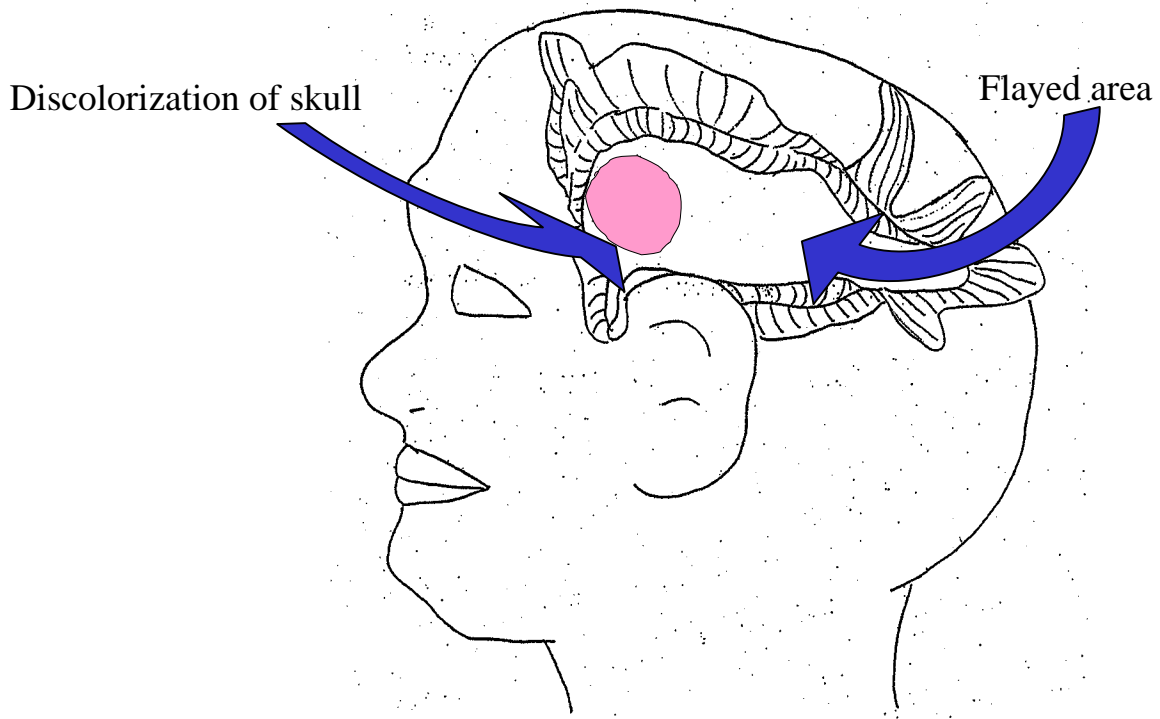
Figure 12: Wound Suffered by E1

The wounds suffered by E1 were sustained by the impact of the C-clamp, which fractured his hard hat, which cut E1s scalp and tore the scalp from his head. The indentation on the hard hat shows the direct point of impact. The discoloration of the skull indicates the indirect contact of the C-clamp on E1’s skull through the hard hat.
