OE-3: 2014-03

August 2014

## Safety Concern: Roll-up Doors

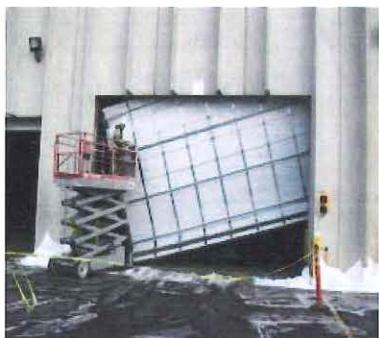
Figure 1: Example of a Roll-up Door Failure
