# Los Alamos National Laboratory Plutonium Facility (PF-4) Seismic Safety

*October 22, 2014*

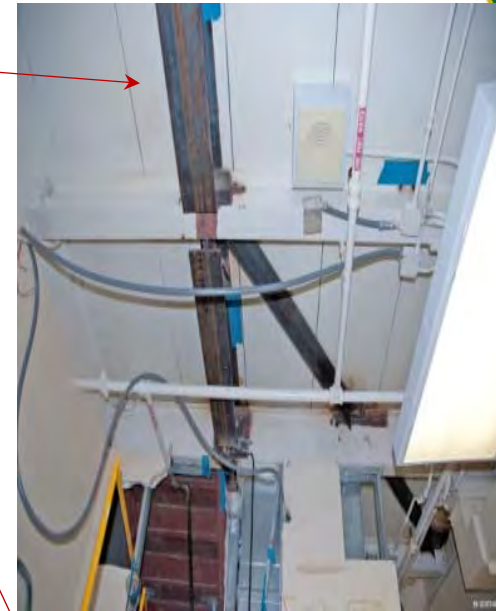
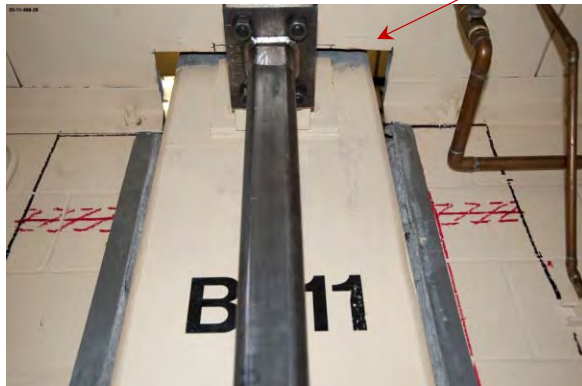
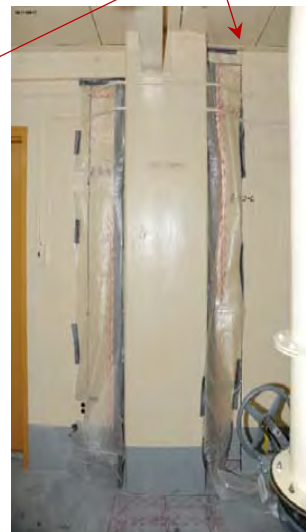
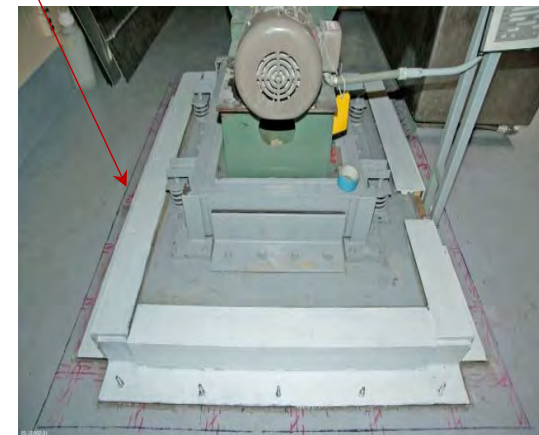
# 2011 modifications addressed confinement weak-links

- Mezzanines above the main floor were strengthened
- Ventilation component pads were reinforced
- Over-constrained basement columns were released
- Ceilings of basement ventilation plenum rooms were reinforced

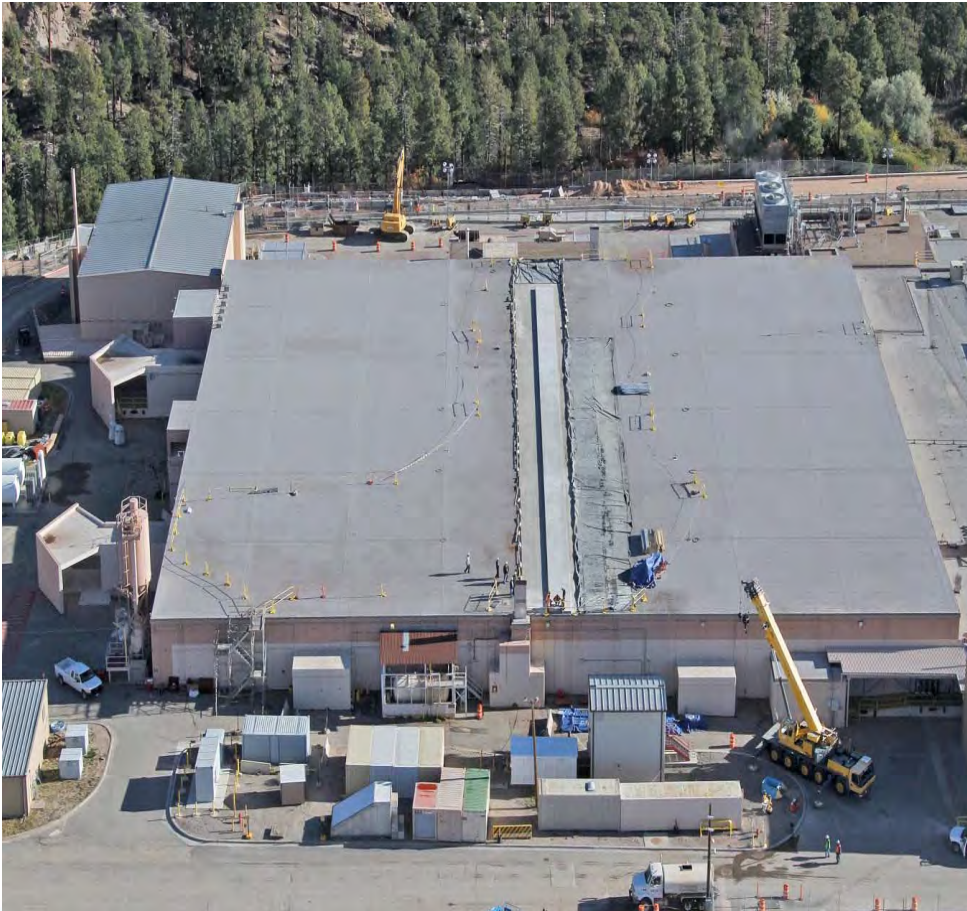
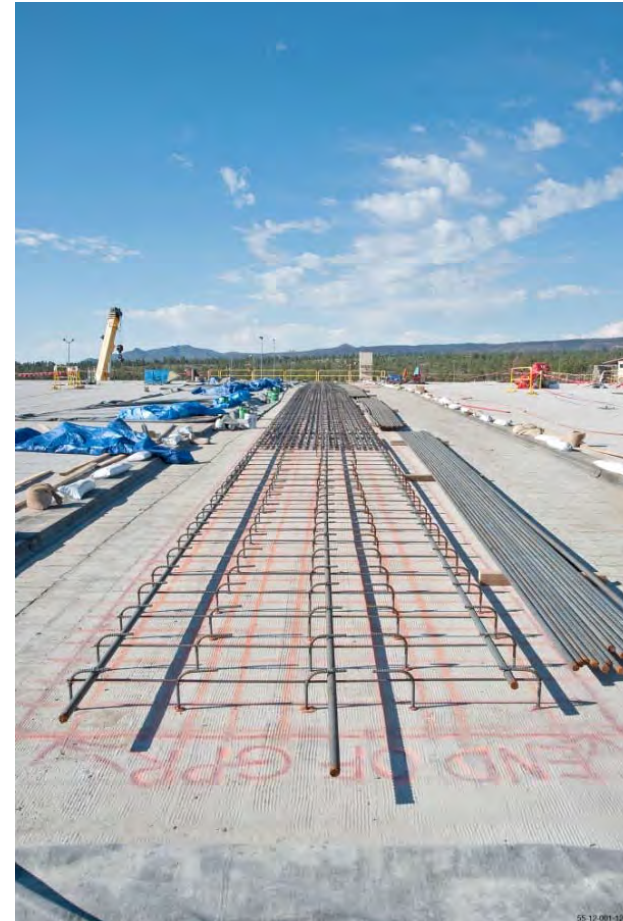
# Roof modification reduced probability of collapse

- Oct 2011 roof (drag strut) reinforcement compensated for incomplete shear wall on the main floor; collects and transfers in-plane roof loads

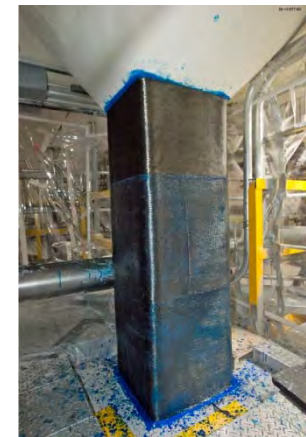
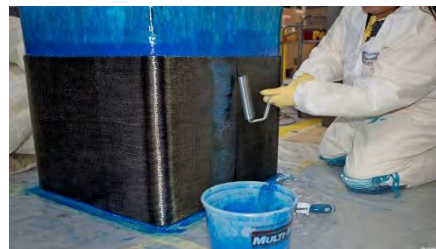
- The 2011 analysis identified columns and an interior shear wall as marginal.
- The Oct 2012 nonlinear pushover analysis better estimated probabilistic performance and identified other “weak links”
- Results indicated additional structural modifications were needed to meet performance requirements
  - Short columns in the basement (modification complete)
  - Interior roof girders (modification design complete)
- Probabilistic performance (probability of failure):
  - Before identified modifications:  $1.2 \times 10^{-4}$  (1 in 8,300 years)
  - With modifications complete:  $0.8 \times 10^{-4}$  (1 in 12,500 years)
  - Target Performance Goal:  $1 \times 10^{-4}$  (1 in 10,000 years)

Installation of  
carbon fiber wraps  
on short columns

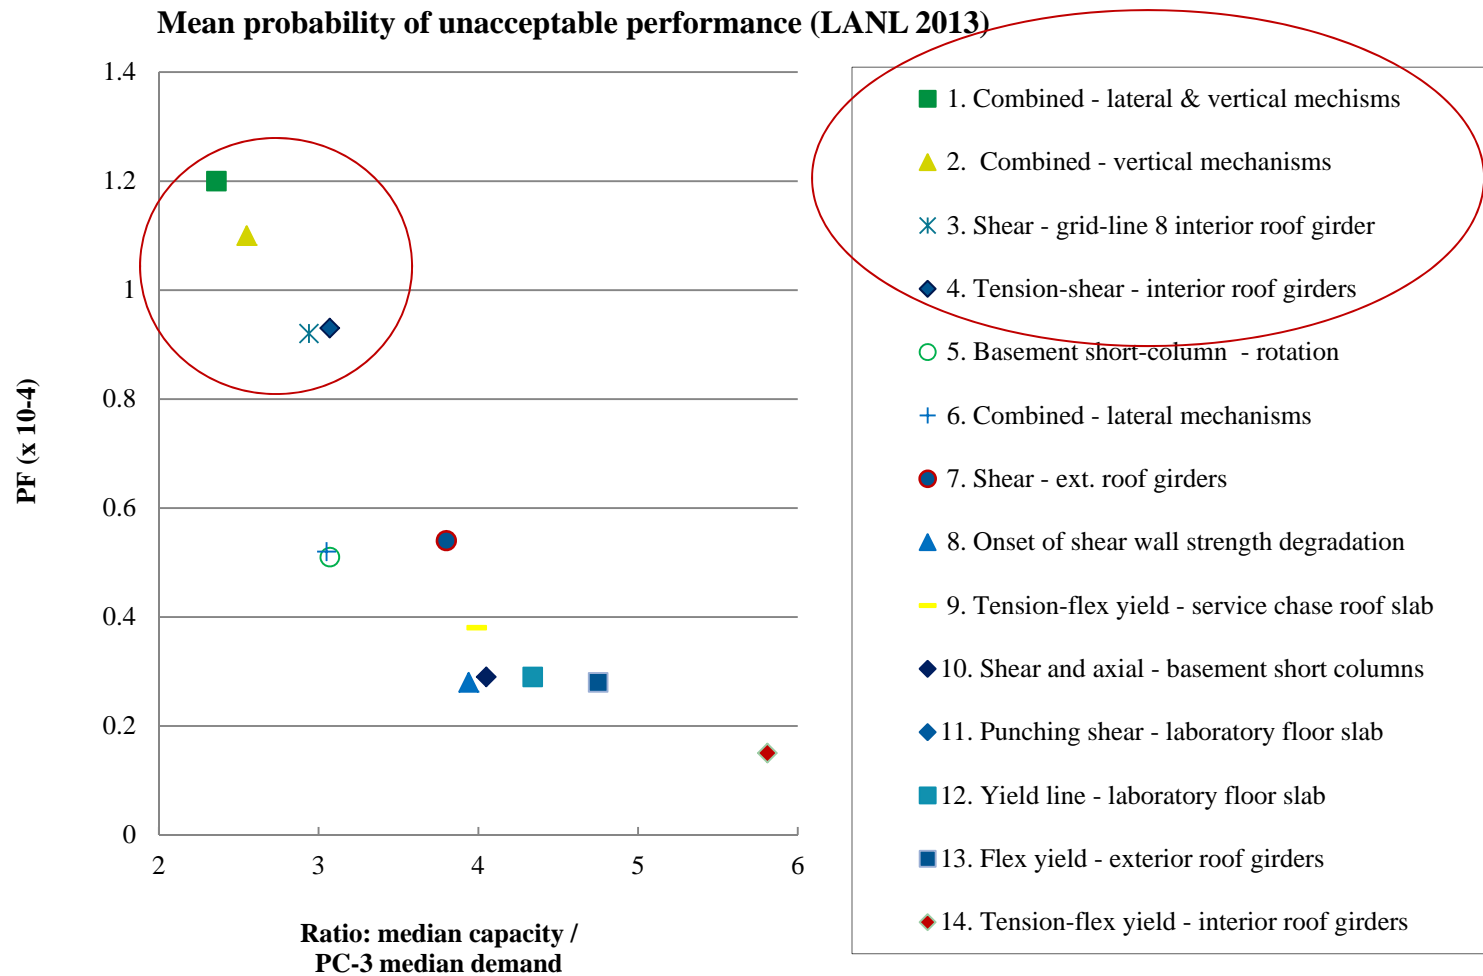
# 2013 Update – girders are the dominant failure mode

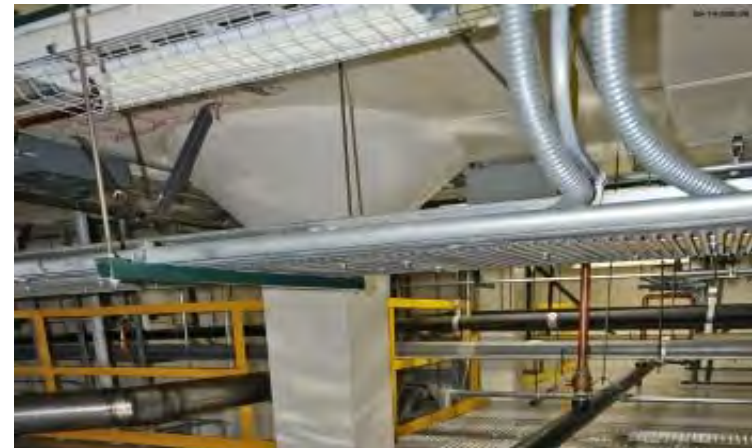
- In 2012, DOE/NNSA initiated a modal loading pushover analysis, by an independently engineering firm
- Reports issued in recent weeks are being evaluated; there may be new concerns (e.g., unreinforced capitals at top of basement columns)
- Preliminarily:
  - Roof girders – results appear consistent with LANL analyses but may include additional girders
  - Column capitals – vertical rebar across a construction joint may de-bond from concrete and propagate
  - Others... To Be Determined...
