## Building America Case Study

# Investigating Solutions to Wind Washing Issues in Two-Story Florida Homes: Phase 2

**Project Name:** Investigating Solutions to Wind Washing Issues in Two-Story Florida Homes: Phase 2

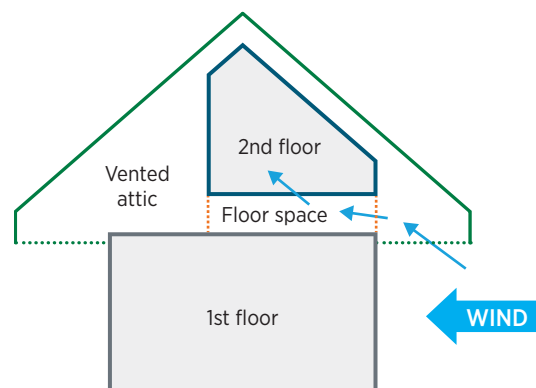
Figure 1. Wind washing is caused by air movement into the soffit, then into the attic, and finally into the floor space. Wind-driven attic air is pushed into the space between floors, bypassing house air and thermal boundaries.

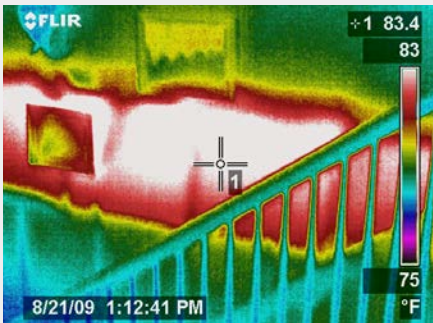
IR scans show temperature variations and reveal the operation of the wind washing phenomenon. As shown in the images above, thermal anomalies are occurring where hot attic air has penetrated into the floor cavity that lies behind the stairwell wall. The wall surface temperature was 83°F compared to 78°F room temperature.

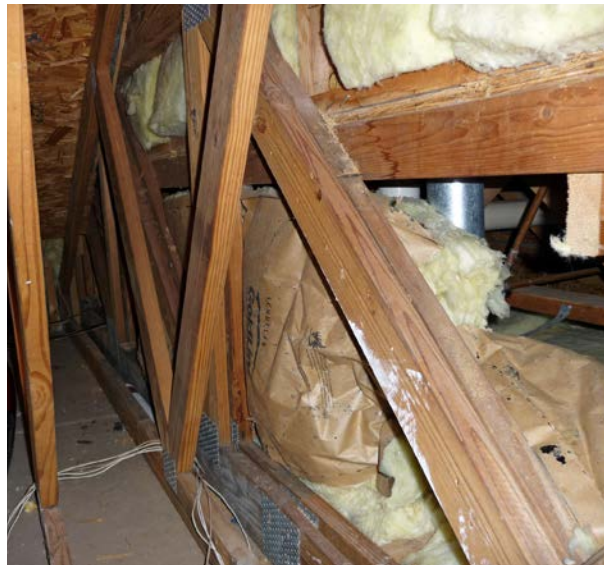
Figure 2. Visual inspection is important to determine the existence of wind washing, the resulting problems, repair strategies, and the potential benefit of the repair. The image on the left shows poorly installed batts and a pathway in a floor cavity open to the attic. Field tests can also be useful. These tests include infrared (IR) scans of house surfaces (see sidebar), house and duct leakage tests, and pressure mapping.
