## PG to Glycerin – Lessons Learned

**Jake Greenwell**

Y-12 Fire Protection Program Lead, Fire Protection Engineering

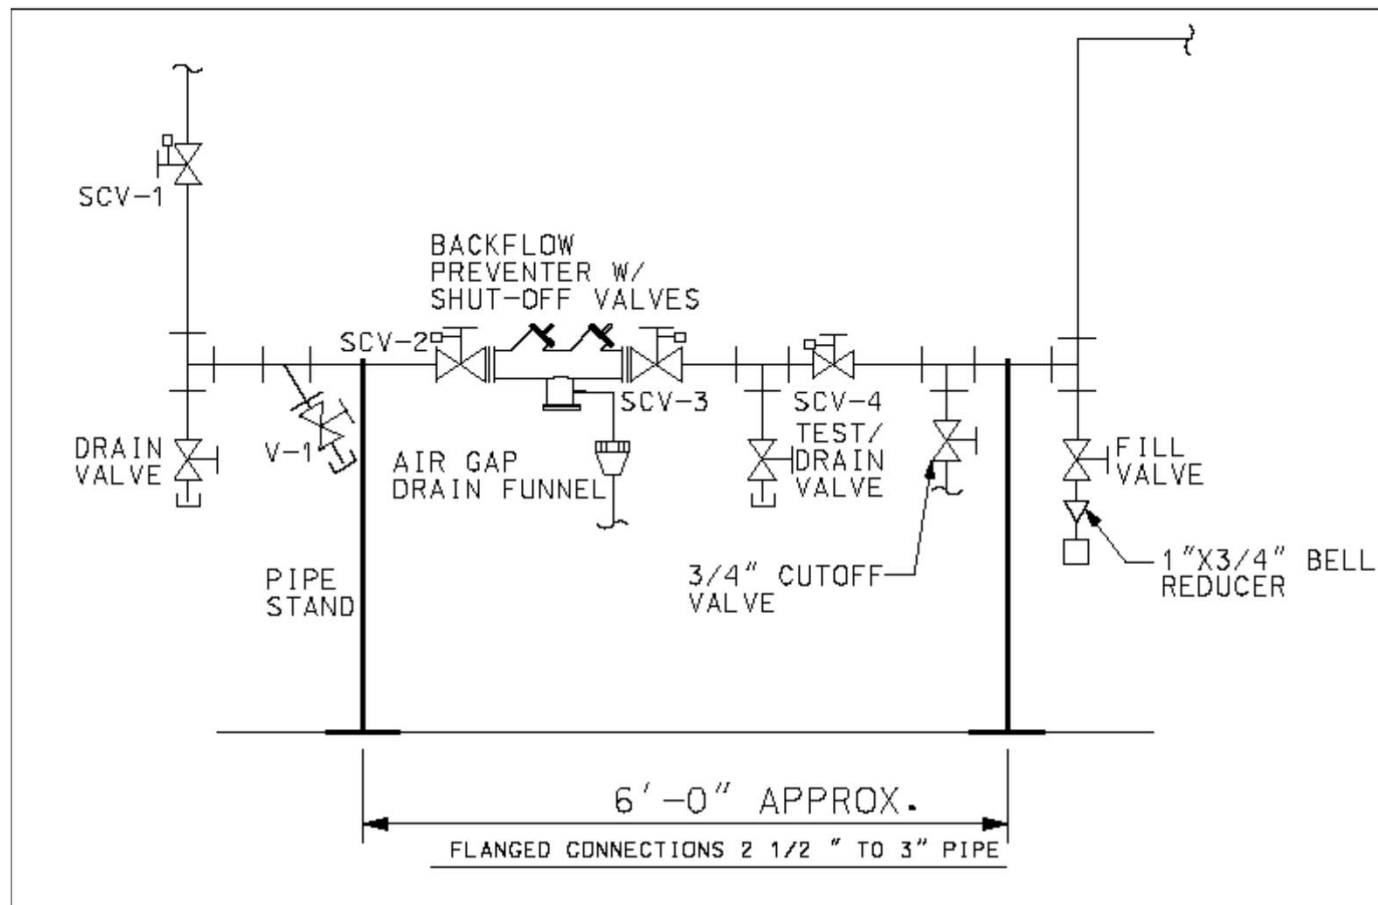
## Typical Backflow Preventer Configuration

- **NFPA 25 requires annual forward-flow testing of the backflow preventer.**
- **Configuration of the system**
  - Majority of our BFP are located between the WPS and AFL
  - Water is introduced to the antifreeze system during testing
- **Timing of the test**
  - Most of the testing took place after the new solution was added to the system
- **Volume of the System**
  - Most of our antifreeze systems are small systems
