Building America Case Study

Field Testing an Unvented Roof with Asphalt Shingles in a Cold Climate

Bolingbrook, Illinois

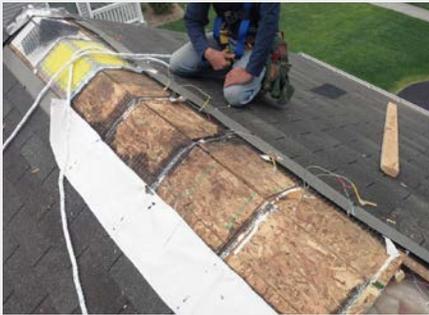
The roof was disassembled at the end of the experiment (top image) to correlate measurements with actual conditions. The unvented fiberglass batt roofs showed wet sheathing and mold growth (middle photo) although no structural failure. The cellulose roofs (bottom photo) exhibited only minor issues such as rusted fasteners, staining, and grain raise in sheathing. This difference was ascribed to three properties of cellulose: borate preservatives, airflow-retarding properties, and ability to safely store moisture.

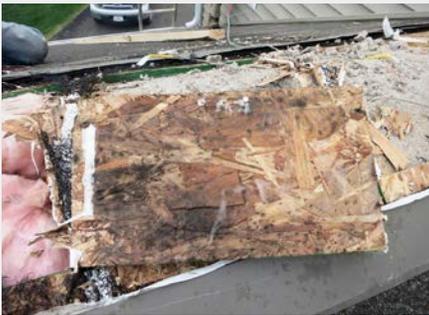
The team disassembled the roofs at the conclusion of the experiment and found that the fiberglass batt roofs had significant mold growth and staining, while the cellulose roofs showed only minor signs of damage (see sidebar). However, all roofs except the vented cathedral assembly experienced wood MC and RH levels high enough to constitute failure.

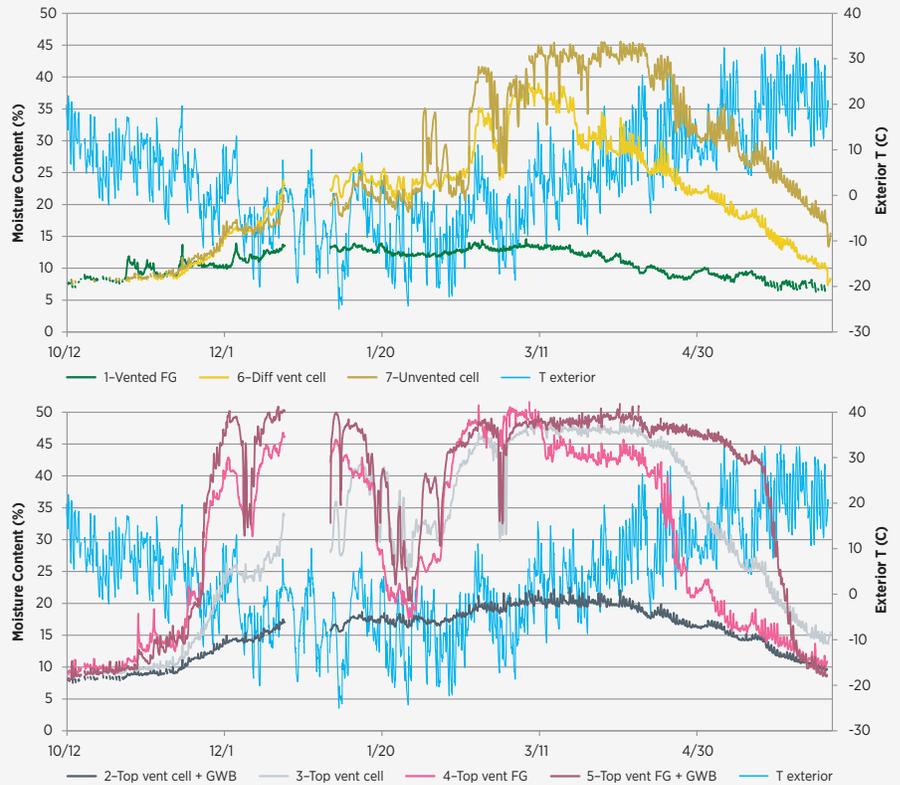
Rafter-framing top moisture contents in experimental roofs

Results were collected from October 2013 through June 2014 to capture winter and spring conditions. The vented roof showed safe moisture conditions despite the severe moisture loading. All other roofs showed high moisture content especially at the ridge/peak, where moist air would concentrate. Rafter-framing moisture content (MC) is shown in the graphs on page 2; all unvented roofs showed long

periods above 20% MC, with many hours in the 30%–40% MC range (high risk of fungal growth). Relative humidity and other sensors corroborated these high-risk moisture levels and showed evidence of condensation in many roofs. Sheathing MCs lower on the roof (near the eaves) were much lower (peaking at 20%–25% MC) compared to middle and upper sensors (some peaking at 40%+ MC).

The cellulose/diffusion vent roof showed peak MCs similar to the unvented roof; however, in the spring, the diffusion vent roof dried much more rapidly than the unvented roof. The top vent roofs also showed similar peaks to the unvented design, indicating that the drying available in the assembly (oriented strand board sheathing, ½-in. airspace) was insufficient to avoid failure. Assemblies with no interior gypsum board (cathedralized roofs) had higher moisture levels than roofs with gypsum board, which acts as an air barrier (with some vapor resistance). Analysis of the data using ASHRAE Standard 160 and other mold growth criteria showed that the roofs remained sufficiently wet into the spring (warmer weather) to run the risk of mold growth.
