Accident Investigation Report

Phase 2 Radiological Release Event at the Waste Isolation Pilot Plant, February 14, 2014

April 2015

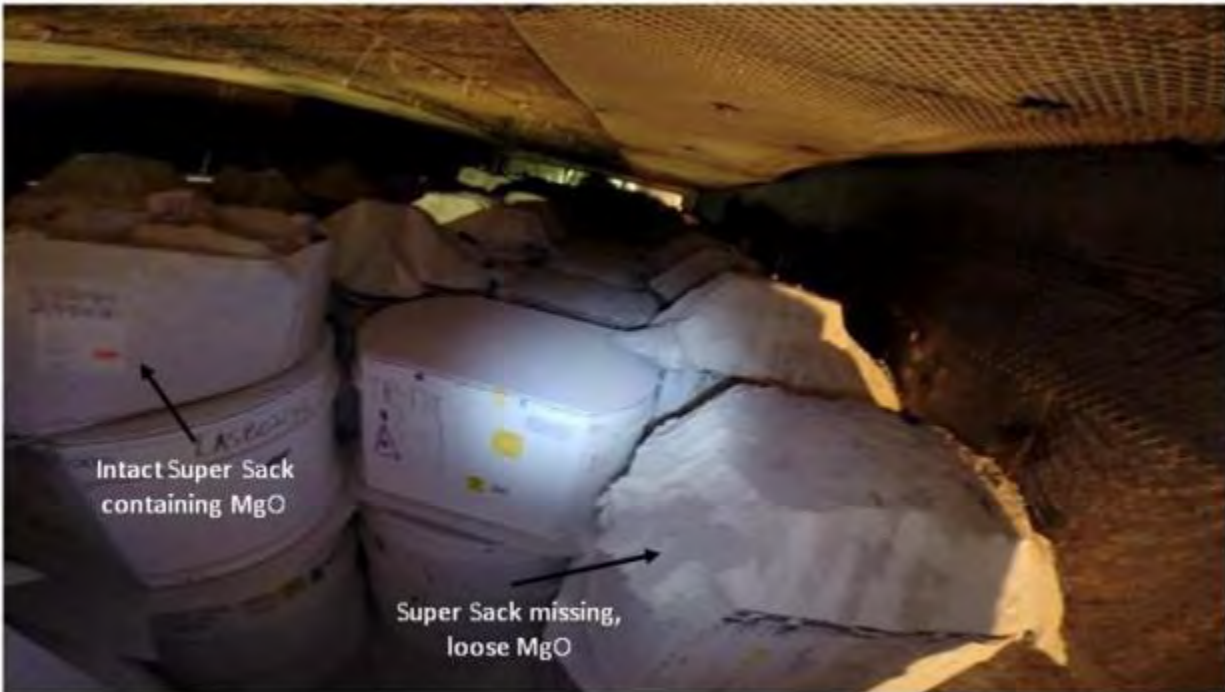
Figure 2-2: Missing Super Sacks Leaving Loose Piles of MgO on Waste Stacks

Photographic evidence of Panel 7 Room 7 from re-entries shows that 17 of the MgO super sacks were damaged. The super sack fabric and stiffener material (cardboard) was damaged or missing as illustrated in Figure 2-2, which allowed MgO to fall between waste stacks and left partial sloped piles of material on top of and between the waste stacks.

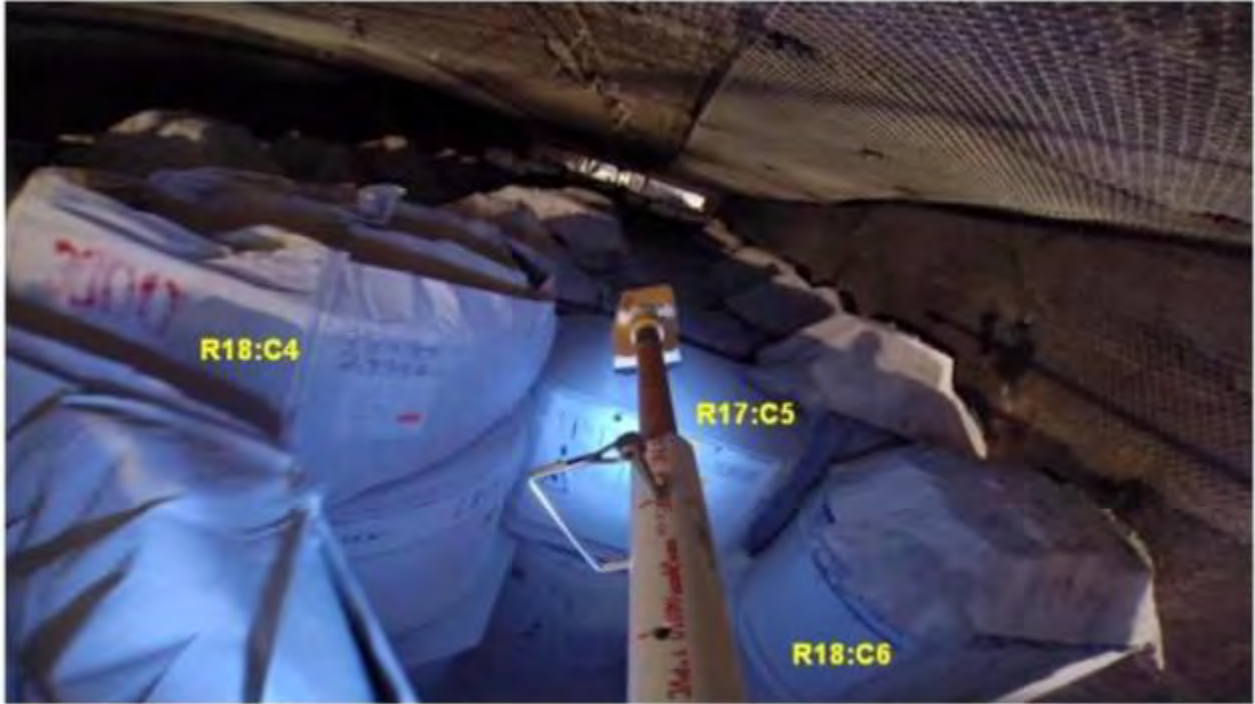
Figure 6-4: Panel 7 Room 7 Array, Columns 4 through 6

The MgO super sacks from Rows 8 through 18 were damaged. The polypropylene fabric that formed the sacks was severely damaged or missing from most of these locations. The fabric damage could have been caused by melting or ignition (Figure 6-4). Polypropylene is categorized as an easy-to-ignite material with a melting temperature in the range of 160°-176°C. Evidence of both mechanisms was identified during the array inspections. When the fabric was damaged, the cardboard stiffeners collapsed, the MgO flowed and formed piles of loose material at the damaged MgO super sack locations. At most of these locations the angle of repose (e.g., slope) was very steep, almost 60°, indicating gravity was the dominant force acting on the MgO after the super sacks were consumed by the fire.

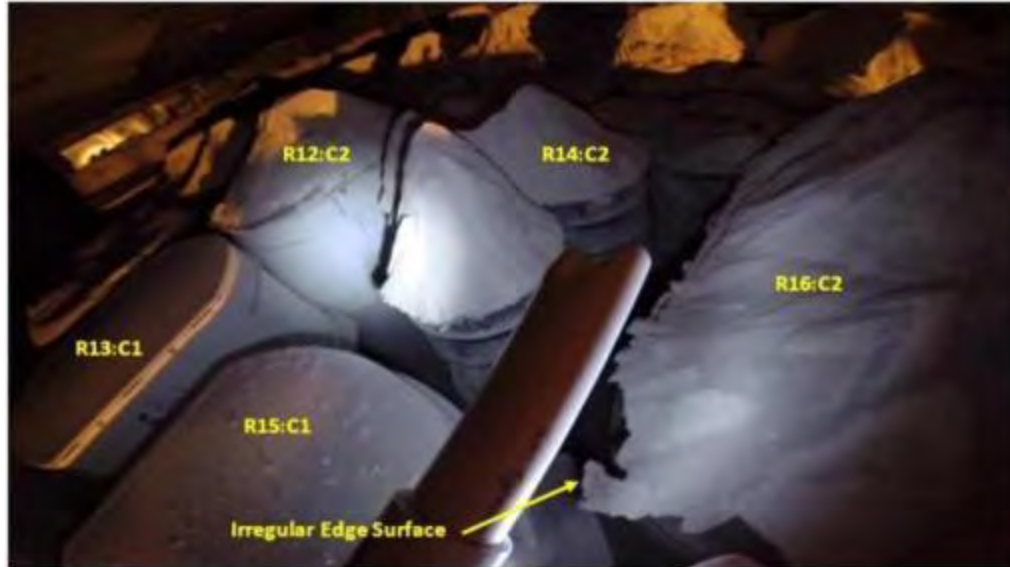
Figure 6-5: Evidence of Irregular Edge Surfaces at R16:C2

The cardboard stiffeners collapsed into multiple final orientations: hanging from a stack edge, cantilevered over the edge of a waste package, bridging between two stacks, or resting on the floor. Some of the locations where the stiffeners were cantilevered or bridging exhibited irregular edge surfaces (Figure 6-5). At R15:C5 there was a concave burn pattern in the portion of the cardboard that was cantilevered over the edge of the lid of a standard waste box (SWB) (Figure 6-6). The burn-pattern is typical of horizontal material exposed to a flame from below. Similar materials may burn as long as exposed to an external flame, but will likely self-extinguish once the flame is removed. There were also smaller cardboard remnants lying on the lid. These remnants display striations of the corrugated layer within the original cardboard matrix.

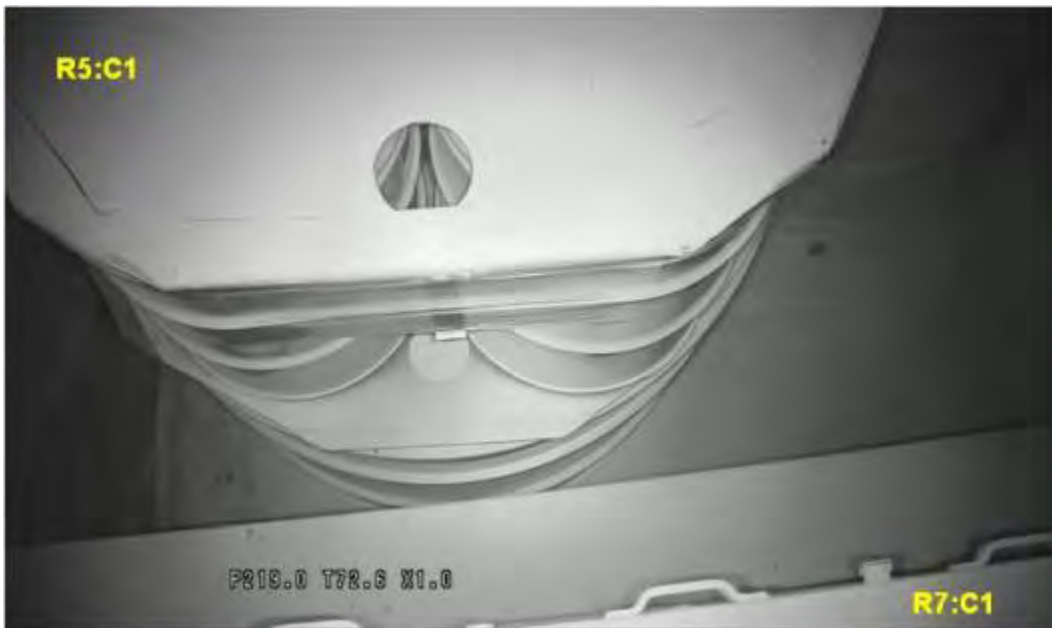
Figure 6-7: Undamaged Stretch Wrap at R5:C1

Rows 2 through 7 contained a mix of TDOPs, SWBs, 55GD assemblies, 100GD assemblies, and Standard Large Box Type 2s. These rows were closest to the bulkhead. The inspection identified no fire-related damage to the polyethylene stretch wrap or the polypropylene super sacks in these rows. The lack of damage to the polyethylene stretch wrap in these rows establishes that the bulk air temperature passing over the array was low, nominally below 135°C, which is the upper value of the melting temperature range of the polyethylene stretch wrap¹² (Figure 6-7, Figure 6-8 and Figure 6-9).

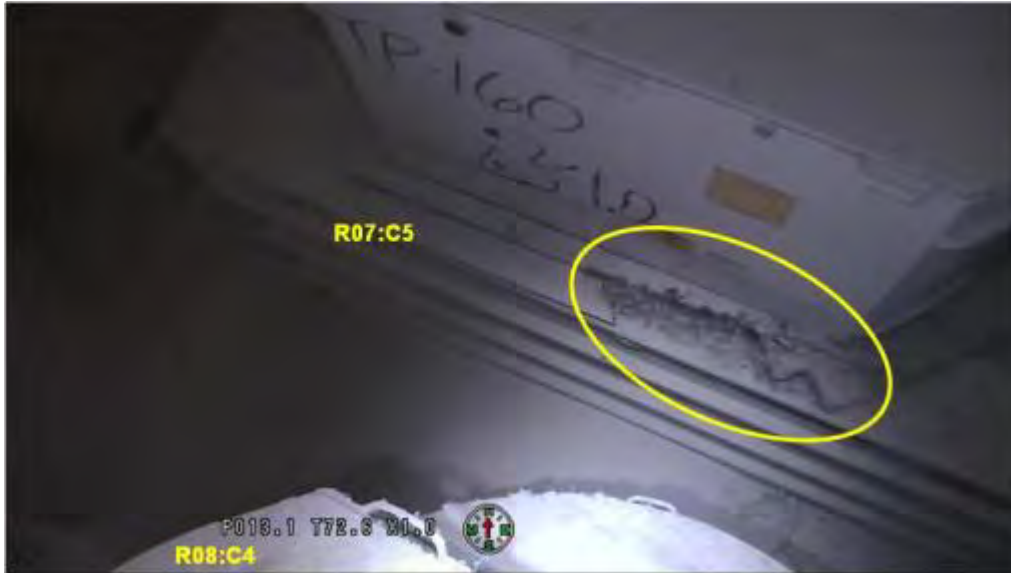
Figure 6-10: Fiberboard Slip Sheet Damage at R7:C5

Ignition of a fiberboard slip sheet did occur at R7:C5. The fiberboard charred over a short region and self-extinguished (Figure 6-10). This region is adjacent to R8:C4, which had a fire-damaged MgO super sack, so ignition could have occurred by direct thermal heat transfer from the fire at R8:C4, from impact by burning material (cardboard or fabric) falling from R8:C4, or by embers generated elsewhere in the array. Damage to this fiberboard was identified as fire damage closest to the bulkhead.

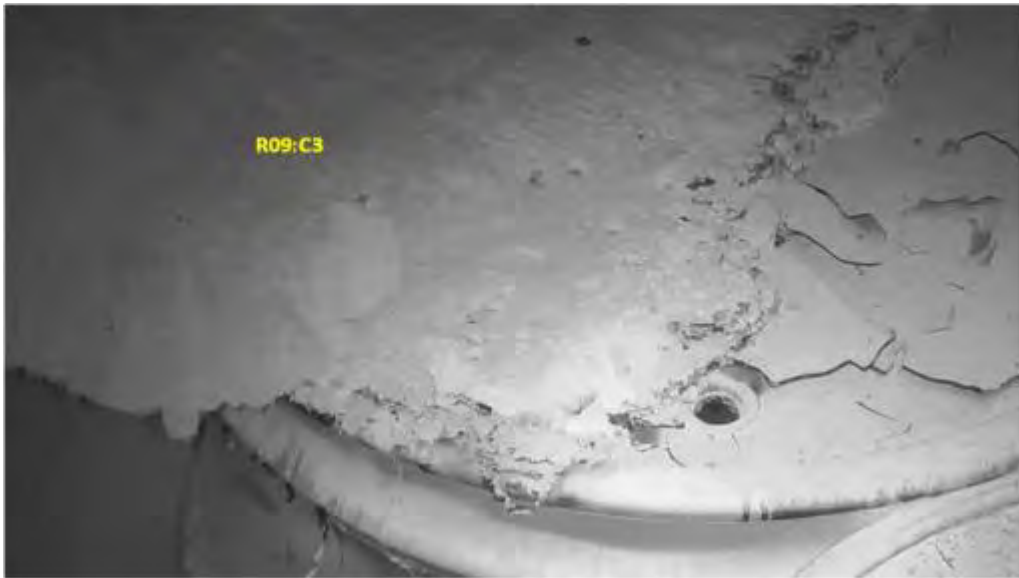
Figure 6-19: Residual Polyethylene on Dunnage Drum at R09:C3

had no observable fire damage, stretch wrap at each of the other five stacks was damaged or missing. The 55GD assembly reinforcement plates at R9:C3 and R9:C5 melted, mixed with MgO, solidified on the drum lids, and cracked into pieces (Figure 6-19, Figure 6-20, Figure 6-21, Figure 6-22, Figure 6-23 and Figure 6-24). There was no evidence of reinforcement plate remaining between the drums. In some instances melting polyethylene formed streaks on the on the side of these drums. In addition, MgO slumped onto some of the drums in both locations.

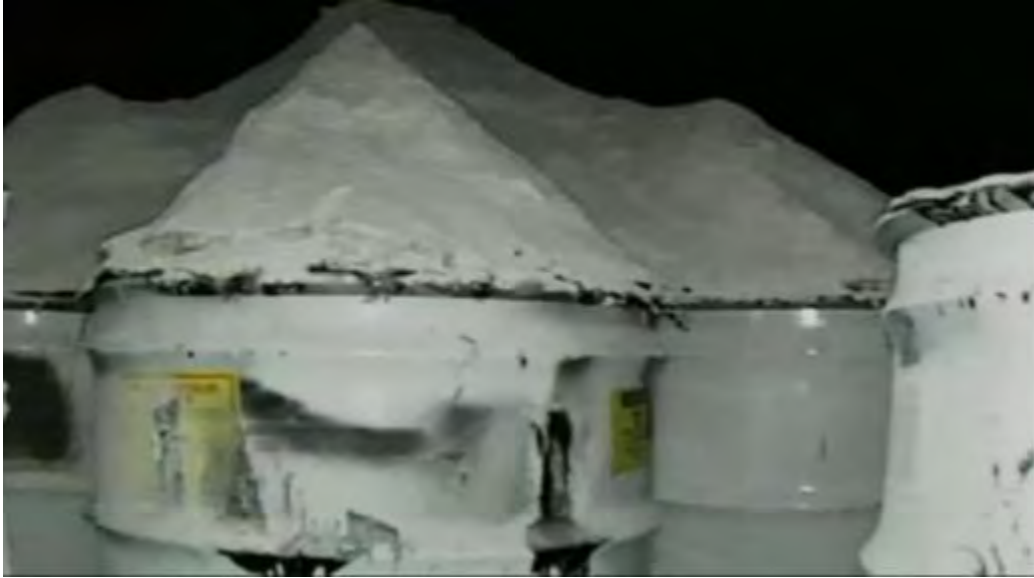
Figure 6-25: Discoloration and Residual MgO at R10:C4

While some of the TDOPs in Rows 9 and 10 exhibited streaks of melted plastic, none had substantive damage. In some instances the depth of the MgO at the floor was so deep that it obscured a substantial portion of the lower stack tier or the lower half of a TDOP.

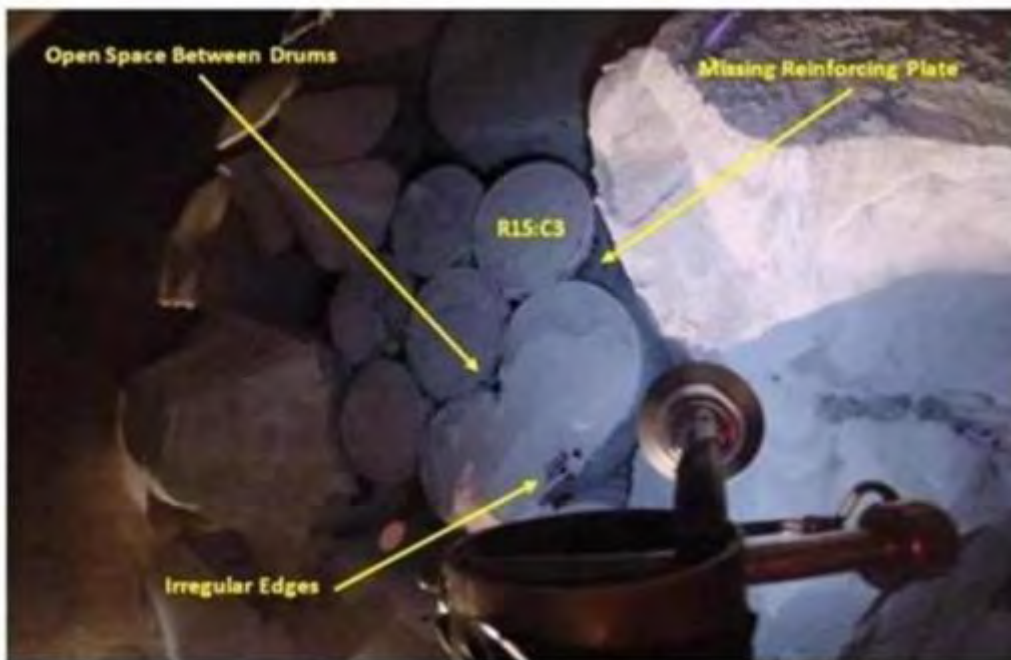
Figure 6-33: Missing Reinforcement Plate at R15:C3

The reinforcement plate at R15:C3 was damaged. The missing plate material conformed to the outline of the seven drums, including the spaces between the drums (Figure 6-33). There was residual stretch wrap visible on some portions of the assembly and some of the drum labels were undamaged (Figure 6-34). The TDOP below the 55GD assembly was undamaged.

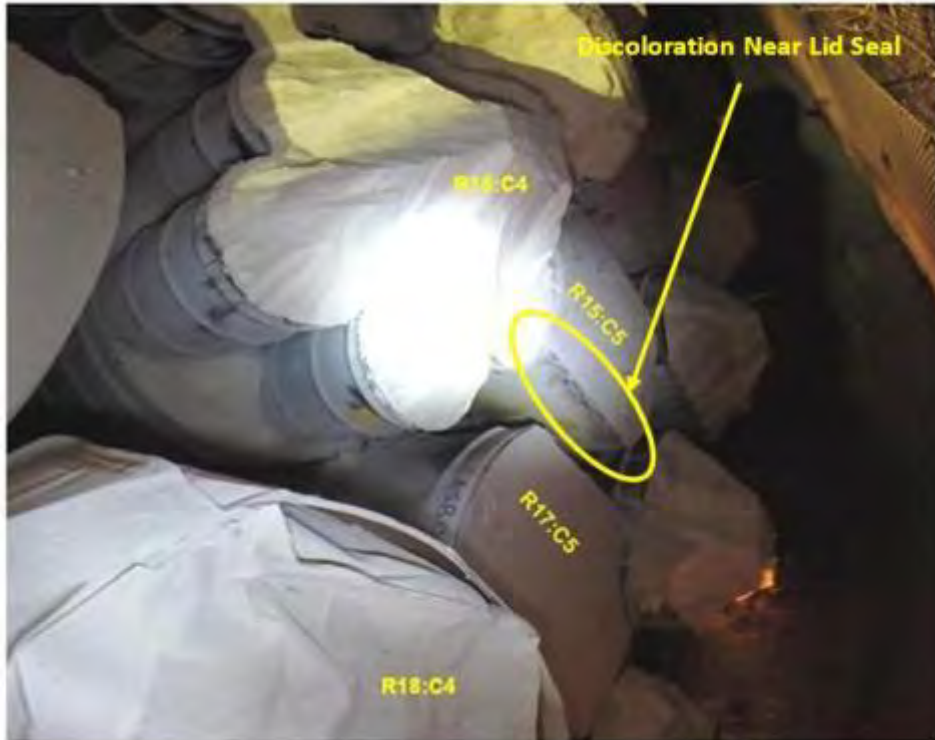
Figure 6-35: Discoloration of SWB at R15:C5

One 55GD on the middle tier of R15:C5 exhibited evidence of localized heat or flame exposure. Between the middle and upper rolling hoop there was one label that had charred, while a second label that showed no damage (Figure 6-39). In addition, there was a dark inverted-cone shaped pattern starting at the base of the drum that extended up the side of the drum about 12 inches. Around this region there was clumped MgO resting on the middle-tier slip sheet. While there was severe flame damage evidence on the west side of the SWB and the middle tier 55GD assembly, the lower tier stretch wrap appeared undamaged on the outer surface as viewed from the west side of the stack.

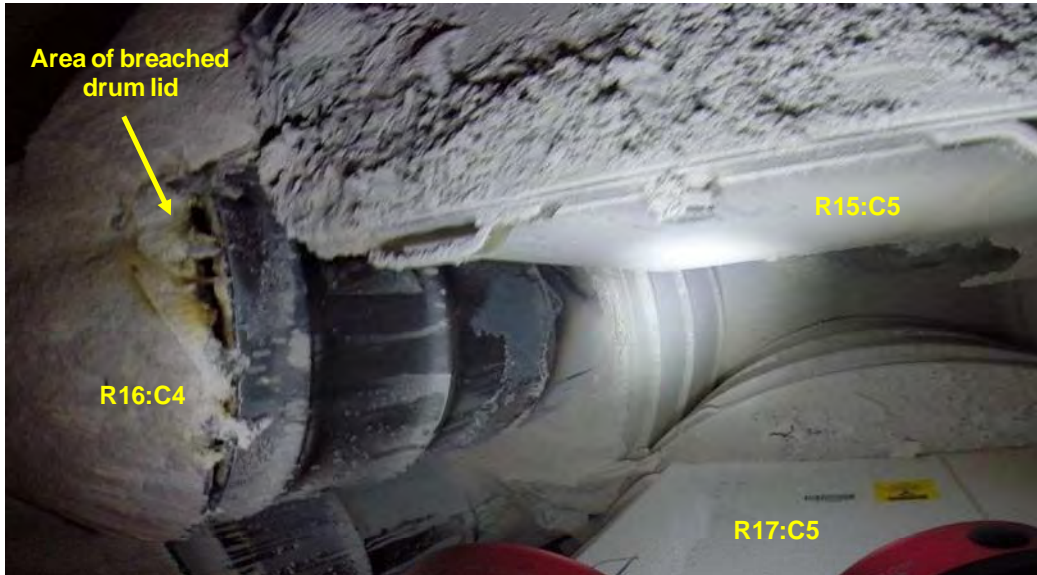
Figure 6-40: Drum 68660 at R16:C4

A drum on the top tier of R16:C4 breached (Figure 6-40). This is waste container 68660; it is on the south side of the stack. The MgO super sack fabric on the top of the 55GD assembly is substantially gone. The MgO piles on 68660 and the neighboring drum to the west are short with a low angle of repose. This was potentially caused by movement of the lid. The cones on the other drums are similar to other stacks where the MgO super sacks have been damaged.

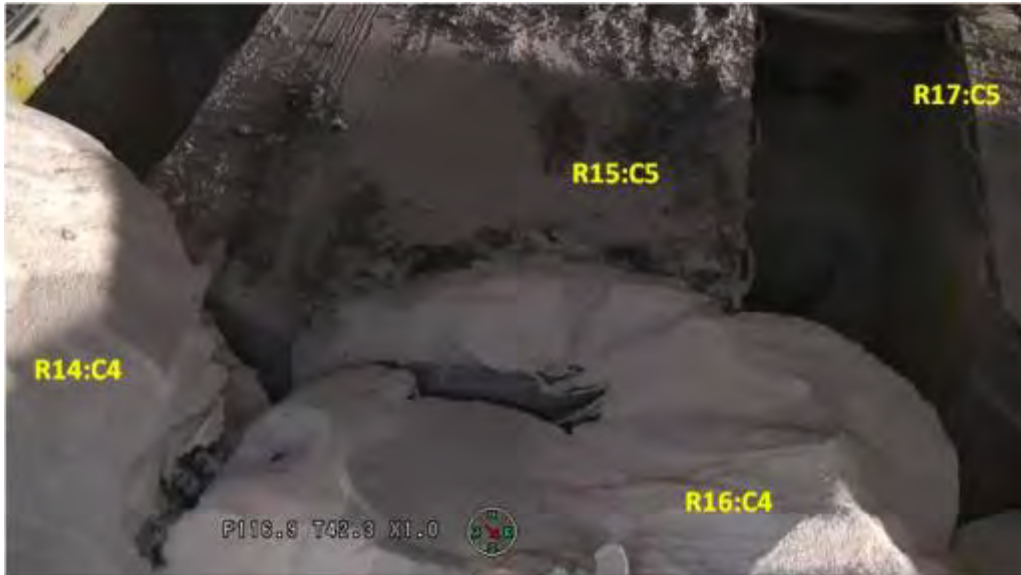
Figure 6-41: R15:C5 SWB Lid from North Looking South

There was a moderate quantity of clumped material and MgO spillover on the SWB lid at R15:C5 (Figure 6-41). The depth of this material was greatest on the northwest corner where the stack is in close proximity to R16:C4 (Figure 6-42). The north end of the lid had evidence of combusted cardboard stiffener material from the MgO bag that was placed on top of R16:C4. Additionally, there was a fallen cardboard stiffener lying on the north end of the lid. There were two spots on the southeast and southwest corners of the lid where white MgO was seen on top of the discolored material spread across the remainder of the lid. This suggests that the MgO sacks on R16:C6 and R14:C6 spilled their contents sometime after the clumped material dispersed across the lid surface.

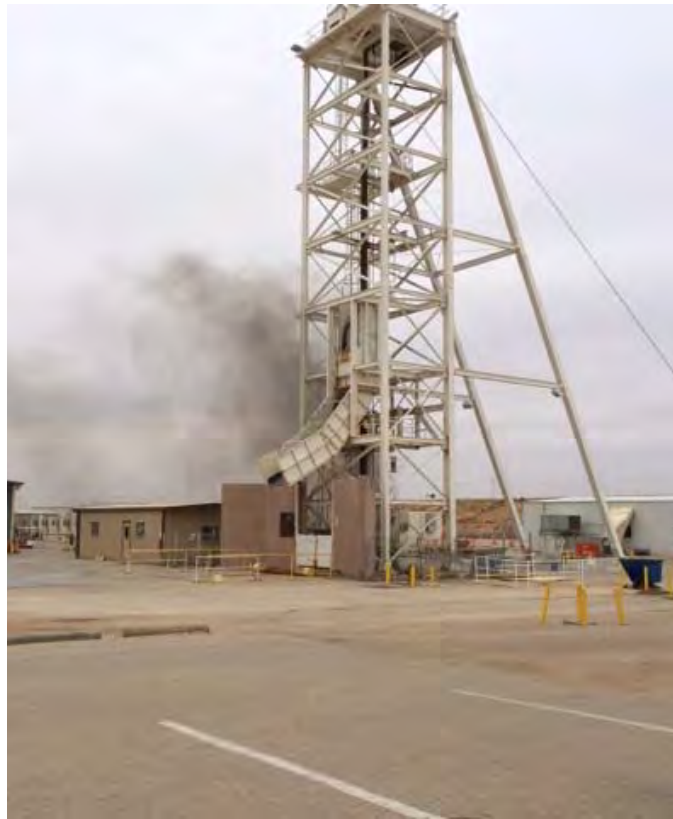
Figure 6-43: Upcasting Observed at the Salt Shaft on February 5, 2014

Upcasting in the Salt Handling Shaft did occur following the change to filtered mode (Figure 6-43). This upcasting increased the airflow moving past the salt haul truck fire. The flow behavior in the Salt Handling Shaft was modeled by a Bernoulli's fluid equation, recognizing that the volumetric flow up the shaft was induced by the thermal gradient, and would create a friction flow resistance. Simultaneous solution of the flow equation, and the energy balance equation, as discussed for the early portion of the fire, demonstrated that the temperature at the based of the Salt Handling Shaft was about 82°C when the energy release rate was 15 megawatts.
