Building America Case Study

Field Testing an Unvented Roof with Fibrous Insulation and Tiles

Orlando, Florida

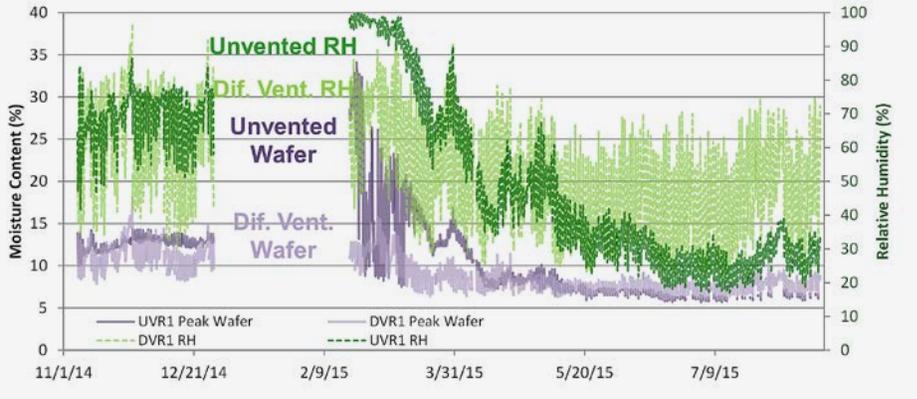
Comparison of unvented to diffusion vent ridge wafer MC and RH

The data collected to date (during 9 months, capturing winter through summer) indicate that the diffusion vent roof shows greater moisture safety than the conventional, unvented roof design. The unvented roof had extended periods (during cold winter months) of 95%–100% RH, and wafer measurements indicating possible condensation. The high moisture levels were concentrated at the roof ridge, which is consistent with previous field experience. In contrast, the diffusion vent roofs had drier conditions, with most peak moisture content (MC) (sheathing) below 20%.

These trends are captured in the plot above, which compares unvented to diffusion vent ridge conditions. These two roofs are directly adjacent to each other, on the same ridge. The plot includes the MC of the ridge wafer sensor (left axis) and the RH at the ridge (right axis).

In the spring, as outdoor temperatures warmed, all roofs dried well into the safe range. The unvented roof dried rapidly, consistent with a vapor-impermeable exterior layer and a strong temperature gradient (which drives moisture downward). The diffusion vent roof also showed a drying pattern during the spring, but RH remained slightly higher (but in the safe range), because the diffusion vent allowed vapor communication with the exterior.
