# 2018 Annual Site Inspection and Monitoring Report for Uranium Mill Tailings Radiation Control Act Title II Disposal Sites

December 2018

**Sherwood, Washington,  
Disposal Site, 2018**

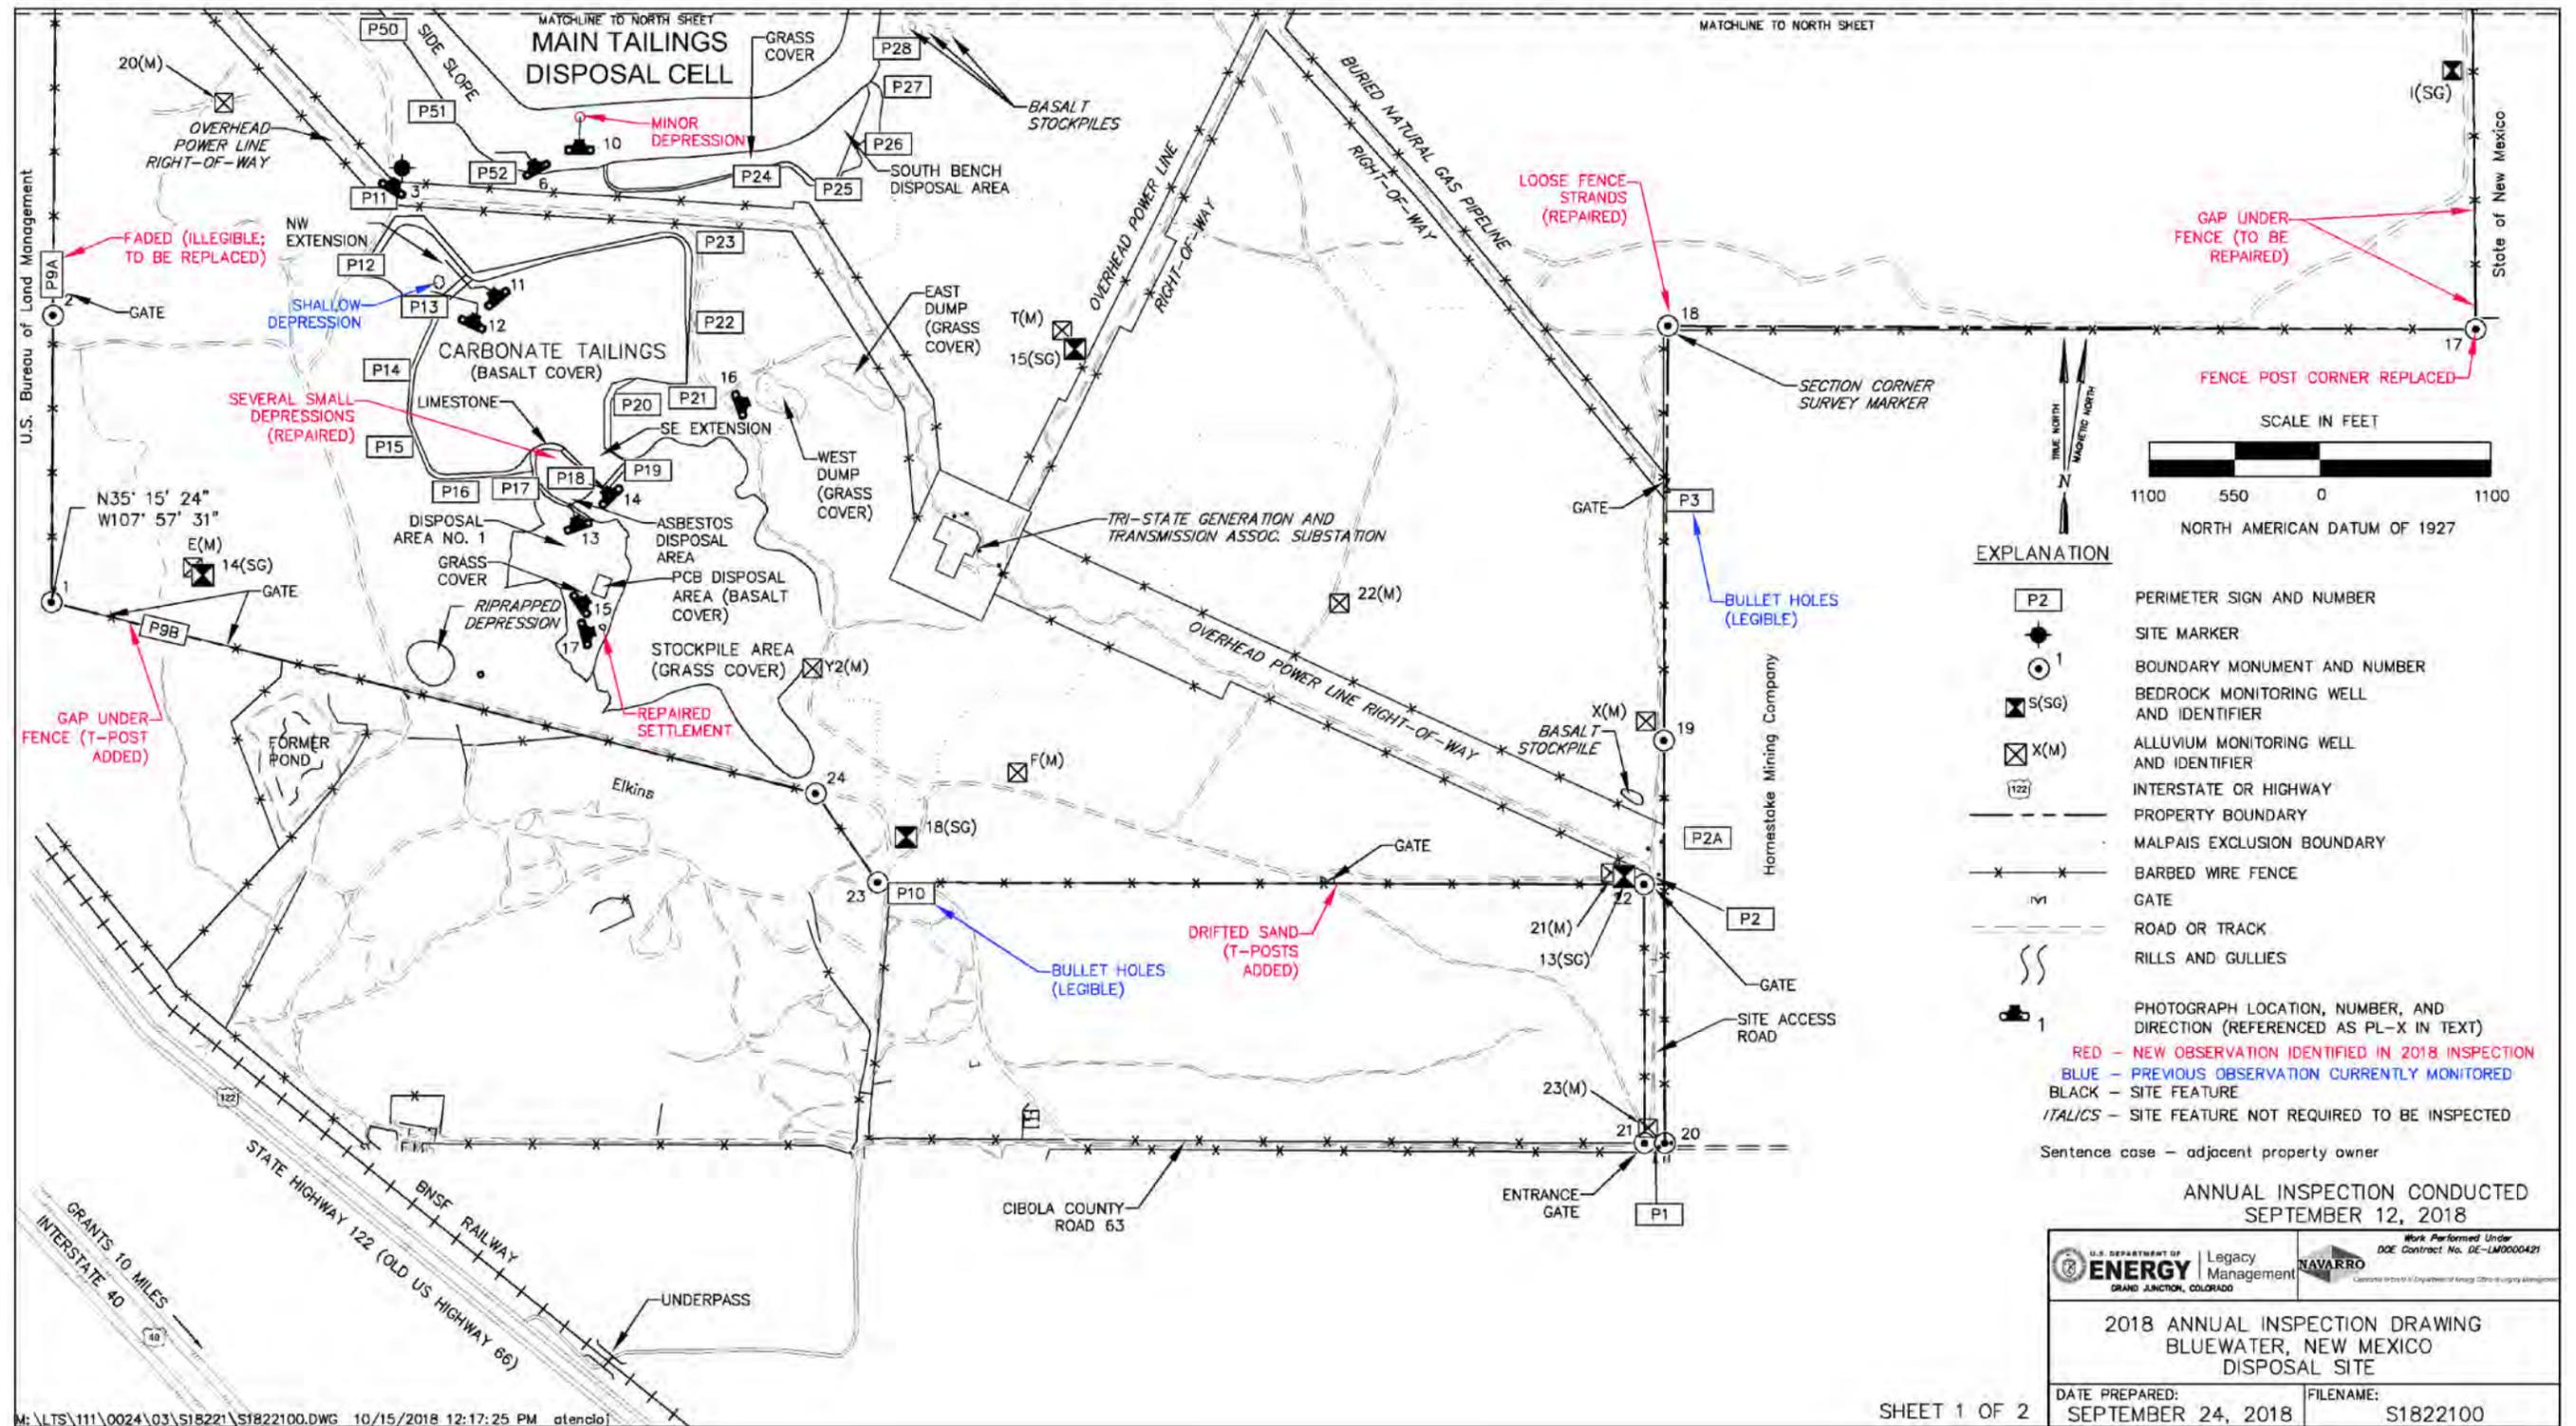
Figure 1-1. 2018 Annual Inspection Drawing for the Bluewater, New Mexico, Disposal Site (South Area)

A four-strand barbed-wire fence encloses the site to facilitate land management by LM, which retains a local subcontractor to periodically check the site perimeter fence and remove trespassing cattle. Minor fence repairs are conducted as needed. Numerous sections of the fence are in remote areas of the site and cannot be observed from site access roads. The entire perimeter fence was inspected on April 25, 2018. Before the inspection, on April 23–25, 2018, a south section of the perimeter fence was repaired by adding additional T-posts and wire to eliminate gaps caused at some locations by erosion and deposition. At the corner where boundary monument BM-17 is located, the old wooden-post corner was replaced with an angle-iron corner post and braces set in concrete. Additional fence repair needs and a damaged lock on a perimeter gate are noted in Figure 1-1 and Figure 1-2; repairs are planned for 2019.

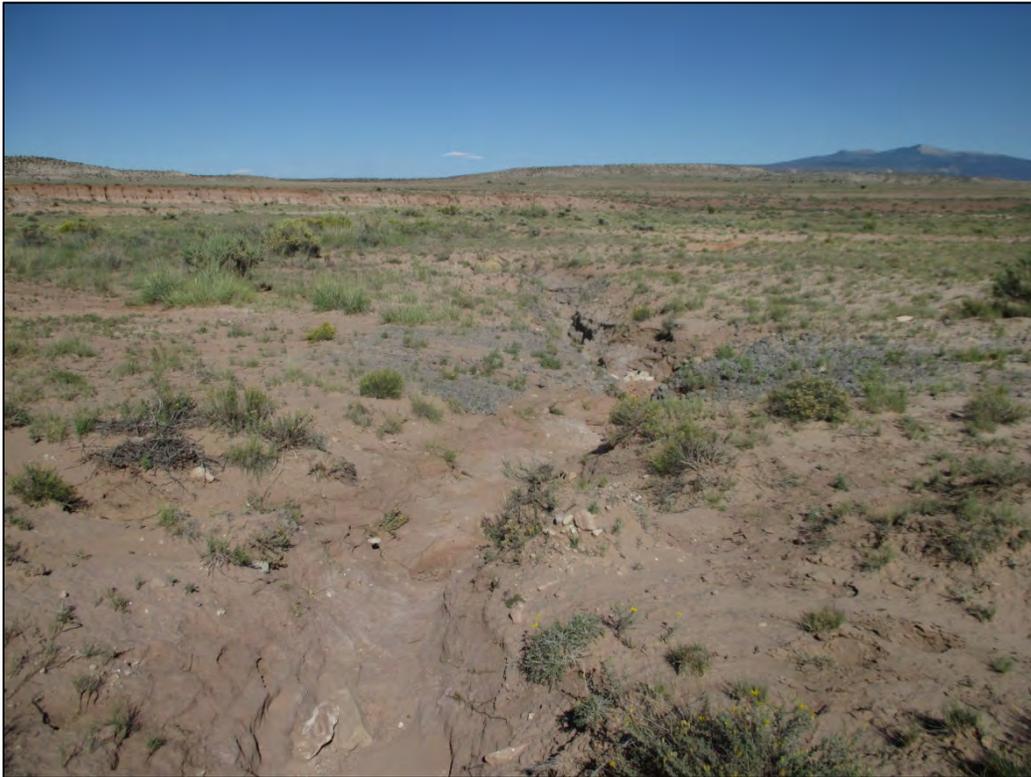
Interior roads used to access LM assets consist of a dirt track covered at places with crushed basalt. The roads are susceptible to erosion and are repaired when they become impassable. Increased erosion was observed on a road northwest of the main tailings disposal cell (PL-1). A gully intersecting the road at this location required maintenance in the past. Riprap previously was added to repair this section of the road; other repair options will be evaluated in 2019. This portion of road is not necessary to maintain access to the disposal cells; it is used to access the northern portion of the site and monitoring well 11(SG), which can be accessed by utility terrain vehicles when necessary. No other maintenance needs were identified.

*PL-1. Gully Intercepting Interior Site Road*

Additional fence maintenance needs identified during the April 25, 2018 fence inspection will be addressed and repairs made in 2019. Potential options to address erosion impacting the interior site road will be evaluated in 2019. No other maintenance needs were identified.

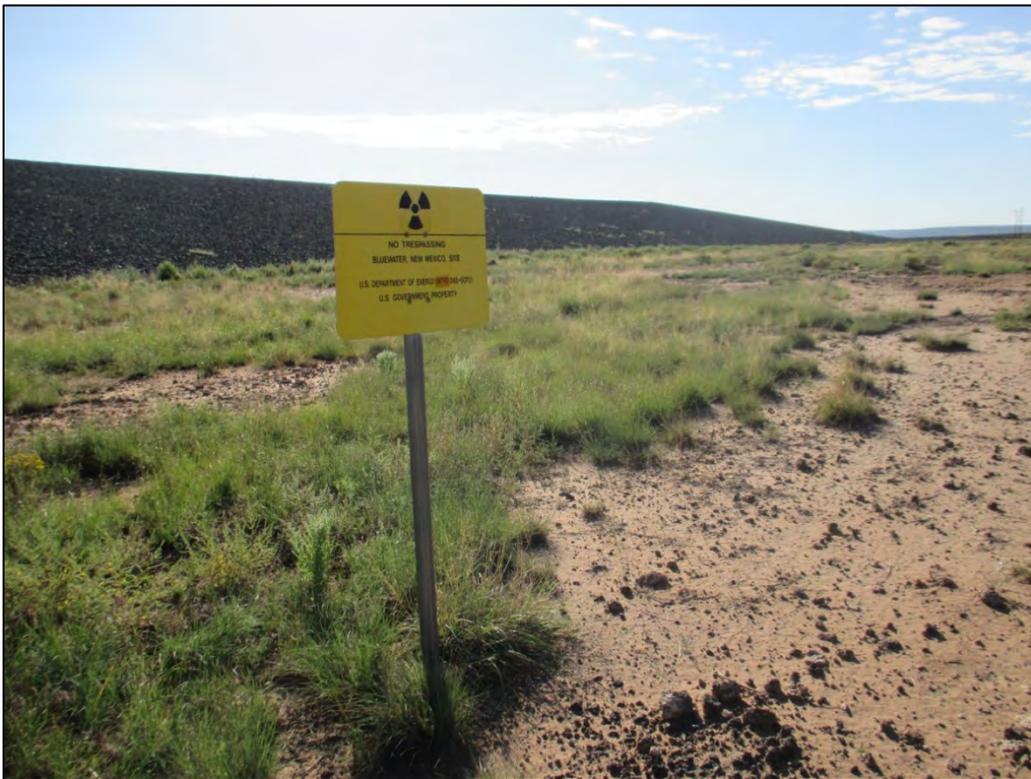
Fifty-five perimeter signs (warning and no-trespassing signs) are mounted on steel posts along the site boundary and around the main and carbonate tailings disposal cells (PL-2). Perimeter signs P3 and P10 have gunshot damage but are legible. Perimeter sign P9A is faded and will be replaced. No other maintenance needs were identified.

*PL-2. Perimeter Sign 49; Southwestern Side Slope in Background*

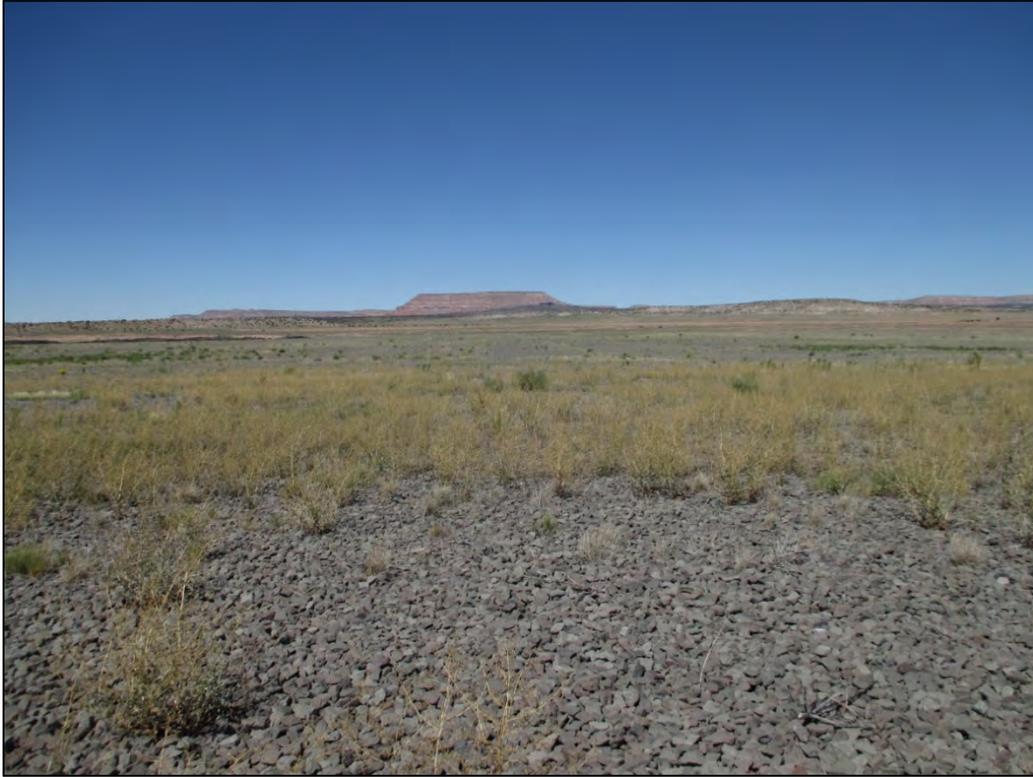
Plant encroachment (by annual weeds, perennial grasses and forbs, and scattered perennial shrubs) continues on the main tailings disposal cell top and side slopes (PL-5, PL-6). Siberian elm saplings on the top slope are managed to prevent the establishment of trees that could damage the main tailings disposal cell cover materials; none were observed during the inspection.

*PL-5. Vegetation on Main Tailings Disposal Cell Top Slope*

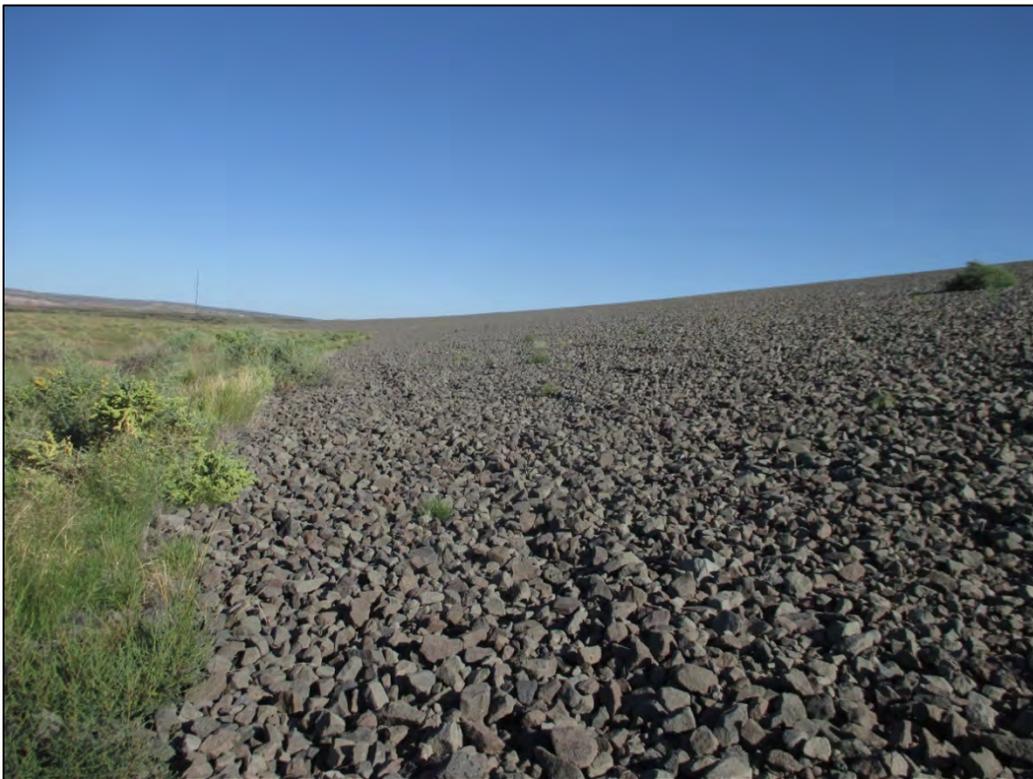
*PL-6. South West Side Slope of the Main Tailings Disposal Cell*

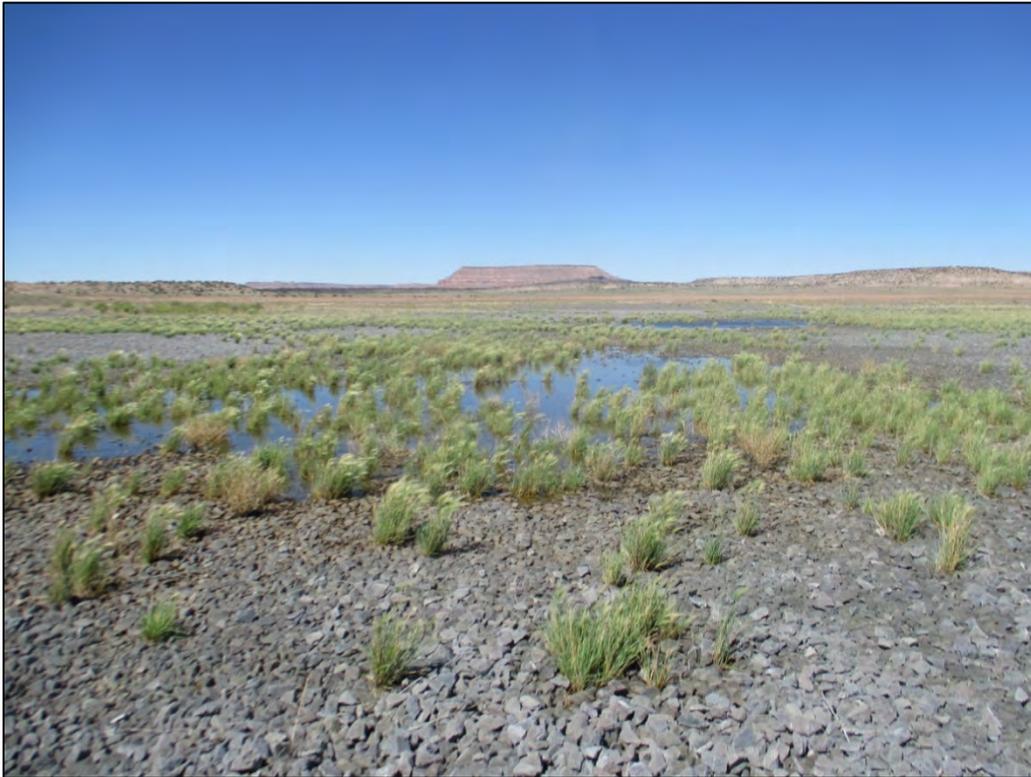
materials if the pond surface reaches an elevation high enough to spill over the north side slope of the disposal cell. Water would start to spill at the lowest point along the north edge of the top slope, and that could initiate erosion at that location. In 2018 LM developed a conceptual design to repair the depressions, regrade the north portion of the top slope, and construct a spillway on the north side slope to ensure positive drainage. In 2019, LM will continue to work on the design and coordinate with NRC regarding its concurrence.

NRC requested that LM evaluate the performance of the radon barrier because of a concern that the ponded water could be degrading the main tailings disposal cell performance (i.e., releasing radon and allowing percolation of water through the cover materials and into the encapsulated tailings). Radon flux measurements were collected in July 2013 on top of the radon barrier in the area of depressions. All radon measurements were below the detection limit, indicating that the radon barrier in that portion of the main tailings disposal cell was performing as designed. Based on the integrity of the radon barrier and the persistence of ponded water, dissipation of the ponded water was determined to be most likely due to evaporation rather than percolation through the cover materials.

*PL-7. Ponded Water on Main Tailings Disposal Cell Top Slope*

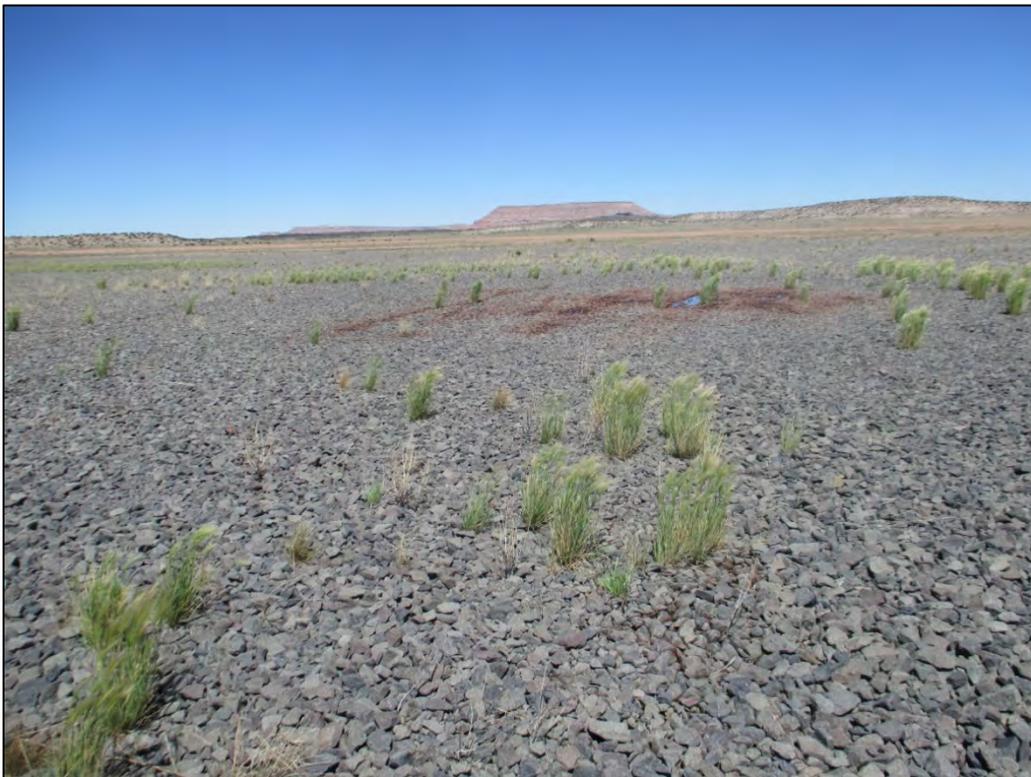
*PL-8. Ponded Water on Main Tailings Disposal Cell Top Slope*

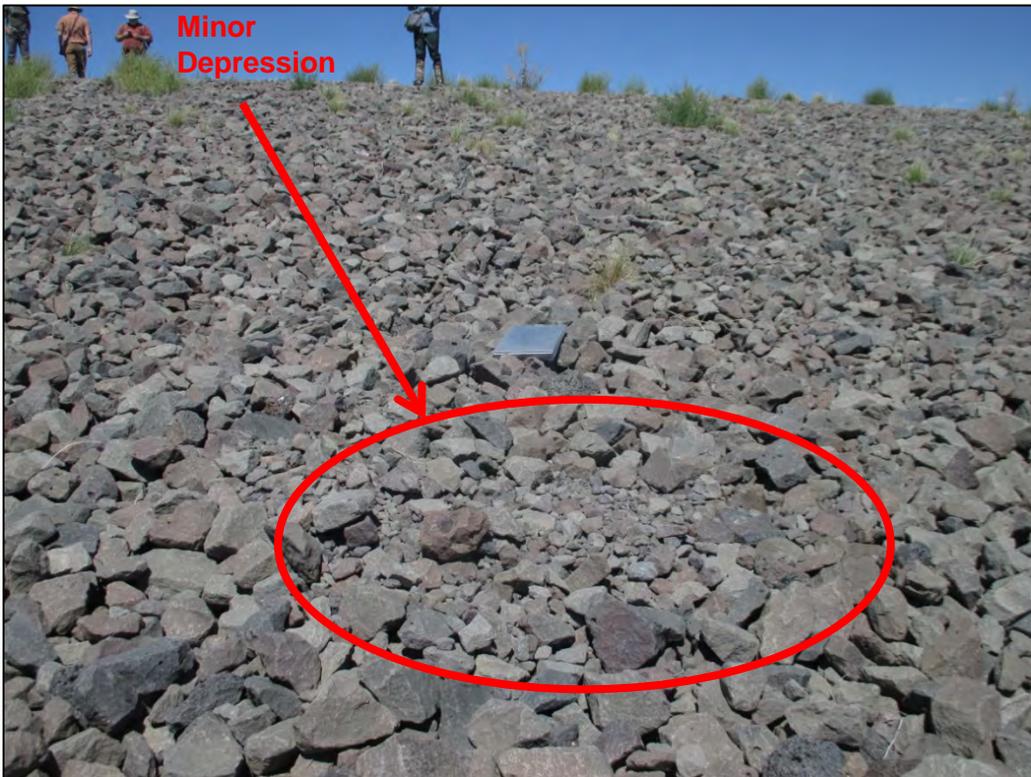
The side slopes and toe of the main tailings disposal cell were inspected for signs of erosion or sediment deposition. An area of minor depression was observed on the southern side slope of the main tailings disposal cell (PL-10). The area was approximately 3 feet wide and 3 inches lower than the surrounding areas. The depression area consisted of smaller sized riprap than that found on the surrounding side slope and is believed to be a construction artifact. This depression will continue to be inspected and will be evaluated using periodic LIDAR survey results. No other

*PL-10. Minor Depression on Main Tailings Disposal Cell South Side Slope*

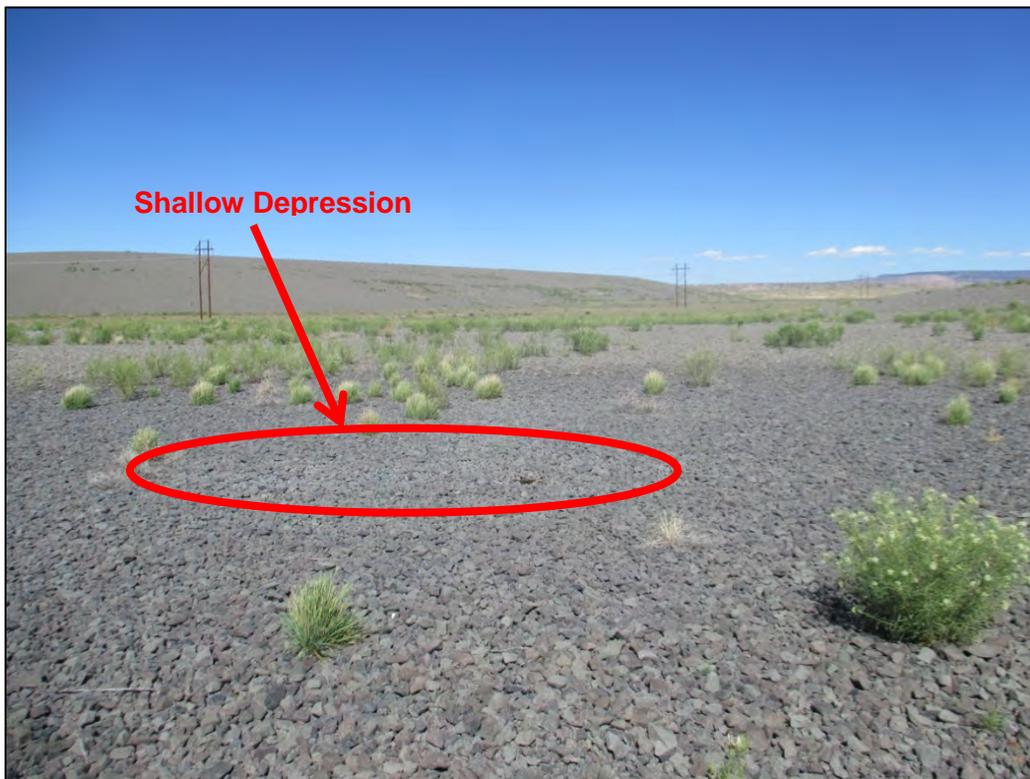
*PL-12. Shallow Depression on Northwest Extension of Carbonate Tailings Cell*

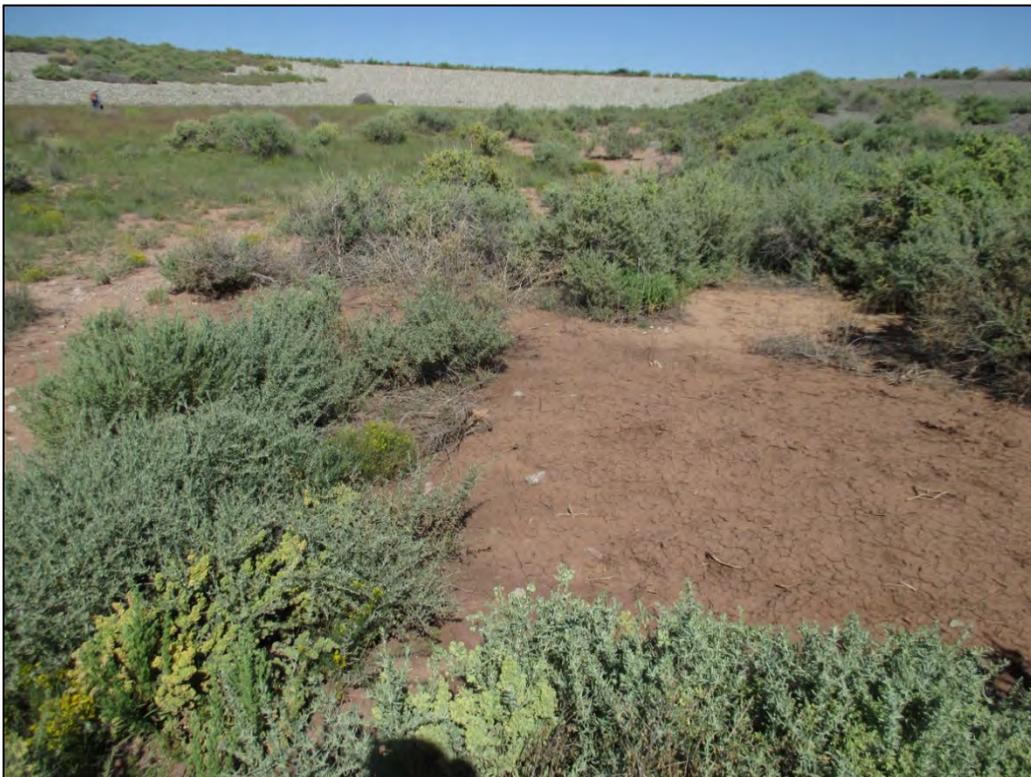
The 2-acre asbestos disposal area is a bowl-like feature just south of the carbonate tailings disposal cell (PL-13). The north, west, and south side slopes of this feature are covered by limestone riprap; the bottom of the bowl (the asbestos cell cover) is grass covered. Several small depressions were identified during the 2017 annual site inspection around the perimeter of the disposal area where relocated clean soil (placed for slope grading) and small-diameter riprap has filtered down through basalt joints and fractures. These depressions were repaired on May 22, 2018, by filling the depressions with either rock or soil, depending upon the surrounding material. These areas were inspected during the 2018 annual site inspection, and no negative impacts were observed (PL-14). No maintenance needs were identified.

*PL-14. Repair of Depression in Asbestos Disposal Cell*

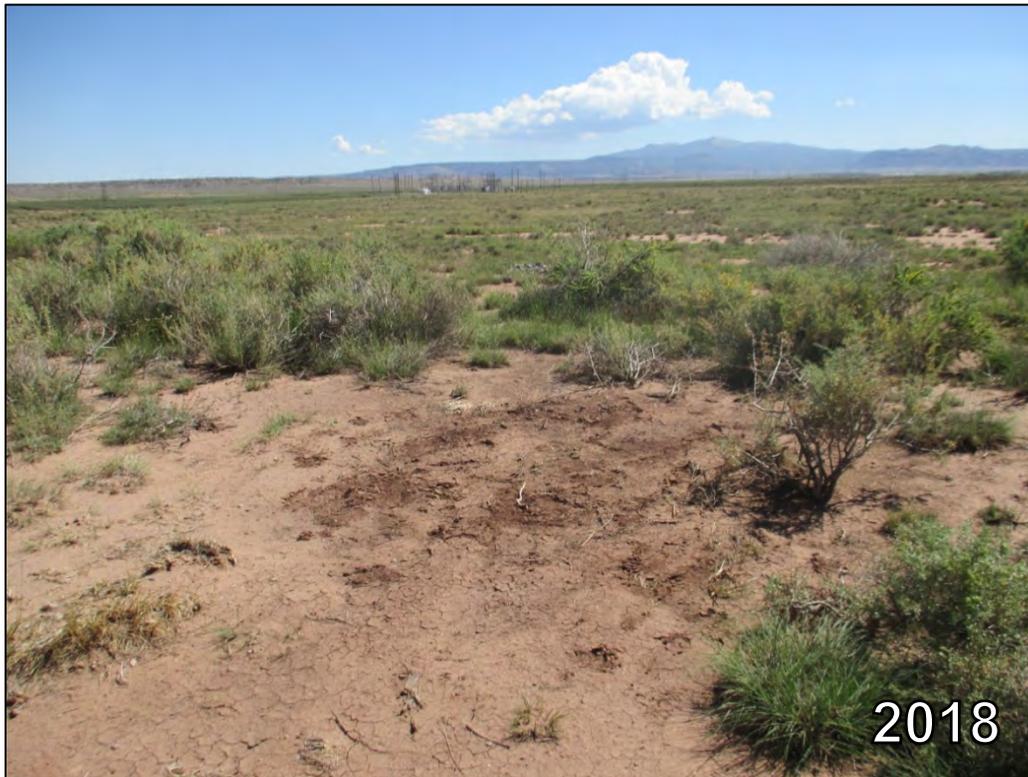
*PL-17. (a) Repaired Settlement on Soil Cover of Disposal Area No. 1–September 12, 2018*

- The perimeter fence was repaired at multiple locations to eliminate gaps, and a new corner post was replaced.
- Scattered tamarisk shrubs and other noxious weeds were treated with herbicide.
- Small depressions near the perimeter of the asbestos disposal area and a small settlement area on Disposal Area No. 1 were repaired.

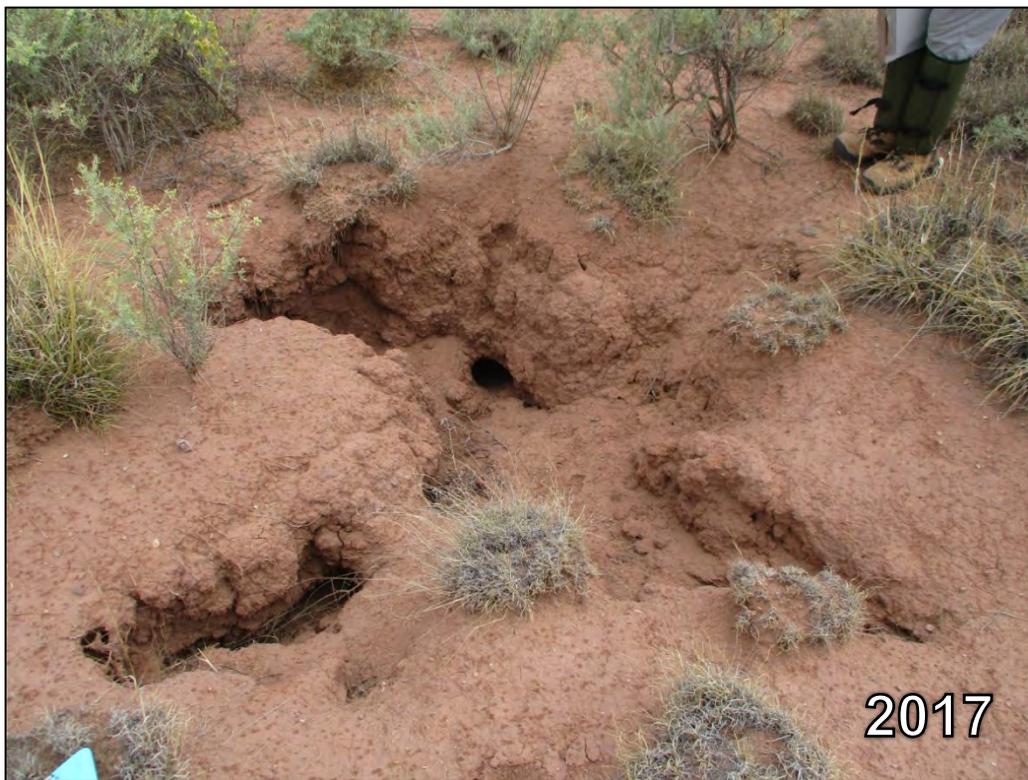
*PL-17. (b) Settlement on Soil Cover of Disposal Area No. 1–2017 (Photo for Comparison)*

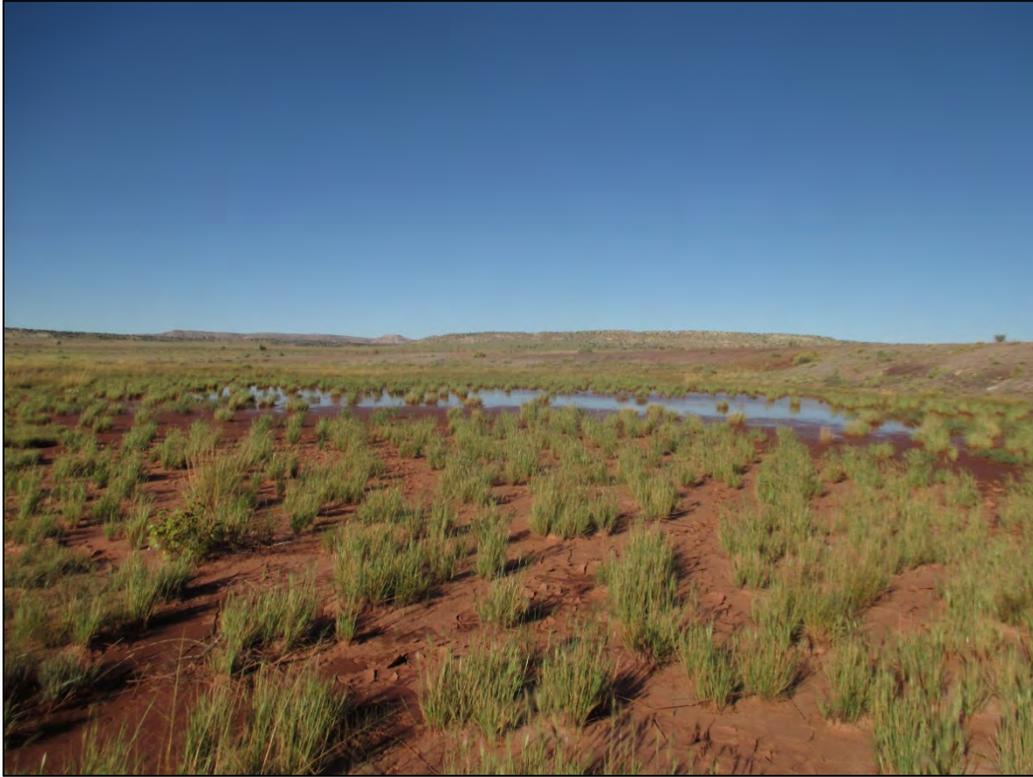
Small ponds often form in an area along the east side of the main tailings disposal cell and in other low spots following storms. The areas of ponding are far enough from the main tailings disposal cell to not impact it. Several ponds were observed in this area during the inspection (PL-18).

*PL-18. Ephemeral Pond*

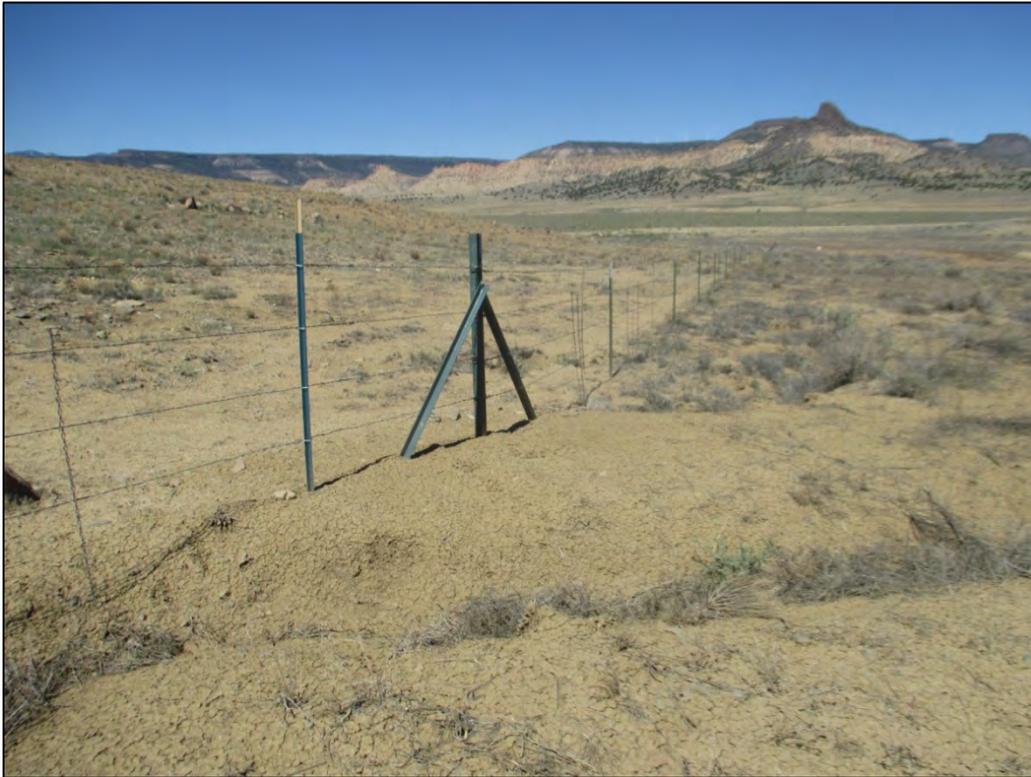
*PL-1. Loose Fence Post Repair South of Perimeter Sign P33*

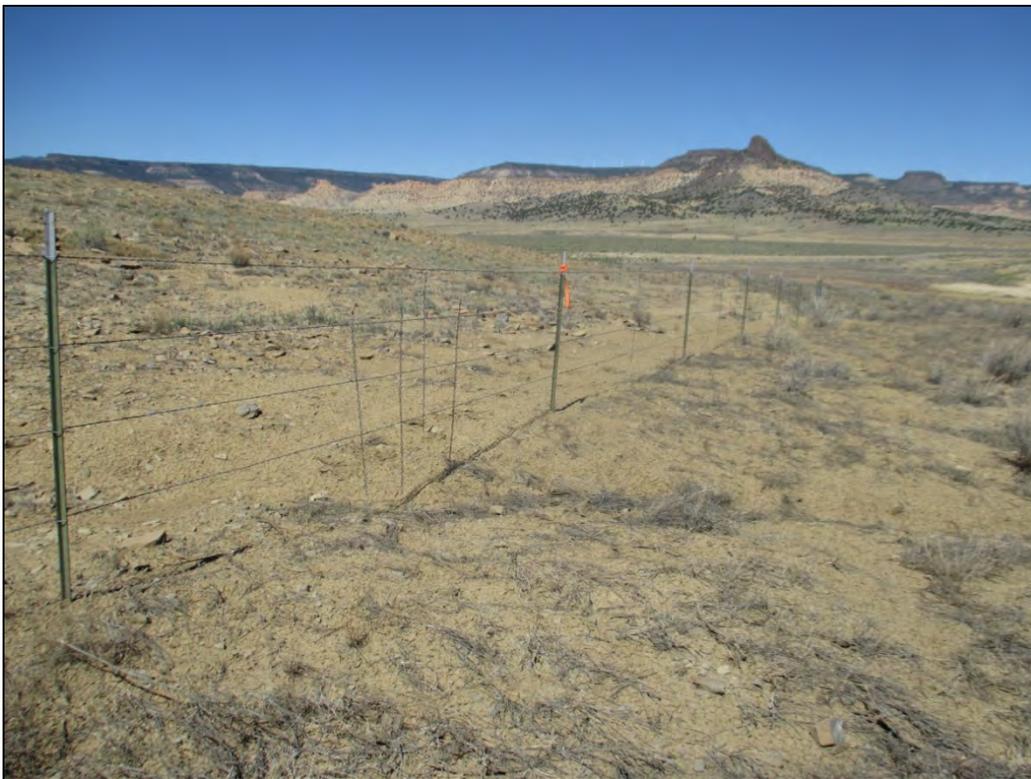
*PL-2. Erosion Under Perimeter Fence and Fence Repair*

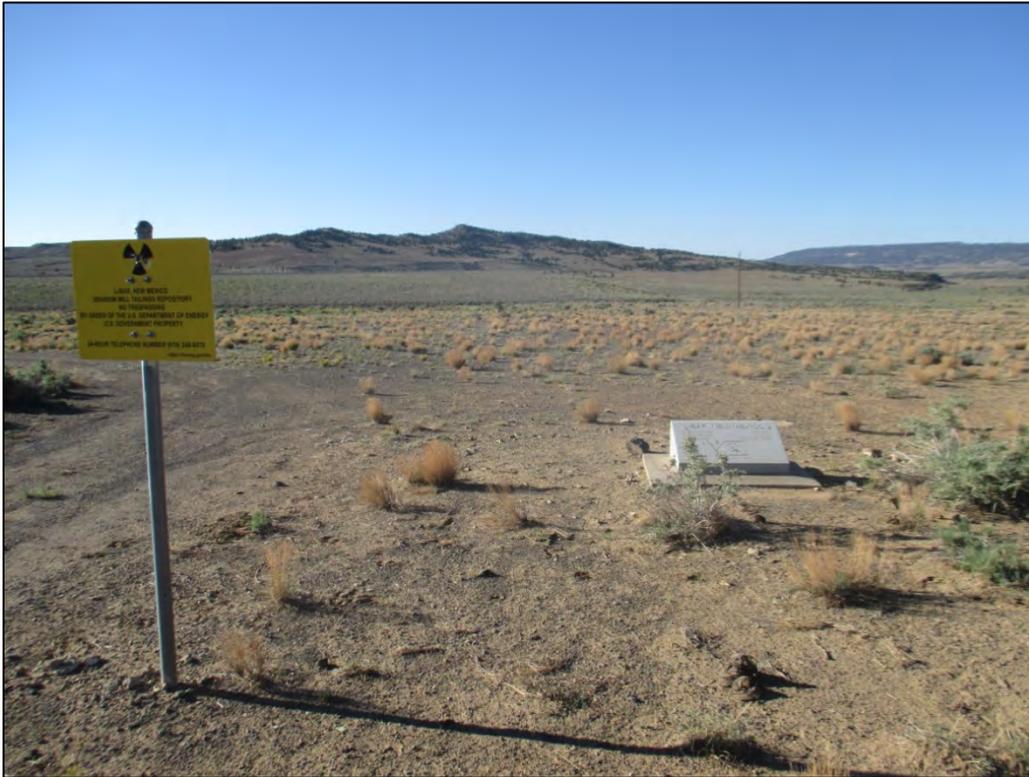
The entrance sign is on the main site access road near the site marker. It has several bullet holes but was legible (PL-3). Thirty-three warning or perimeter signs are attached to the barbed-wire fence that surrounds the disposal site structures and an area of excessive gully erosion in the southeast portion of the site (PL-4). Perimeter sign P1 was replaced during a previous 2018 site visit. No other maintenance needs were identified.

*PL-3. Entrance Sign and Site Marker*

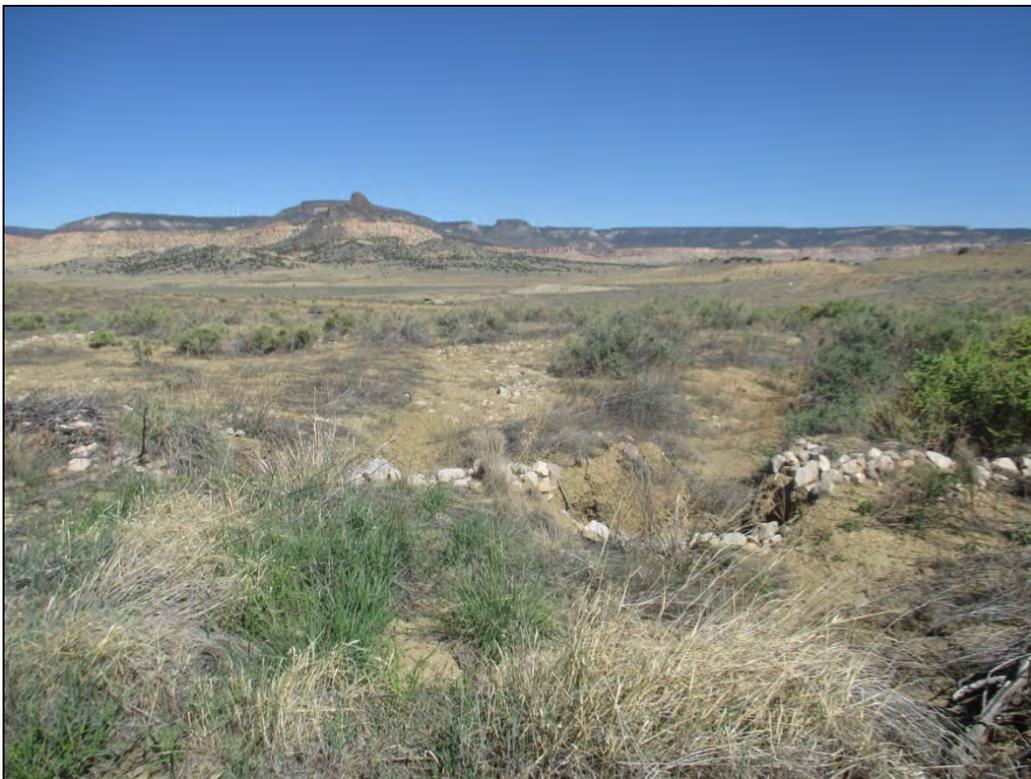
*PL-12. Breach of Runoff Control Structure A Berm*

- **L-Bar, New Mexico:** In 2018 LM developed conceptual designs to repair damaged erosion control structures that LM had installed in 2009. In 2019, LM will continue to work on the designs and coordinate with NRC, as needed, regarding its concurrence.

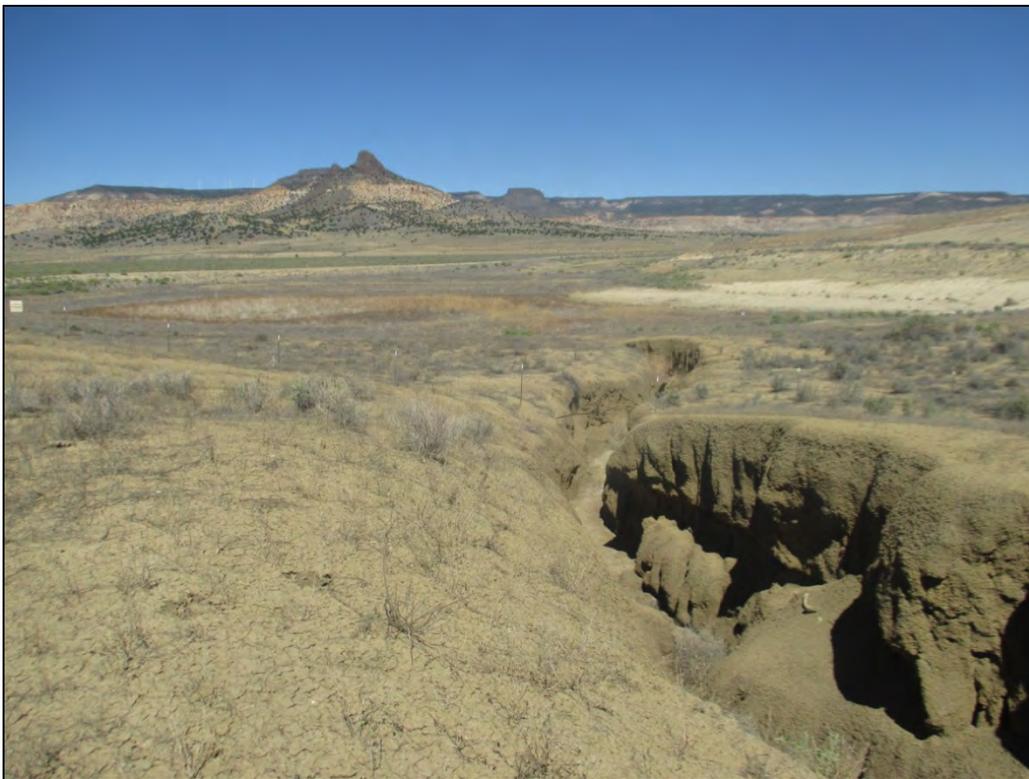
*PL-14. Gully Upgradient of Sediment Trap*

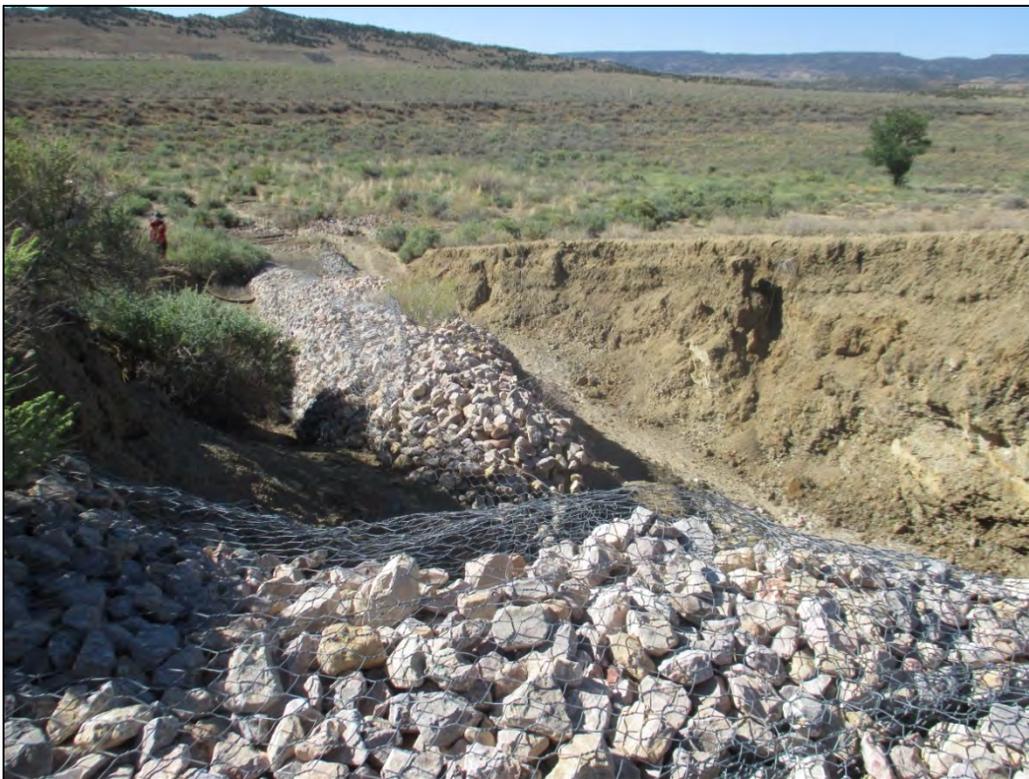
*PL-16. Damaged Runoff Control Structure G*

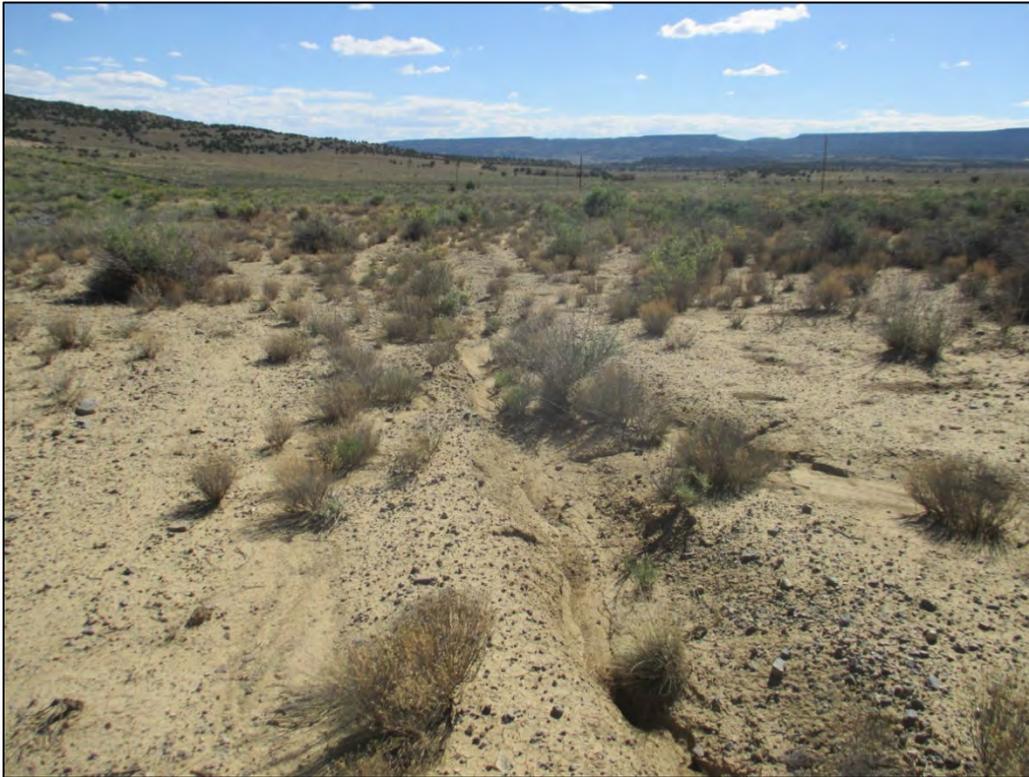
*PL-17. Erosion East of Riprap Cutoff Wall at Outlet of North Channel*

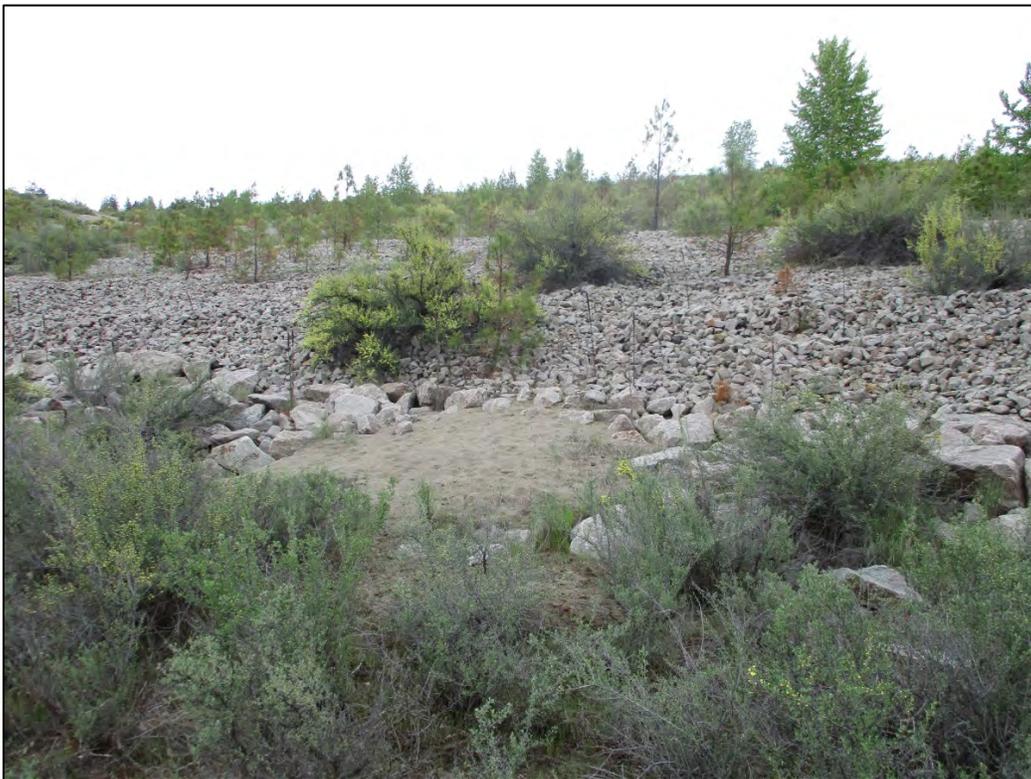
*PL-8. Sand Washout Watch Area at Base of Outslope*
