U.S. DEPARTMENT OF  
**ENERGY**

Legacy  
Management

# 2019 Annual Site Inspection and Monitoring Report for Uranium Mill Tailings Radiation Control Act Title II Disposal Sites

December 2019

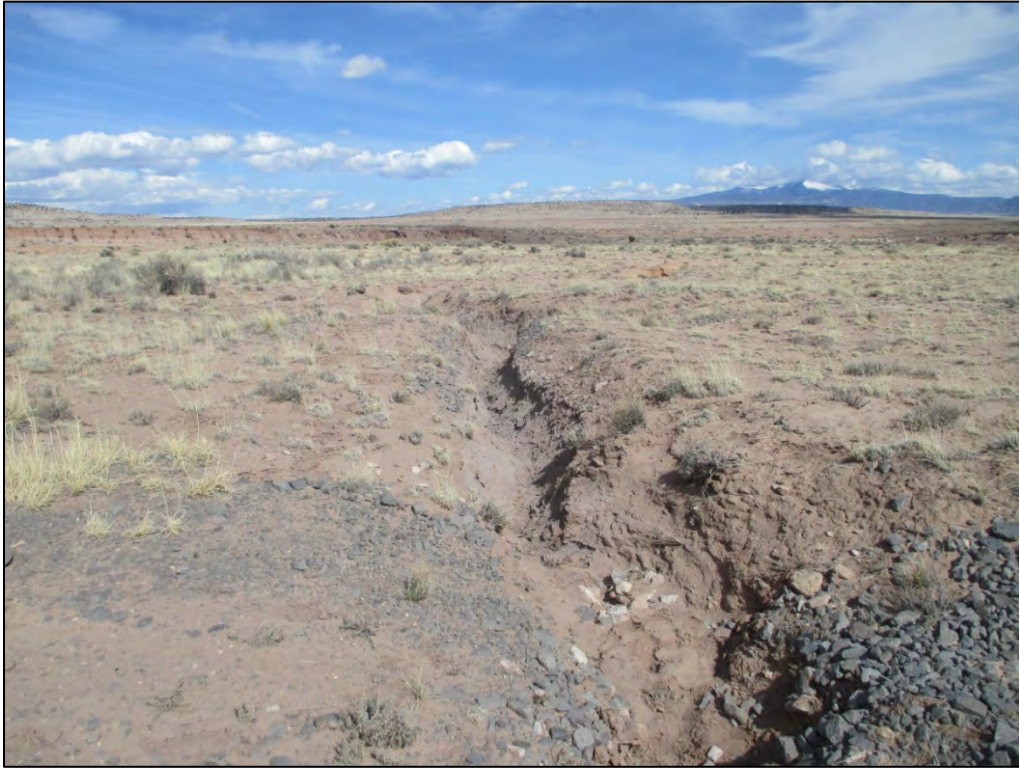
Interior roads used to access LM assets consist of a dirt track covered at places with crushed basalt. The roads are susceptible to erosion and are repaired when they become impassable. Increased erosion continued to be observed on a road northwest of the main tailings disposal cell (PL-1 and PL-2). A gully intersecting the road at this location required maintenance in the past. Riprap previously was added to repair this section of the road; other repair options were evaluated in 2019. LM is proposing to repair the road in 2020 and to construct two armored low-level crossings to protect against future erosion. No other maintenance needs were identified.

*PL-1. Erosion of the Site Perimeter Road (South Area)*

Inspectors also identified the need to repair erosion along the interior road. This work is currently proposed for 2020.

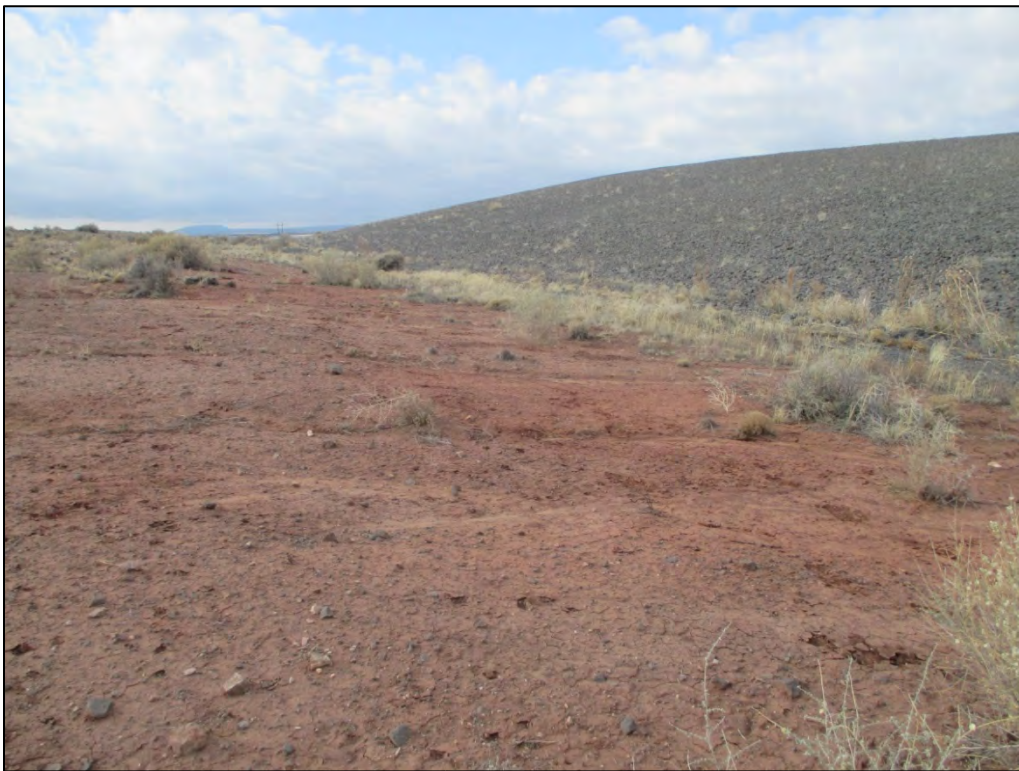
*PL-10. Rills at the Base of the Main Tailings Disposal Cell East Side Slope*

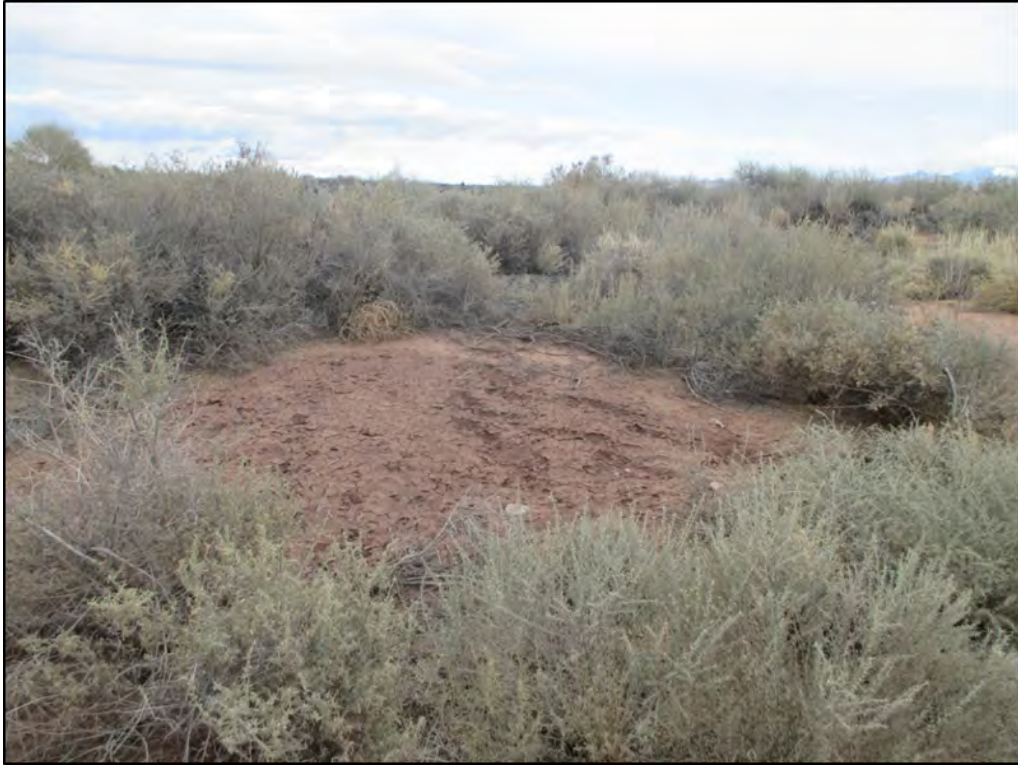
The 2-acre asbestos disposal area is a bowl-like feature just south of the carbonate tailings disposal cell. The north, west, and south side slopes of this feature are covered by limestone riprap; the bottom of the bowl (the asbestos cell cover) is grass-covered. The depressions repaired in May 2018 were observed, and no negative impacts were apparent (PL-13). An additional depression was identified on the north side slope (PL-14). The depression was approximately 6 inches deep and 3 × 6 feet in area. LM will continue to observe the depression and make repairs as necessary. No immediate maintenance needs were identified.

*PL-13. Area of Depression Repaired in the Asbestos Disposal Area*

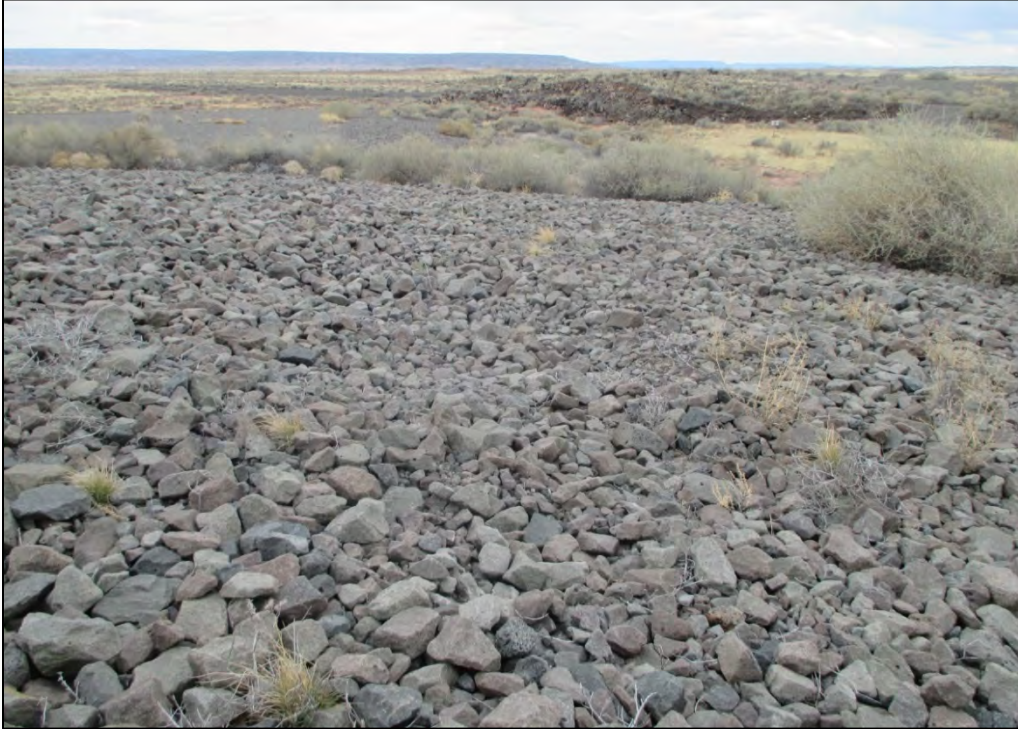
*PL-14. Minor Depression on the Asbestos Disposal Area North Side Slope*

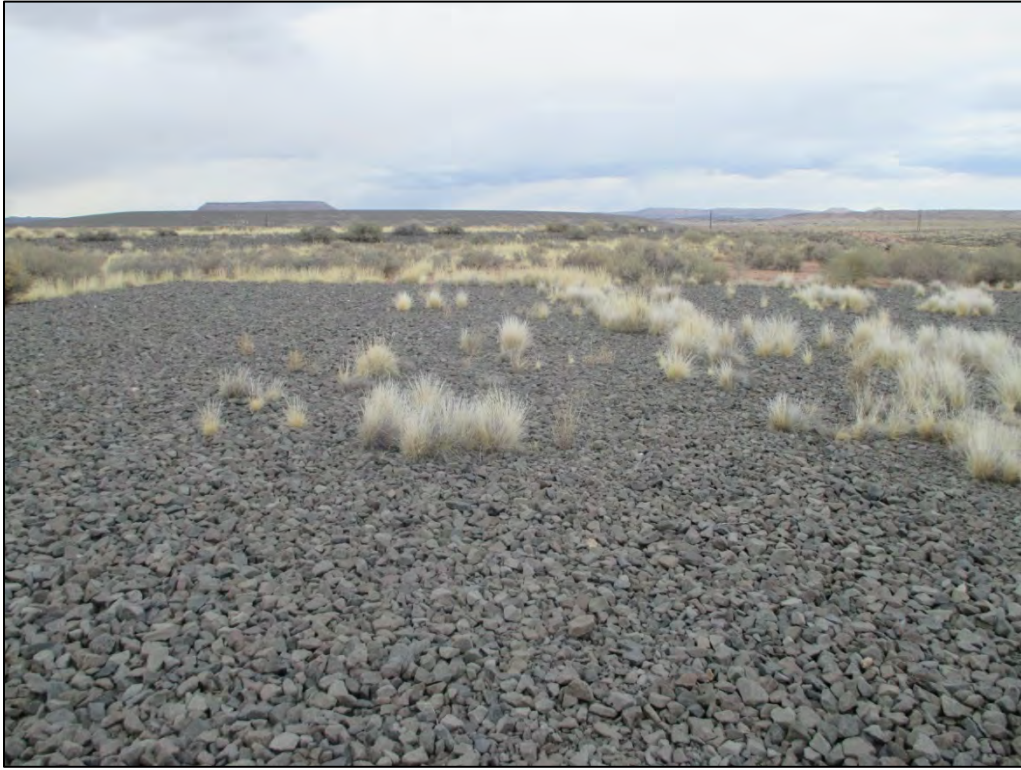
There is an 11-acre grass-covered disposal area south of the asbestos disposal area. A small riprap-covered PCB cell (less than 1 acre) is within the disposal area (PL-15). Two grass-covered dumps, totaling about 2 acres, are east of the carbonate tailings disposal cell (PL-16). Fill material had settled into the basalt in an area at the southern interface of the east dump (PL-17). LM will continue to observe the settlement and make repairs as necessary. No immediate maintenance needs were identified.

*PL-15. PCB Disposal Area*

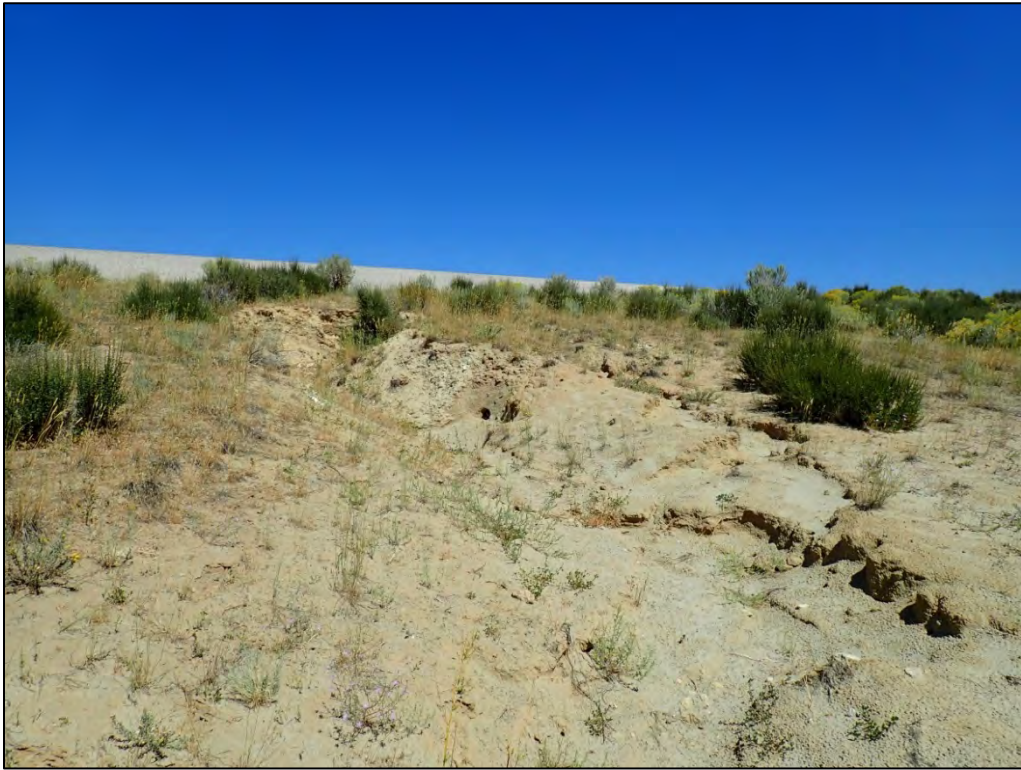
*PL-19. Erosion West of Diversion Channel No. 2*

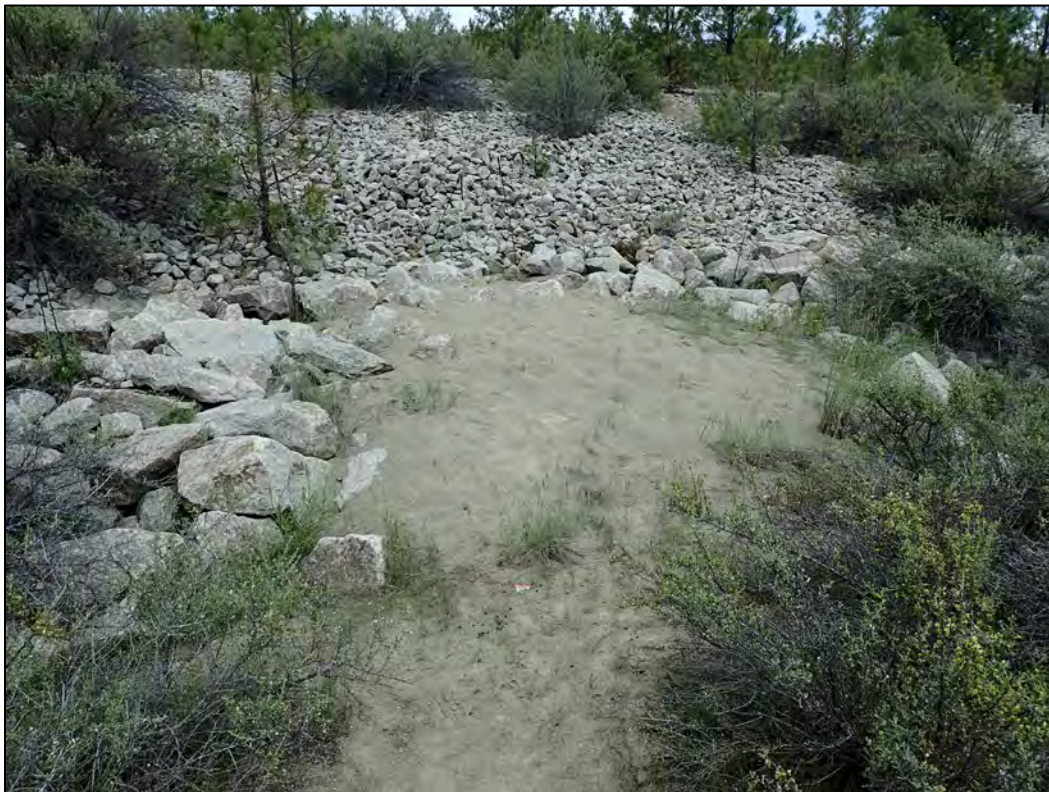
*PL-8. Sand Deposit at Toe of Containment Dam Outslope*

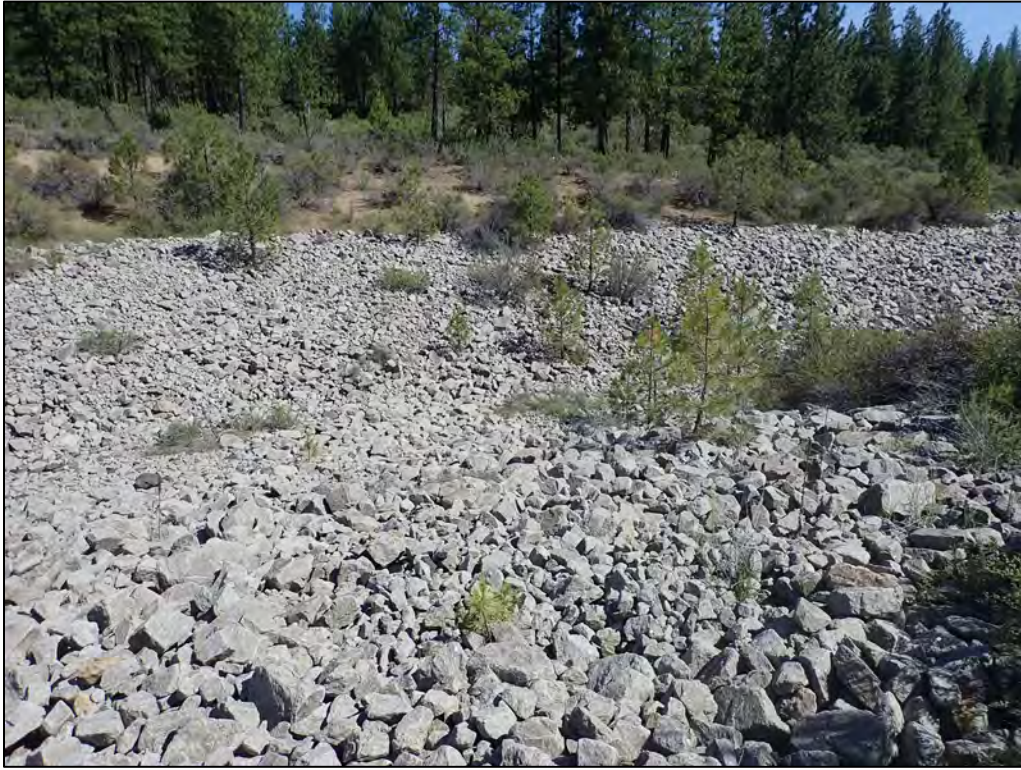
*PL-9. Vegetation in Diversion Channel*

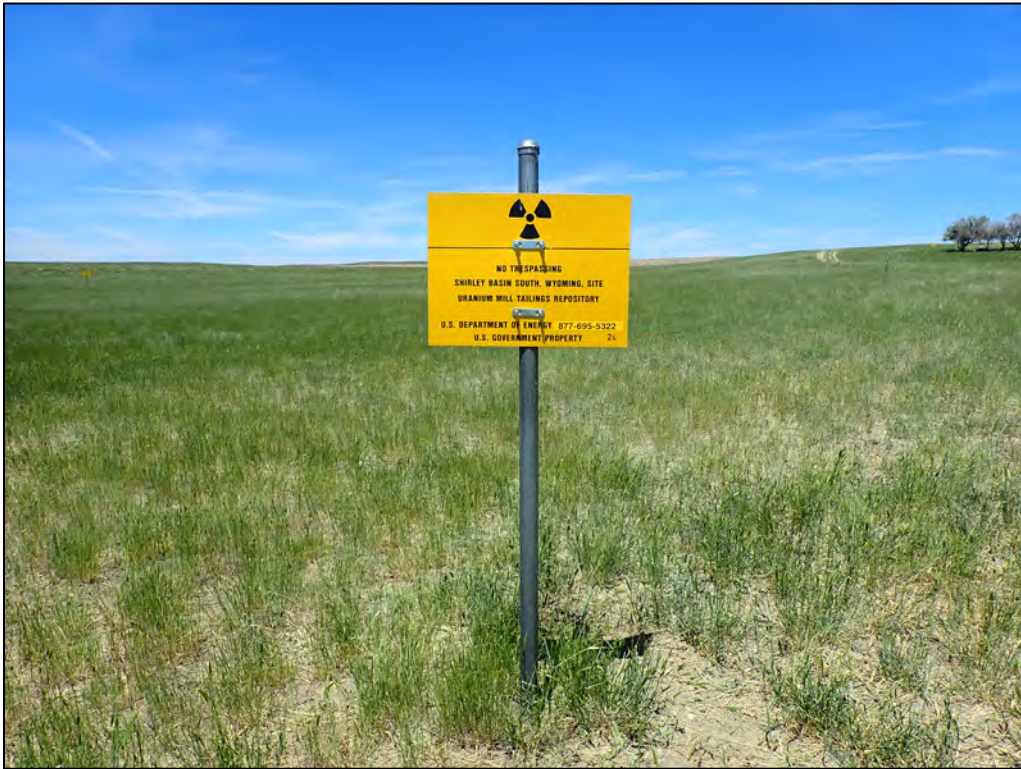
*PL-2. Perimeter Sign P26 (Entrance Sign, Replaced)*

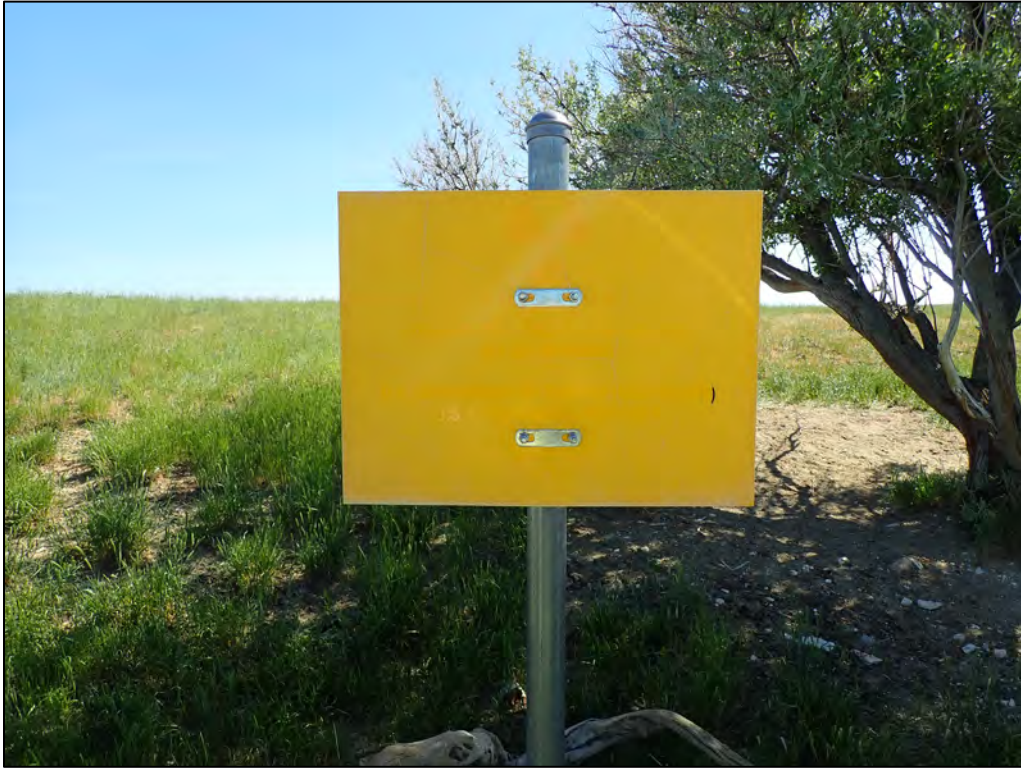
*PL-3. Perimeter Sign P3 (Illegible, Replaced)*

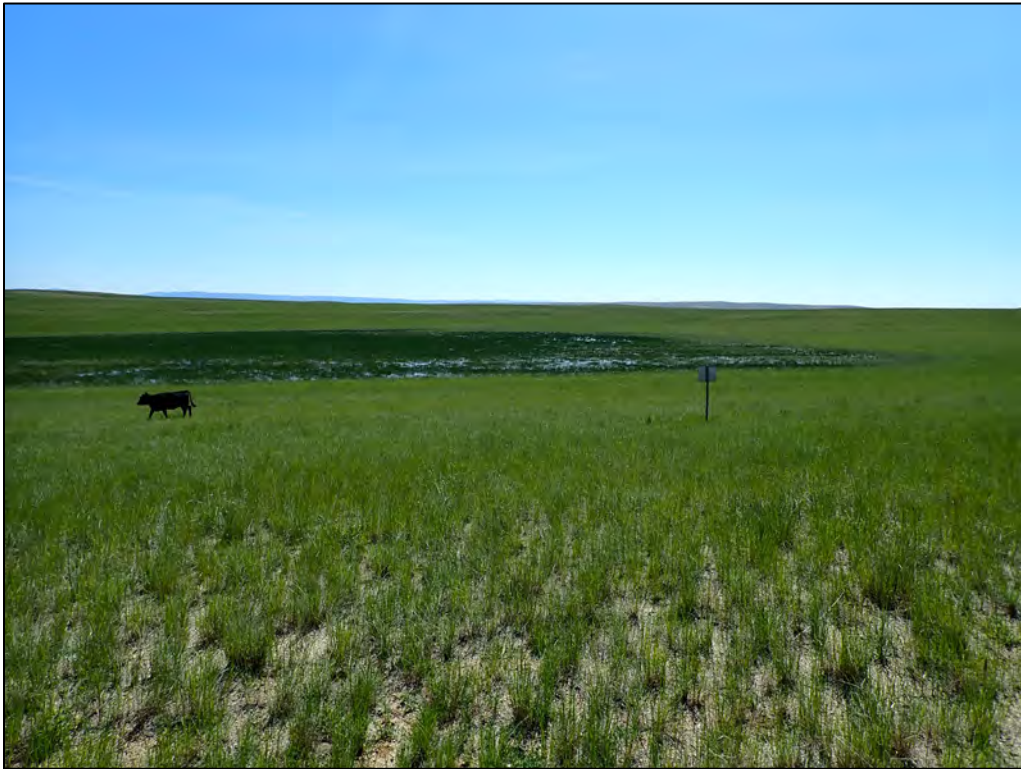
*PL-14. East Drainage Basin (Standing Water)*
