U.S. DEPARTMENT OF
ENERGY

Legacy
Management

2019 Annual Site Inspection and Monitoring Report for Uranium Mill Tailings Radiation Control Act Title I Disposal Sites

March 2020

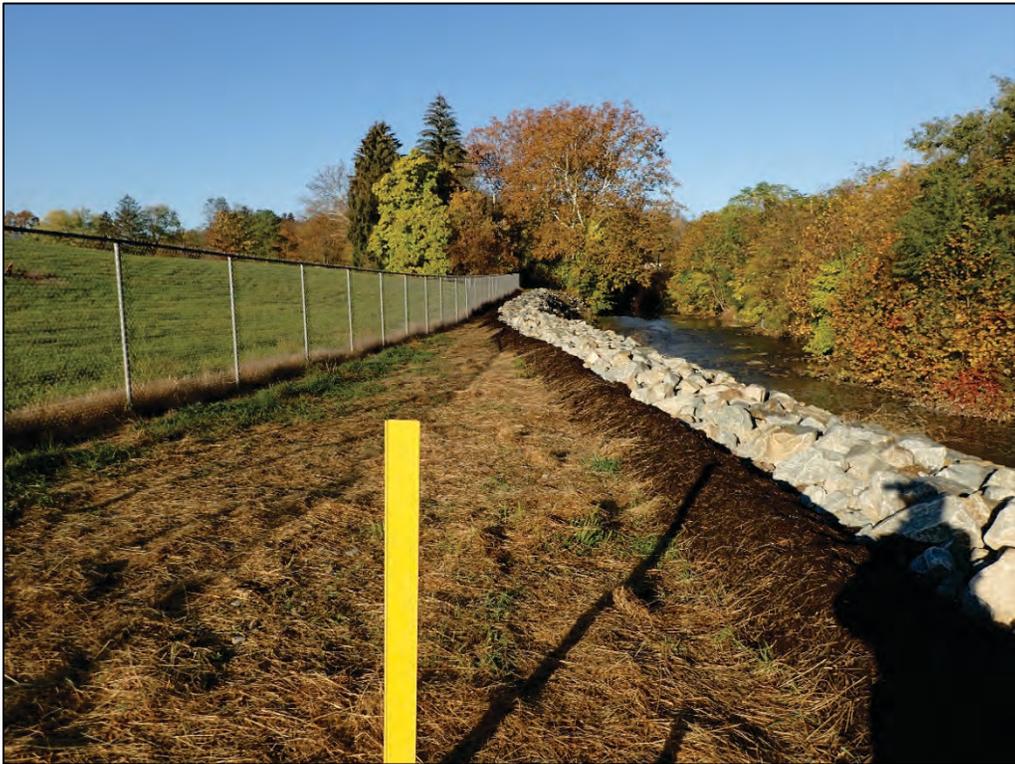
PL-5. Newly Repaired Riprap Embankment

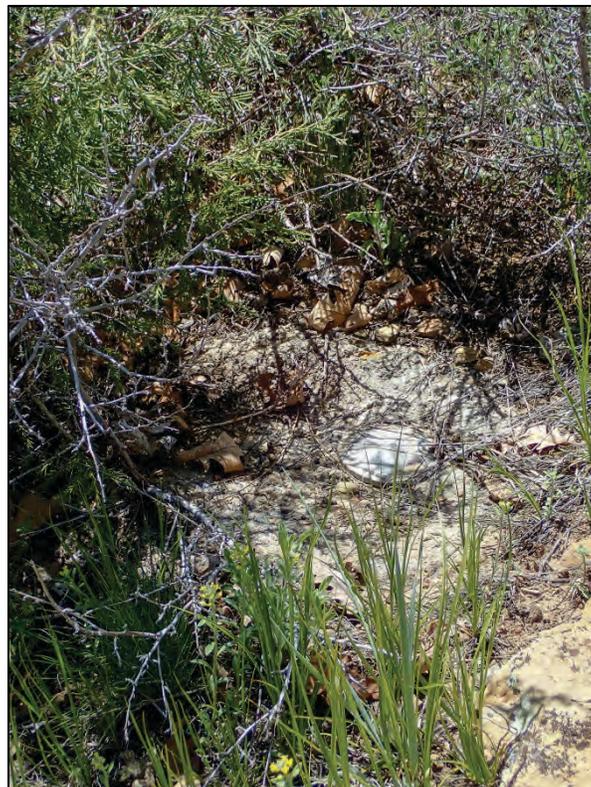
PL-3. 2018 Repairs to Base of Site Marker SMK-2

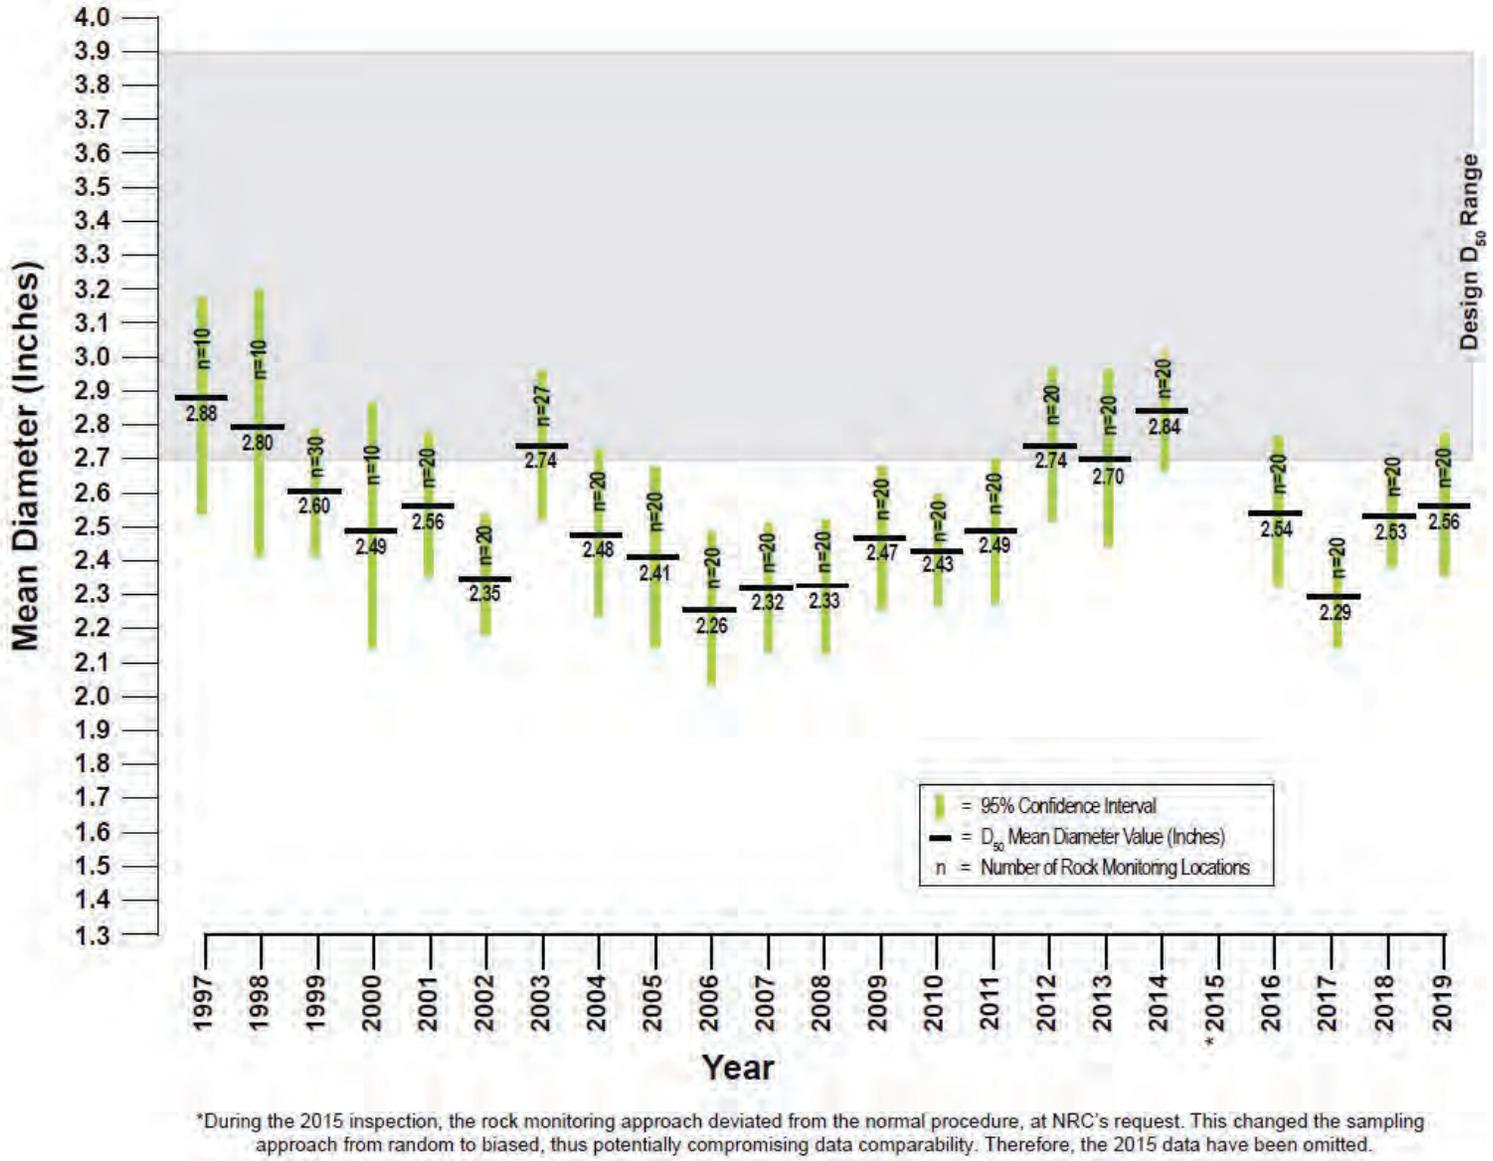
Figure 9-2. Riprap Gradation Monitoring D_{50} Values (1997–2019)

Minor rock degradation has been observed in the EDA (PL-11) since monitoring began at the original 10 photograph locations established in 1997 and at the eight additional locations established in 2000. Annual photographic monitoring of the 18 locations for long-term rock monitoring was conducted during the 2019 inspection. In 2018, it was observed that some of the numbered rocks had faded labels, and they were repainted before the 2019 annual inspection. Location 15 was missed and will be repainted next year. The rock at photo monitoring location 5 is shown in PL-12. No significant degradation of the EDA rock has been observed since monitoring began.

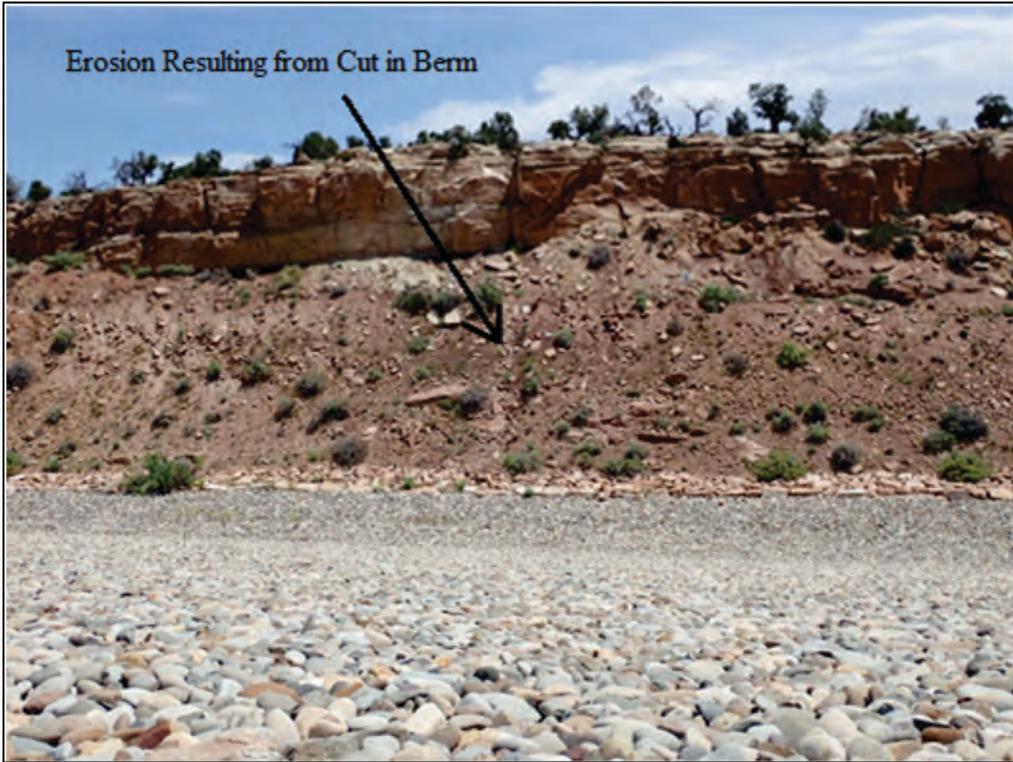
PL-12. Berm Cut off County Road EE22 (Repaired Following Inspection)

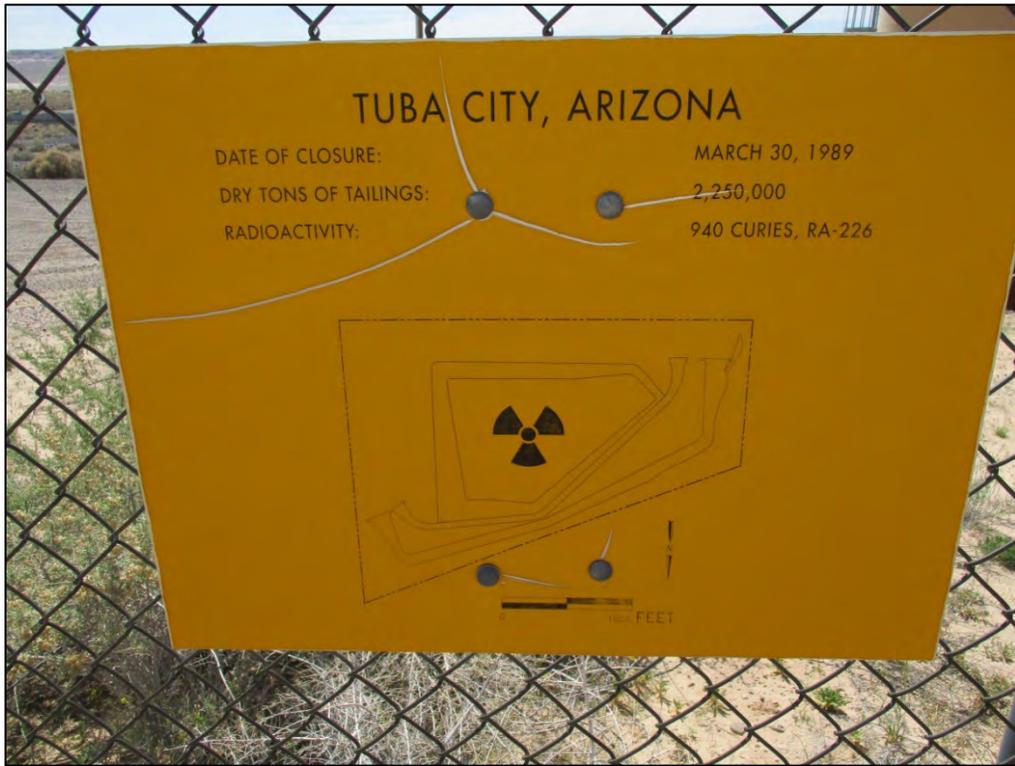
PL-2. Entrance Sign on Post at Entrance Gate (Replaced Following Inspection)

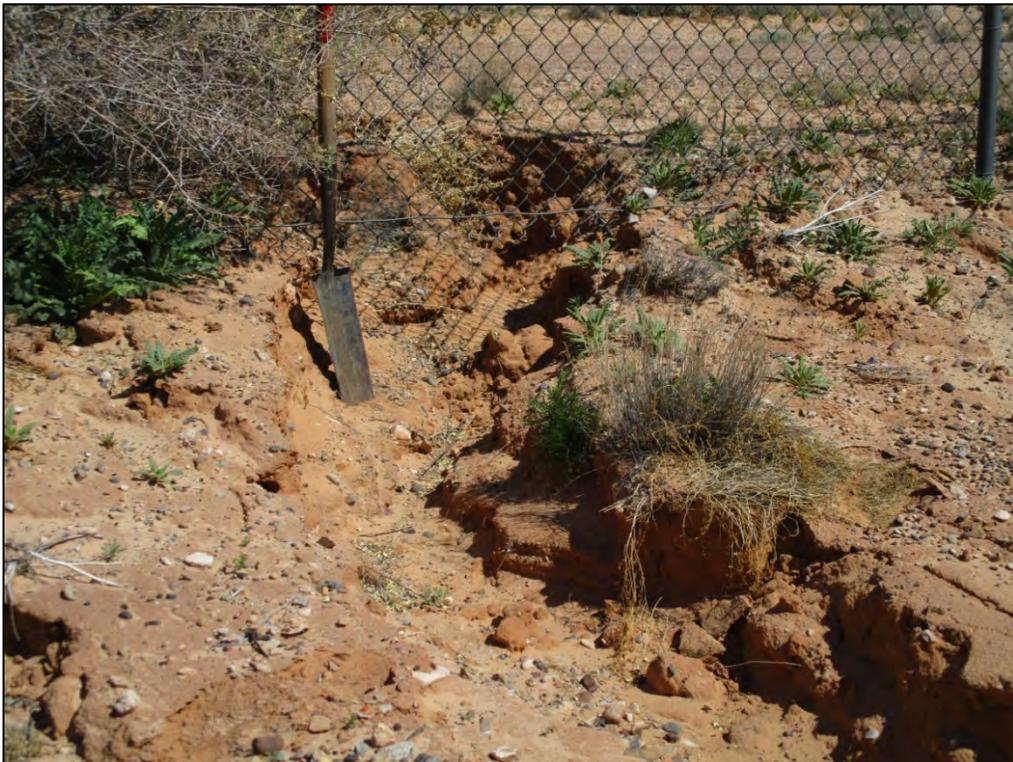
PL-5. Animal Burrow Under Perimeter Fence (Repaired Following Inspection)

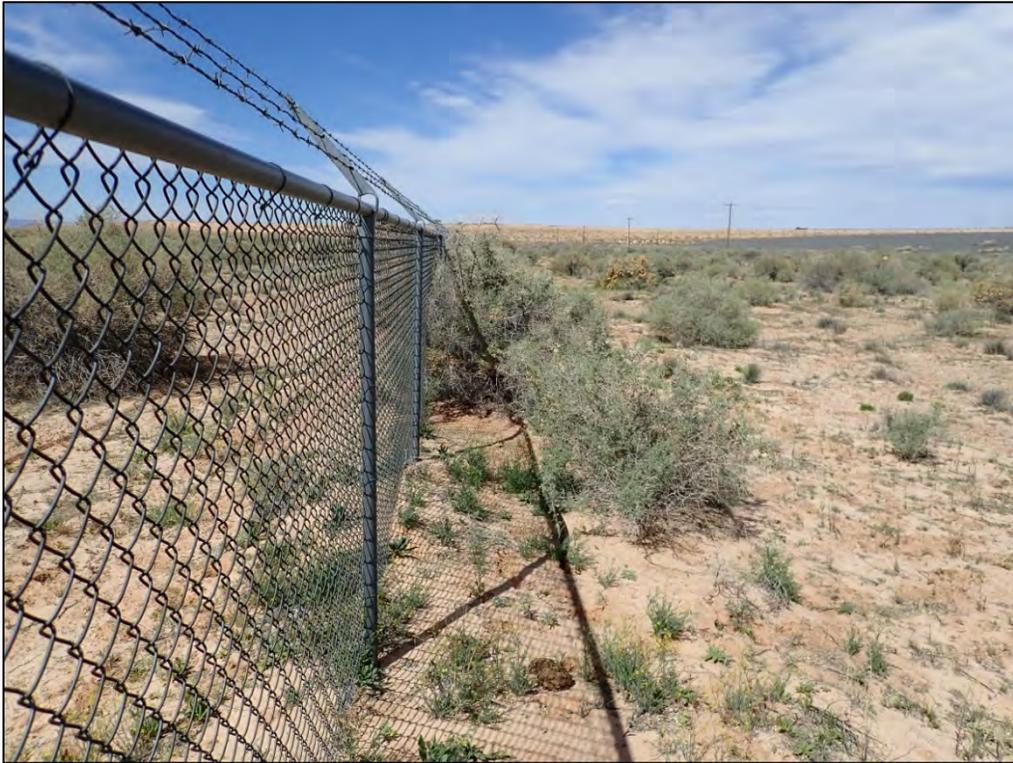
PL-6. Soil Erosion Under Perimeter Fence Between Perimeter Signs P27 and P28 (Repaired Following Inspection)

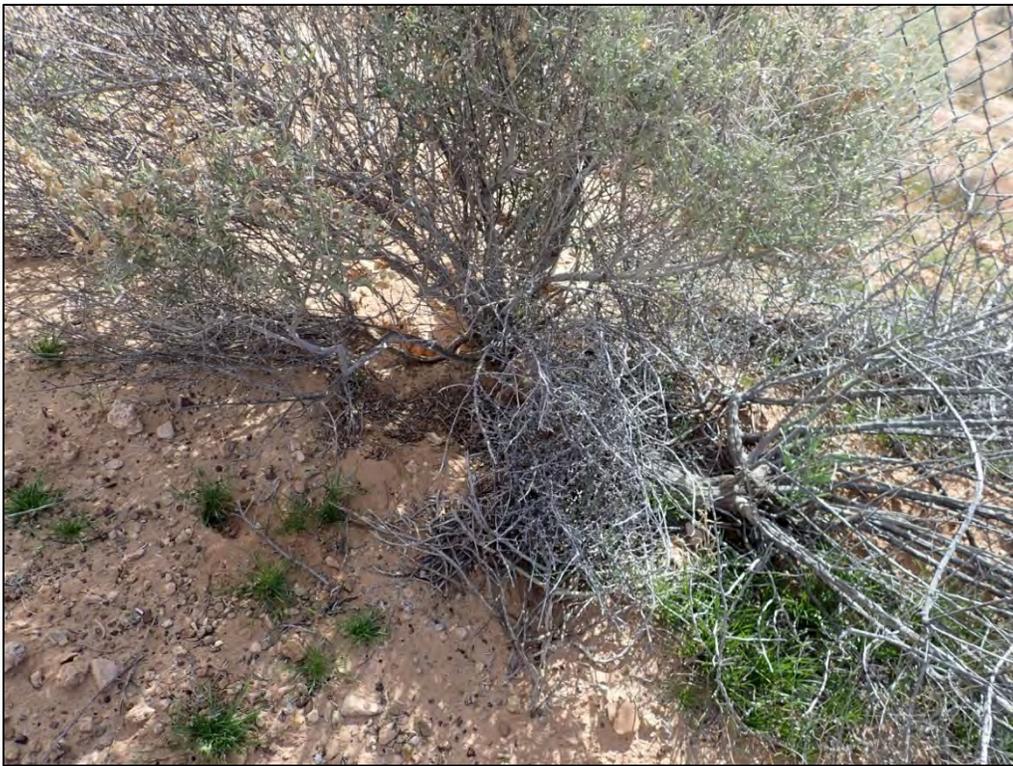
PL-7. Dense Shrub Growth on Perimeter Fence (Removed Following Inspection)

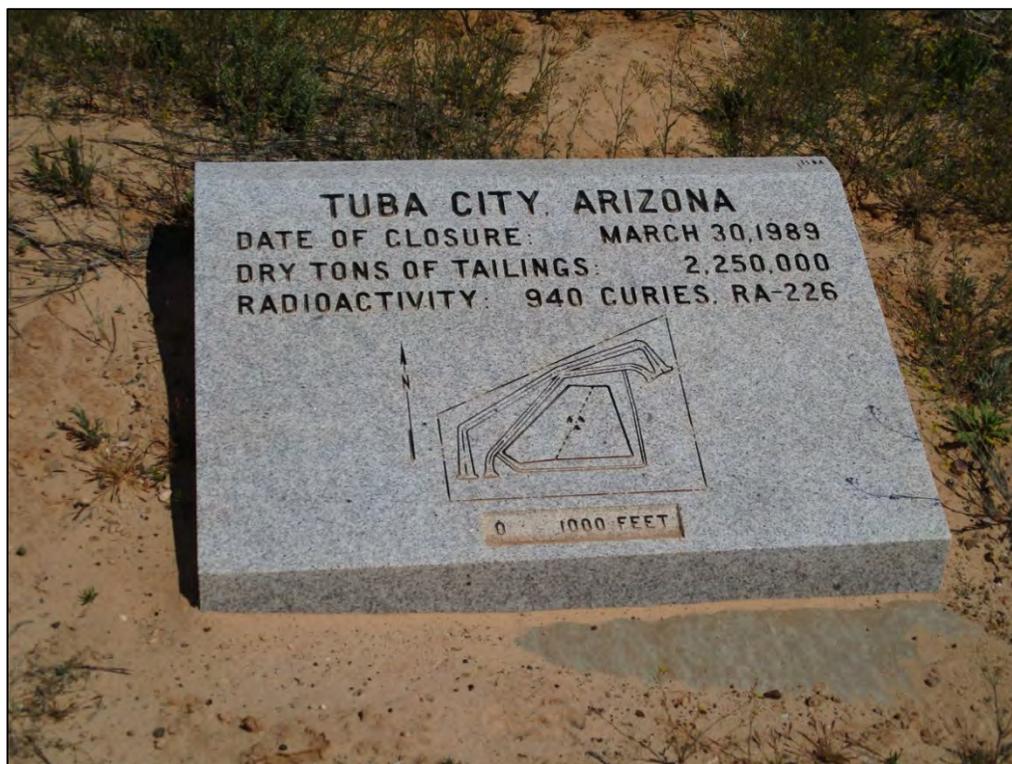
PL-9. Perimeter Sign P24; Pictorial Sign Faded (Replaced Following Inspection)

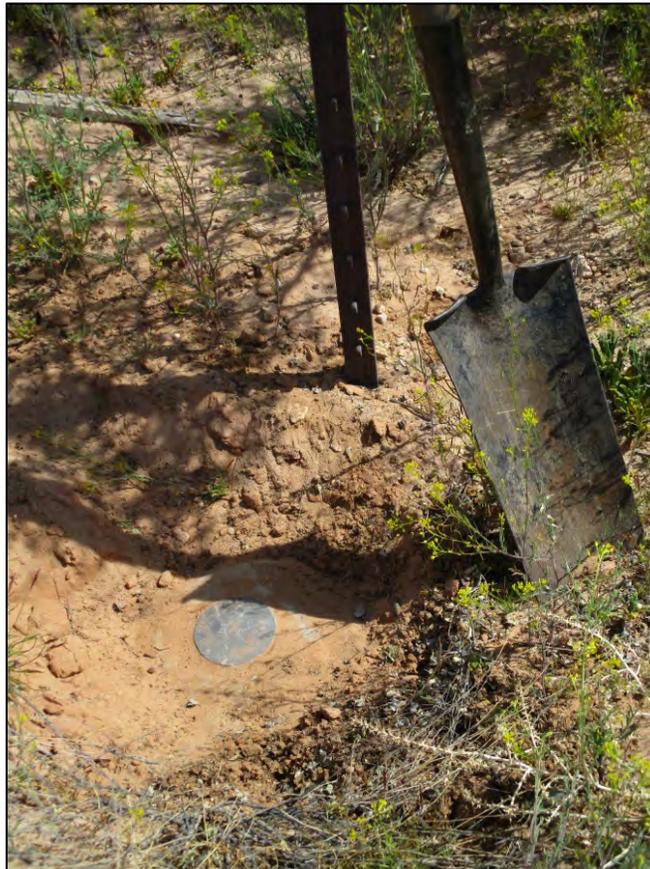
*PL-11. Survey and Boundary Monument SM/BM-1 Buried in Sand
(Found Following Inspection and Permanent T-Post Installed)*
