Inspection Report

Protective Force Property Management
at Lawrence Livermore National
Laboratory

DOE/IG-0742

October 2006

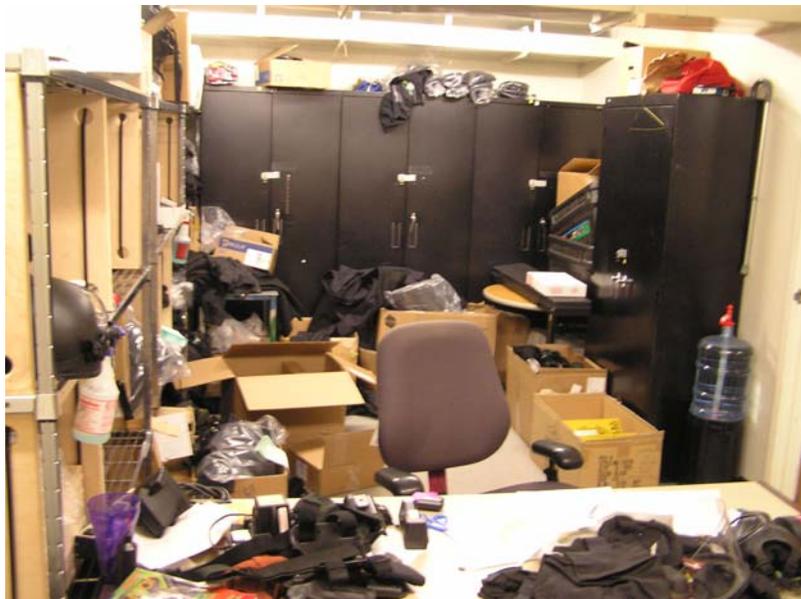
Picture 1 (Livermore)

We conducted an unannounced visit to the LLNL protective force supply room and found the supply room to be in the disorganized condition shown in Picture 1. We learned that the LLNL supply room contained many items of equipment that were: (1) pending issuance to officers; (2) returned from departing SPOs; (3) damaged and needing repair or pending replacement; or (4) obsolete.

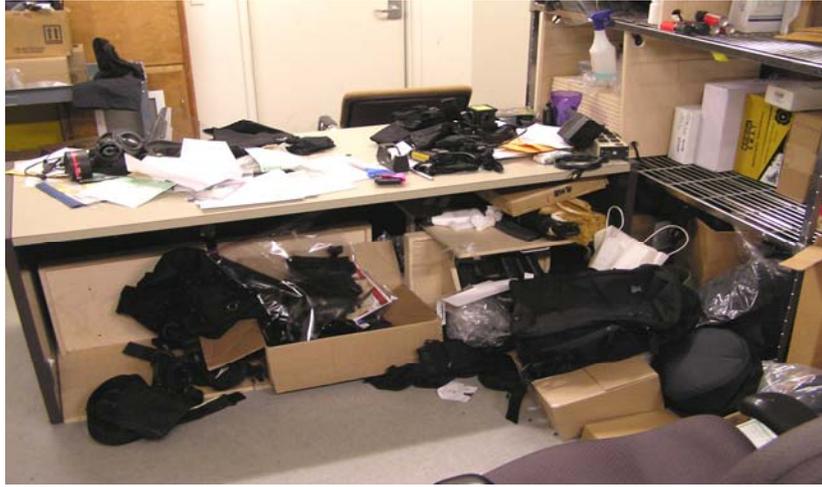
Picture 2 (Livermore)

We observed that there were many items of equipment scattered around the supply room (see Picture 2). This included items that are normally issued via other entities, not the supply room, such as a gas mask, a rifle barrel, and night vision goggles and a scope. We inquired about the source and status of these items. We were told that some items had been left by unknown persons, that others

probably required repair, and that it was unknown what the disposition of the items would be.

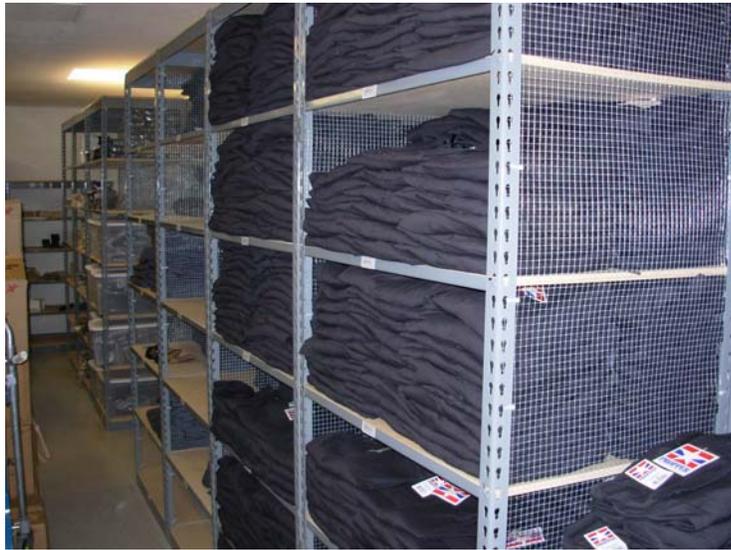
Picture 3 (Los Alamos)

We determined that, in contrast to the approximately 14 people who had access to LLNL's protective force supply room, both Los Alamos and Sandia limited access to their supply rooms to a cadre of trained personnel authorized to distribute equipment for the protective force. Further, these two sites had established systems to separate and organize equipment for easy accountability, accessibility, and distribution (see Pictures 3 and 4); required written documentation for all orders to be processed; and maintained an individual file for each SPO, with either the SPO's initials or signature required for all uniform and equipment transactions. The sites also maintained a computer database to assist in accounting for on-hand and issued equipment. Their procedures appeared to reduce the opportunity for equipment to become lost or stolen.
