**U.S. Department of Energy
Office of Fossil Energy**

Accident Investigation Report

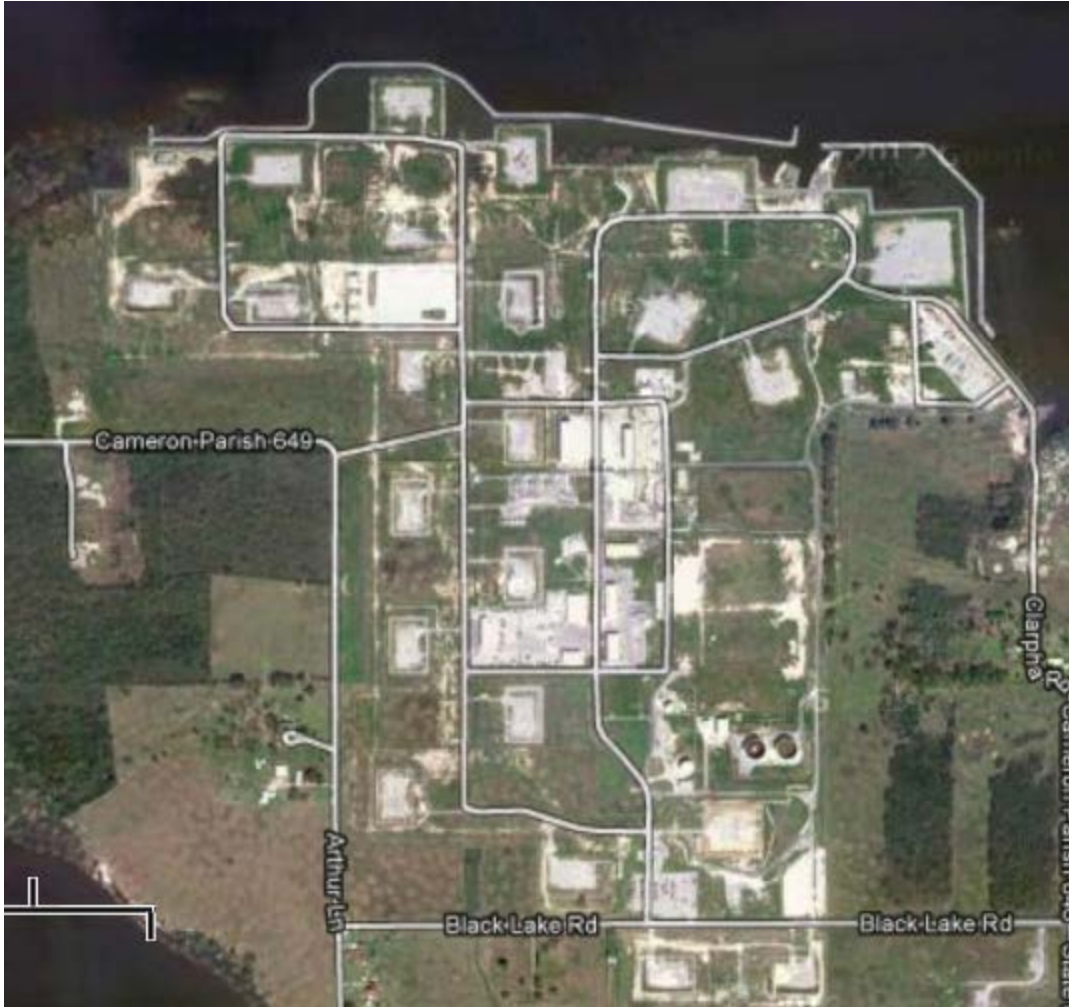
Figure 1: West Hackberry Site, Cameron Parish, Louisiana

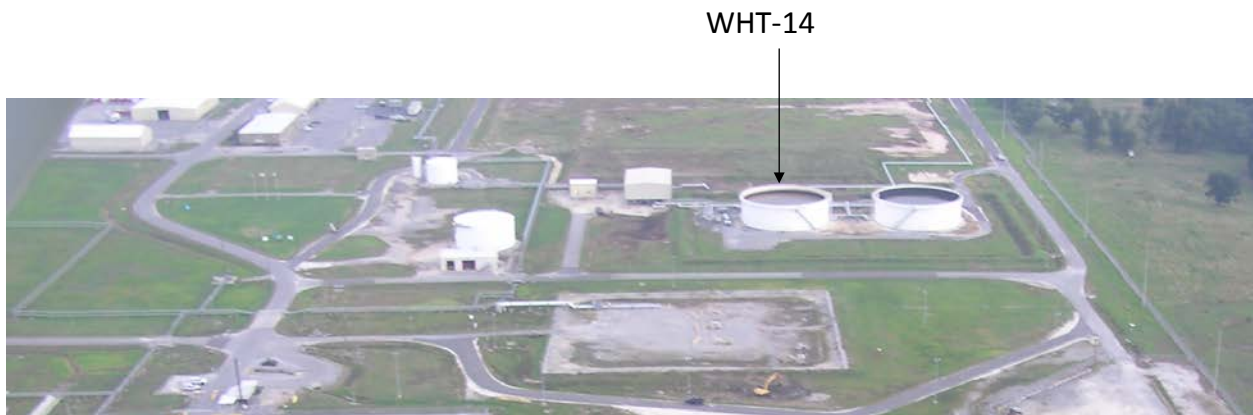
Figure 3: WHT-14 at the SPR West Hackberry Site

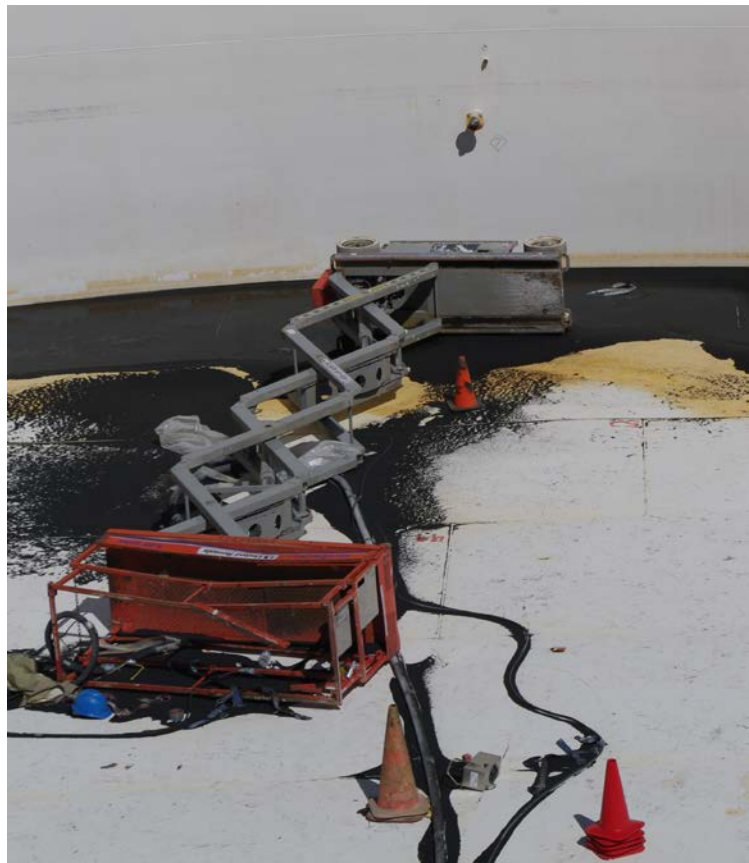
Figure 6: Overturned Scissor Lift in Tank

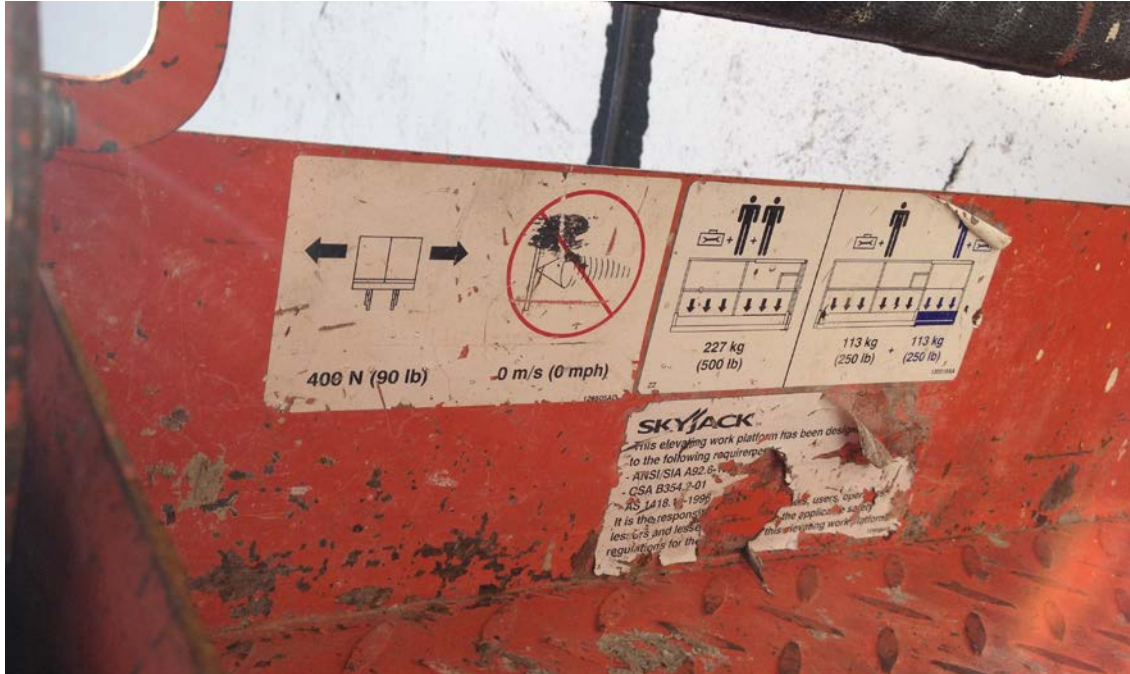
Figure 8: Manufacturer-Applied Label shows 0 wind and 90 lb side force

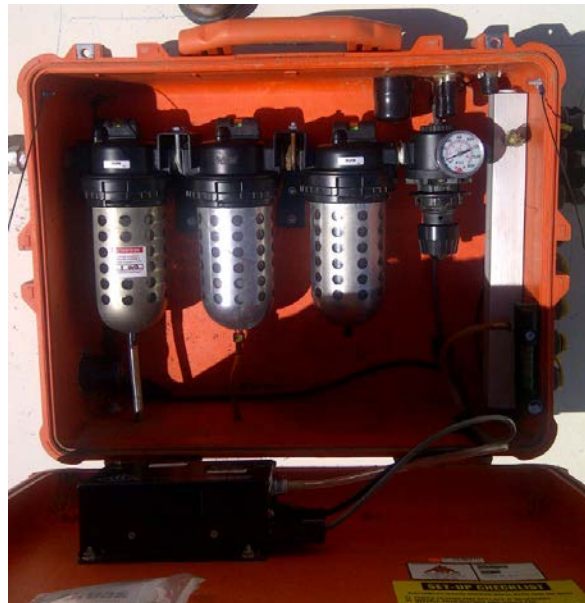
Figure 9: Breathing Air Filtration System

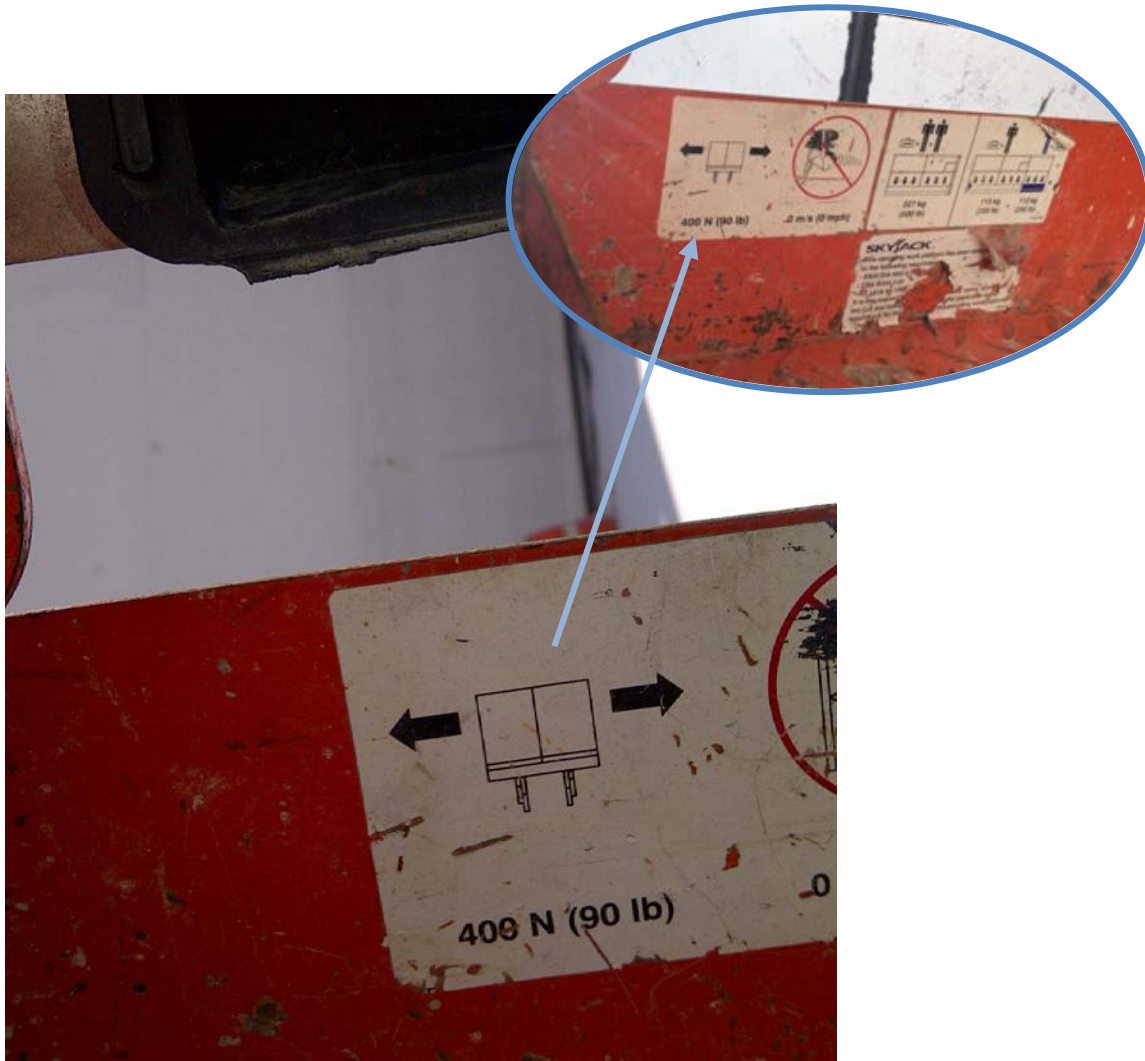
Figure 10: Warning Label inside Scissor Lift Identifying Side Force Limitations

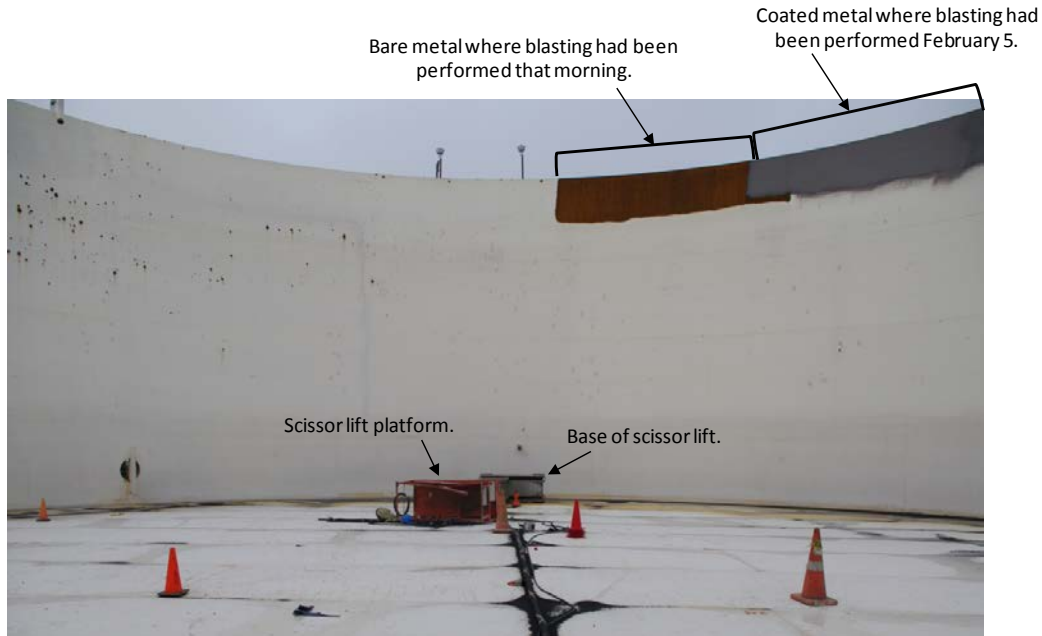
Figure 11: Position of the scissor lift in relation to work completed.

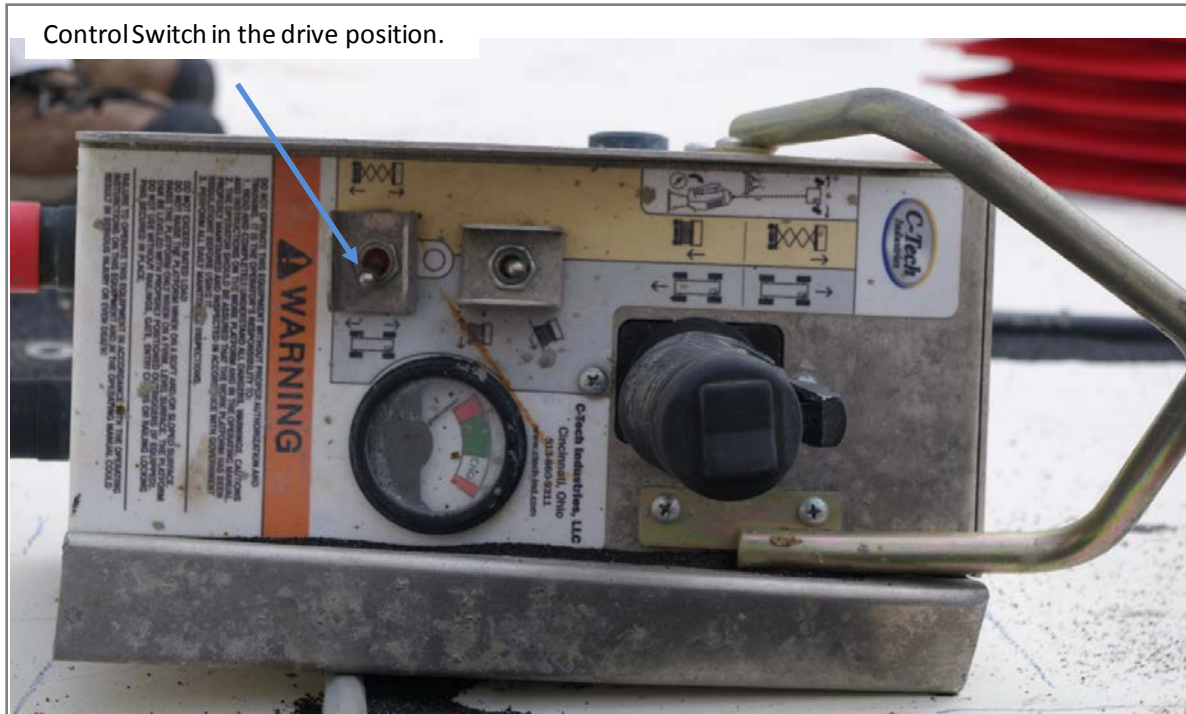
Figure 12: Control Box with three-way switch pointing to the drive position
