### LONG-TERM MONITORING INSPECTION REPORT YEAR 2, Quarter 1 INSPECTION #5

### LOS ALAMOS COUNTY AIRPORT LANDFILL COVER REPLACEMENT

Inspection Date:	August 31,	2017
Report Date:	October 5,	2017

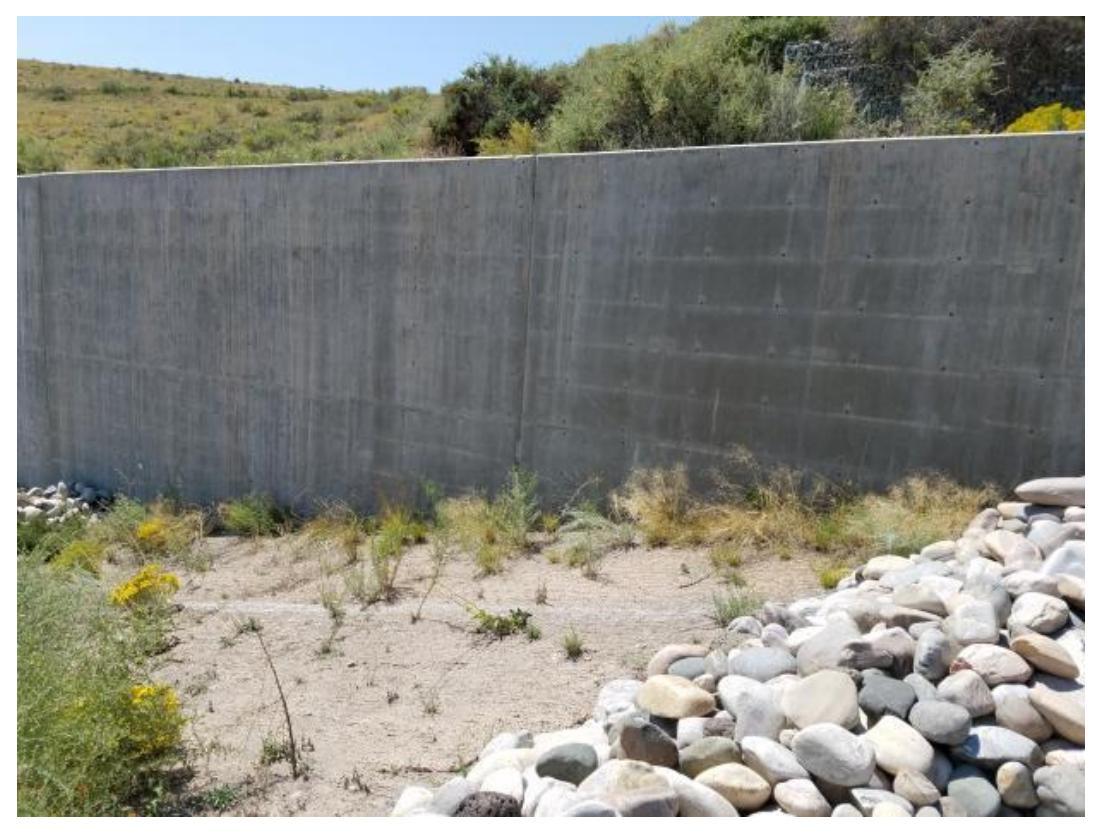
Picture 24. Concrete Retaining Wall - East End of Landfill

1.Retaining Wall Condition:	Retaining walls are in good condition. No damage or
General Condition progressing as expected:	issues were noted (Pictures 22 to 26).
Yes ( X ) No ( ) If no, explain

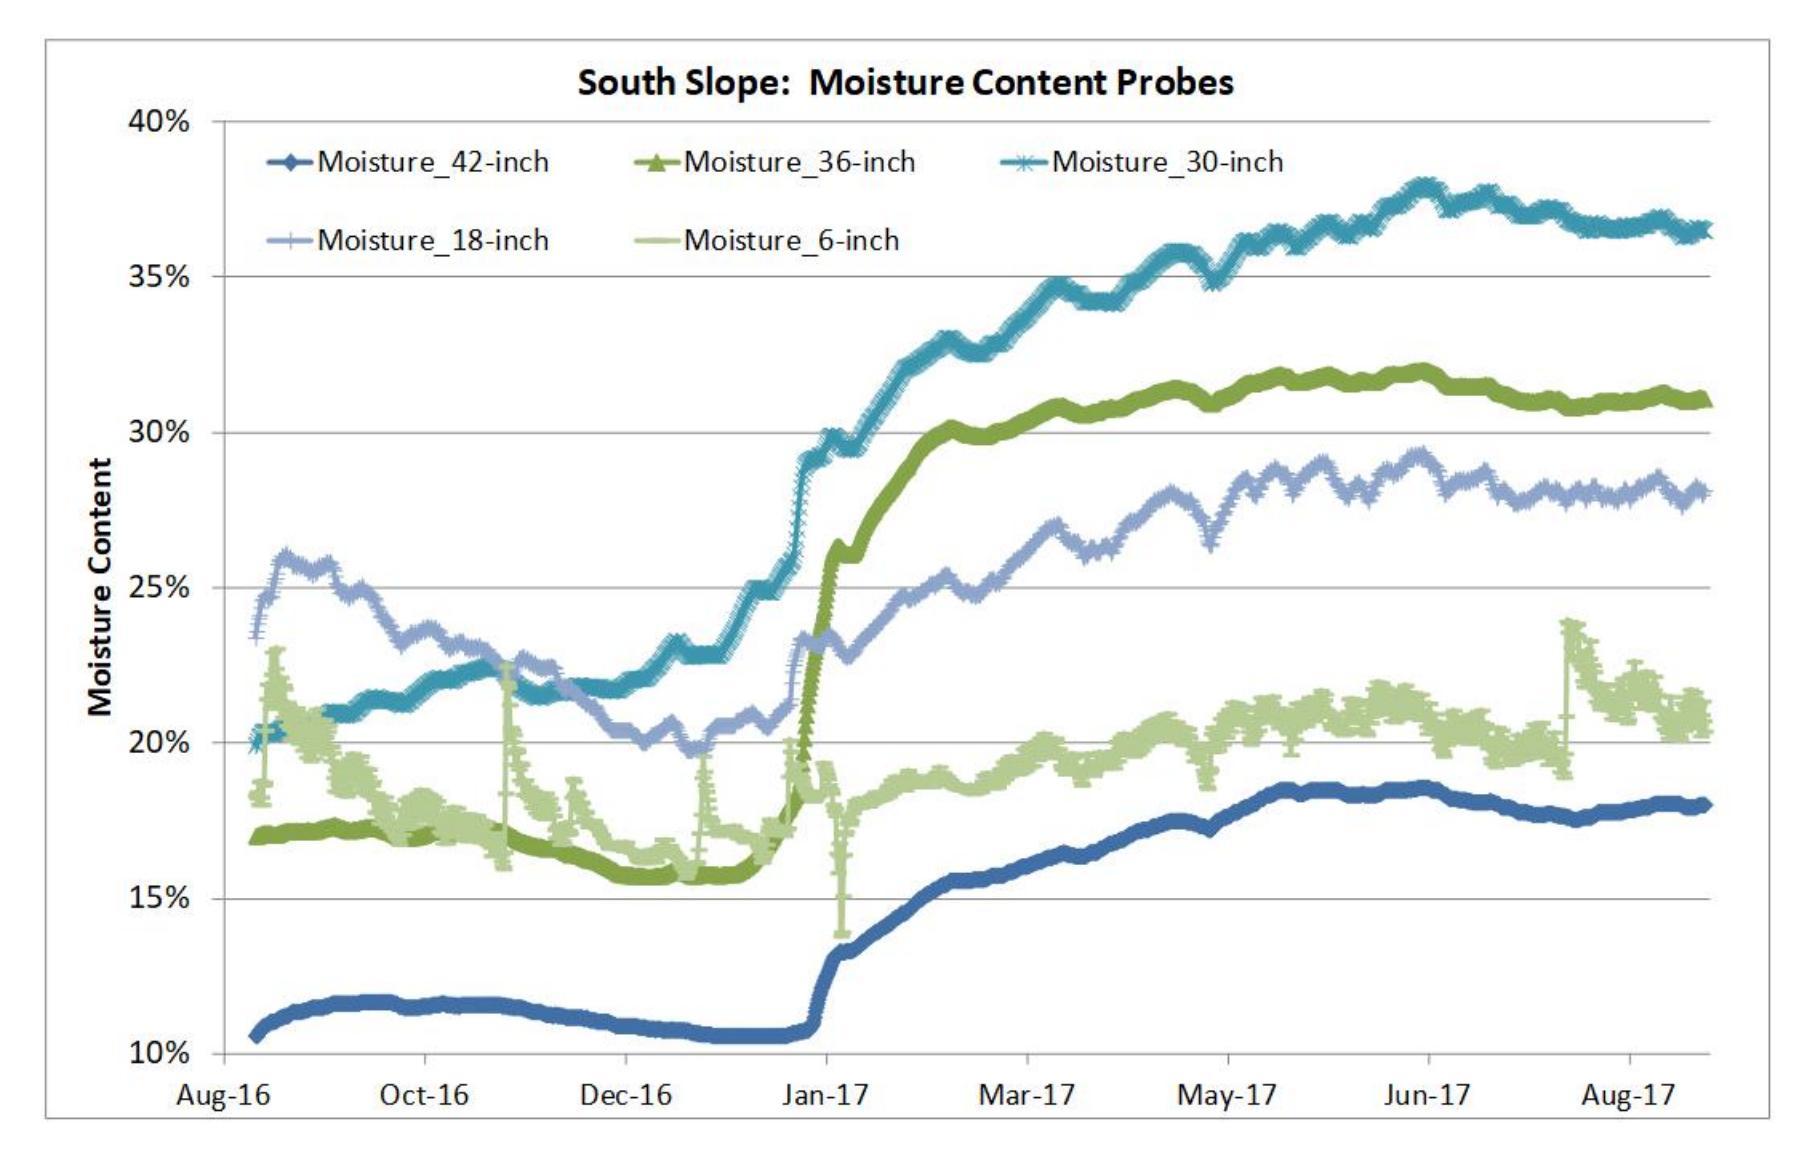
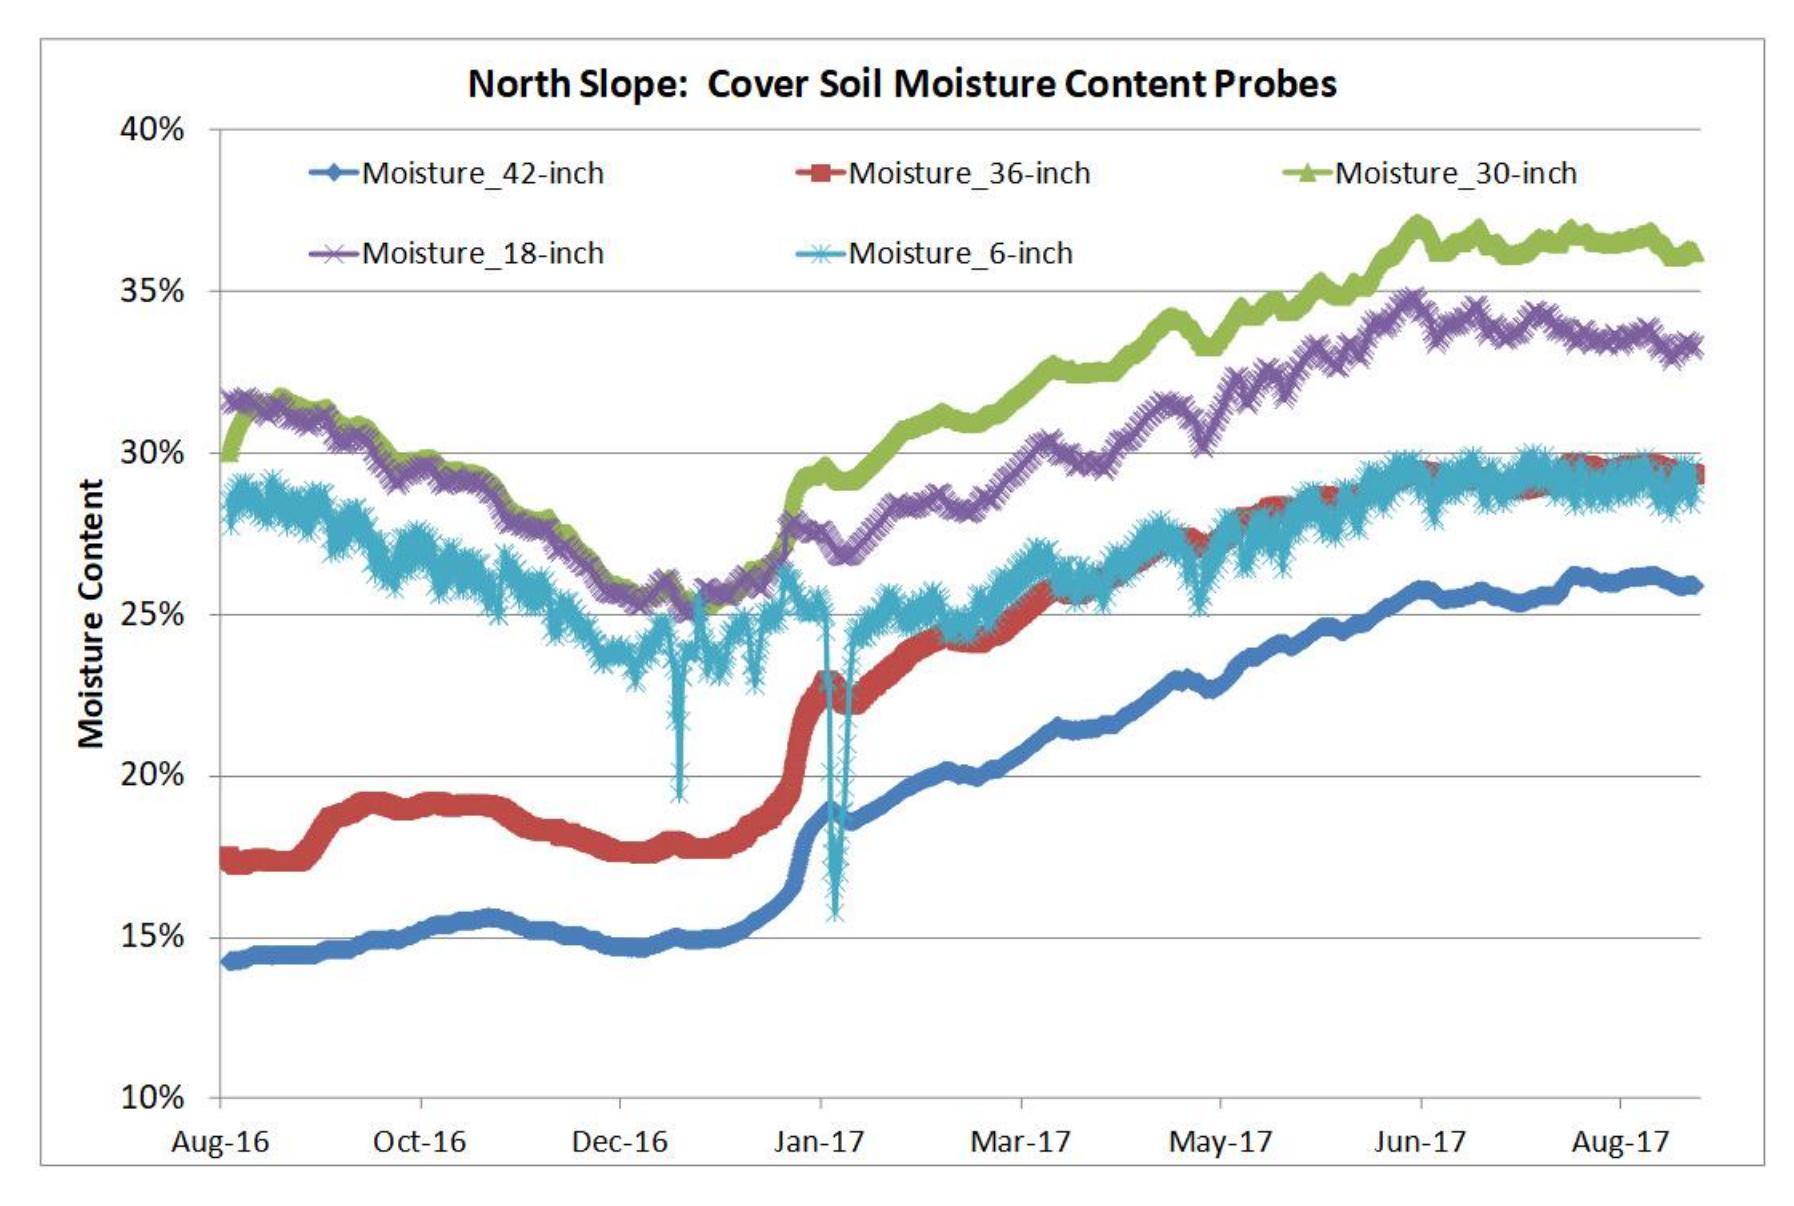
The moisture content probes reveal that moisture is migrating upward from the underlying waste through the cover system (Figures 1 and 2). That is, the landfill is drying. There is some undulation in the upper 6-inches - wetting due to precipitation and quickly drying thereafter. There also appears to be some sensitivity of the moisture content measurements to soil temperature.

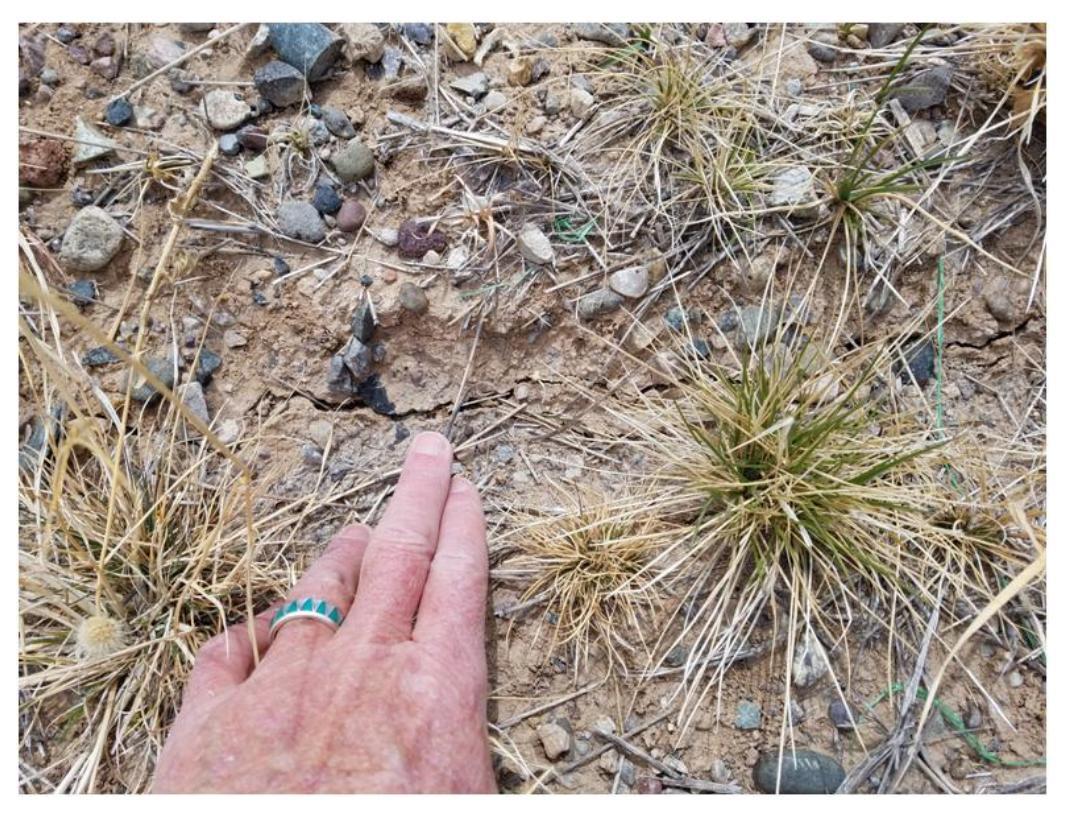
Picture 19. Surface Tension Crack – North Slope / Eastern Half of Landfill

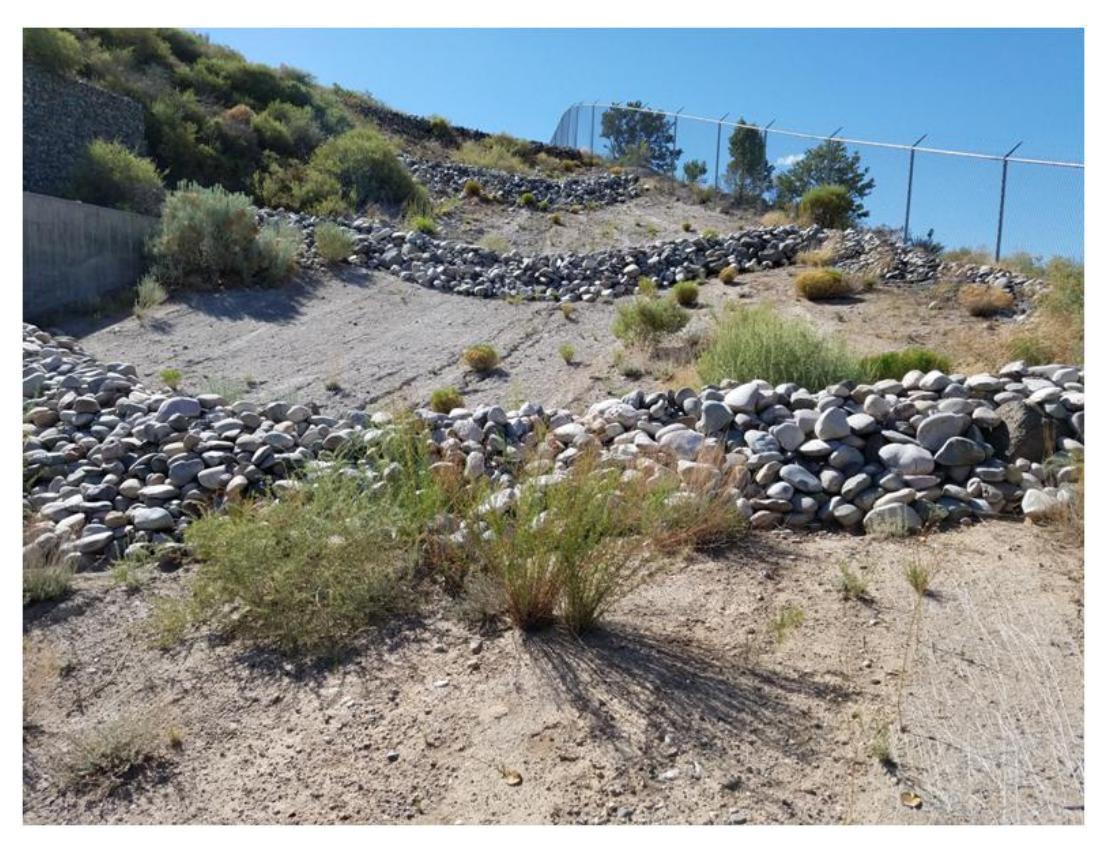
Picture 26. Rock Check Dams - Erosion Control East End of Landfill

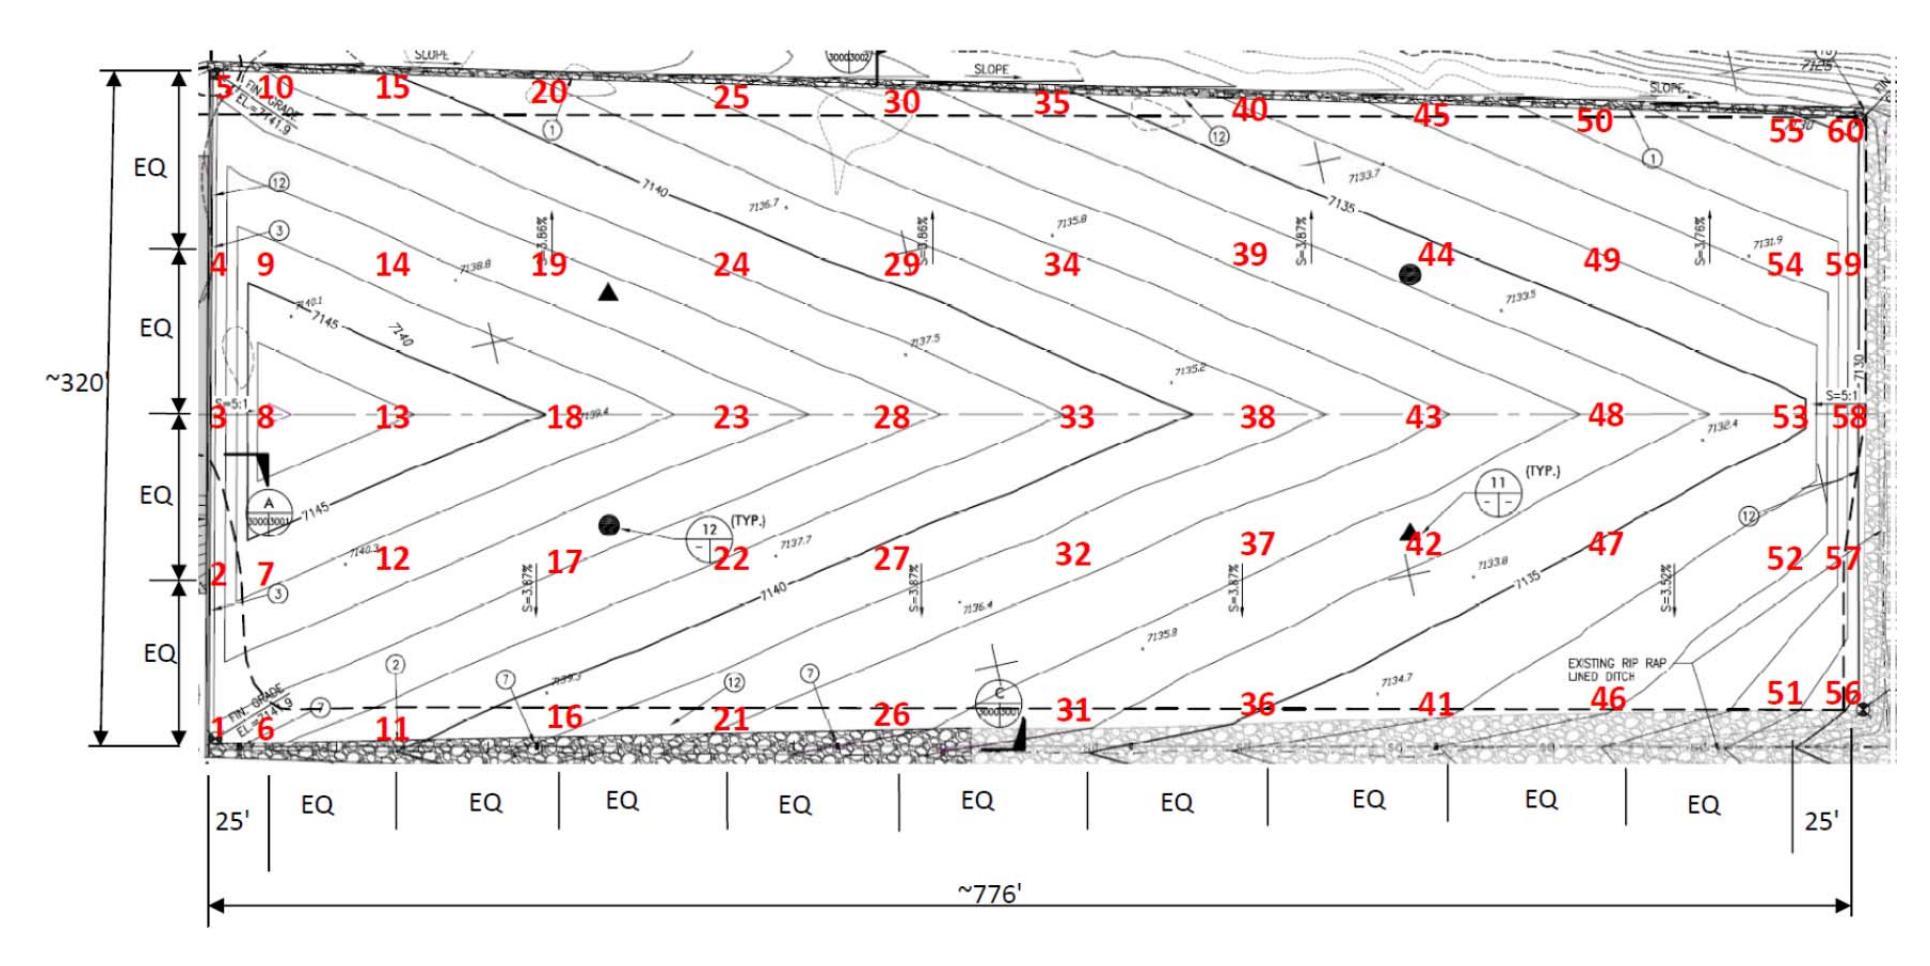
Figure 1. Survey Locations on ET Cover

Survey Data Summary					
Survey	Elevation – feet above sea level				Settlement
Point	9/17/2017	12/10/2017	3/27/2018	6/22/2018	(ft)
43	7137.28	7137.19	7137.23	7136.92	0.36
44	7134.56	7134.47	7134.53	7134.22	0.34
45	7131.89	7131.83	7131.90	7131.59	0.30
46	7131.91	7131.71	7131.75	7131.44	0.47
47	7134.12	7134.12	7134.07	7133.76	0.36
48	7136.06	7135.96	7136.03	7135.72	0.34
49	7133.29	7133.22	7133.23	7132.92	0.37
50	7130.81	7130.79	7130.78	7130.47	0.34
51	7130.48	7130.42	7130.46	7130.15	0.33
52	7132.27	7132.27	7132.28	7131.97	0.30
53	7134.60	7134.48	7134.51	7134.20	0.40
54	7132.38	7132.40	7132.39	7132.08	0.30
55	7129.37	7129.40	7129.26	7128.95	0.42
56	7129.08	7129.00	7129.08	7128.77	0.31
57	7130.40	7130.32	7130.26	7129.95	0.45
58	7129.75	7129.67	7129.76	7129.45	0.30
59	7129.59	7129.51	7129.58	7129.27	0.32
60	7128.90	7128.81	7128.84	7128.53	0.37
