# Chicago North, Illinois, Site

## SITE CERTIFICATION SUMMARY

This Site Certification Summary provides information about the **Chicago North, Illinois, Site**. The U.S. Department of Energy Office of Legacy Management is responsible for long-term stewardship of the site under the **Formerly Utilized Sites Remedial Action Program**.

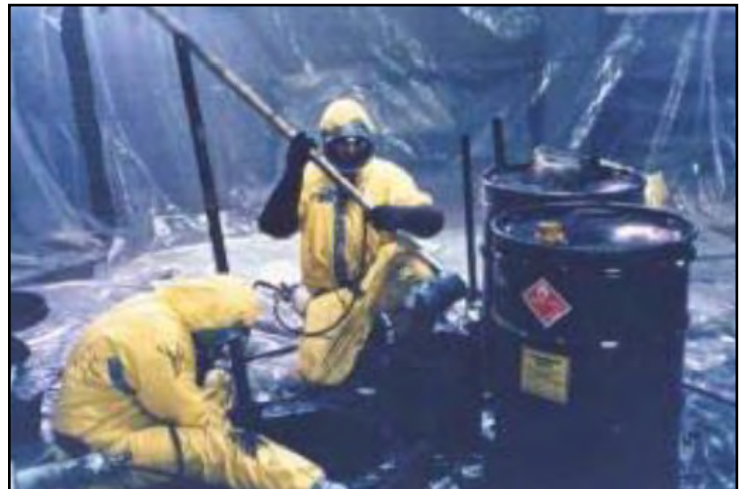
*Removing sludge and placing it in drums at the Chicago North site (1987).*
