ESG-DOE-13403

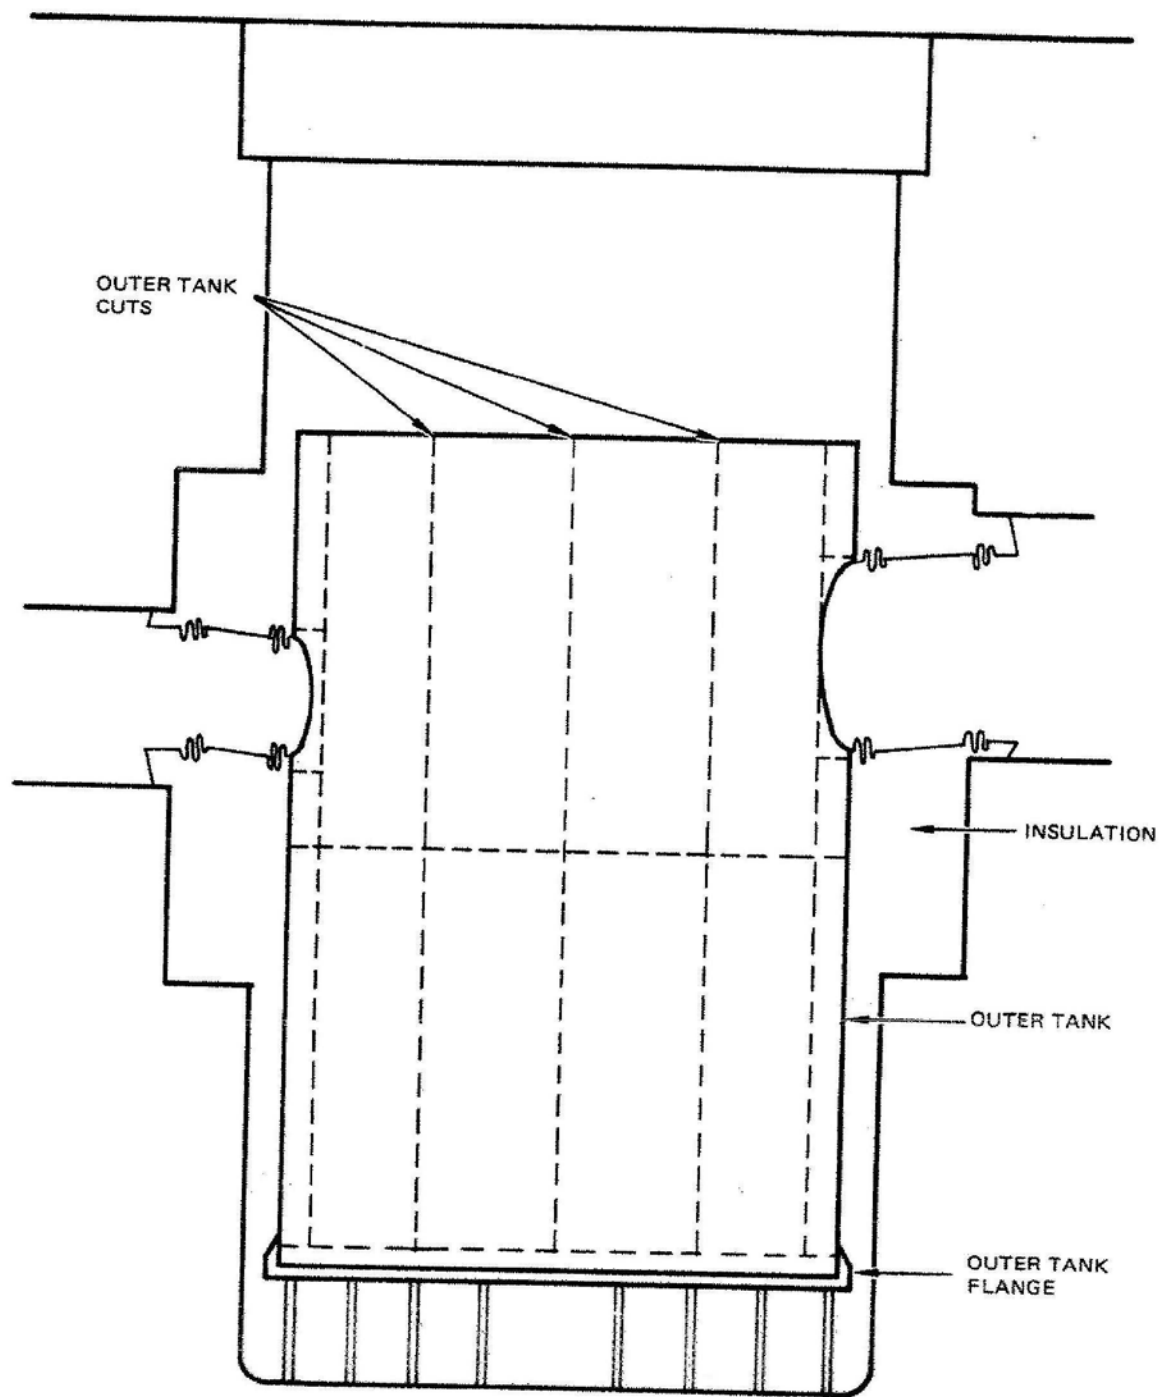
The outer tank was a 15-ft-diameter, 19-ft-high, open-top vessel installed 8 ft below floor level and surrounded by thermal insulation (see Figure 45). The 1/4-in.-thick carbon steel tank was used for cover gas containment. Two horizontal corrugated cylinders (bellows) intersected the tank at 14 ft below floor level. A 3/4-in.-thick doubler plate reinforced the bellows-to-tank junction.

Figure 45. Outer Tank Cuts

The outer tank bottom flange taper dimensions were not the same as indicated by the drawing dimensions. As a result, the horizontal cut severed the flange where its thickness was too great for lifting grips to be installed easily. Several grips were inadvertently installed in the wrong locations and could not be remotely removed. This caused the cutting pattern to be revised and produced two double and several half-size segments.

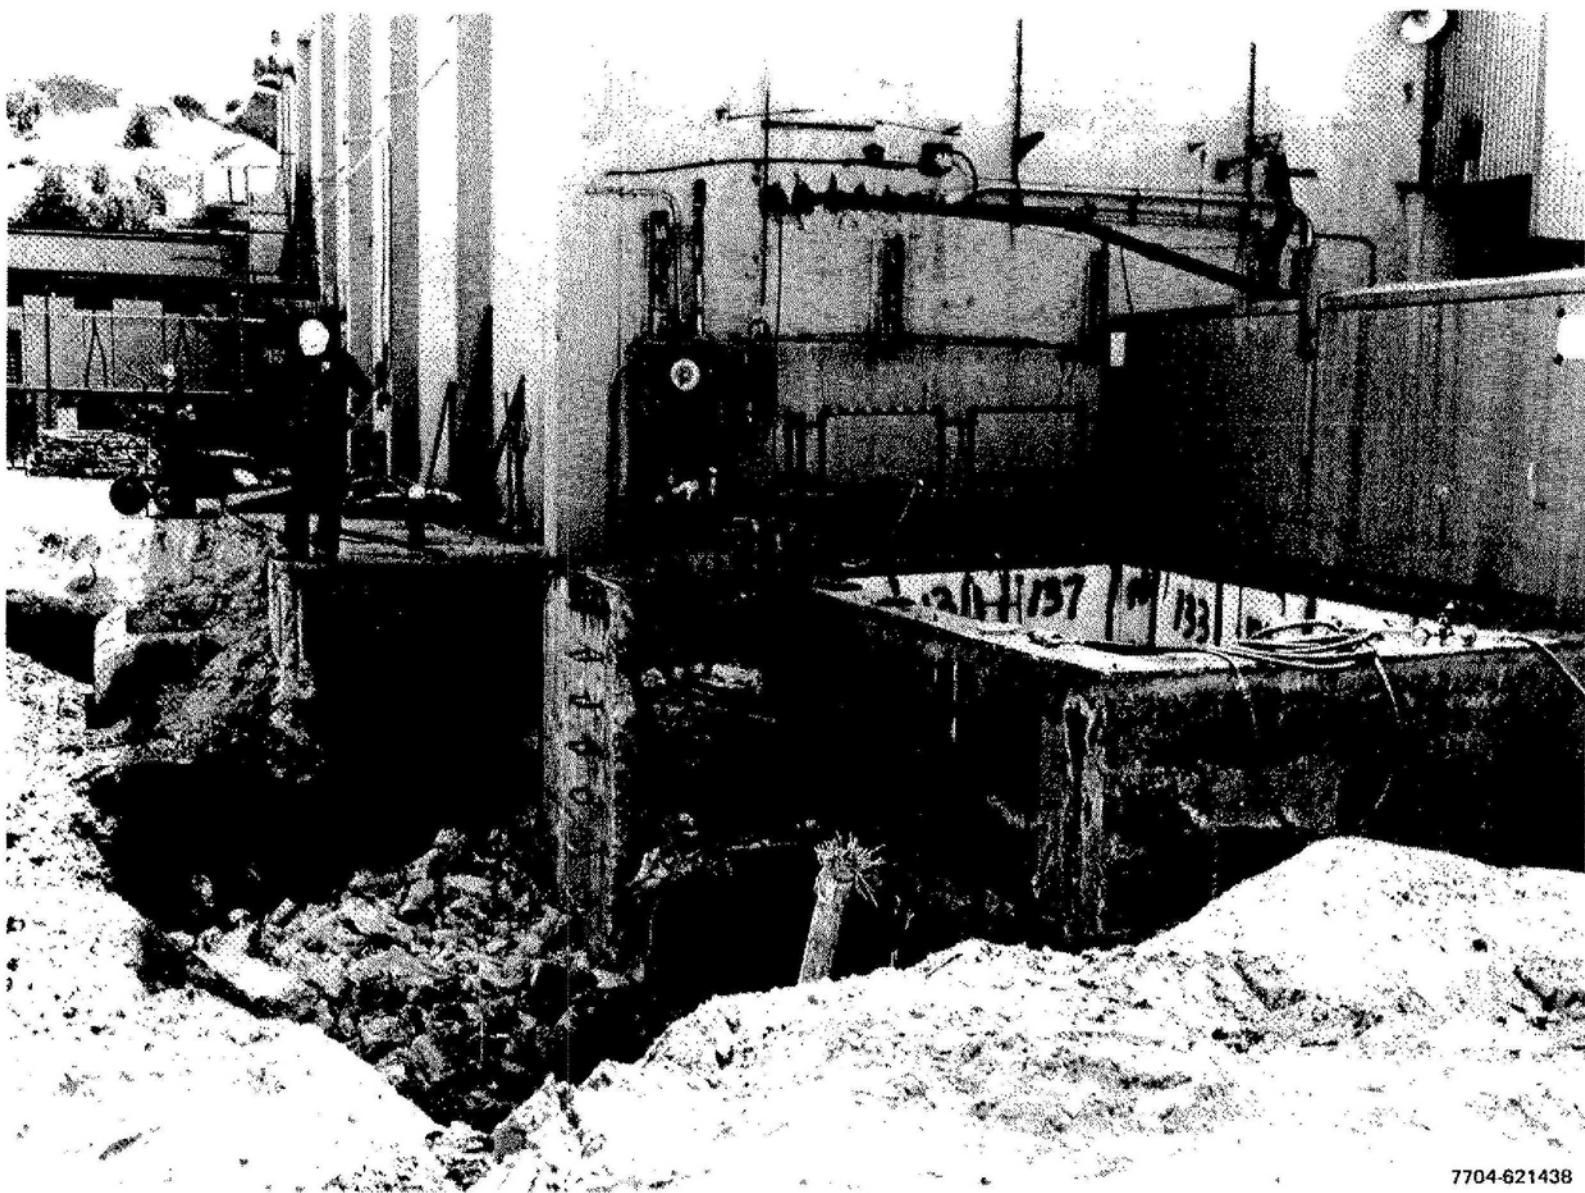
During this excavation, contamination above the Table 3 limits was found in the soil surrounding the footing at the northeast corner of the high bay. Further excavation uncovered contamination as high as 13,000 pCi/g located in cracks in the bedrock east and north of the high bay (see Figure 48). Figure 49 shows the excavation along the east face of the building. Contaminated

Figure 46. Initial Excavation at Northeast Corner of the SRE High Bay

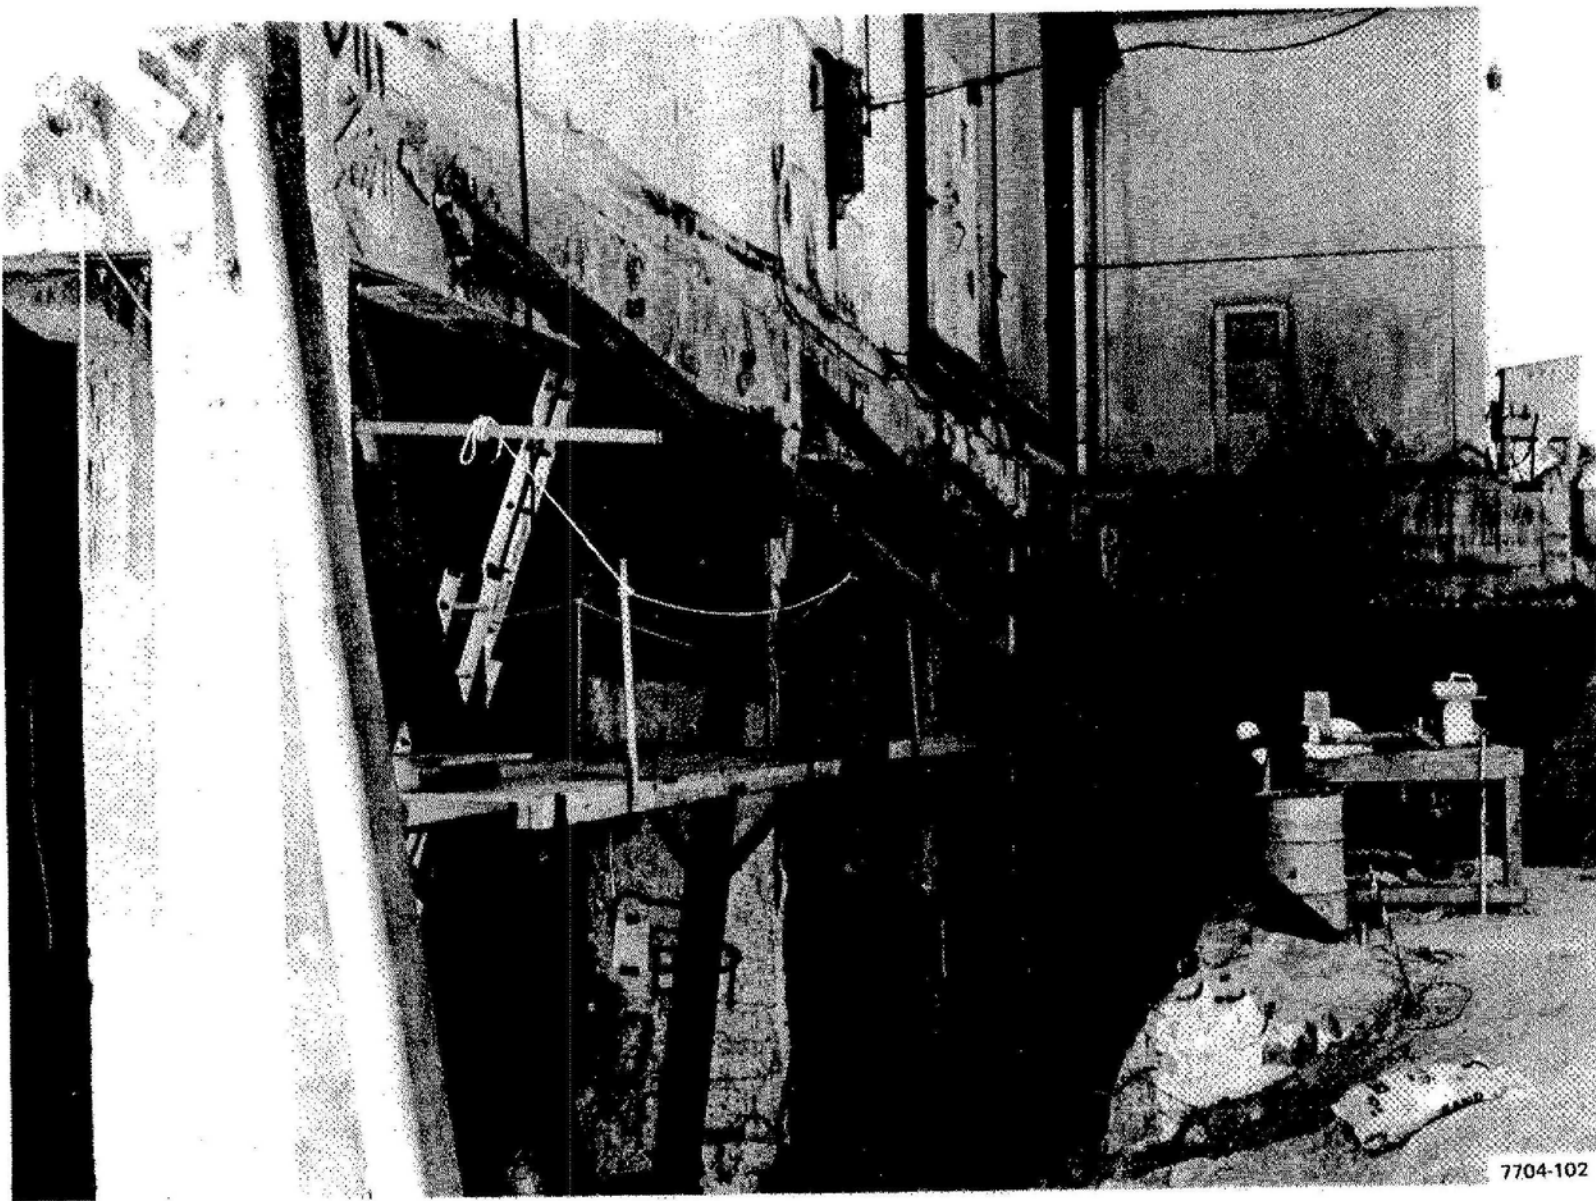
The level chosen for a specific column footing was based on the extrapolated amount of contamination expected. One column was partially undermined (10/11). Two columns were totally undermined (7A and 11D). And two columns and footings were removed and later replaced (8B and 9B). The installation of temporary footings and columns was subcontracted. Only one column was worked on at a time, and a full, 28-day cure was permitted on a foundation or column before work was started on an adjacent footing. Figure 54 shows the column supports and the seismic braces anchored to the floor of the primary fill tank vault. Figure 55 shows the column bracing inside the high bay. Column 7A, on the left, already has a new foundation and reinforced footing in place. Note that Column 9B has been removed.

Figure 54. Column Supports and Seismic Bracing Installed under North Wall of SRE High Bay

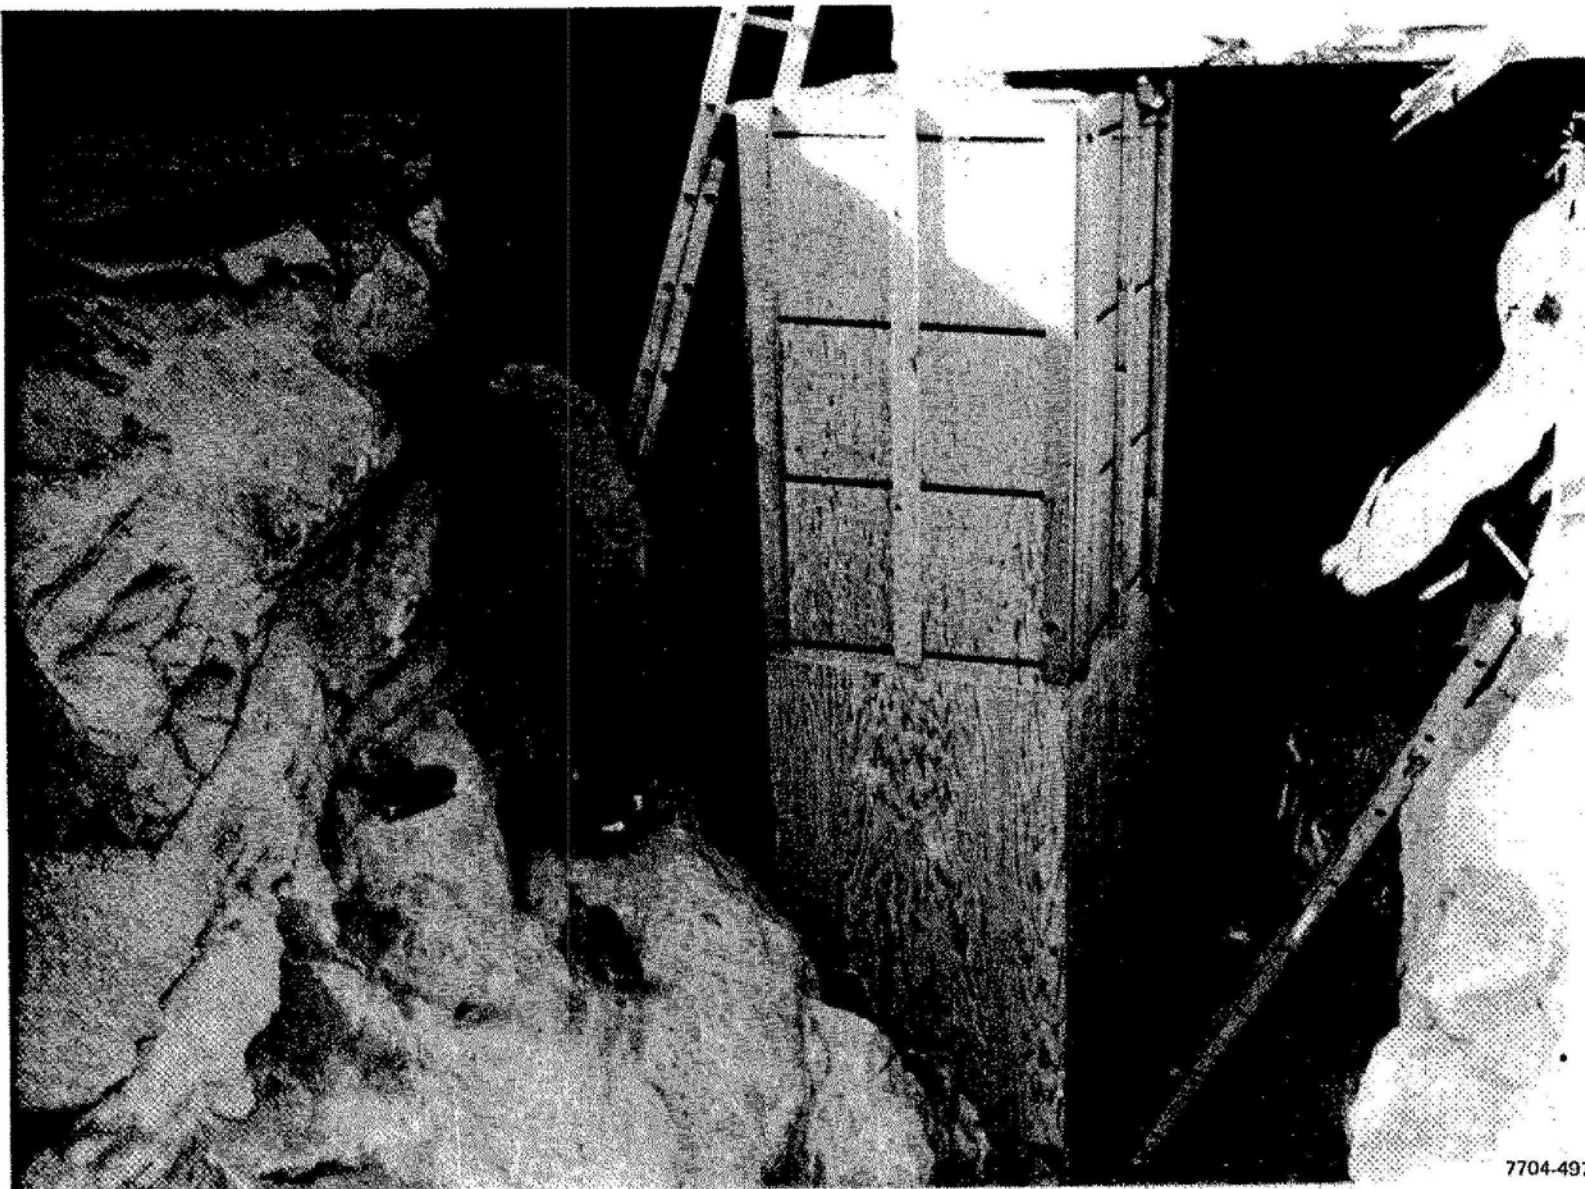
The excavation east of Column 11D was opened once access through this area was no longer required. The contaminated bedrock directly under the column footing was removed and a new concrete foundation was installed. Excavation of contaminated soil was continued east of the facility. A 6- by 10- by 12-ft-deep hole was excavated below Column 11D to remove all of the contaminated bedrock. Figure 56 shows a part of this excavation.

Figure 56. Construction of Form for Replacement Foundation under High-Bay Column 11D

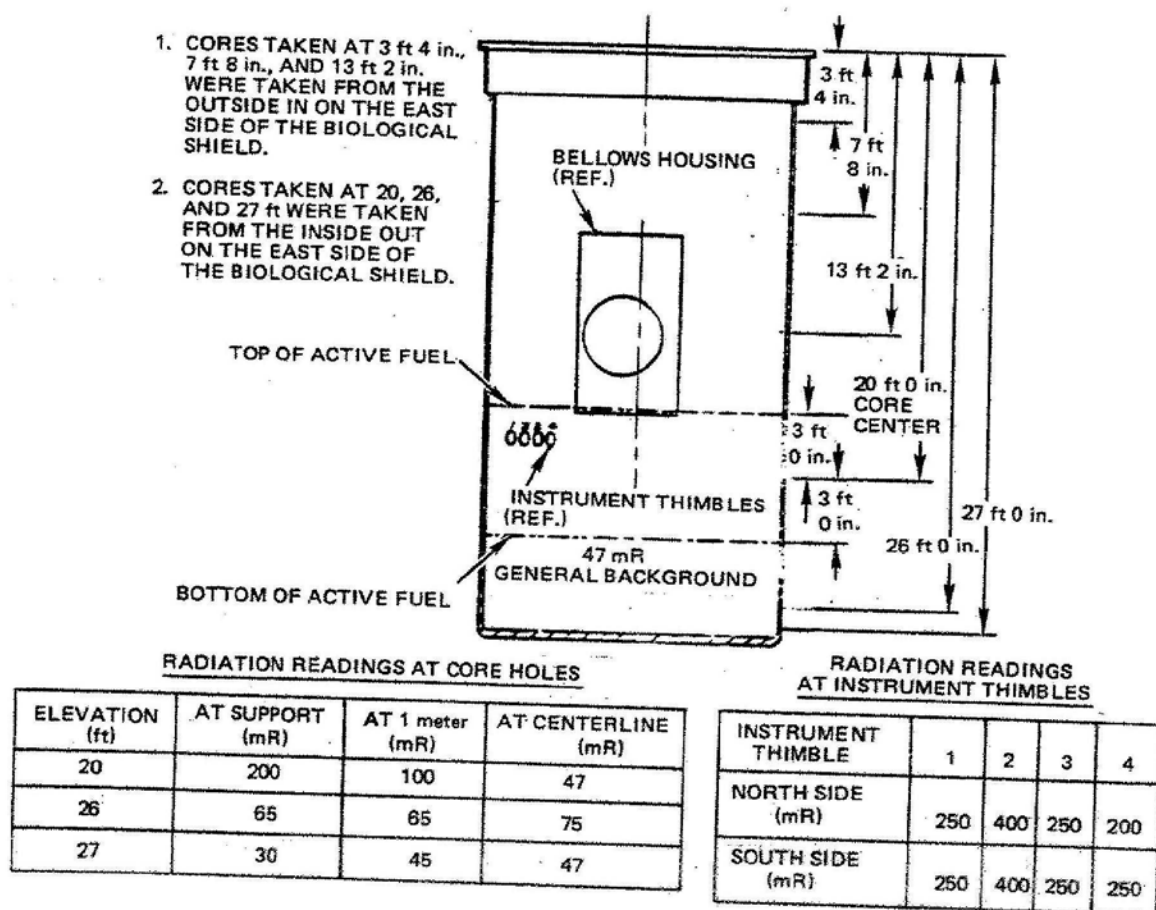
The first three samples were taken at 3 ft 4 in., 7 ft 8 in., and 13 ft 2 in. below-grade level. The drilling was accomplished from the outside of the biological shield to the inside. The next three samples were removed from 20, 26, and 27 ft below grade and were drilled from the inside of the biological shield out. The sample locations and their relationship to the reactor core are shown in Figure 57.

Figure 57. Biological Shield Core Sample Locations

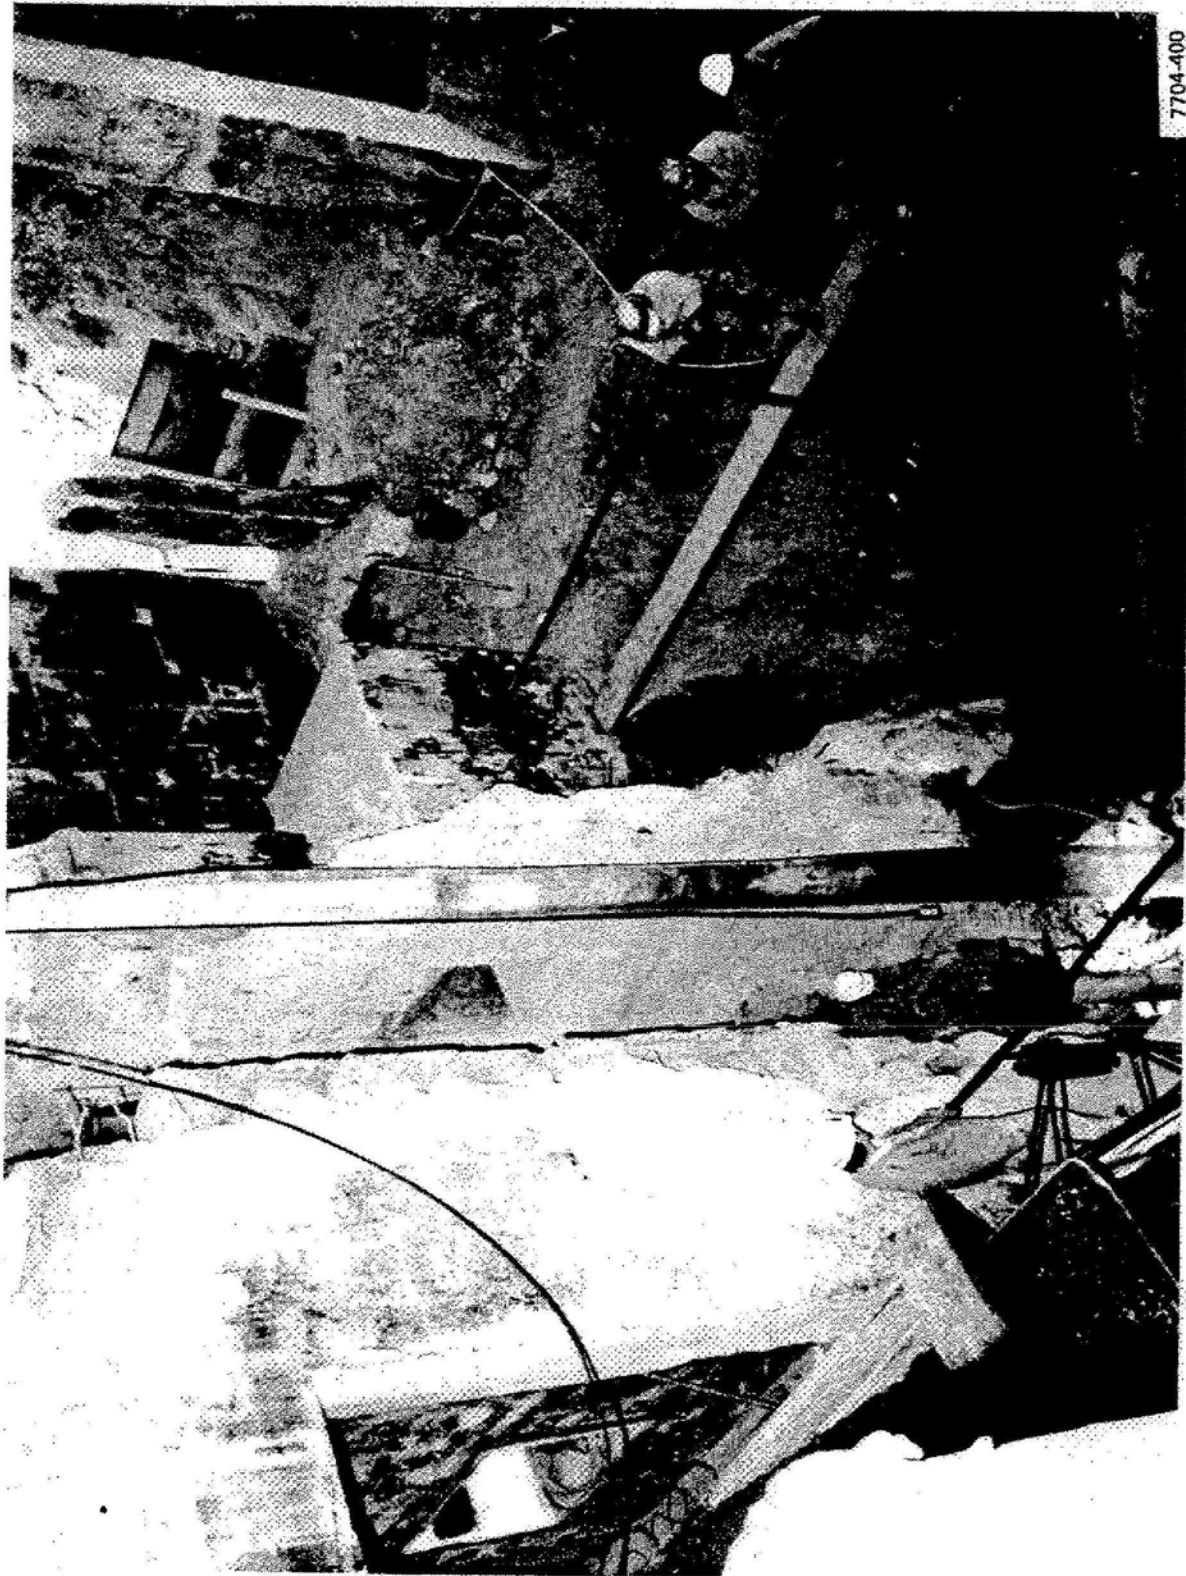
When the sleeves were uncapped, they were found to contain 2 to 4 ft of water. Analysis of samples indicated levels above the maximum permissible concentration for mixed fission products. The small side diameter of the sleeves made decontamination of the interior surface virtually impossible. It was decided to remove the sleeves. The Hy-Ram was used to expose the top section of the two units. It quickly became apparent that the small backhoe/Hy-Ram combination would not be capable of excavating a hole deep enough to reach the bottom of the sleeves. The preliminary excavation also showed that the two units were most likely encased in concrete for their entire length.

Figure 68. Fuel Element Enclosure Sleeve Removal
