Section Four

ALARA Activities at DOE

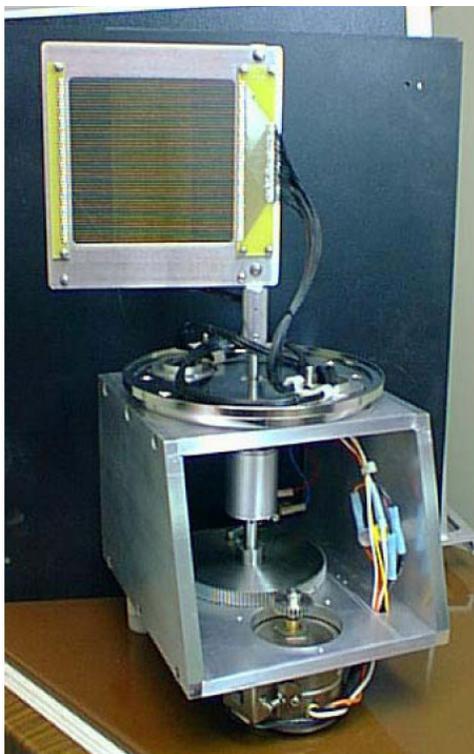
Exhibit 4-1:
Main Injector Multiwire Paddle

Replacement of the weak LEP corrector magnets and repair of the 851 multiwire proportional chamber improved the performance of the Main Injector 8 GeV collimator system (see *Exhibit 4-1*). The small aperture LEP dipole magnets were replaced with

rebuilt LEP corrector magnets that can run more current than the previously installed LEP magnets. This improvement will help to reduce losses in the Main Injector. The multiwire at 851 measures the transverse beam prior to injection into the Main Injector. The mechanical system that moved the multiwire into and out of the beam was repaired. This job required radiological control technician (RCT) coverage, and radiation surveys were conducted as needed to monitor exposure rates during the work. There were five persons assigned to this job in addition to the RCT. The job went as planned, so the estimated collective dose of 64 person-mrem matched extremely well with the actual collective dose received of 61 person-mrem. This LEP magnet replacement and multiwire repair is estimated to reduce future doses by 300 person-mrem annually.

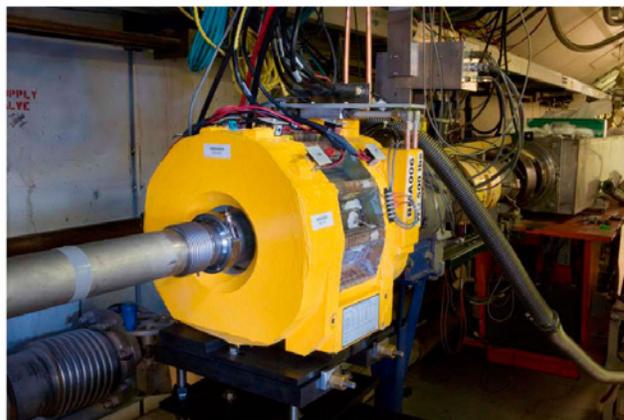
Exhibit 4-2:
Booster Corrector Prototype Installation

The Booster is the first circular accelerator, or synchrotron, in the chain of accelerators at Fermilab. It consists of a series of magnets arranged around a 75-meter radius circle (see *Exhibit 4-2*). A prototype corrector magnet was installed in the Booster during the summer of 2007. A total of 15 people participated in this work. The estimated collective dose for this job was 310 person-mrem and the actual collective dose received was 163 person-mrem. Actual doses were lower than estimated for several reasons. First, the general area exposure rates were estimated to be 10 mR/hr. In actuality, general area exposure rates were less than half of the estimate. Second, the surveyors and electricians completed their work much faster than estimated in the ALARA plan. A third reason for actual doses being lower is that the shielding placed in the 8 GeV beamline was more effective than the ALARA plan had estimated. This task was very successful because basic radiation dose reduction principles of time and shielding were integrated into the work.

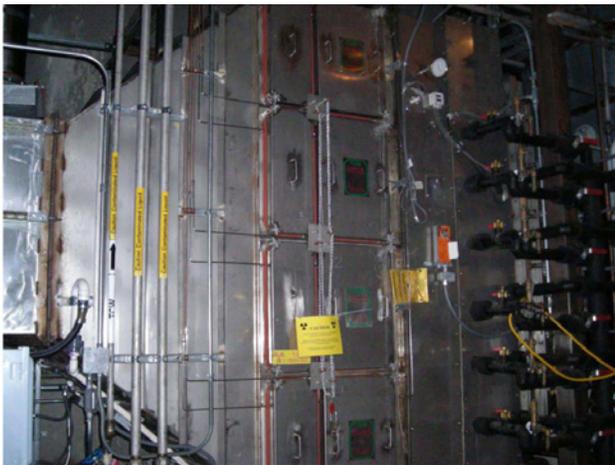
Exhibit 4-3:
NuMI Target Chase Ventilation Bank

During the summer 2007 shutdown, work was performed to change out high-efficiency air bank filters in the NuMI target chase inside the NuMI target hall (see *Exhibit 4-3*). The air filter banks consisted of four levels of filters with each containing three pre-filters and three high-efficiency filters. The three pre-filters measured approximately 20 mR/hr at 1 foot. The other filters read about 2 mR/hr at 1 foot. The procedure used a bag-in bag-out procedure to prevent airborne contamination. Because the air filters were known to be highly contaminated, workers wore forced-air hoods, personal air monitors, and full anti-contamination clothing. The collective dose estimate for this work was 100 person-mrem and the actual collective dose received was 34 person-mrem. The reason the actual dose was much lower than estimated is that the workers were very efficient in their work despite the difficult conditions of the job. Also, the bag-in bag-out procedure for changing the filters proved to work well because no airborne radioactivity was created. Analysis of the worker's personal air monitors showed no detectable airborne activity.

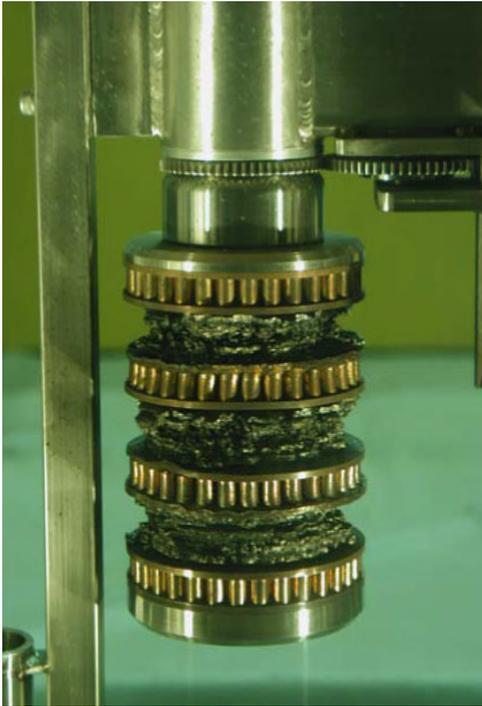
Exhibit 4-4:
Used Nickel Antiproton Target

Fermilab creates antiprotons by striking a nickel target with protons. It takes 100,000 to a million protons to make an antiproton. Over time, these nickel targets become damaged by the proton beam and must be replaced (see *Exhibit 4-4*). In May of 2007, work was performed to replace a target and also replace a drive shaft. Before the work began, the Accelerator Division ordered beam to be shut off from the area approximately 4 hours to allow for cool down. Plastic was placed on the floor and the alcove before the target module was moved. When the used target was removed and placed into the alcove, it measured approximately 300 R/hr at 1 foot from the upstream side of the target. It is interesting to note that several pieces of the target were observed on the antiproton target stand frame. When the target was placed into the coffin, it measured about 150 mR/hr at 1 foot. The coffin was wrapped in plastic to contain any highly activated material fragments. Once the work was completed, the plastic on the floor between the alcove and the lower vault was placed into a bag. The bag measured approximately 700 mR/hr on contact from highly activated particles. Next, the drive shaft on the target module was replaced (see *Exhibit 4-5*). Plastic was placed over the old shaft and the shaft was transferred to the storage vault. The drive shaft measured about 600 mR/hr at 1 foot. All areas were carefully surveyed to ensure that there were no highly activated material fragments present. During this work, pictures of the lithium lens and the pulsed magnet were also taken. Unexpected difficulties in obtaining photos of these items added 16 person-mrem to the overall collective dose. The collective dose estimate for the target and drive shaft replacement was 285 person-mrem and the actual collective dose was 290 person-mrem. This actual dose was well within the contingency estimate of 340 person-mrem. This job was carefully planned, well-executed, and workers diligently followed ALARA. The time estimated for this work was 12 hours, but it was completed in 10 hours.

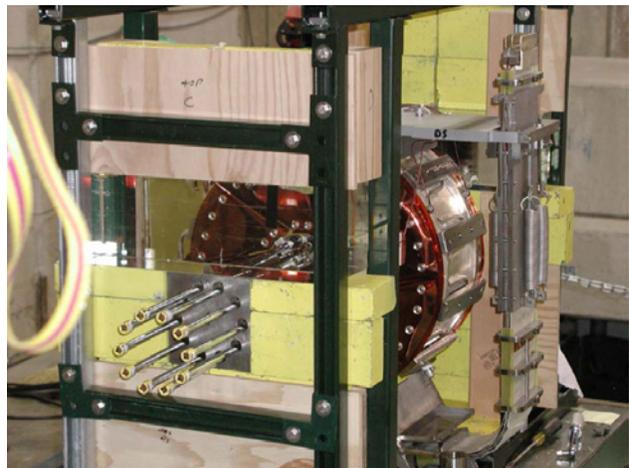
Exhibit 4-6:
Lithium Lens in New Transformer

The purpose of a lithium lens is to focus newly created antiprotons into a beam. In September of 2007, a used lithium lens was placed into a new transformer (see *Exhibit 4-6*). This work required continuous Radiological Control Technician coverage and an extensive, detailed ALARA plan. The dose rate on contact with the lithium lens was approximately 10 R/hr (2.8 mR/sec). The dose rate at 1 foot upstream and downstream of the lens was approximately 2.8 R/hr (0.8 mR/sec). Due to the high exposure rates, ALARA plan time estimates were made in seconds rather than minutes. The work was completed in about 5 hours. During the work, circles were drawn on the floor to indicate the lowest exposure rates in each of the work areas. The workers were very careful to stand inside these circles to minimize their exposure. The collective dose estimate for this job was 114 person-mrem and the actual collective dose received was 65 person-mrem. The workers practiced installing the new transformer on a mock setup of the lens assembly prior to performing the work. The primary reasons the actual doses were almost half of the dose estimate were due to thorough prior job planning, successful use of a mock-up, and conscientious ALARA work practices.

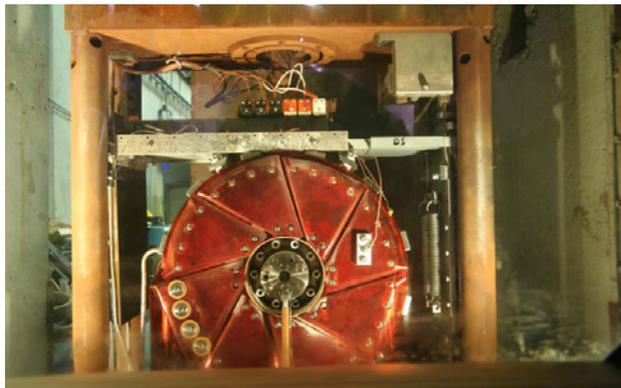
Exhibit 4-7:
Lens Module Replacement with New Pre-Attached Lithium Lens

A spare lithium lens module was refurbished complete with a replacement lens already attached (see *Exhibit 4-7*). In the past, when a lithium lens failed, the lens was replaced with a new lens on the same highly radioactive lens module. In this case, a new lens was attached to a previously used spare lens module. In the future, when a lens failure does occur, the entire lens module will be switched out by remote crane operations and replaced with another less radioactive lens module. In this ALARA job, the highly radioactive lens module was placed directly in the storage vault for cool down. The exposure rate at the downstream side of the lithium lens was about 200 R/hr at 1 foot. The estimate for this job was 257 person-mrem and the actual collective dose received was 234 person-mrem. Another unique ALARA feature of this job was fabrication of a screwdriver with long extension to reduce exposure. Additionally, there was effective use of temporary shielding in the APO alcove. Another feature of this work was careful pre-planning and use of a mock-up to practice the job before it was performed. The mock-up work was performed on a radioactive spare module with a much lower exposure rate than the lens module being replaced. The highest dose rate on the spare mock-up lens module was about 4 R/hr at 1 foot. The use of a spare lithium lens module will save both time and dose in future lens replacements. It is anticipated that the refurbishment of a spare replacement lens module will require about 50 person-mrem. A typical lithium lens replacement job results in a collective dose of approximately 300 person-mrem. Therefore, a spare lens module with a new lens will save an estimated dose of about 250 person-mrem.

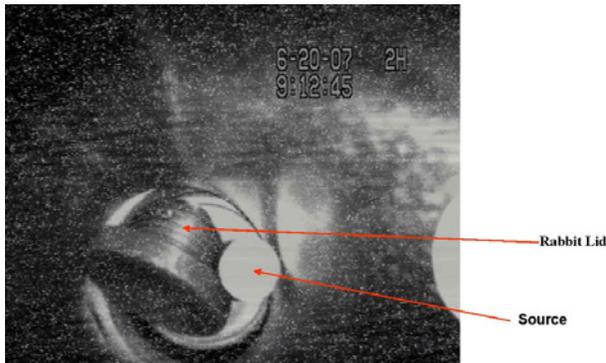
During routine operation, in June 2007, the vacuum failed to capture and hold one of the Co-60 sources (1 Ci) at the suction cup. Several attempts were made, but all attempts failed. The carousel was then rotated to another source position and an attempt was made to transport it to the top of the transport tube. Instead, the carousel jammed. A time-out was called and the HPS Technical Director was notified.

The HPS Technical Director decided to insert a boroscope into the source transfer tube to determine the cause of the obstruction. The boroscope revealed the rabbit's lid containing the 1 Ci Co-60 source had become unscrewed causing the obstruction (see *Exhibit 4-11*). The HPS Technical Director notified the vendor and scheduled an appointment to come out to resolve the jam.

Exhibit 4-11:
Boroscope view of rabbit lid and source.

All other sources in the GBI had a second, longer set screw added to ensure that their rabbit's lid would remain intact during operation of the GBI.

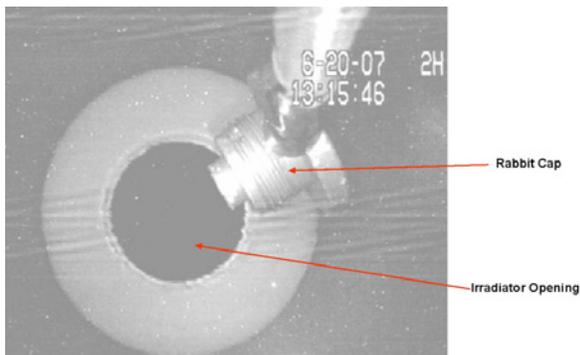
During the vendor's visit, the rabbit lid was removed (see *Exhibit 4-12*) from the GBI and the source was returned to the rabbit until the vendor, HPS Director, and Radiation Controls Operation (RCO) could determine a path forward for removing the rabbit and source from the GBI.

Exhibit 4-12:
The Rabbit Lid being removed from the

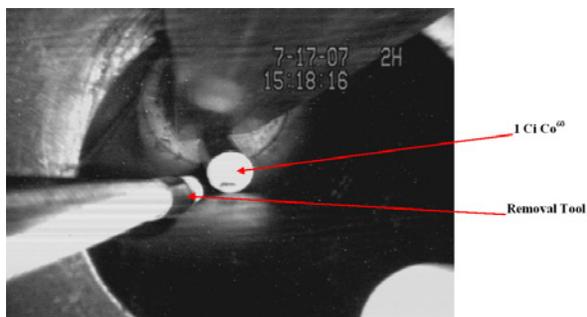
Radiological conditions of the GBI were determined before the rabbit and source were removed. Dose rate calculations were performed based on decay of the source (0.254 Ci). It was determined that at 5 cm the unshielded dose would be 150 R/hr and at 30 cm this rate would be 3.6 R/hr. Based on these dose rates, RCO determined that an extension tool had to be used to remove the 1 Ci Co-60 source and place it into a storage carousel (see *Exhibit 4-13*).

Exhibit 4-13:
Source removed from the GBI.

In July 2007, the vendor returned to remove the source and rabbit from the GBI. The vendor used the appropriate tools and removed the source and failed rabbit from the GBI. All rabbit internal parts (2 washers and spacer) were accounted for.

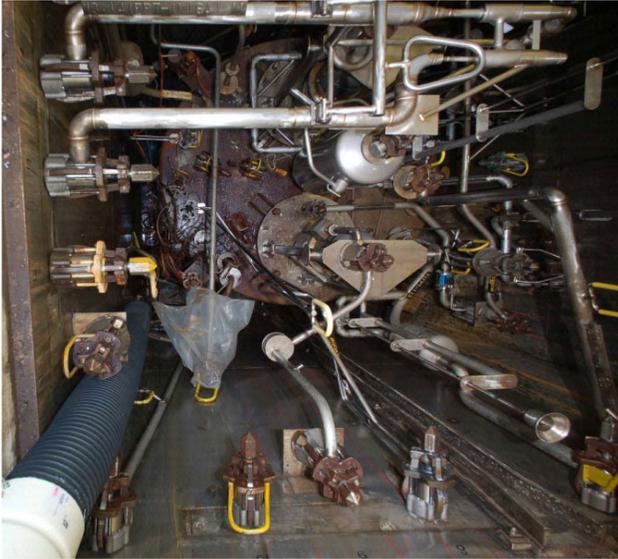
Due to tank closure missions to re-direct waste transfers, a plan was developed to re-configure the jumper alignment, which would include repairing and replacing several jumpers. A total of 13 jumpers had to be removed from the highly contaminated 15' x 15' x 25' deep pit cell. The size of the cell opening created a very prohibitive maintenance of negative airflow.

Exhibit 4-14:
Pump pit with jumpers and valves.

Historical data has shown a Price-Anderson Amendments Act (PAAA) investigation was performed, due to contamination being detected outside the containment (e.g., windbreak), which resulted in a personnel contamination case. During the past, the pump pit collected spent equipment (e.g., sump pumps, cords, jumpers, ventilation duct, etc), making it very difficult to remove any jumper from the pit area. Recent waste transfers from the F Canyon included Am/Cm (americium/curium). These isotopes increased the risk of spreading contamination, once the jumpers were disconnected.

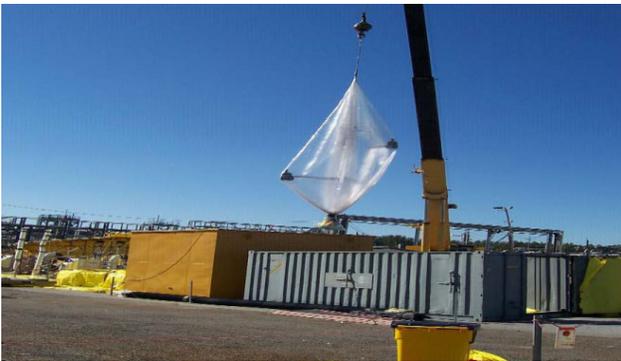
- ◆ The jumpers being replaced with newly fabricated ones were directly placed in their respective disposal container (e.g., Sealand, JB-2 Box, etc.).
- ◆ Sleviers provided a hands-off approach to sleeving the jumpers (over an open pit 15' x 15' x 25').
- ◆ The sleeving deployed off the sleever (positioned over the pit) as the jumper was lifted out of the pit (see *Exhibit 4-21*).

Exhibit 4-21:
Sleeved jumper lifted out of the pit.

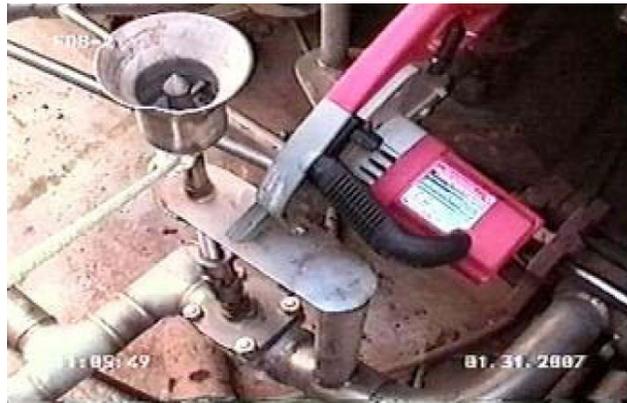
Exhibit 4-22:
Cutting Tool with Extension Handle

- ◆ Due to the spent equipment being overlapped on the jumpers, contamination was released inside the walls of the windbreak and on the extra layers of plastic flooring. Work was temporarily suspended for decontamination activities. Contamination was not released outside of the windbreak.
- ◆ While the jumpers were being re-installed, one of the jumpers would not connect to the wall nozzle. A time out was declared and upon investigation, it was determined the jumper identification plate was interfering with the alignment. A plan was developed to remove the name and a section of the jumpers lifting bail.
- ◆ Mock-ups were performed to determine the cutting tool required to handle the weight on a 25' rod (see *Exhibit 4-22*).
- ◆ A minimum amount of dose was received.
- ◆ The mechanics were stationed behind the shield wall.

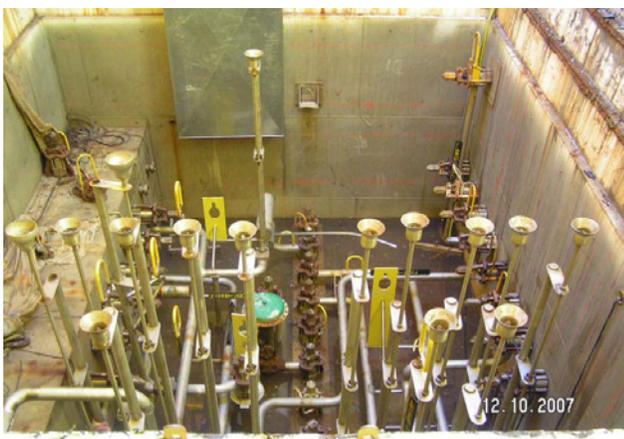
- ◆ A coating of Sherwin Williams ProBlock Primer Sealer paint was applied to all jumpers prior to removal to further fix contamination (see *Exhibit 4-25*).

Exhibit 4-25:
Jumpers prior to removal

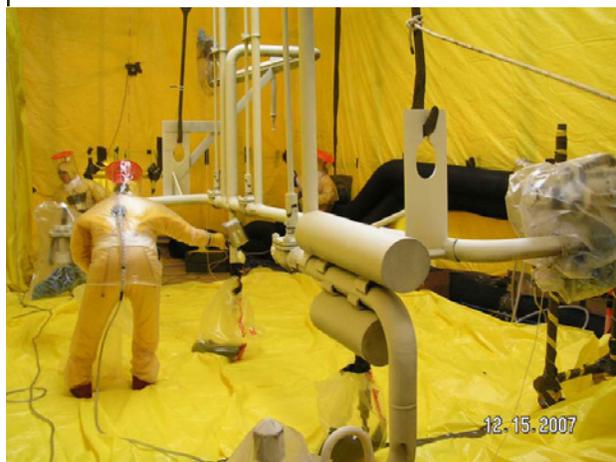
- ◆ Eleven cell covers were removed, 12 jumpers were removed and disposed (see *Exhibit 4-26*), 3 new jumpers were installed (see *Exhibit 4-27*), and the 11 cell covers were replaced.

Exhibit 4-26:
Removed jumper

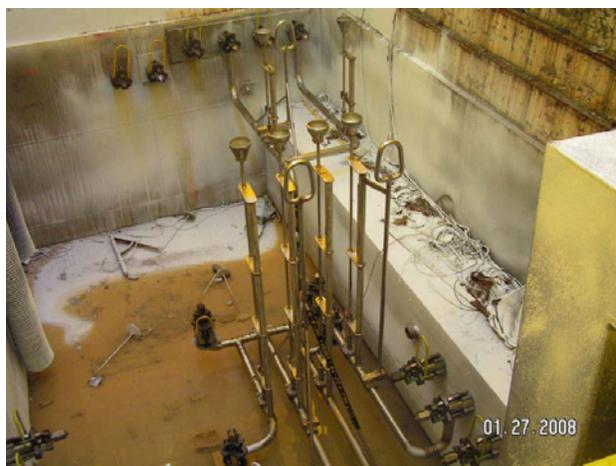
Exhibit 4-27:
New jumpers installed
