APPENDIX N
PRELIMINARY GEOTECHNICAL INVESTIGATION RESULTS

Shell Wind Energy, Inc
Hermosa Wind Project

B&V Project 163577
B&V File 41.0403
September 8, 2009

Subject: Preliminary Geotechnical Investigation Results

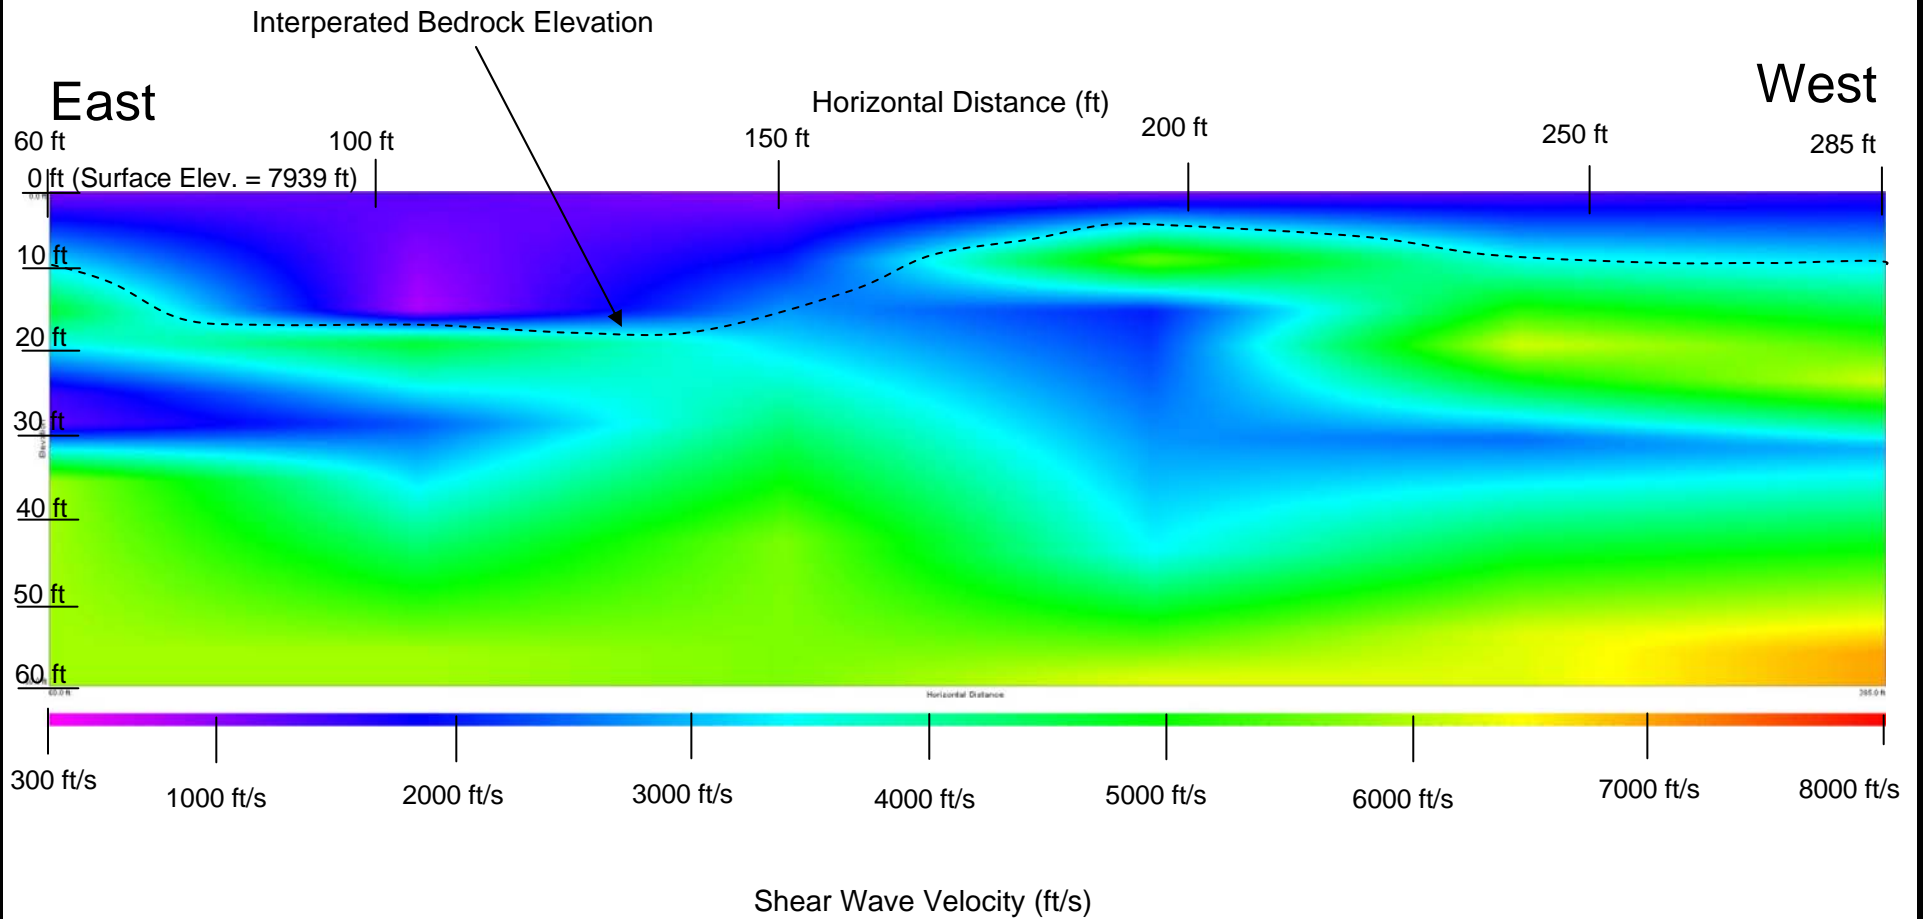
Line B8 Profile

Line 8 Shear Wave Velocity Two-Dimensional Profile
Hermosa Wind Project
Tie Siding, Wyoming

Sandstone bedrock was generally described as cemented and fractured to highly fractured. Rock RQD values ranged from zero to as high as 72 with a general trend of increasing RQD with depth. Based on the geophysical testing, test location B-8 had shear wave velocities ranging from 3,500 to 6,500 feet per second (fps) with some softer zones, suggesting portions of the sandstone are highly weathered or uncemented.

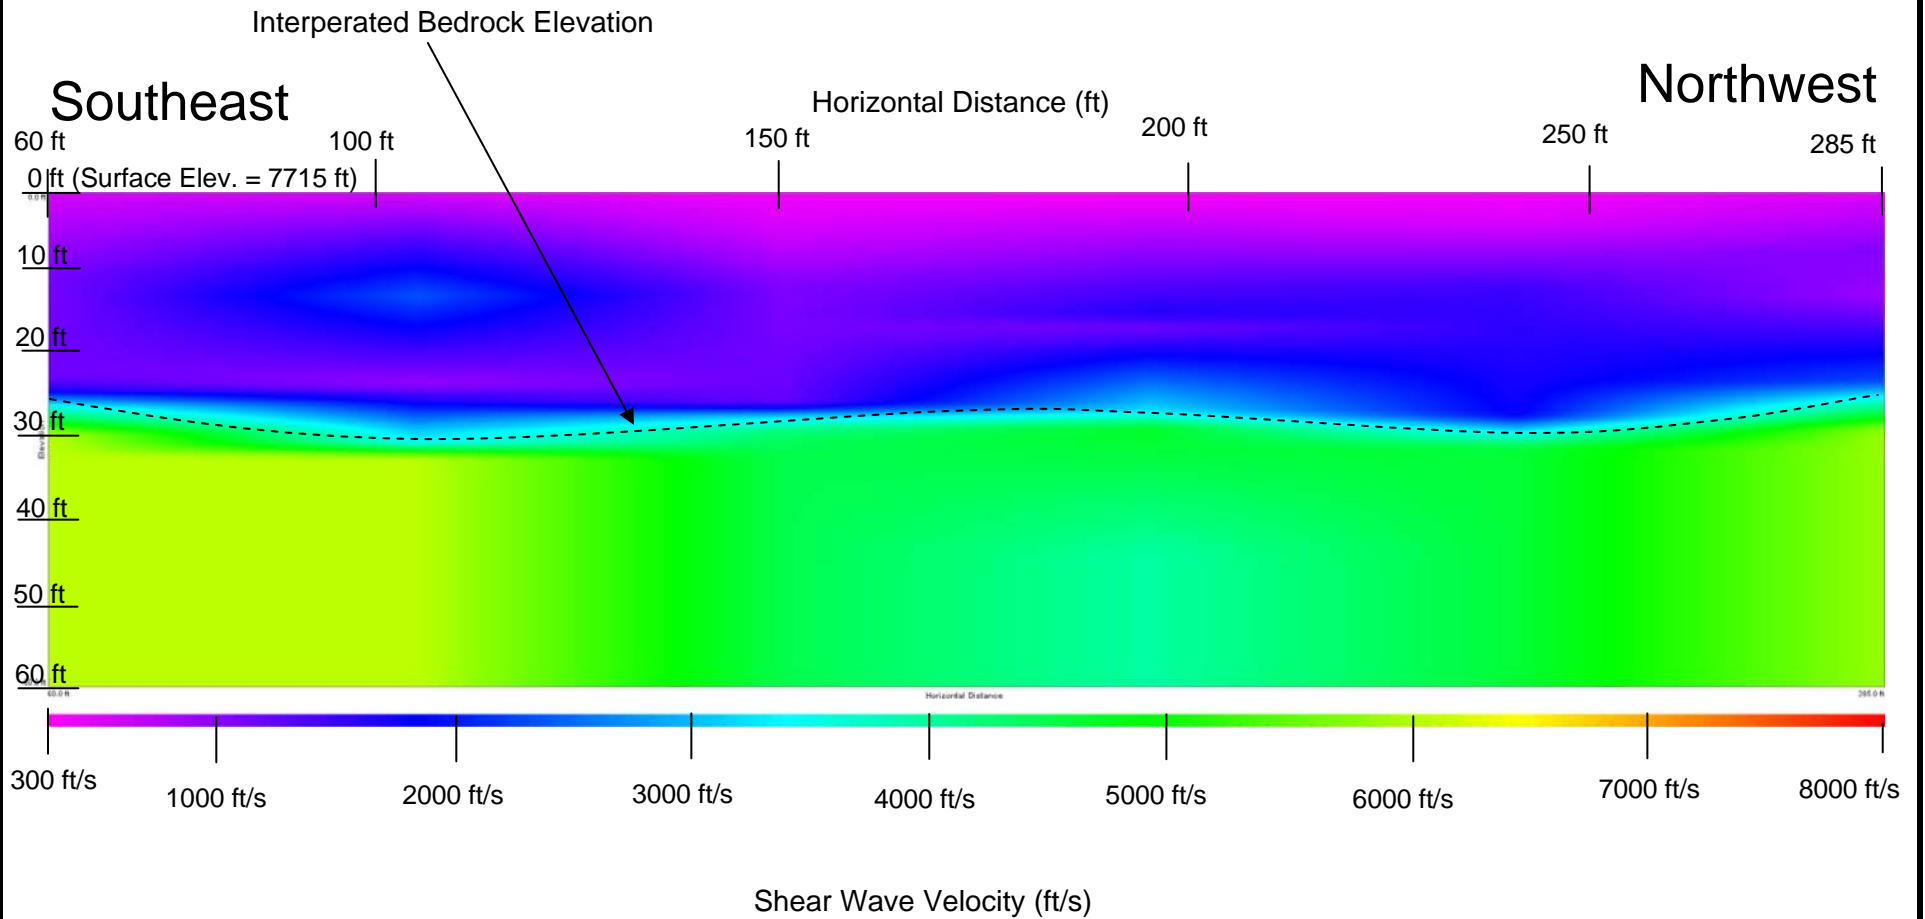
Line B9 Profile

Line 9 Shear Wave Velocity Two-Dimensional Profile
Hermosa Wind Project
Tie Siding, Wyoming

Granite was generally described as fractured in parts with RQD values ranging from 20 to 60. Geophysical testing at yielded shear wave velocities that were slightly higher than the sandstone with values ranging from 4,000 to 8,000 fps.

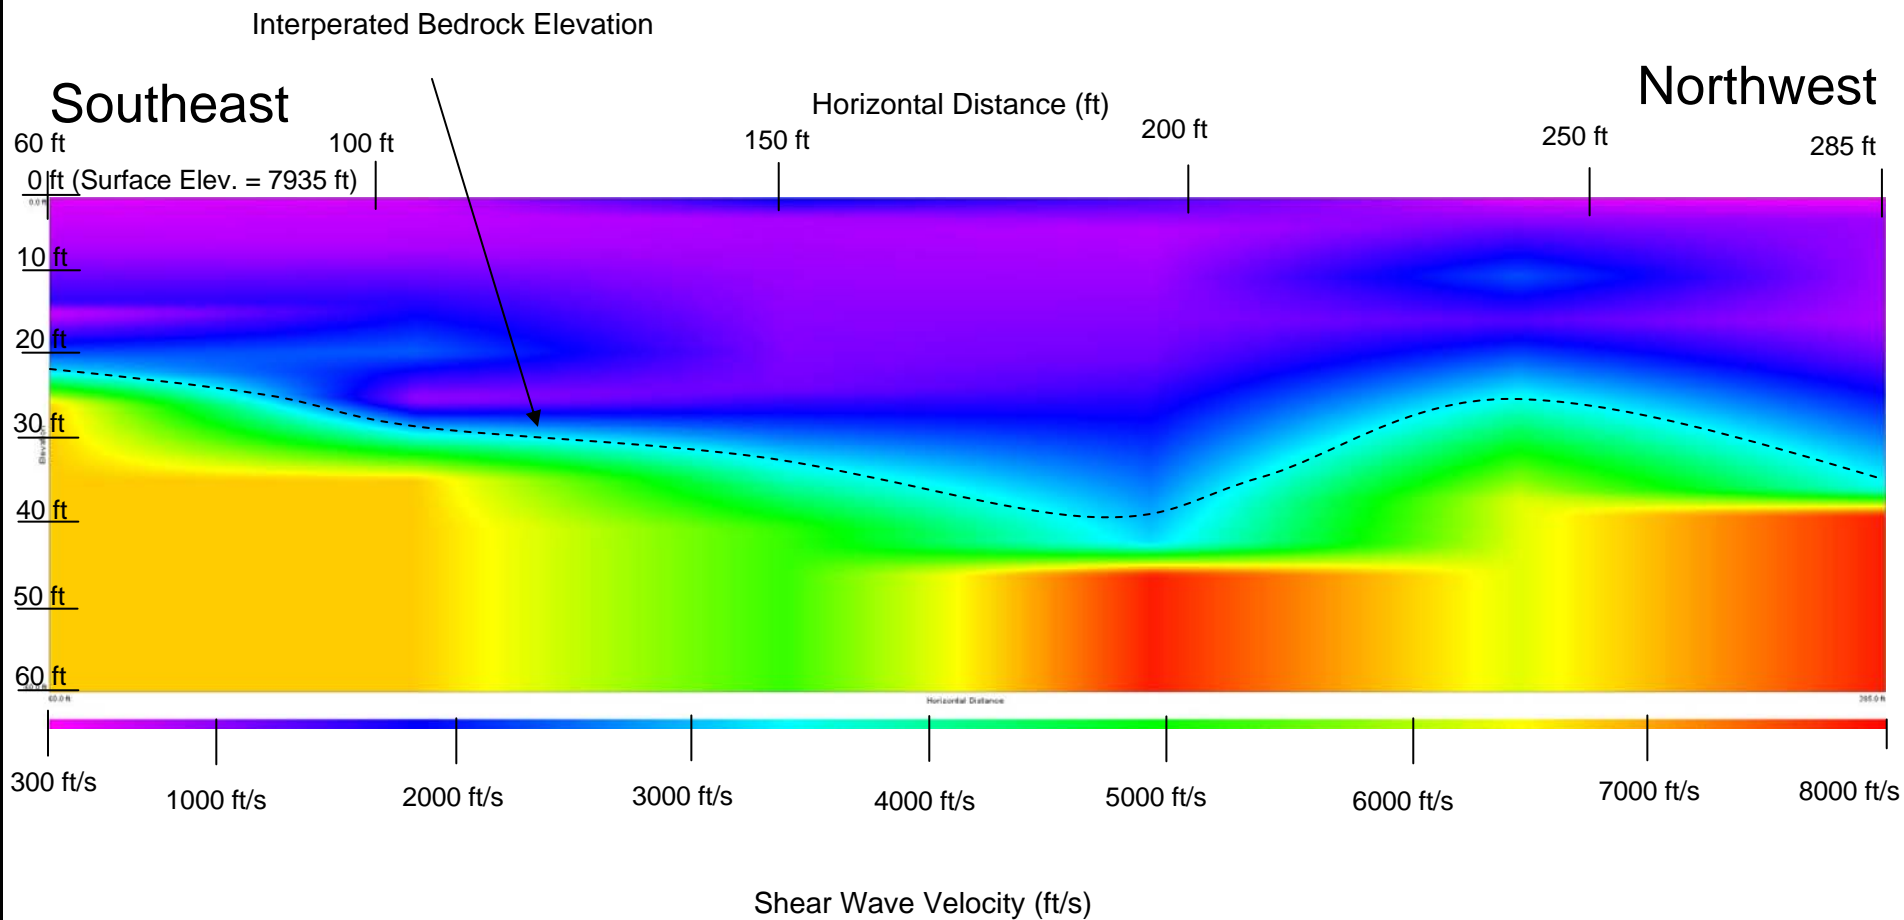
Line B13 Profile

Line 13 Shear Wave Velocity Two-Dimensional Profile
Hermosa Wind Project
Tie Siding, Wyoming

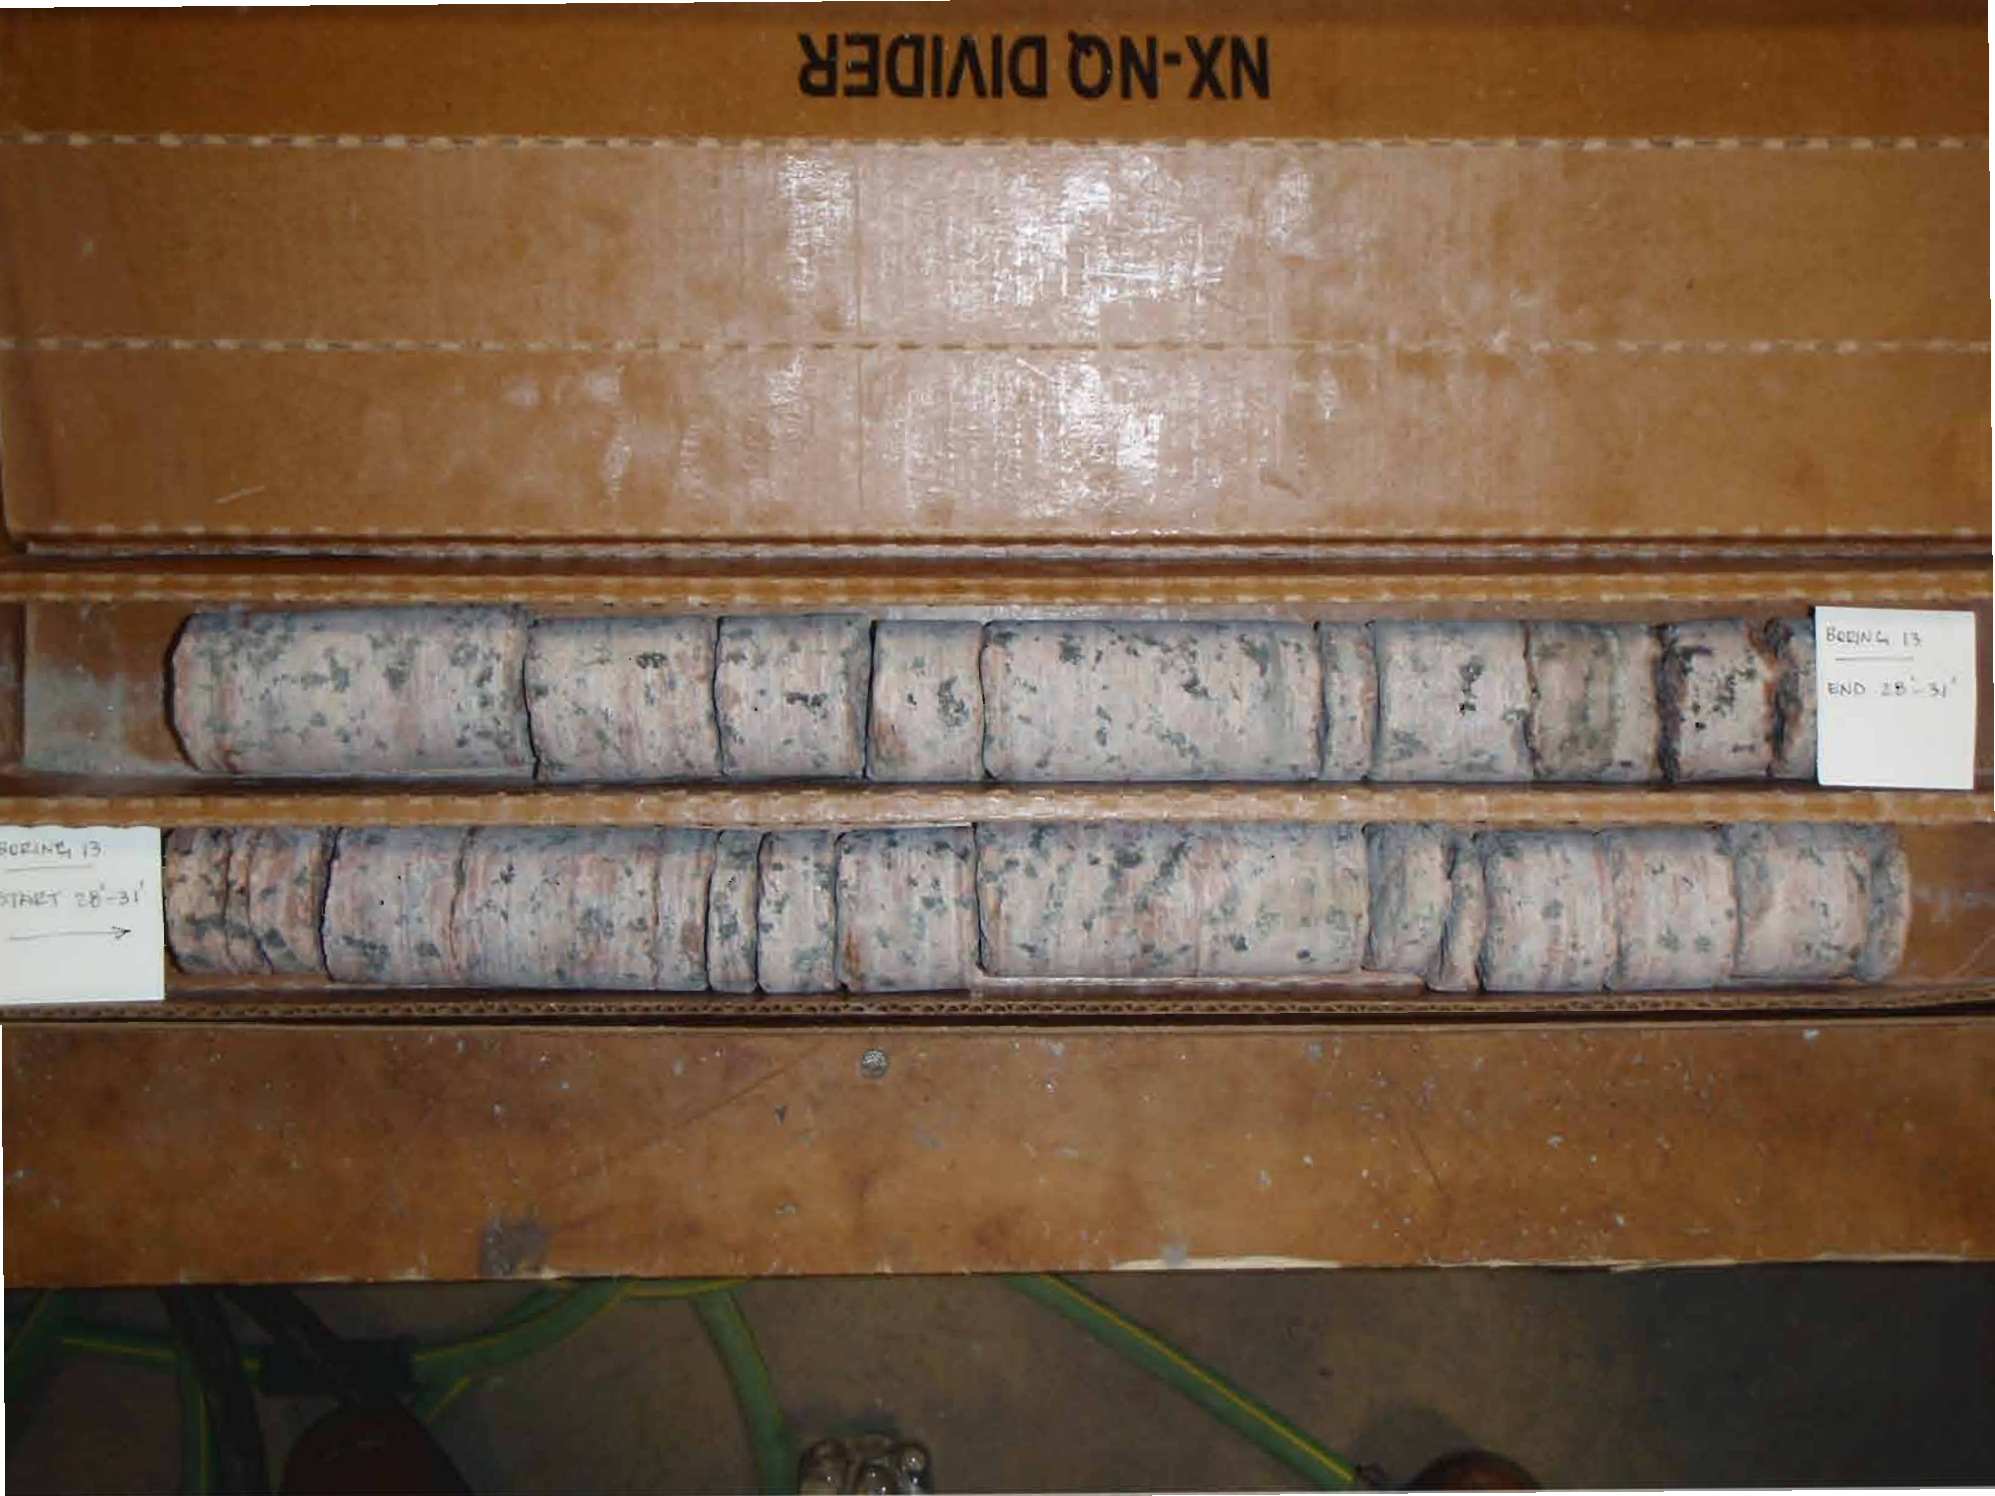
BOEING 7
END 14-20'

BOEING 7
END 10-14'
START 14-20'

BOEING 7
START 10-14'

Rock coring was started at the top of bedrock as determined by auger bit refusal. Core runs were limited to less than 6 feet long to limit damage to the core during drilling. All cores were measured for percent recovery and rock quality designation (RQD) and photographed. The rock core photographs are included in the PSI report (Attachment B). With the exception of boring B-13, all boring locations were cored 10 feet. Boring B-9 was only cored 3-1/2 feet. The coring was stopped early because of the excessive time it was taking to advance the drilling, likely due to extremely hard rock. Boring B-11 was unable to retrieve core during the coring. Field notes for the boring indicated that highly fractured granite was encountered at 5 feet to the termination of the boring.

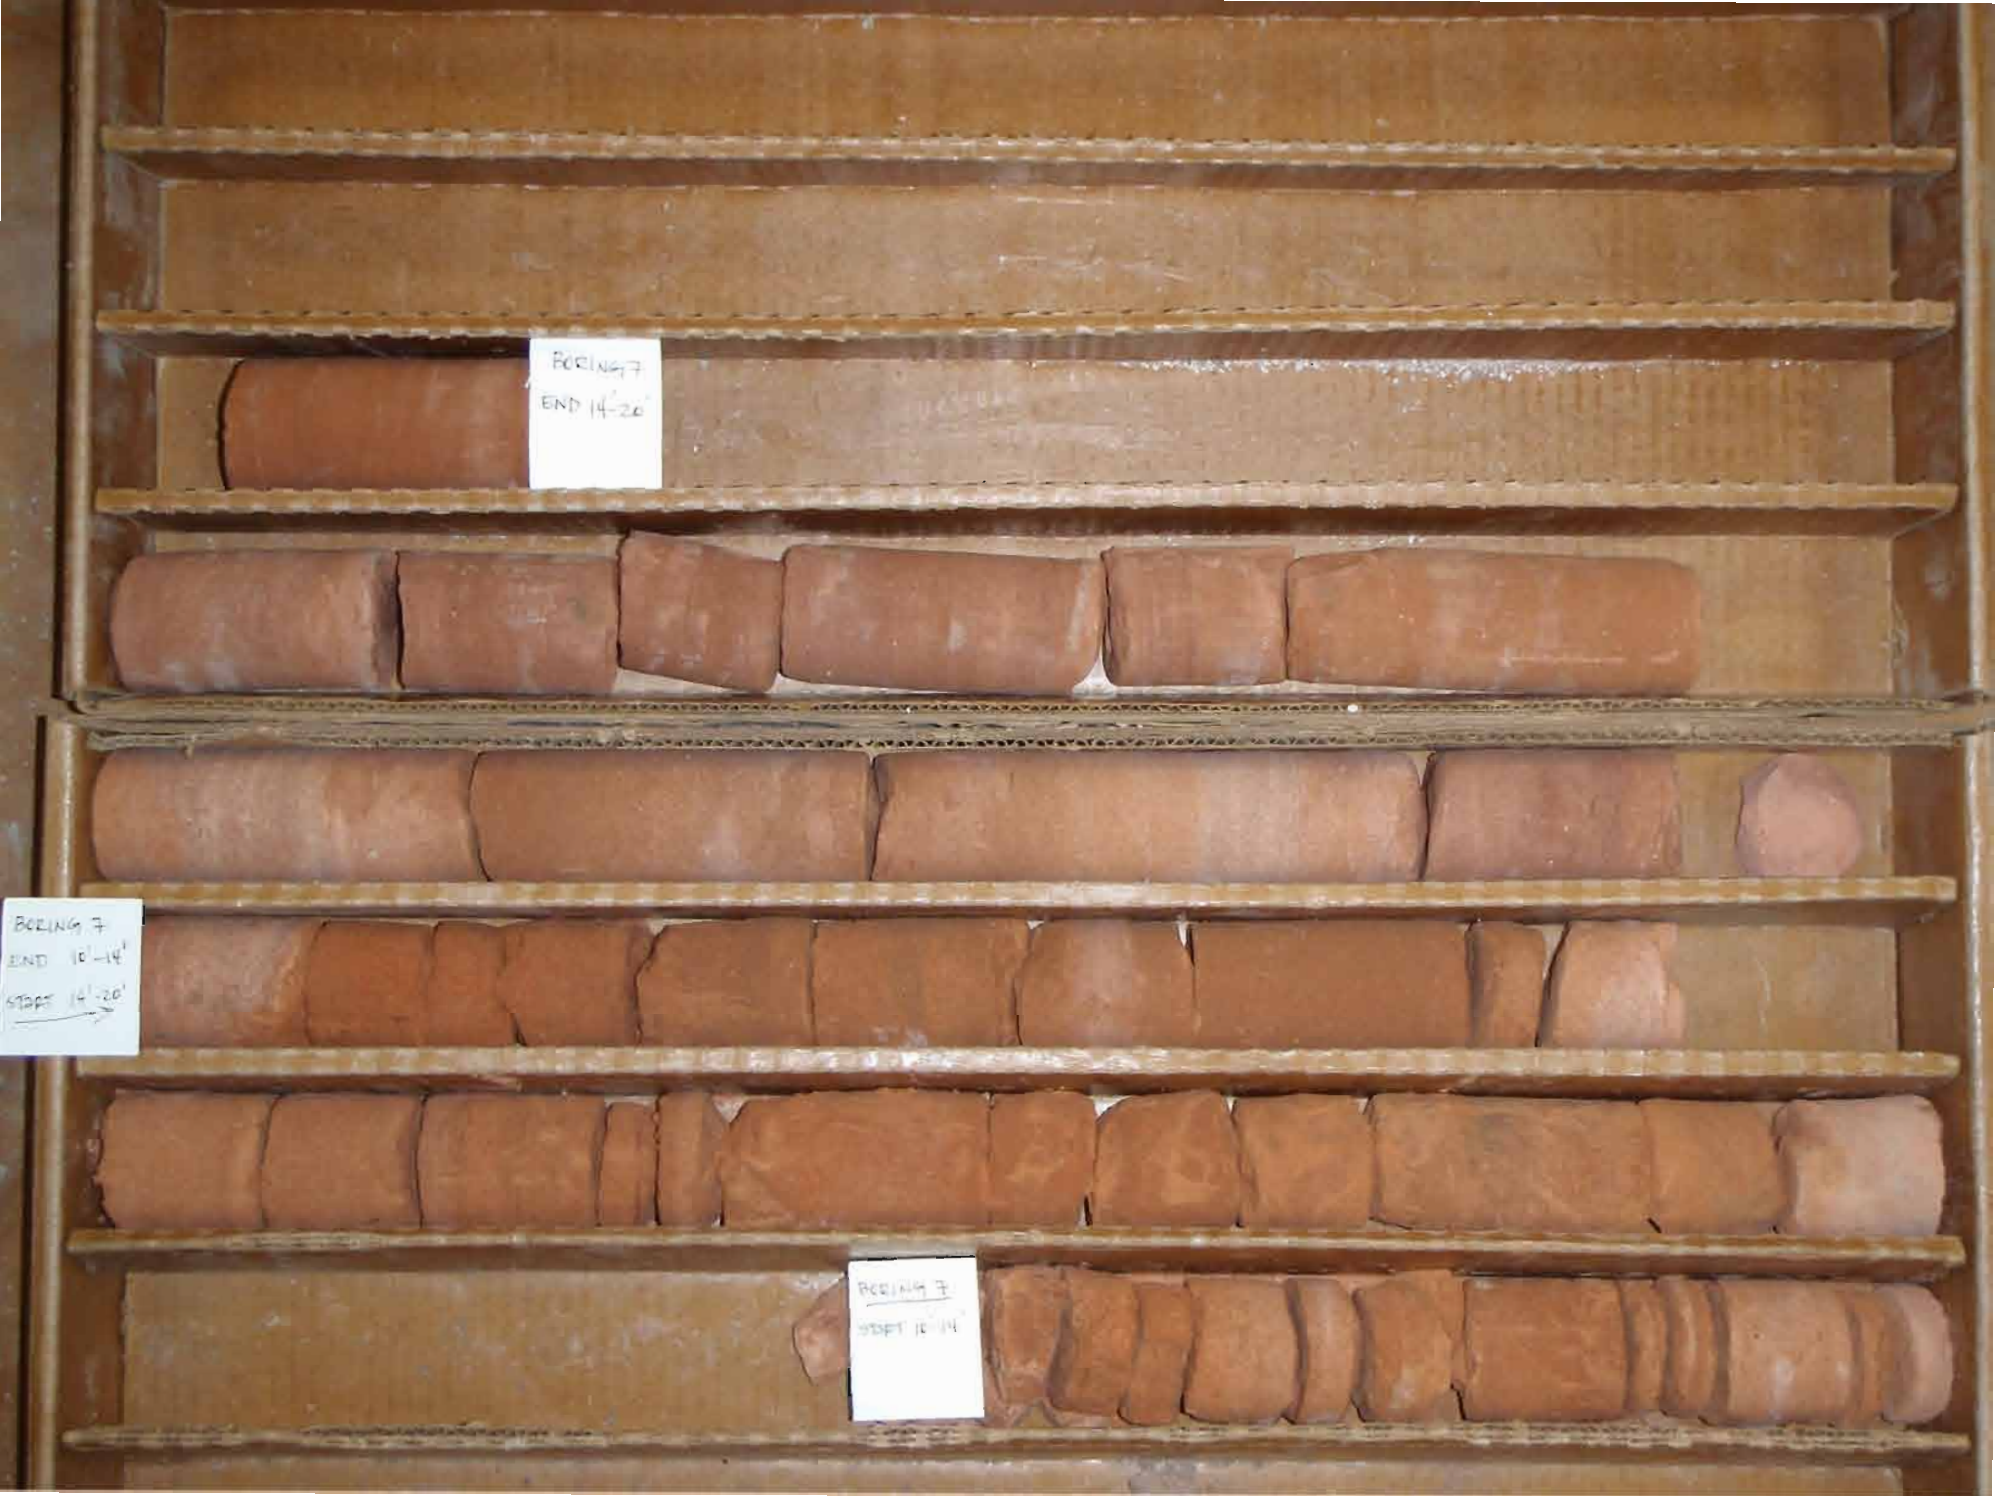
BOEING 8
START
12'-13'
→

BOEING 8
END 12-13
START 13-18
→

BOEING 8
END 13-18
START 18-23
→
