TRANSMITTAL OF THE PHASE I-LEVEL DOCUMENTATION OF FOUR HISTORIC-ERA FARMSTEAD SITES (33PK311, 33PK312, 33PK317, AND 33PK318) WITHIN THE PORTSMOUTH GASEOUS DIFFUSION PLANT, PIKE COUNTY, OHIO

Enclosed for your information is the *Phase I-Level Documentation of Four Historic-Era Farmstead Sites (33PK311, 33PK312, 33PK317, and 33PK318) within the Portsmouth Gaseous Diffusion Plant (PORTS), Pike County, Ohio*

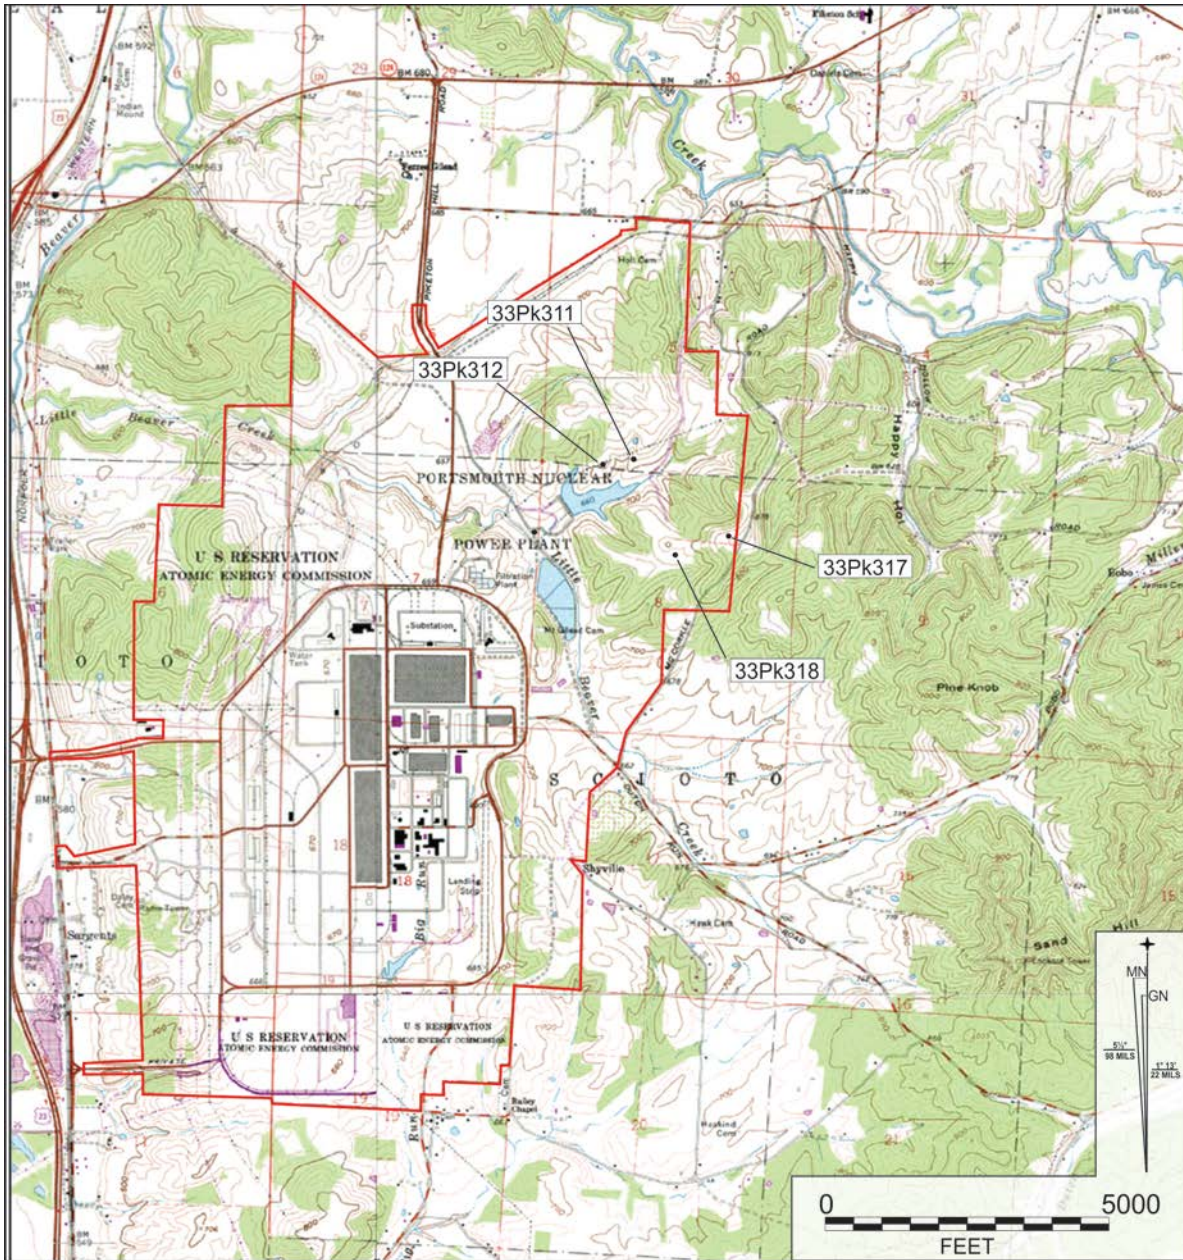
Figure 2. Portions of the 1992 Waverly South, 1961 (PR 1974, PI 1979) Piketon, 1961 (PR 1986) Wakefield, and 1961 (PR 1975) Lucasville, Ohio 7.5" USGS topographic maps showing 33Pk311, 33Pk312, 33Pk317, and 33Pk318.

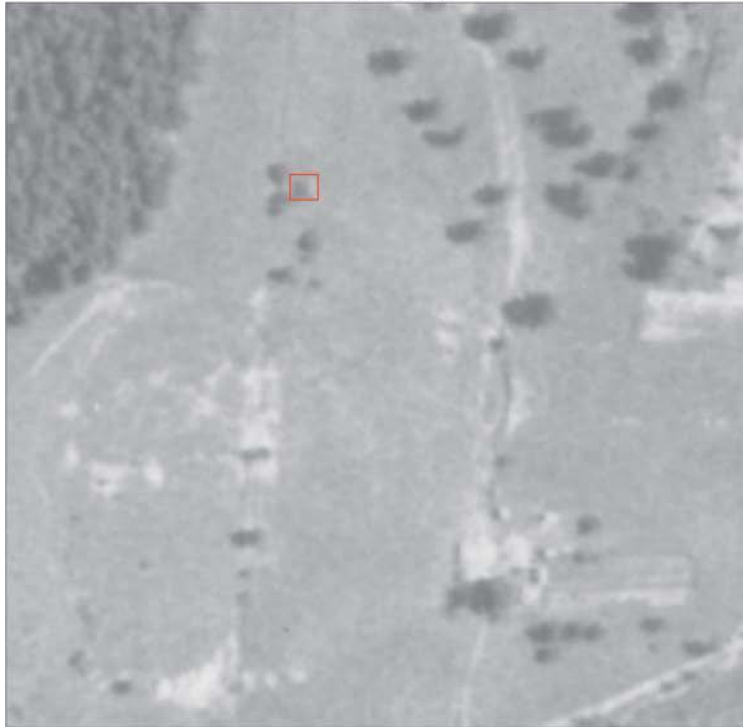
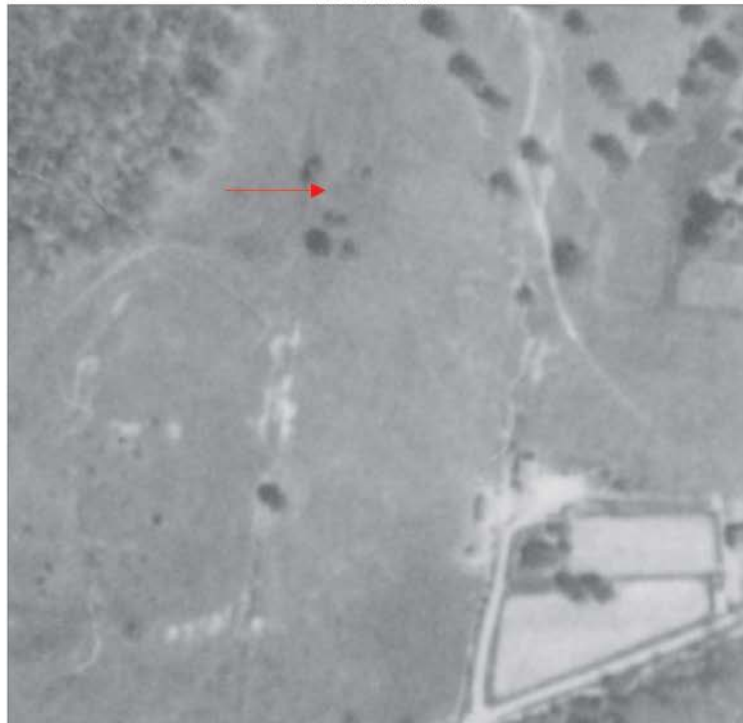
Condon Farmstead
1939 Aerial

Condon Farmstead
1951 Aerial

Figure 5. 1939 and 1951 aerial photographs showing the Condon Farmstead (33Pk312).

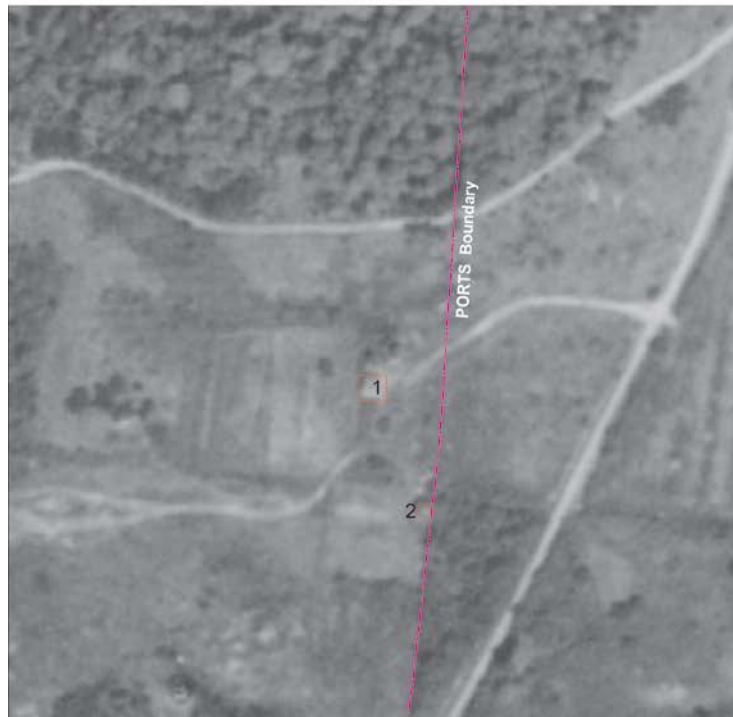
Mechling House Site
1951 Aerial

Figure 6. 1939 and 1951 aerial photographs showing the Mechling House (33Pk317).

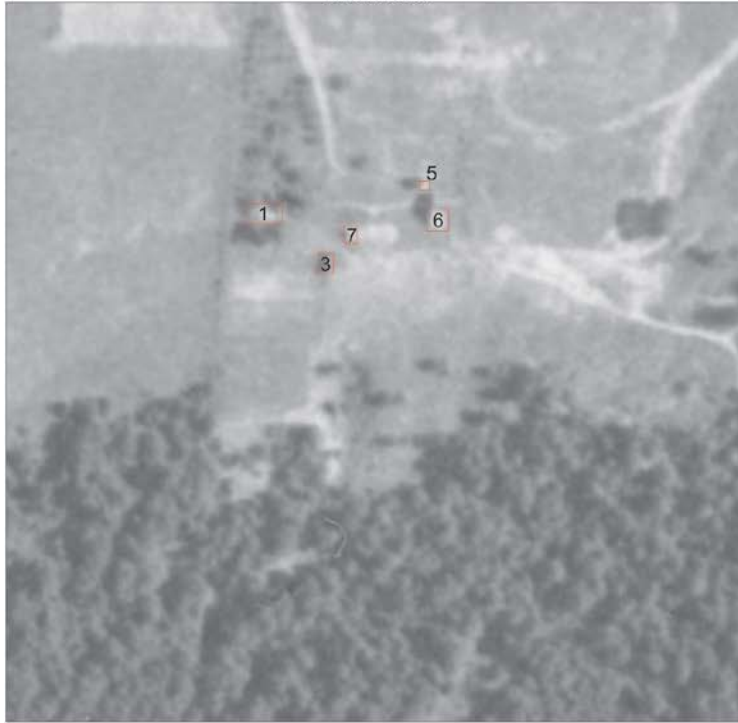
Figure 7. 1939 and 1951 aerial photographs showing the Mechling Farmstead (33Pk318).

Figure 7 depicts the Mechling Farmstead on the 1939 and 1951 aeriels. In 1939 the farmstead contains at least five structures including the probable house (#1), a barn (#6), and three outbuildings (#3, #5, and #7). A possible grove of trees (fruit?) is present just north of the house and along the west side of the driveway/road. By 1951, the Mechling Farmstead has grown to contain at least nine structures. Five of these correspond to the structures indicated on the 1939 aeriels, though their sizes may have changed. The grove of trees to the north of the house seems to have withered, though this patch of ground is still separated from the rest of the farm and being used, perhaps as a garden. By 1951, most of the open area around the farmstead appears to be cultivated fields.

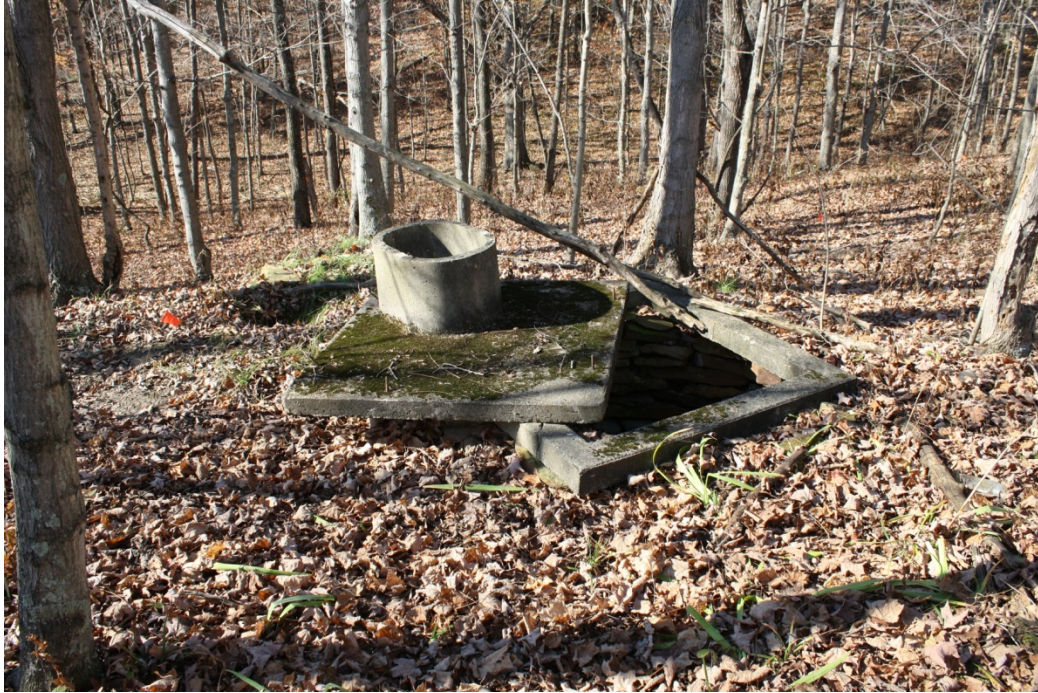
Figure 10. Photograph of Brodess Farmstead cistern.

Adjacent to the southern edge of the house foundation is a stone-lined well with a concrete top; a large cistern is located approximately 7 ft west of the cellar. The cistern is dome-shaped and appears to be made entirely of poured concrete. West of the house foundation by approximately 22 ft is a double-chambered septic system (Figures 10-11). The septic system is constructed from dry-laid sandstone fieldstone forming two subterranean cylindrical-shaped chambers. A formed concrete cap covers the eastern-most chamber.

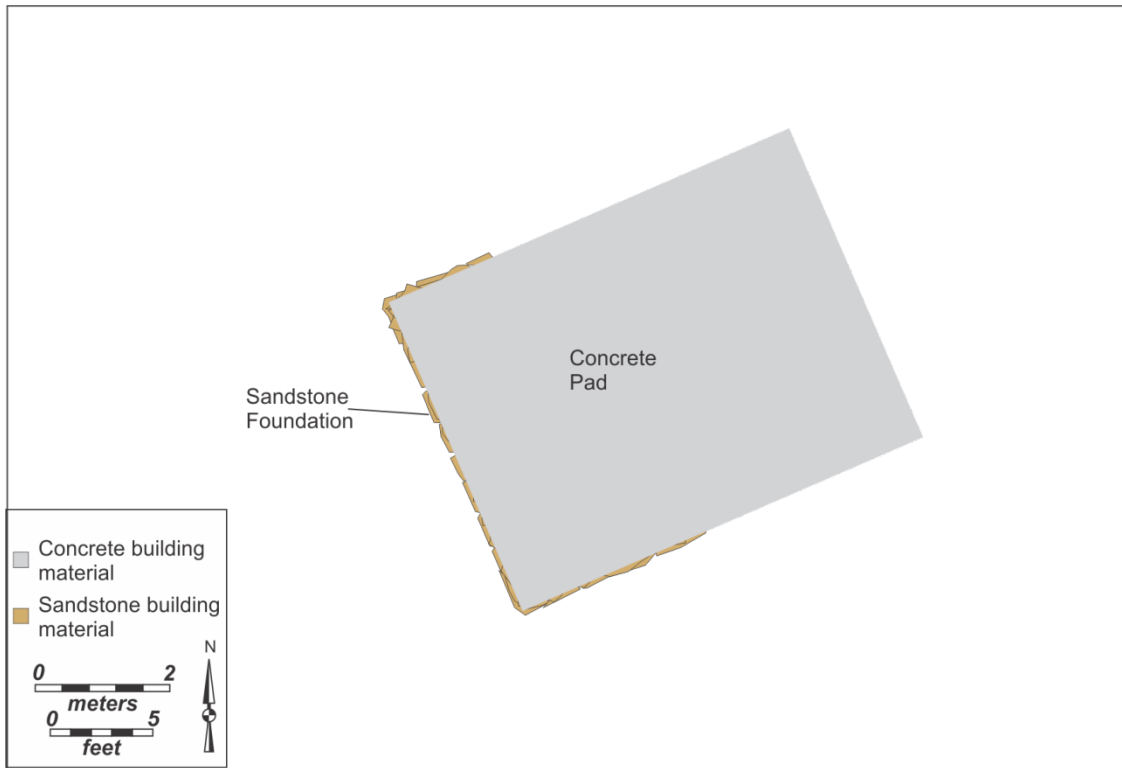
Figure 13. Plan map of a Brodess garage foundation (Structure 3).

The outbuilding foundation (#3) is a large concrete pad that sits on a dry-laid sandstone fieldstone footer located approximately 120 ft north of the house foundation and 115 ft southwest of the barn foundation (Figures 8 and 13). The foundation is a 16 ft by 20 ft rectangle and, with the concrete floor, may have served as a garage foundation. It appears that the poured concrete floor represents an improvement to an older stone outbuilding foundation. Several fragments of large stoneware crocks are present on and near this foundation.

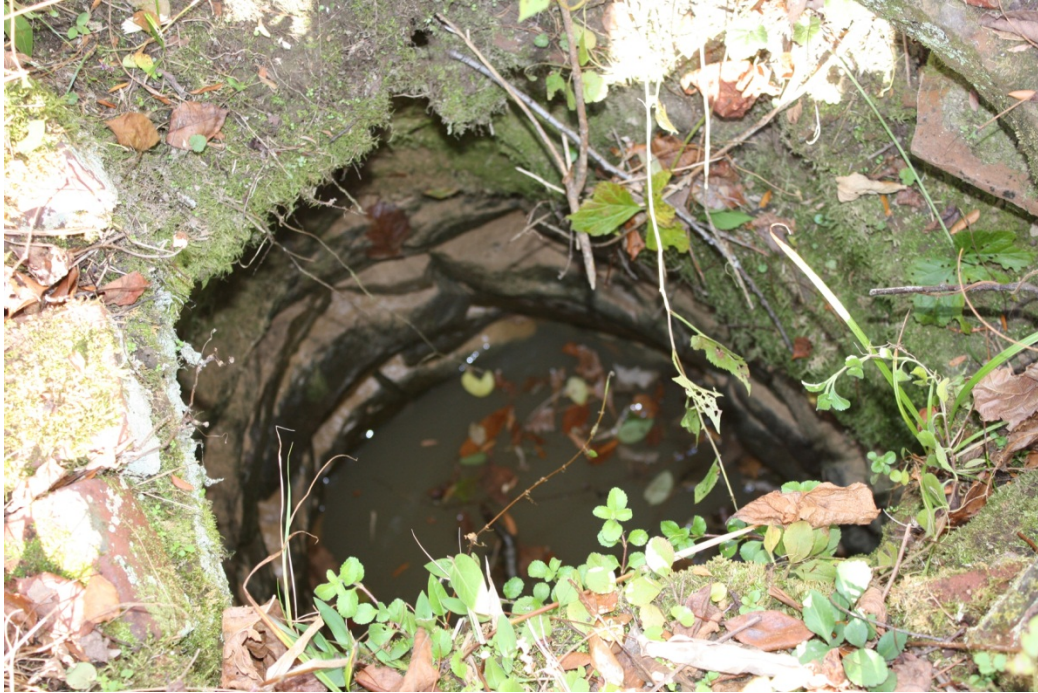
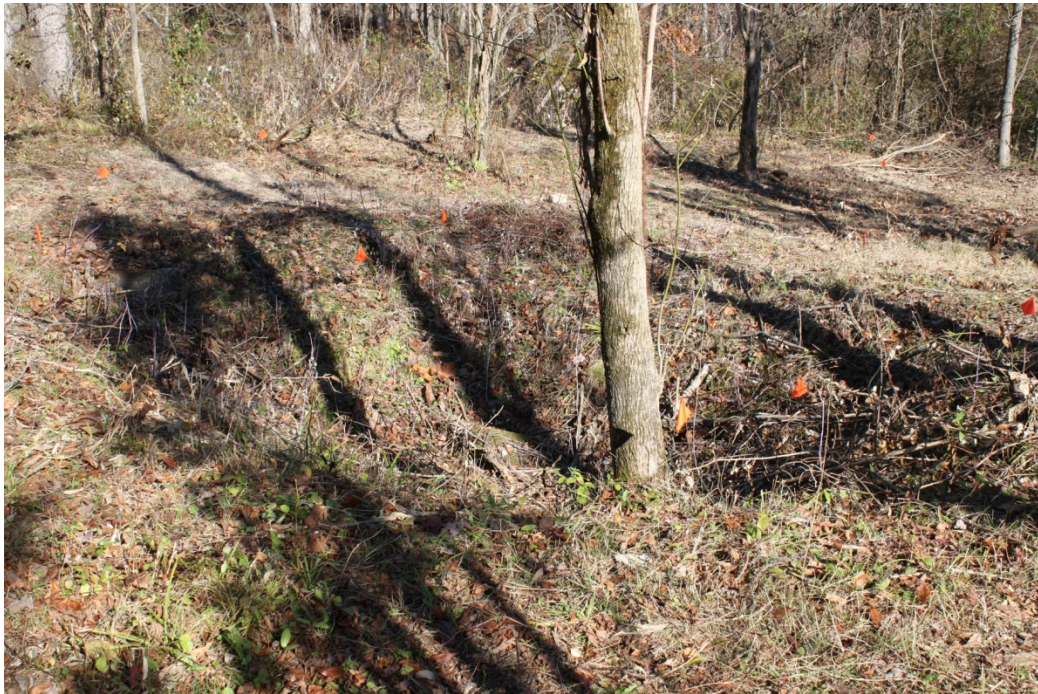
Approximately 12 ft east of the house seat is a stone-lined well and approximately 23 ft southeast of the house seat is a key-hole shaped depression (Figures 18-20). This approximately 3 ft deep depression measures 10 ft by 14 ft and has a 2.5 ft by 10 ft extension off the north side. Although no building stone was visible, this depression resembles the footprint of a subterranean root cellar. Root cellars with similar footprint plan shapes were found on other PORTS farmstead sites, including the Mechling House Site (33Pk317) and Mechling Farmstead (33Pk318).

Figure 18. Plan map illustration of the Condon Farmstead (33Pk312).

Figure 19. Photograph of Condon Farmstead well.

Figure 20. Photograph of Condon Farmstead root cellar depression.

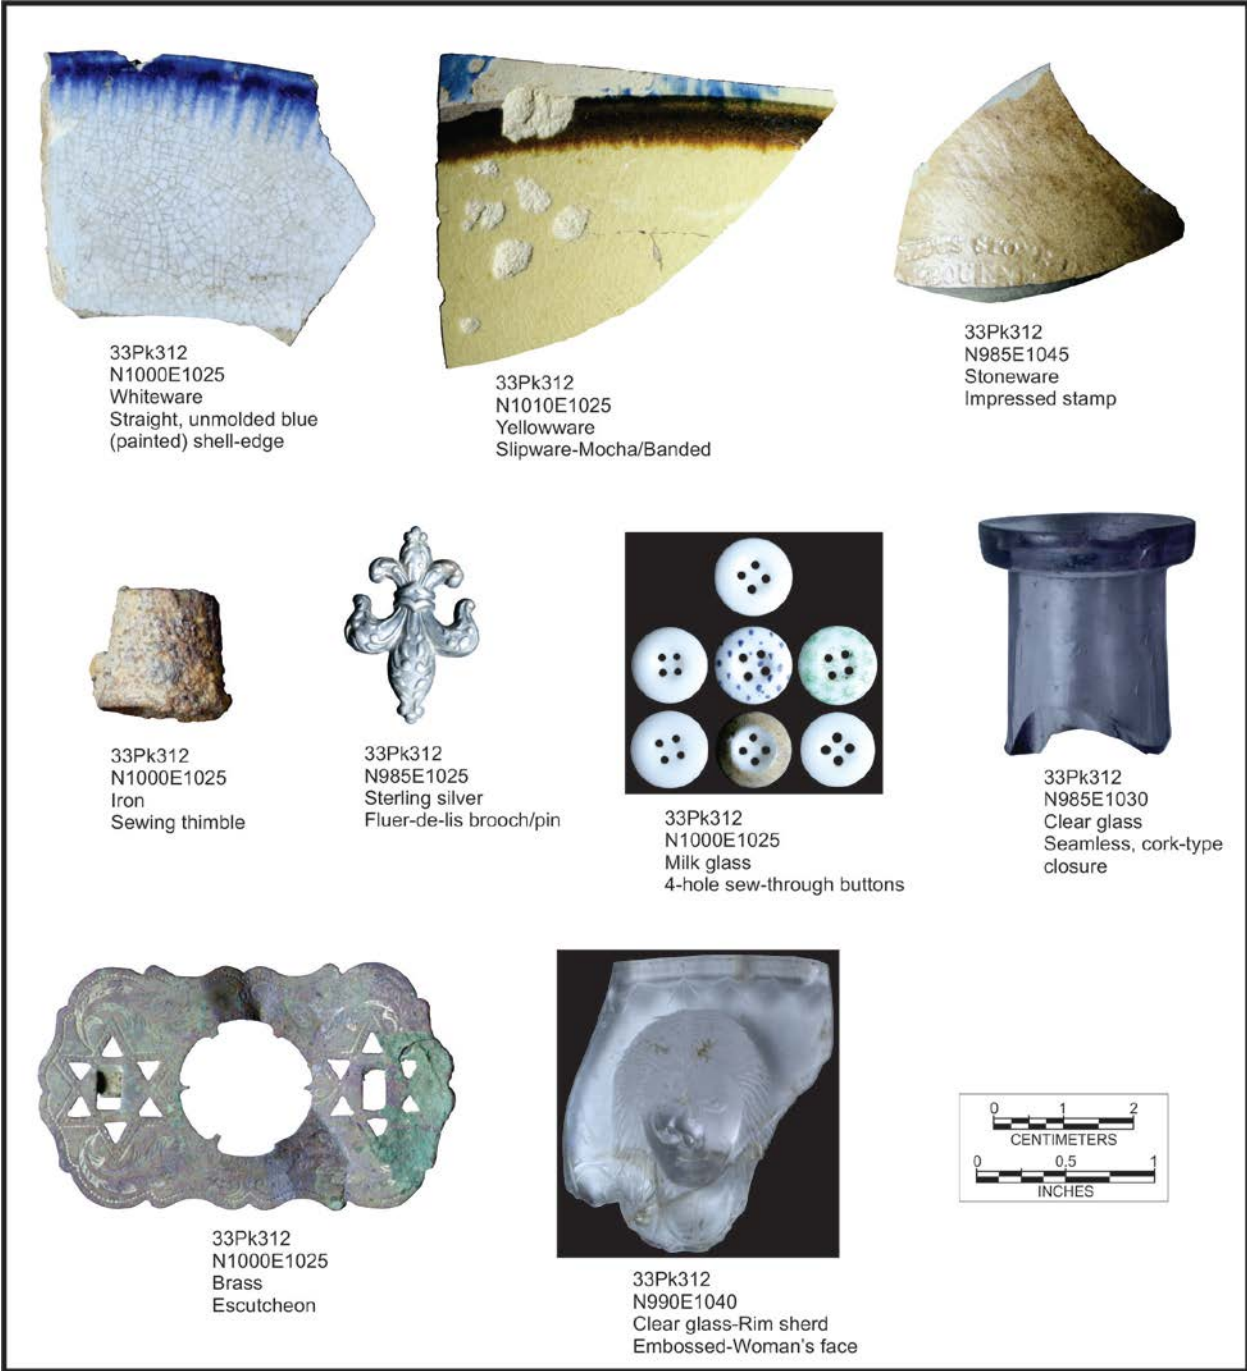
Figure 21. Images of selected artifacts from the Condon Farmstead.

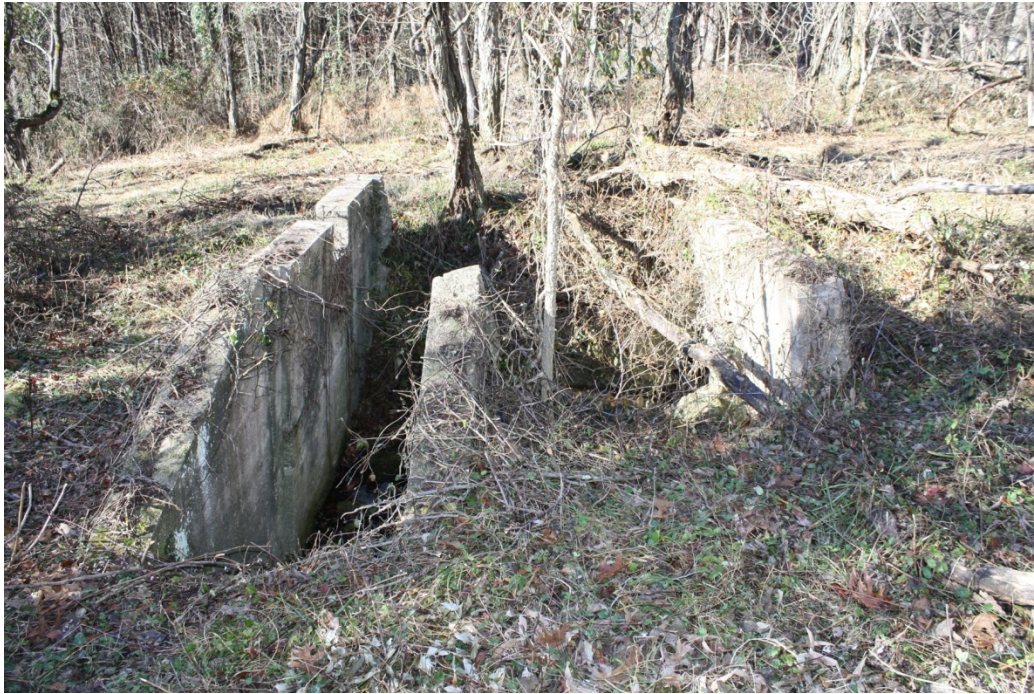
The poured concrete root cellar is located approximately 5.5 ft of the southwest corner of the house seat (Figures 31, 33-34). This cellar is a 9.5 ft by 10 ft rectangle with a 4 ft wide by 5 ft long stairwell on the west side. The walls of the cellar are 5.5 ft tall, but extend approximately 1.5 ft above the ground surface. Although the floor was covered with water, a probe indicated that it was made with poured concrete. The eastern and western walls are collapsed, but iron bolts evenly spaced along the tops of the intact walls demonstrate that the structure had a wood super structure above the foundation walls.

Figure 33. Plan map illustration of the Mechling Farmstead root cellar (Structure 2).

Figure 34. Photograph on the Mechling Farmstead House root cellar.

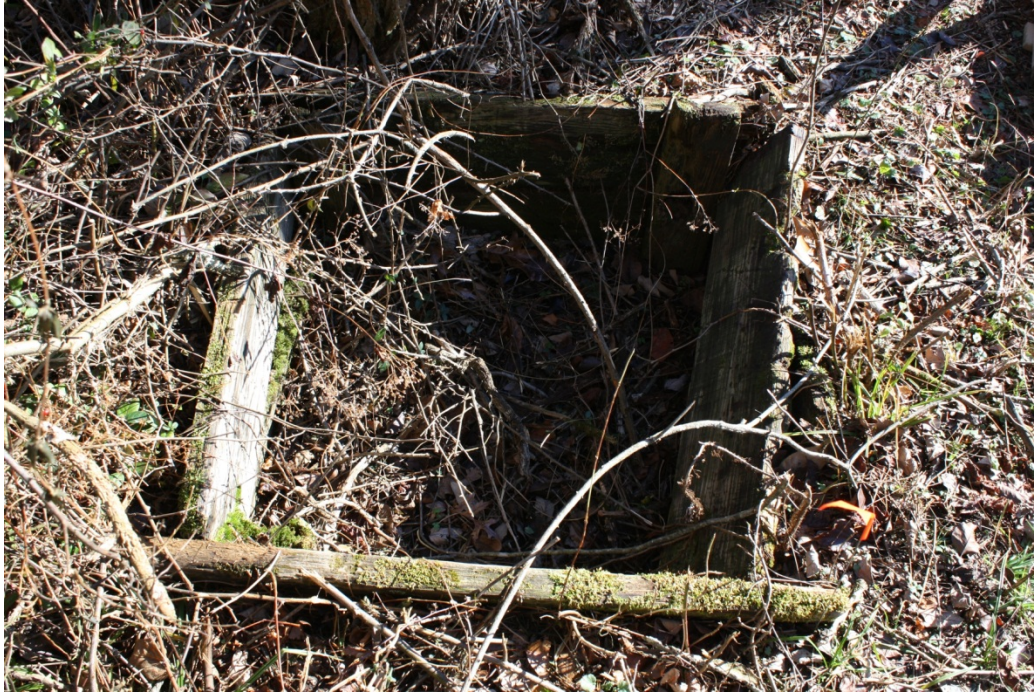
A cluster of two, or possibly three, privy pits were documented approximately 35 feet southwest of the house seat (Figures 31, 36-37). A small privy-sized structure is indicated in this area on the 1951 aerial. The northern most privy is represented by 3.5 ft by 3.5 ft square subterranean box made with 2"x8" wood planks. The vault is filled in to 1.5 ft below surface. The eastern most privy is a 1.5 ft deep by 5 ft square depression. No building material was visible, but its size and shape is reminiscent of a filled in privy pit. The third is tentatively thought to be a privy, but it is represented by a 3ft square pavement of sandstone flagstone. Its size and orientation is similar to the wood-lined privy vault to the north, and it is possible that it is an older privy pit that was filled in and capped with stone.

Figure 36. Plan map illustration of the Mechling Farmstead privies (Structure 4) and barn cistern (Structure 5).

Figure 37. Photograph of Mechling Farmstead wood-lined privy vault.

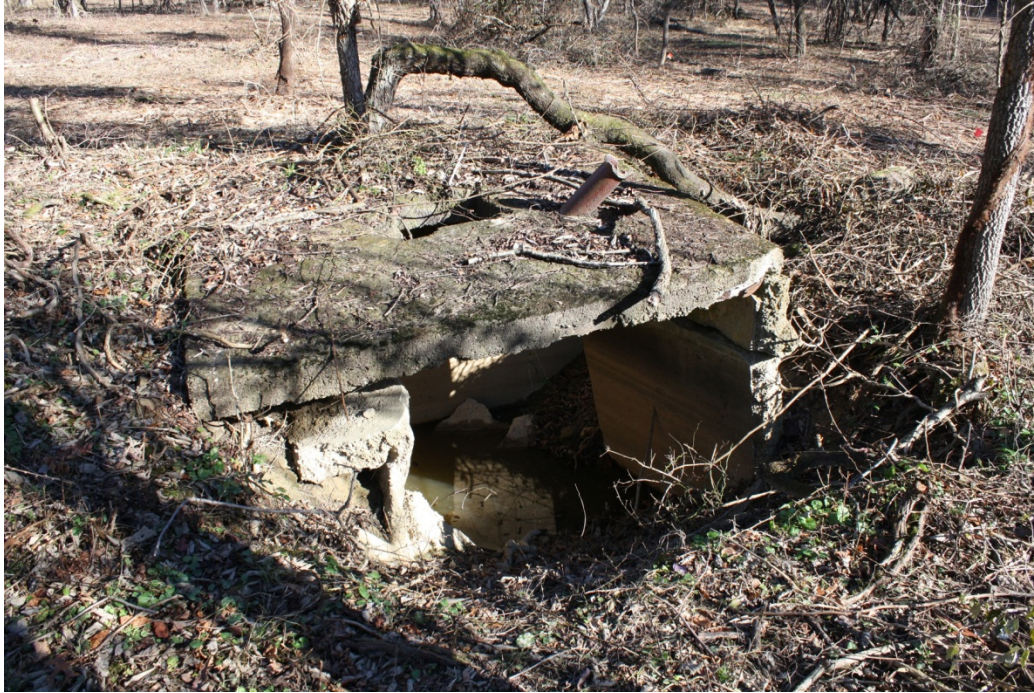
Figure 38. Photograph of the Mechling Farmstead cistern.

A poured-concrete cistern is located 120 ft northeast of the house seat (Figures 31, 36 and 38). The cistern is partially collapsed, but it was an 8.5 ft square by 7 ft deep structure with a square portal and tile vent on its cap. The floor of the cistern is also made of concrete. A structure is indicated in this area on the 1939 and 1951 aerials, though why a structure would sit atop a cistern is not clear. The cistern location is adjacent to a large barn-like structure that is also visible on both aerials. If this structure was a dairy barn, the cistern would have been an important component for dairy sanitation.

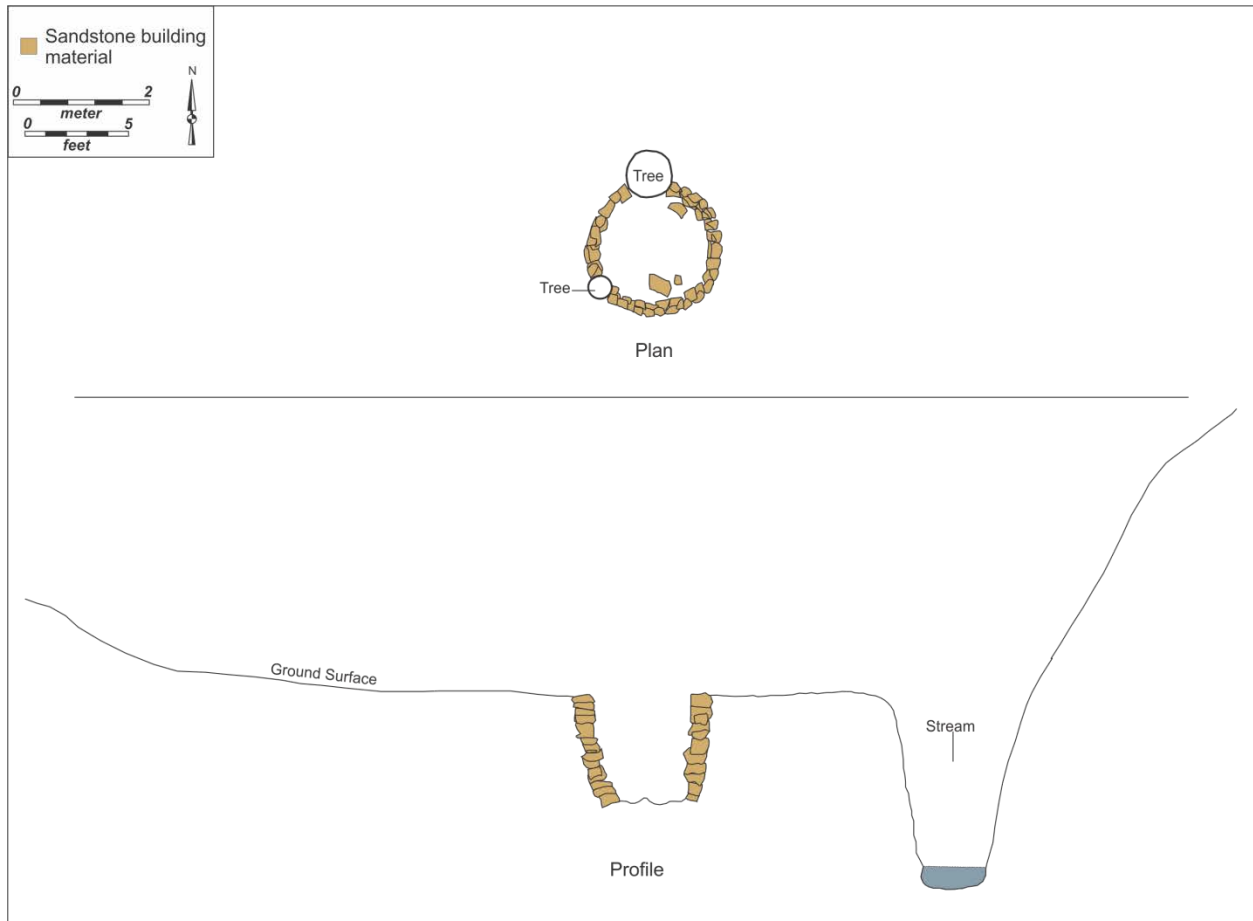
Figure 39. Plan map illustration of the Mechling Farmstead well/water catch.

A stone-lined water catch is located approximately 315 ft southeast of the house seat in the bottom of a steep-sided, narrow draw (Figures 31 and 39). This feature resembles a shallow well, but is 6.5 feet in diameter and five feet deep. Given the distance from the house and any known outbuildings, this feature probably served as a water catch meant to water livestock in a pasture.

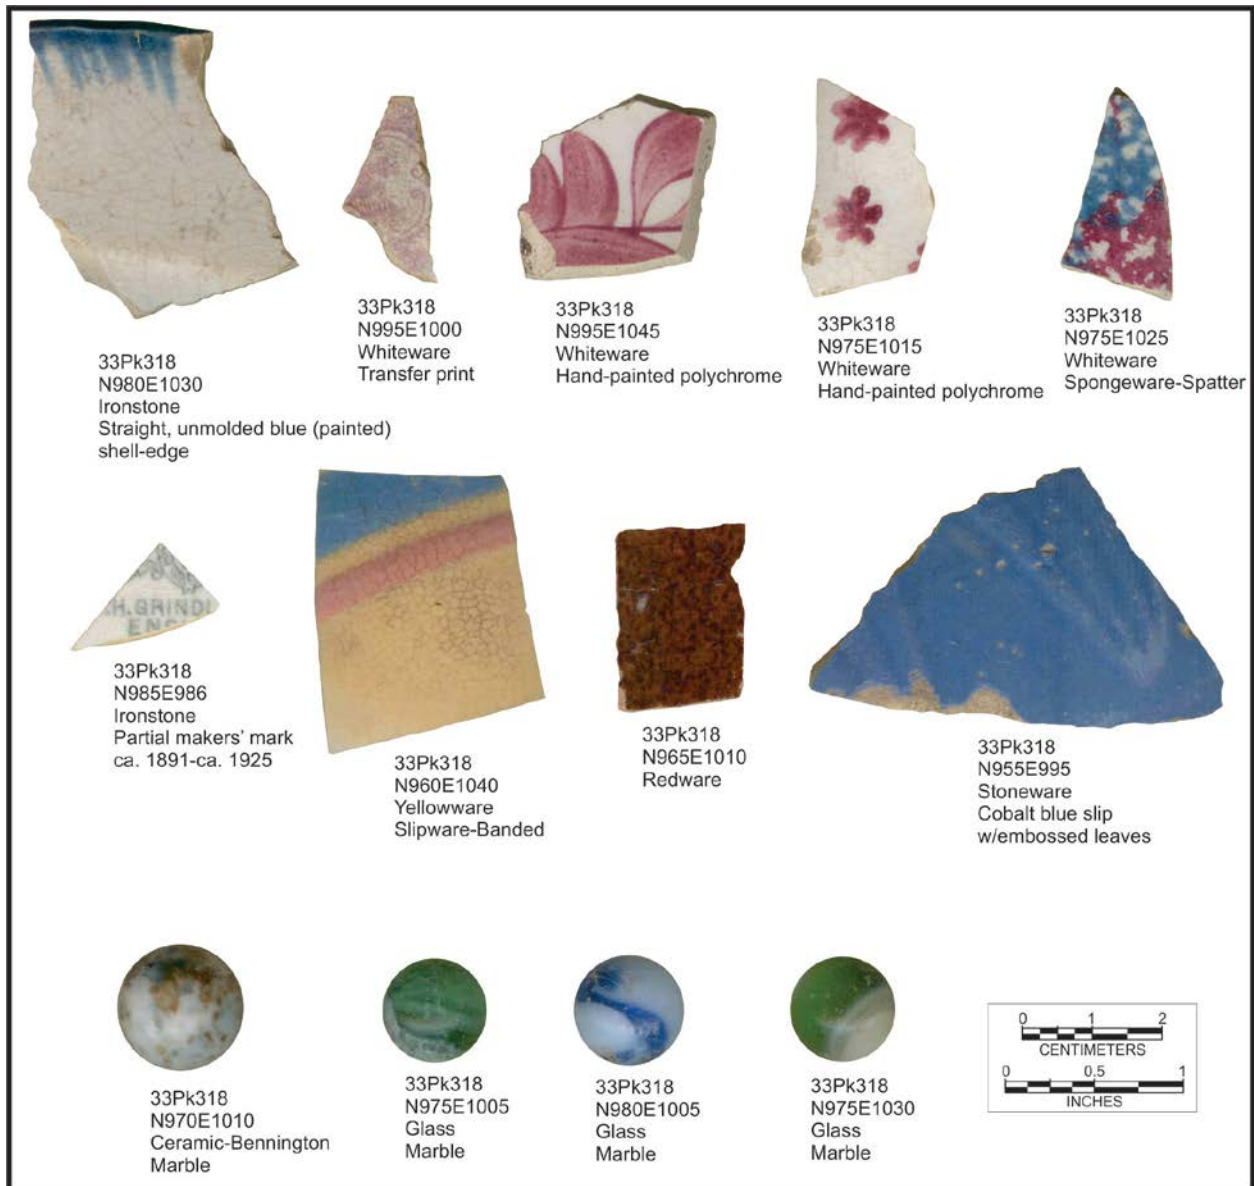
Figure 40. Images of selected artifacts from the Mechling Farmstead.

Personal items are rare in the Mechling Farmstead assemblage and are limited to a few clothing related items and marbles. One of the marbles is a Bennington ceramic marble, which was manufactured around 1870 (Gartley and Carskadden 1998) (Figure 40).

Excluding the three redware sherds, the decorated whiteware is potentially the oldest datable artifact type in this assemblage. This artifact type, however, is also very rare and is comprised of only eight artifacts (Figure 40). The remainder of the whiteware assemblage is plain or undecorated. Decorated whiteware includes hand-painted polychrome (ca. 1830-1860) (MACL 2003), banded slipware (ca. 1830-1850) (Sussman 1997), blue and red spongeware-spatter (ca. 1820-1860) (MACL 2003), and mulberry transfer-print (ca. 1818-1870) (Samford 1997). Most of the ironstone and all of the semi-vitreous porcelain were manufactured late in the nineteenth century and into the twentieth century. The small yellowware assemblage and larger stoneware assemblage represent items that could have been manufactured in the early part of the nineteenth century, but continued to be produced into the 1930s and 1940s.
