# **Stainless Steel Canister Challenges**

**Steve Marschman**  
**Field Demonstration Lead**  
**Idaho National Laboratory**

**NEET ASI Review Meeting**  
**September 17, 2014**

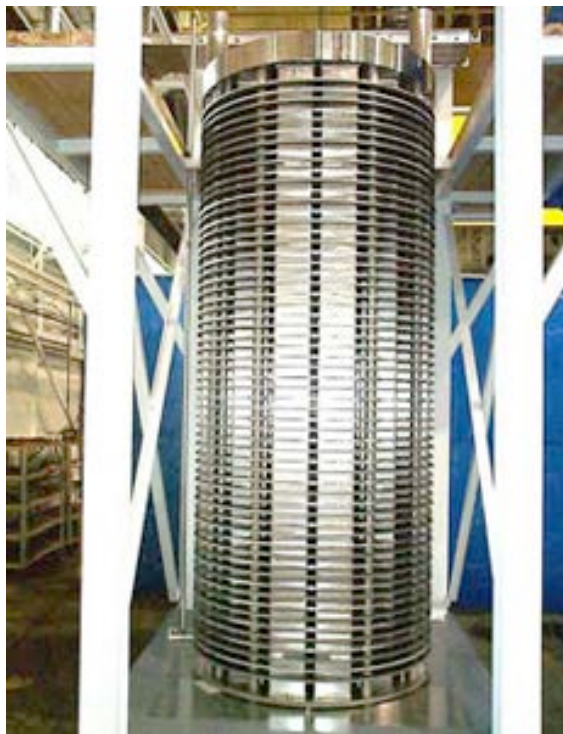
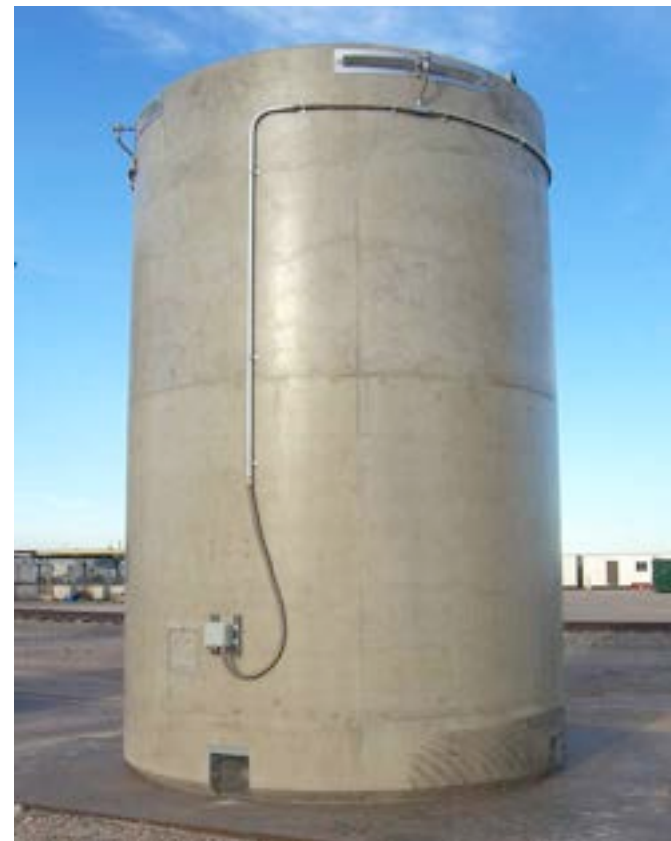
- **NAC International, Inc.**
- **UMS (transportable canister in NAC-STC)**
- **24 PWR or 56 BWR**

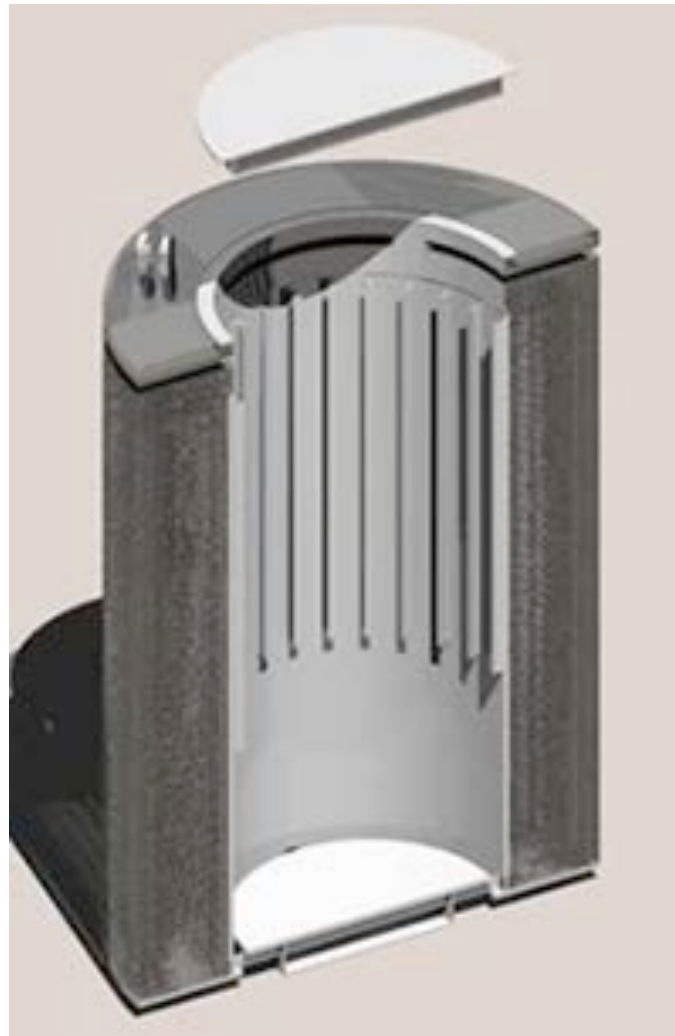
- **MagnaStor**
- **Newly in-service**
- **37 PWR or 87 BWR**

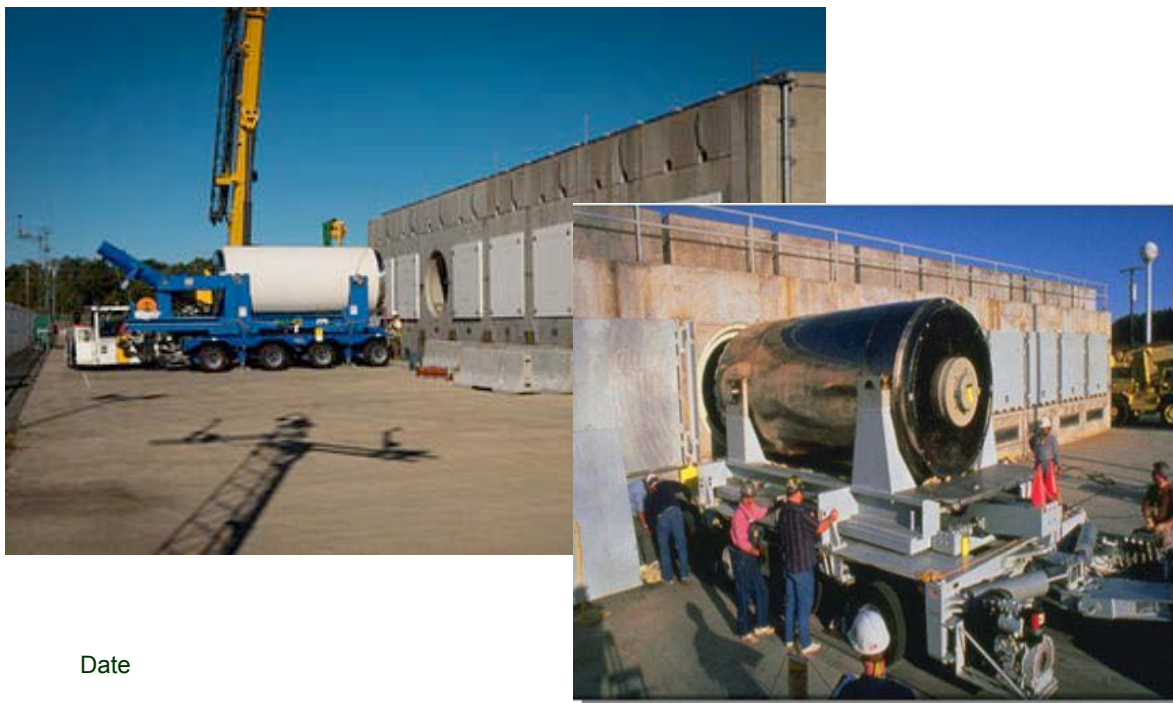
- AREVA-TN NUHOMS horizontal storage system
- 32-37 PWRs or 61-69 BWRs
- Canisters transferable using MP197HB transport cask

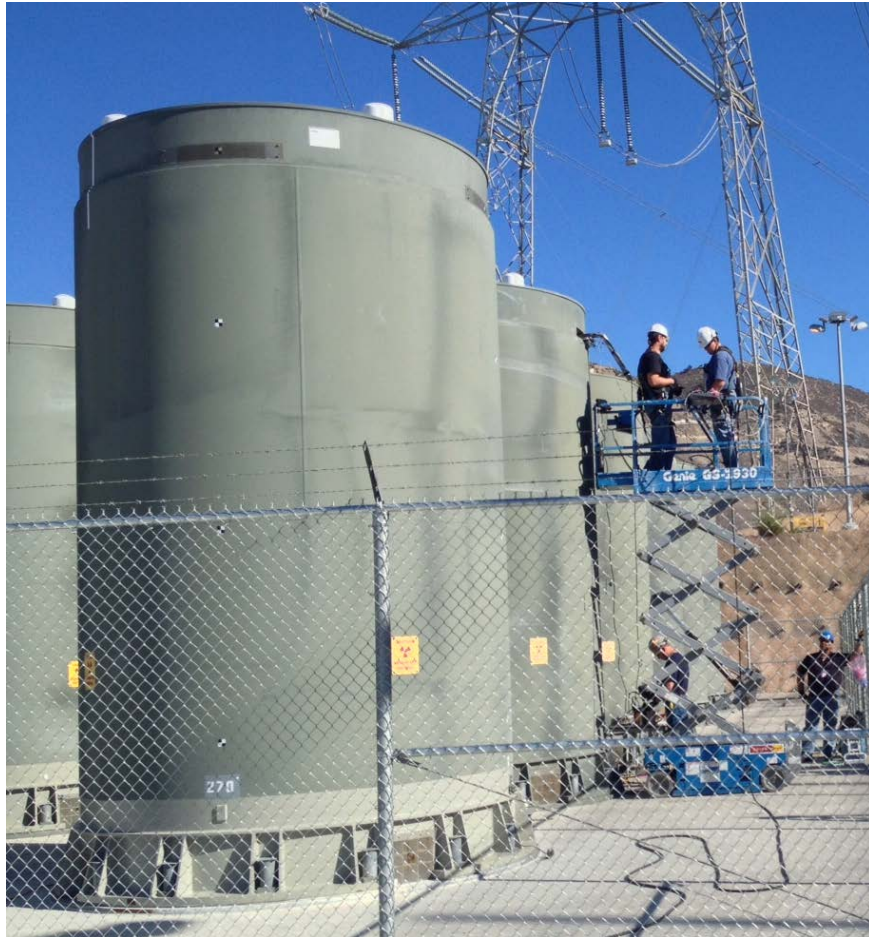
**These two Hi-Storms are not the same. Can you see the differences?**

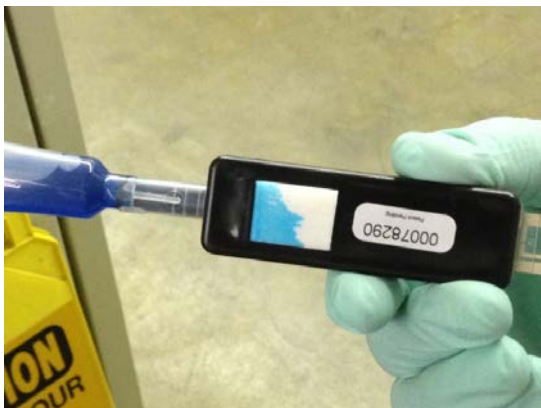
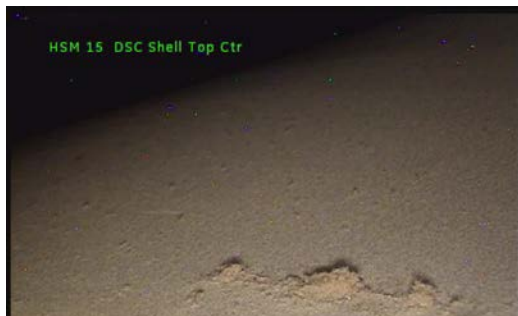
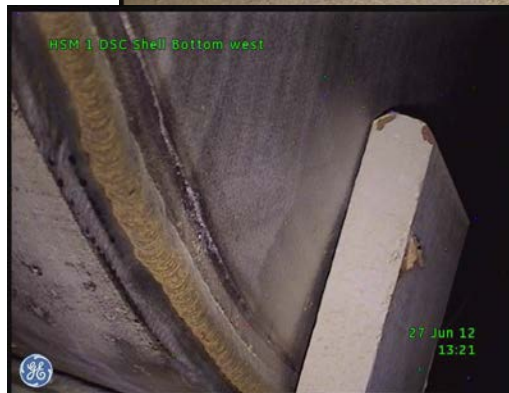
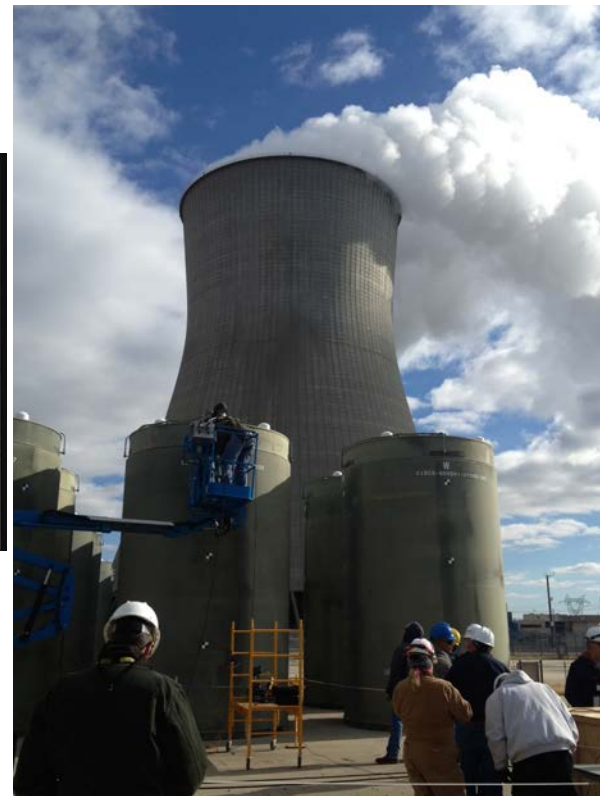
- EPRI led three examinations (partly funded by DOE); Calvert Cliffs, Hope Creek, Diablo Canyon
- Inspections generally consisted of:
  - Temperature measurements of cask at points inside the annulus between the cask and canister
  - SaltSmart™ measurements in similar locations
  - Dust collection from the cask lid
  - Visual inspection

- Visual Inspection
  - We did not see any evidence of cracking, but did we have good enough imaging capability?
    - Color could be misleading. If something appears orange-brown, is that really corrosion (on SS)?

- Very limited in surface area that could be covered (particularly for Holtec Hi-Storms)
    - Lighting inconsistent
- Sampling for “Dust”
  - Use of a spun nylon/alumina pad to collect samples was difficult.

- Hard to get pressure on the surface
    - Some sample falls off
    - Hot canisters partially melted the nylon substrate
  - “Salts” can degrade in handling and shipping; did we alter the sample through the sampling process?

- SaltSmart Device
  - Used a device outside its design space
  - Effected by heat and gravity
  - Instrument could never be correlated to laboratory analyses.

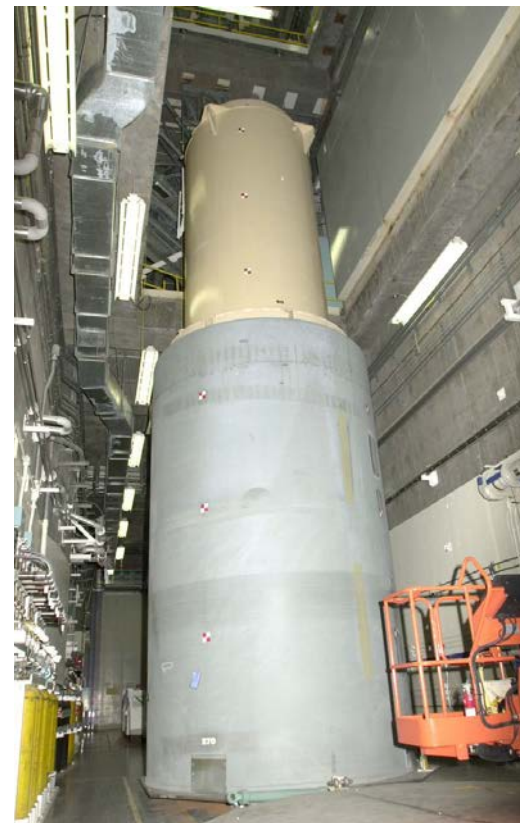
- Canisters do not sit straight
- Canisters may not be centered
- Nothing is truly round
- Tolerances are fairly large
