**Group 5 - Central Portion of Areas III and IV  
RCRA Facility Investigation Report  
Santa Susana Field Laboratory,  
Ventura County, California**

**Volume VII - RFI Site Reports  
Appendix M**

**Building 65 Metals Laboratory Clarifier**

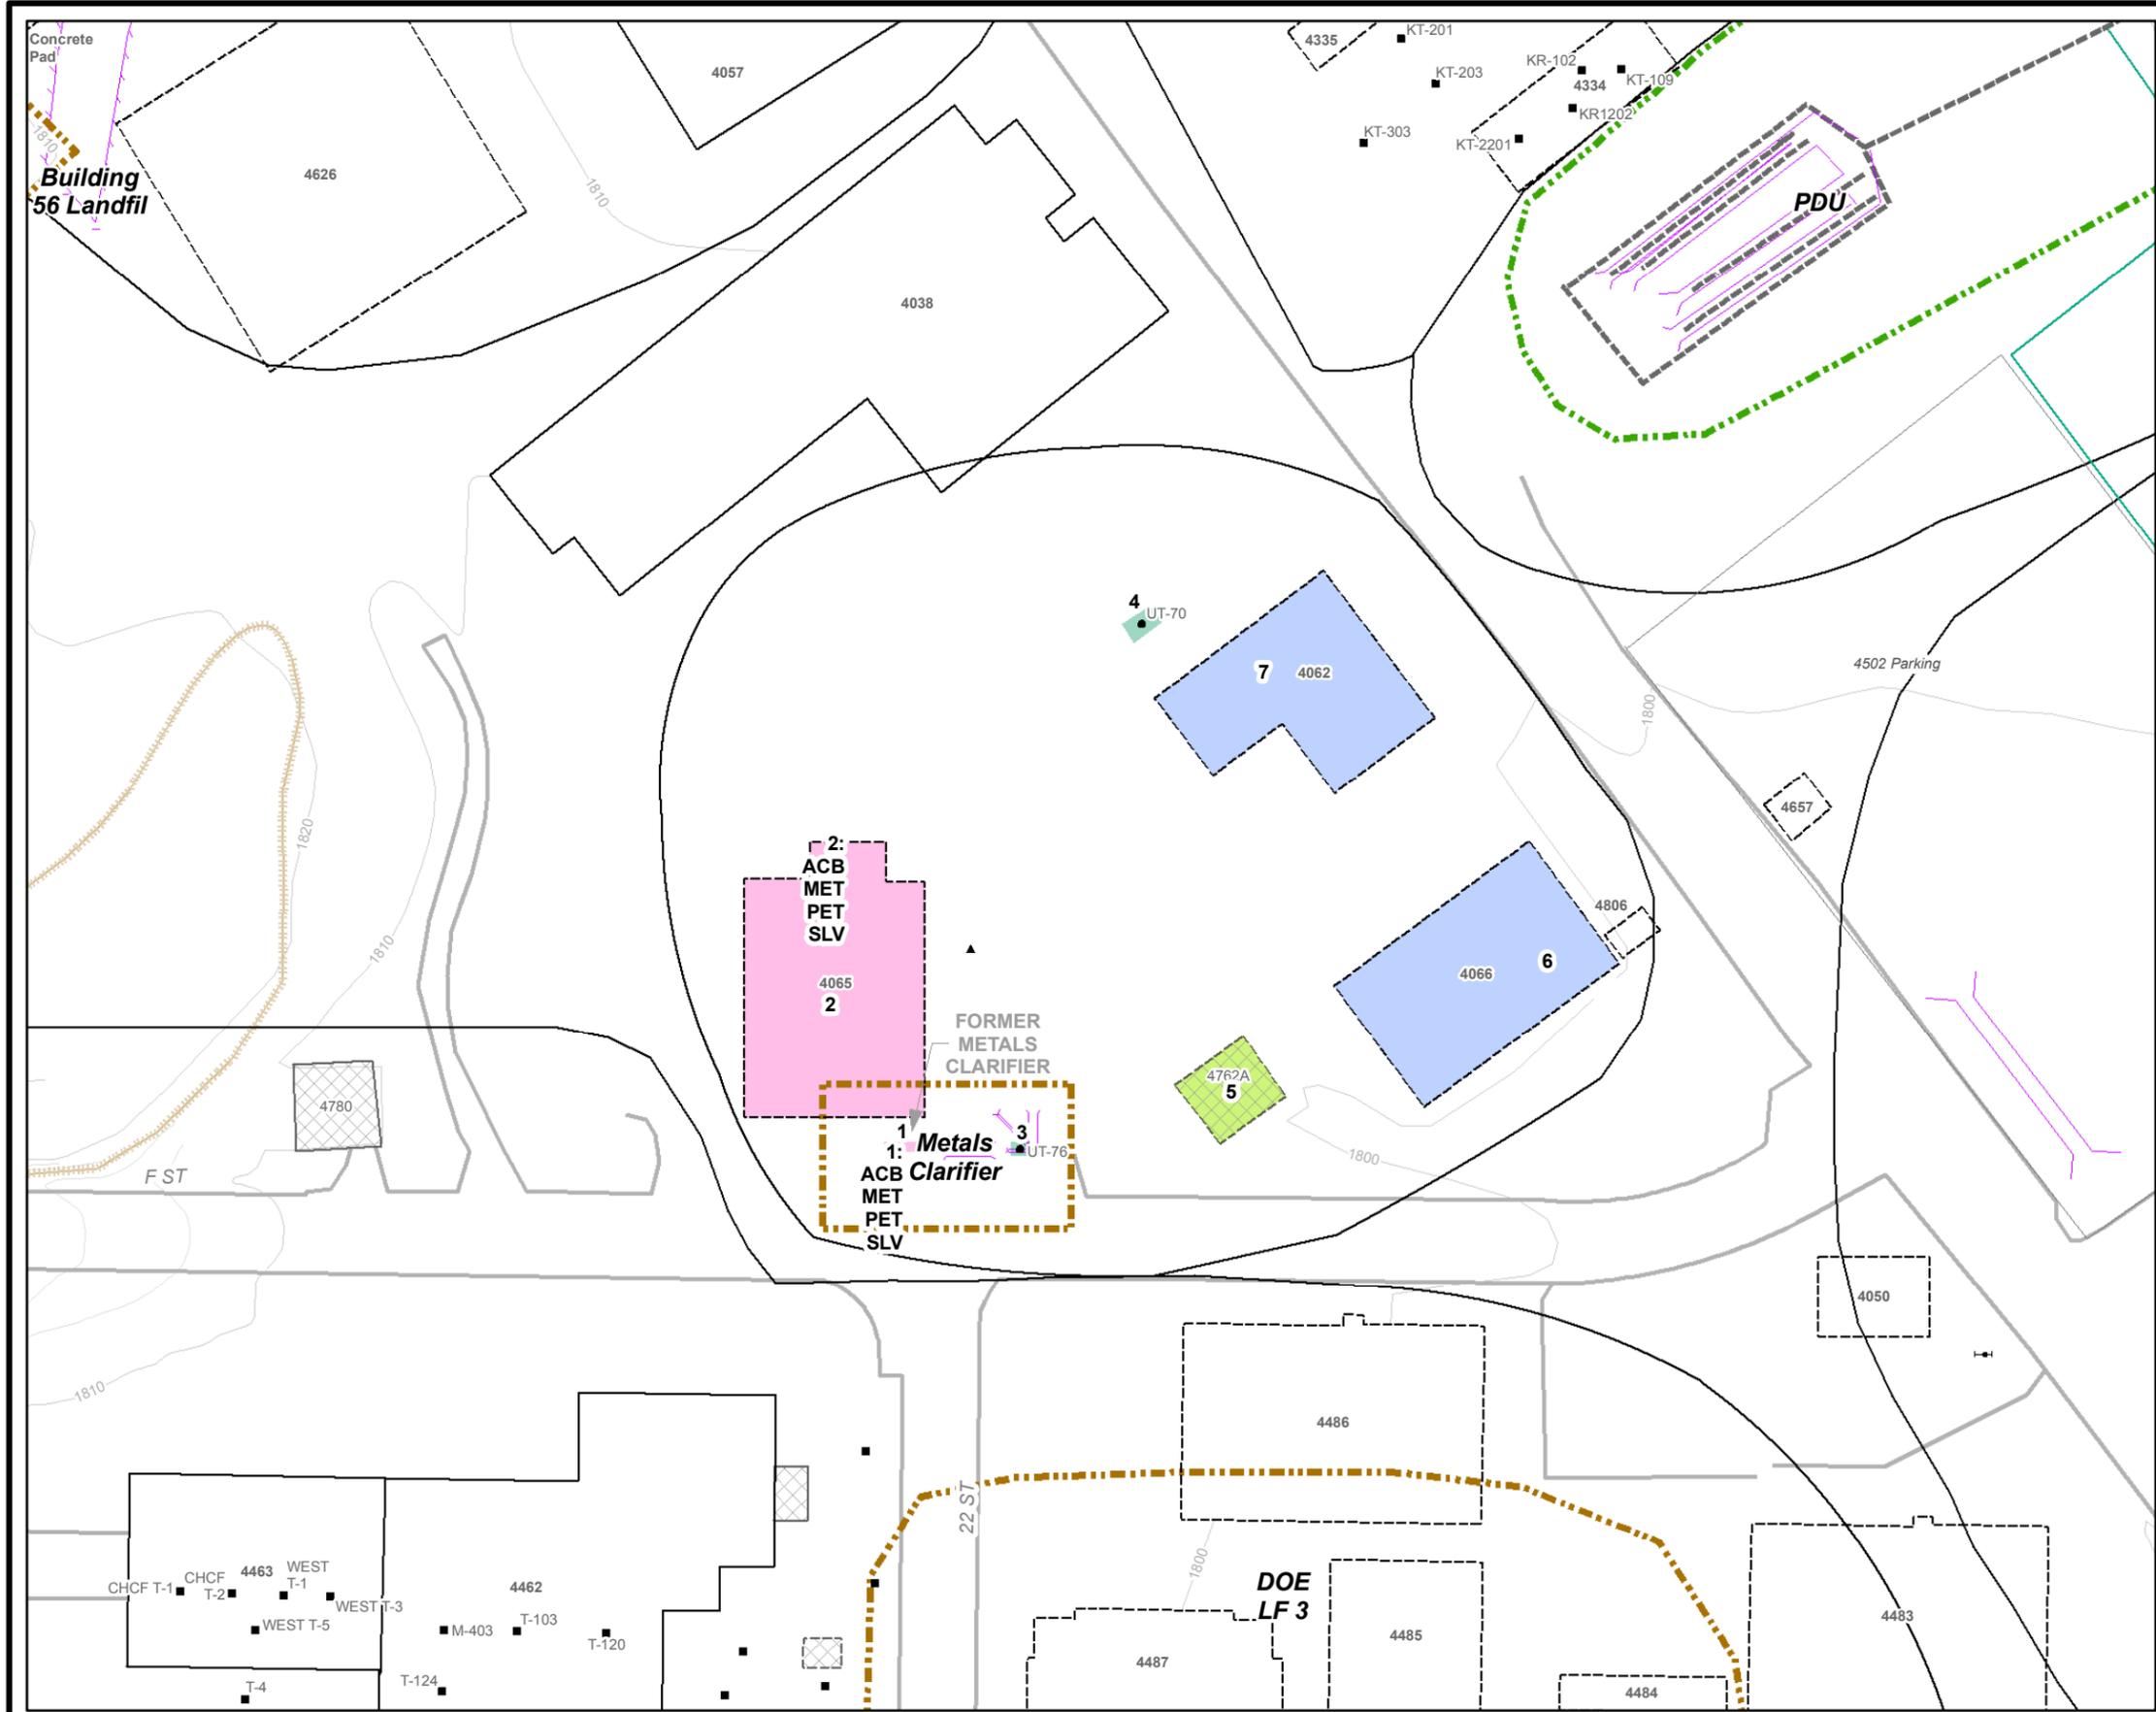
**Chemical Use Areas  
Building 65 Metals Laboratory  
Clarifier RFI Site**

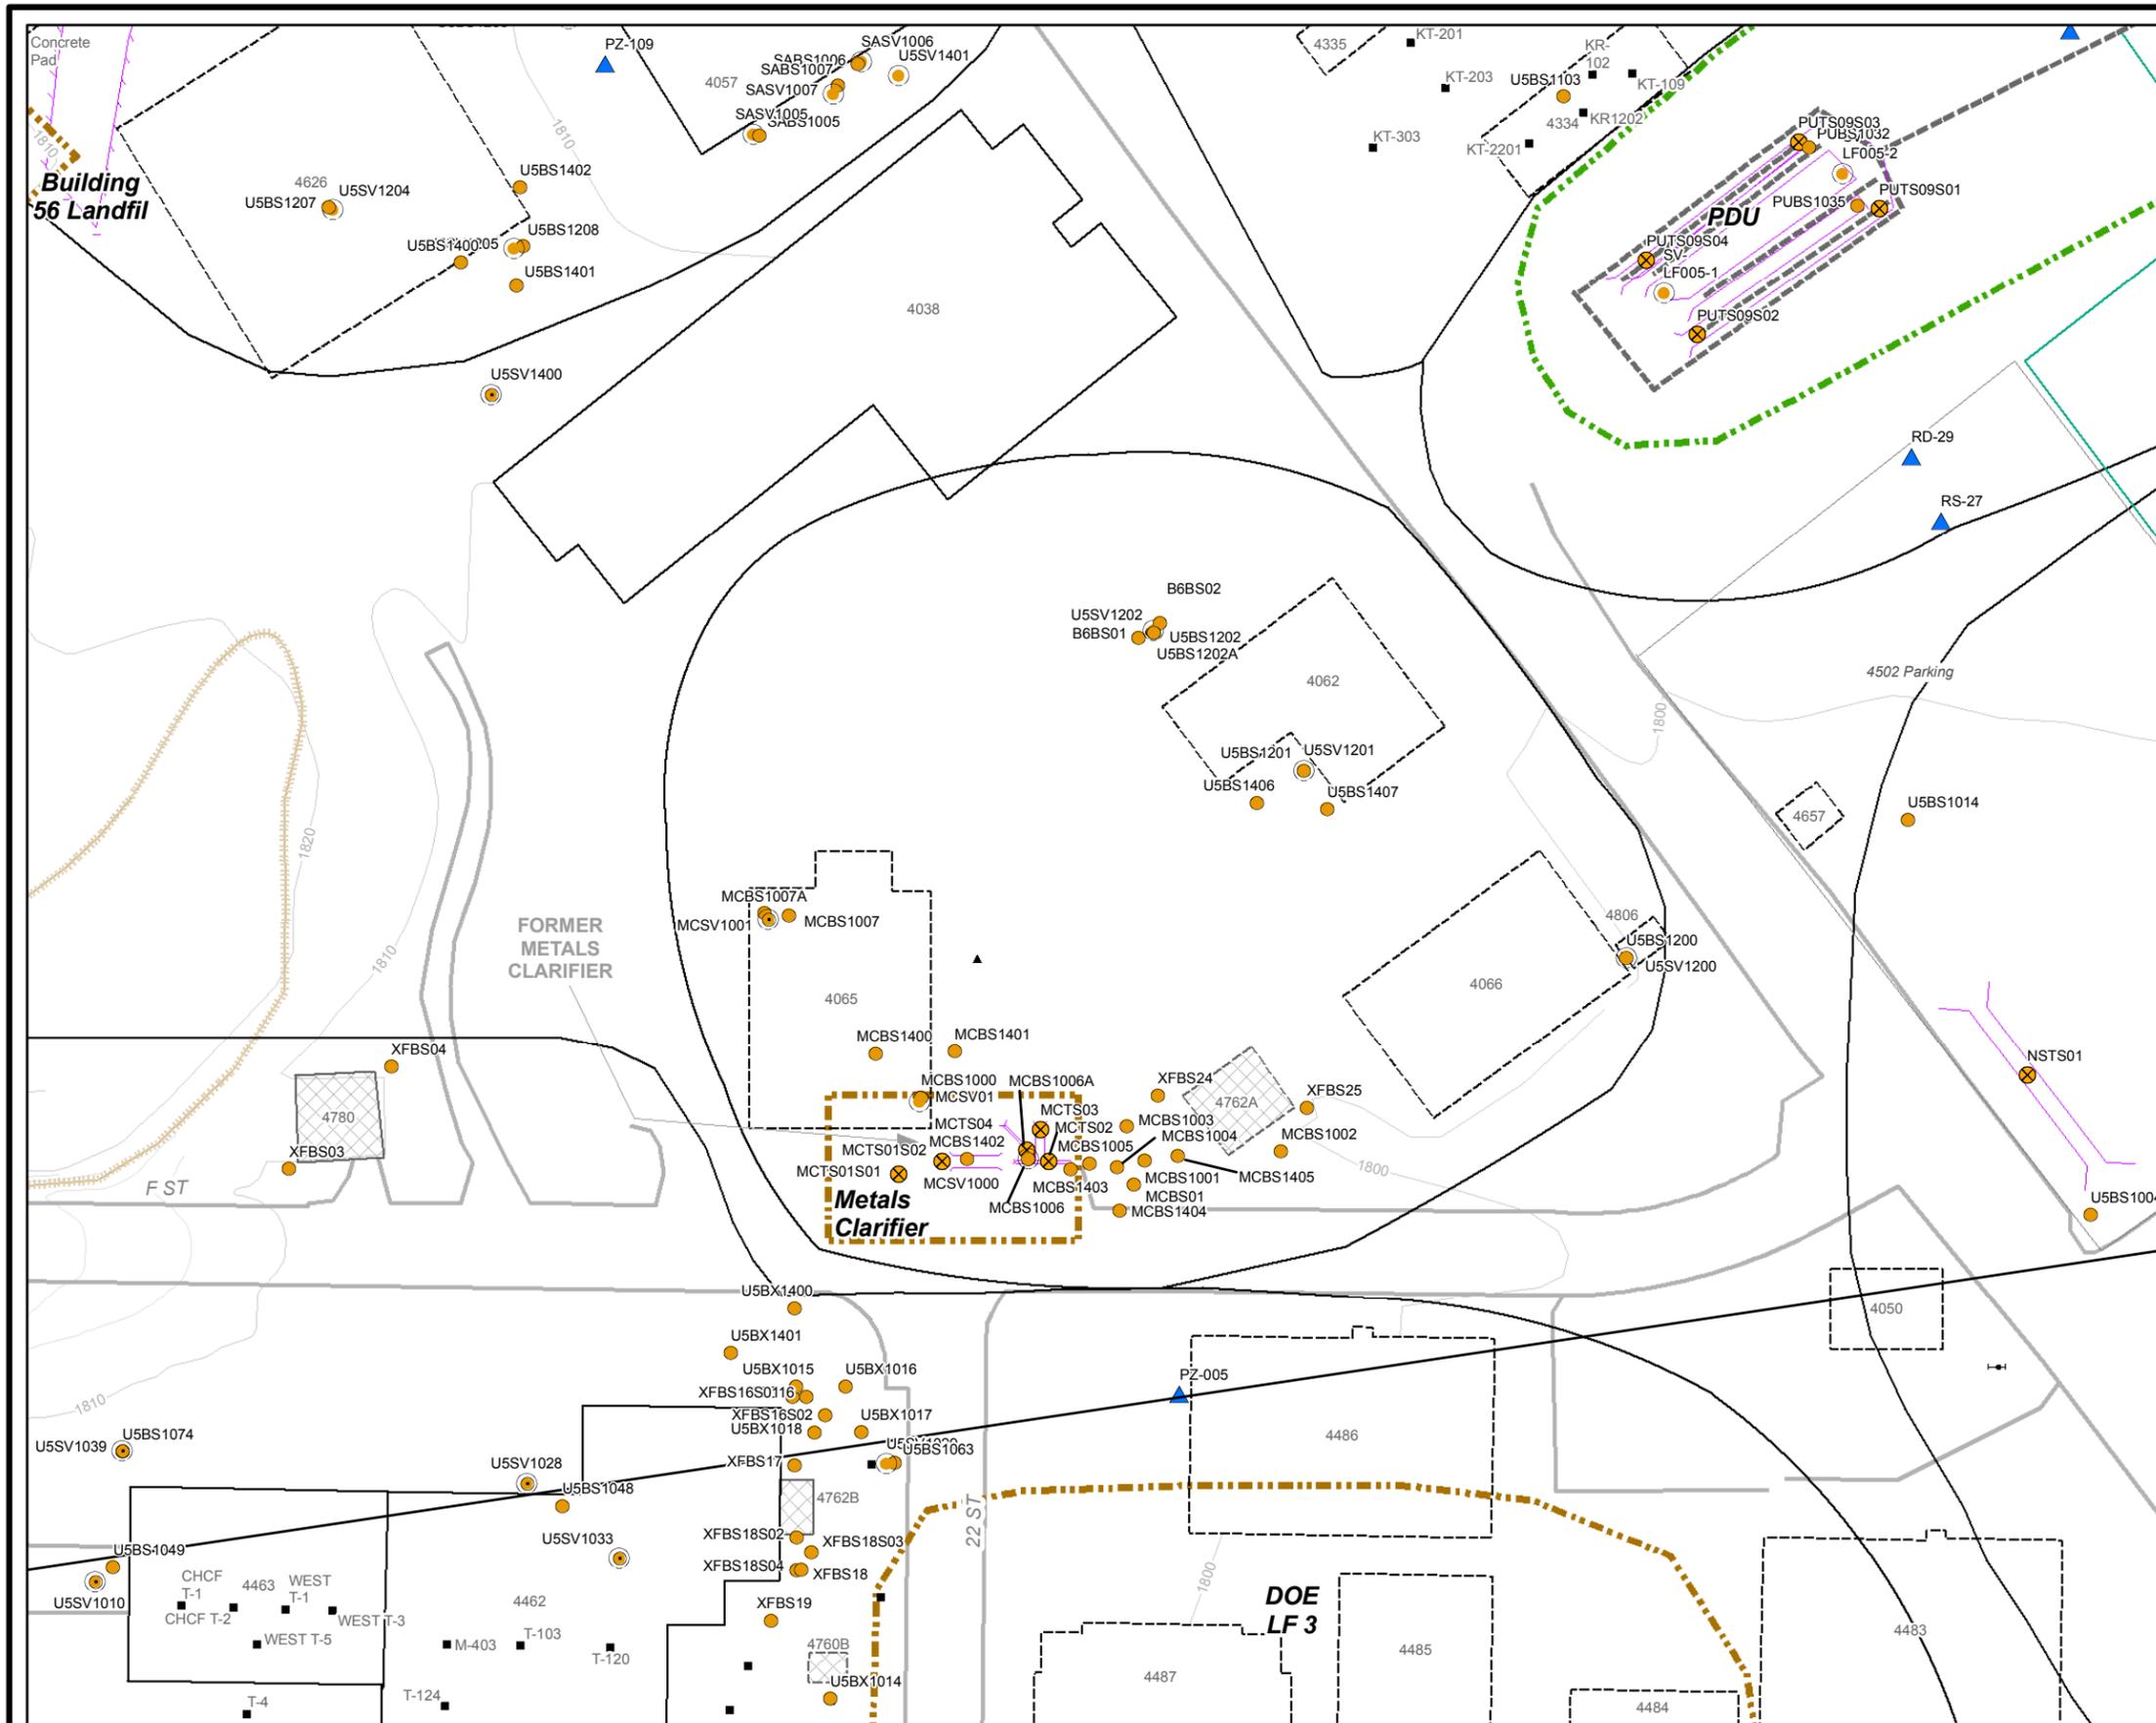
**Sample Locations  
Building 65 Metals Laboratory  
Clarifier RFI Site**

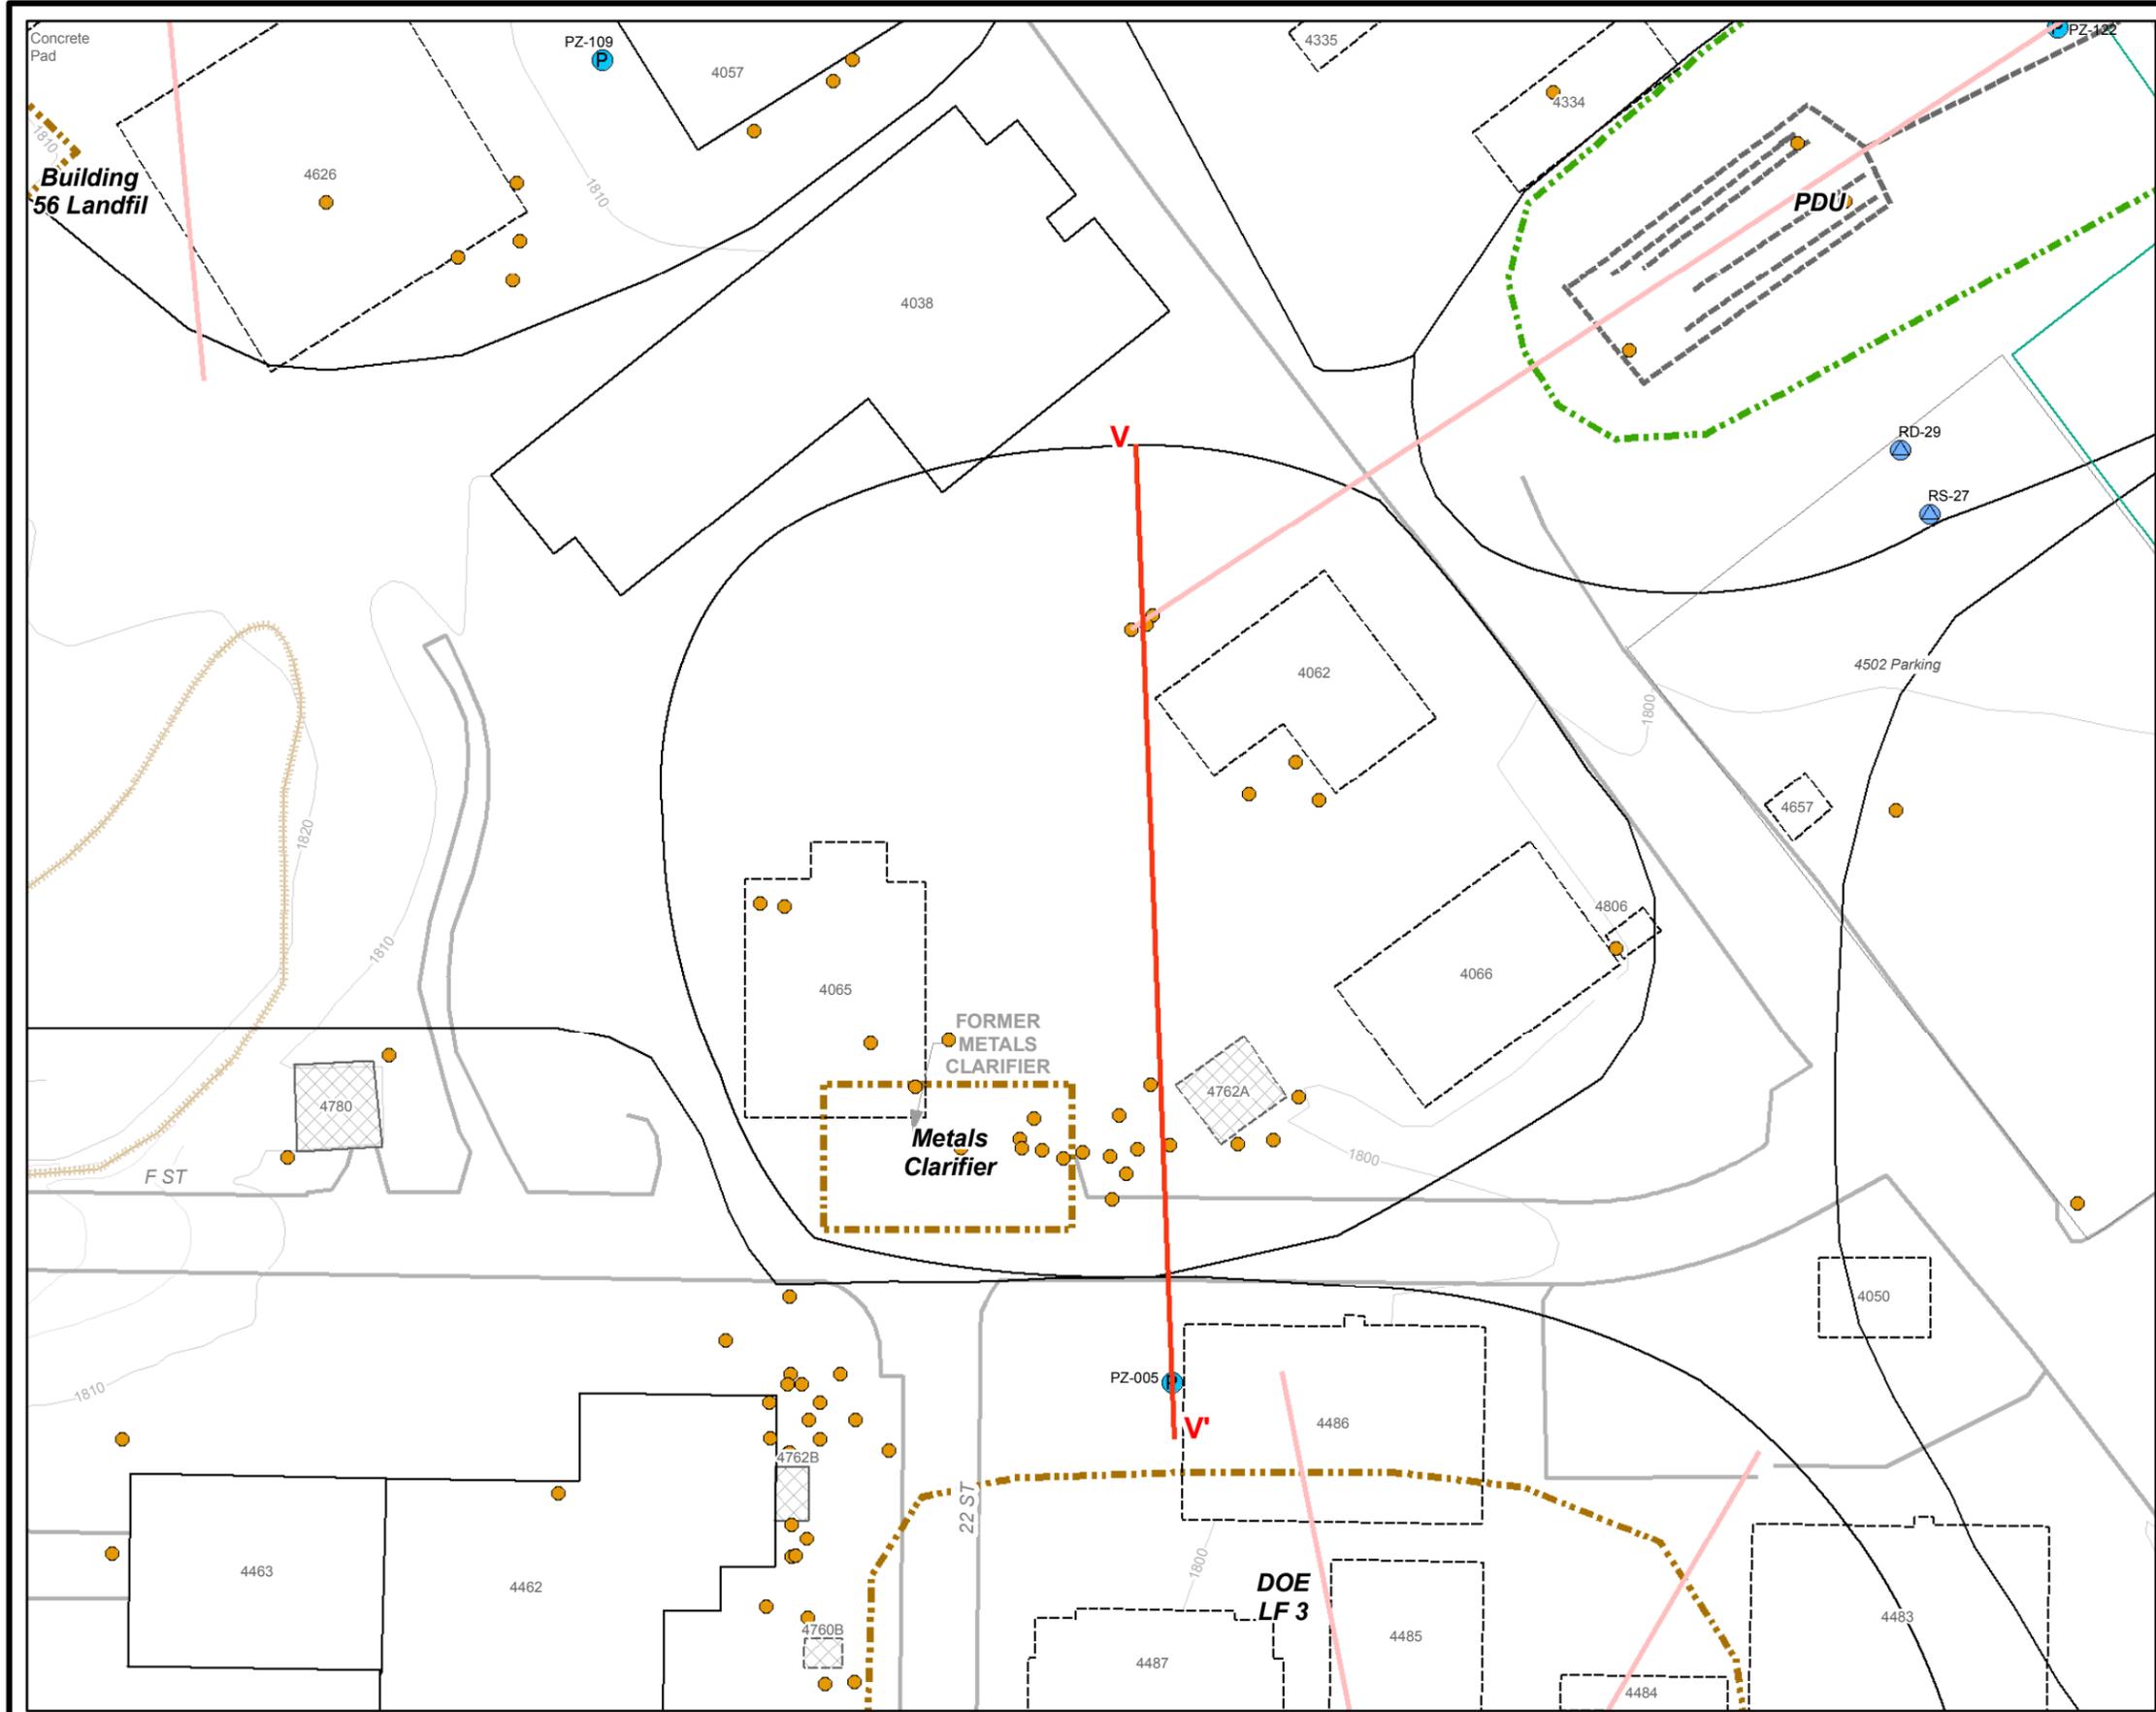
**Building 65 Metals Laboratory Clarifier Cross Section Location V-V'**

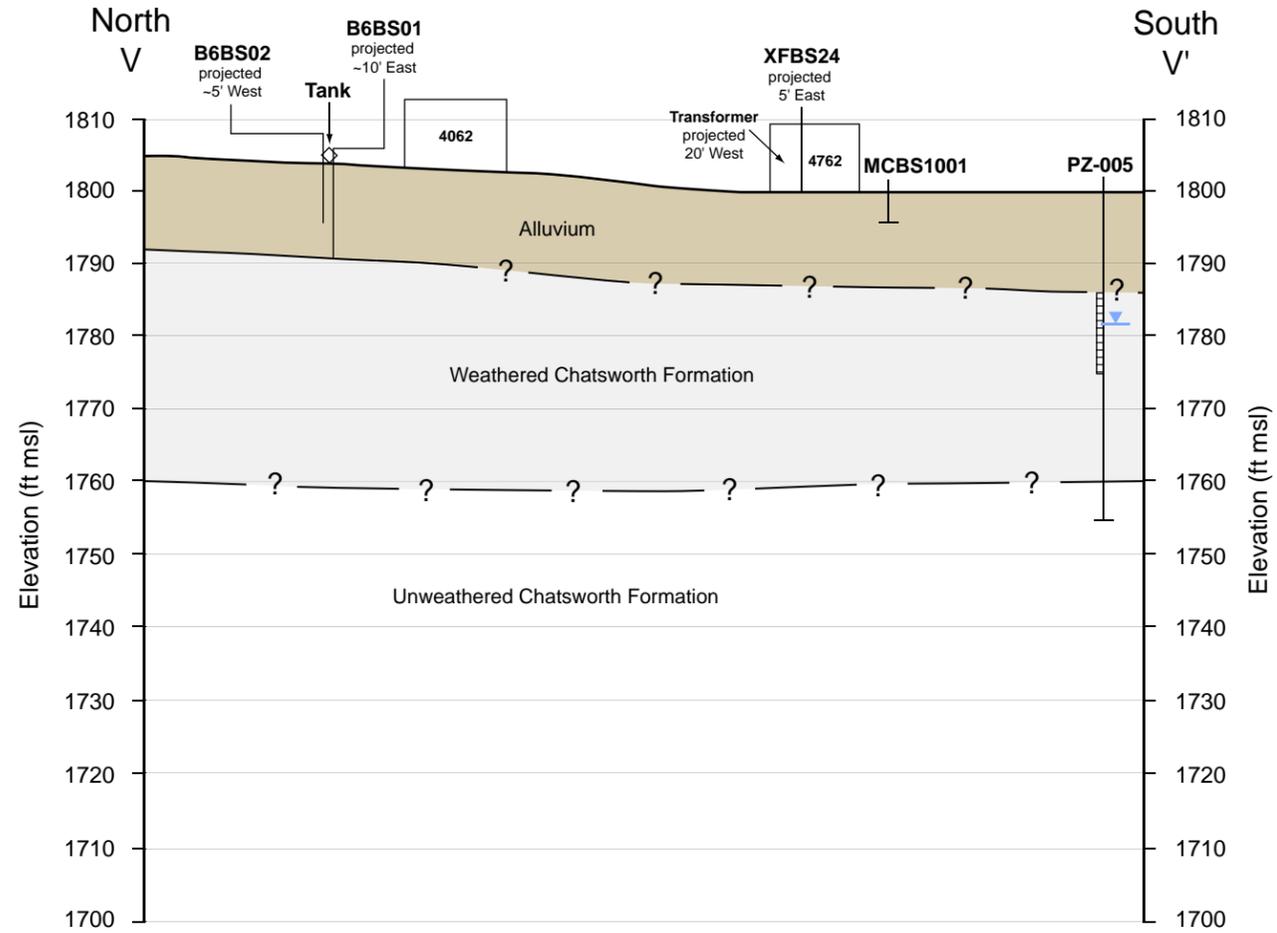
FIGURE M.2-3A  
 Surficial Cross Section V-V'  
 Building 65 Metals Laboratory Clarifier  
 Santa Susana Field Laboratory  
**CH2MHILL**

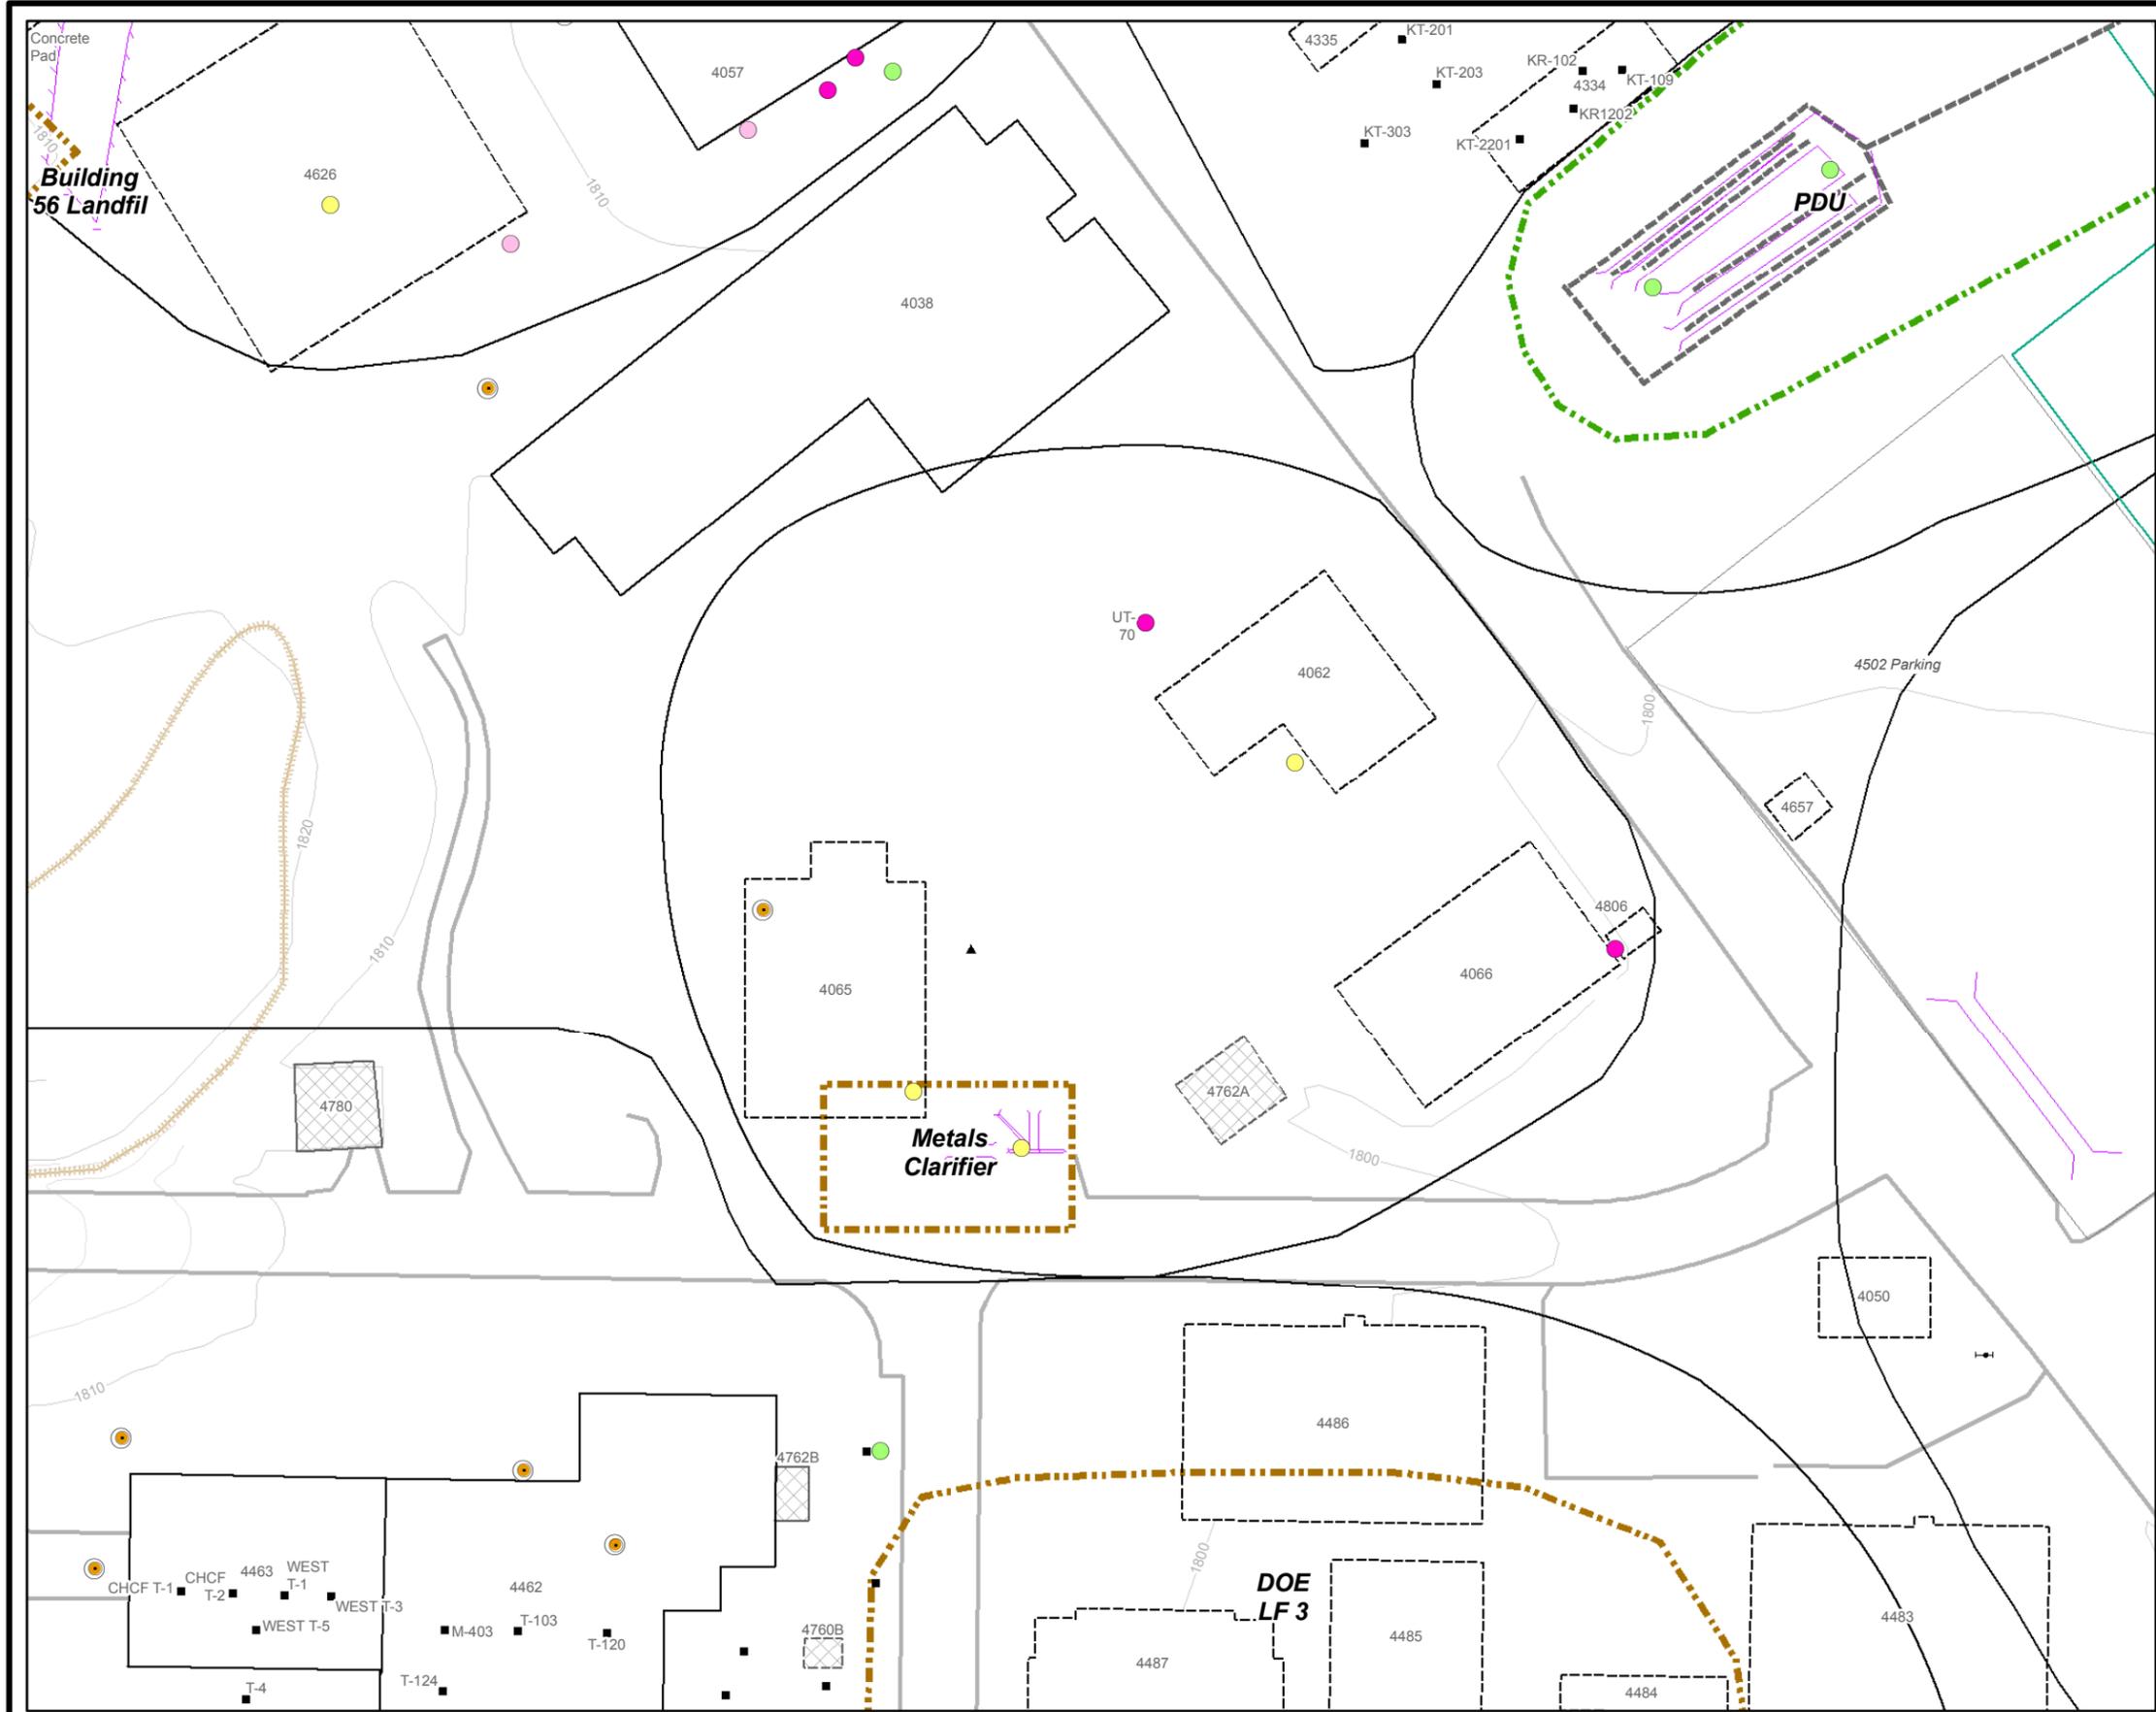
**Figure  
M.3-1A**

**VOCs in Soil Vapor**

The VOC detections described above occurred at several single-point screening locations at the site. However, based on the generally low concentrations observed, further characterization is not recommended for VOCs in soil and soil vapor at the Building 65 Metals Laboratory Clarifier Site.

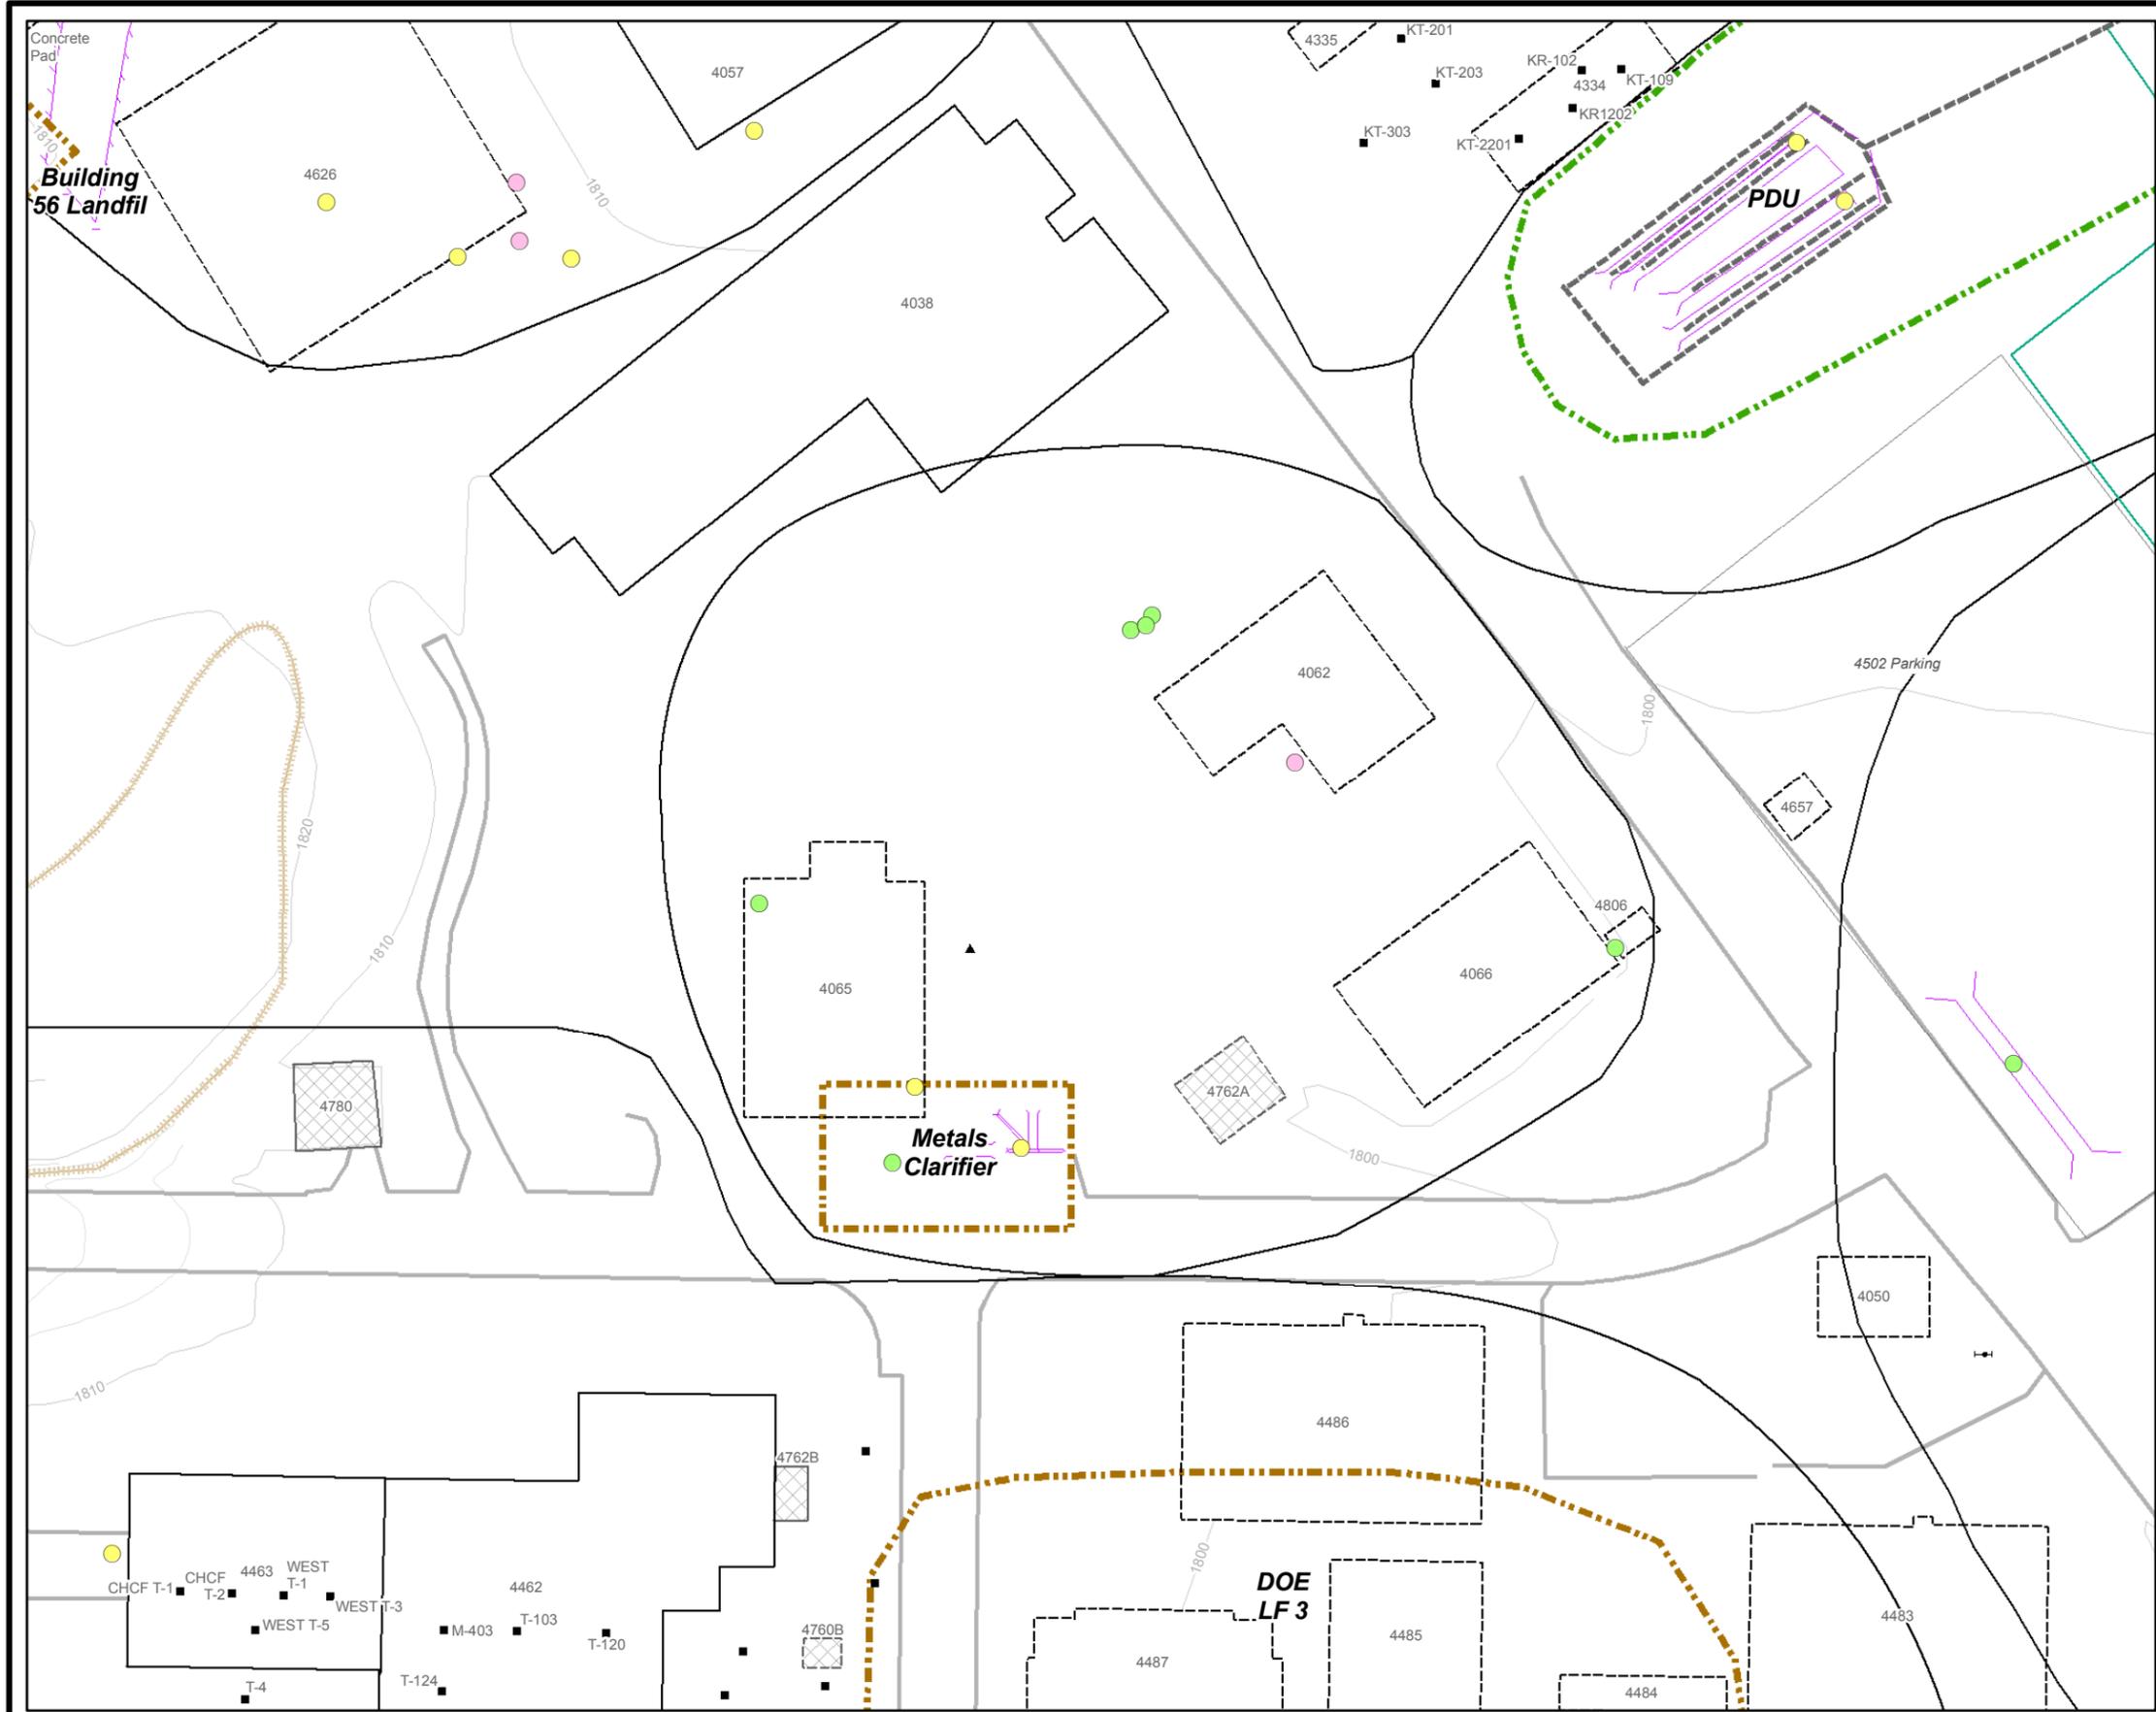
**VOCs in Soil  
Building 65 Metals Laboratory  
Clarifier RFI Site**
