**Group 5 - Central Portion of Areas III and IV  
RCRA Facility Investigation Report  
Santa Susana Field Laboratory,  
Ventura County, California**

**Volume VII - RFI Site Reports  
Appendix M**

**Building 65 Metals Laboratory Clarifier**

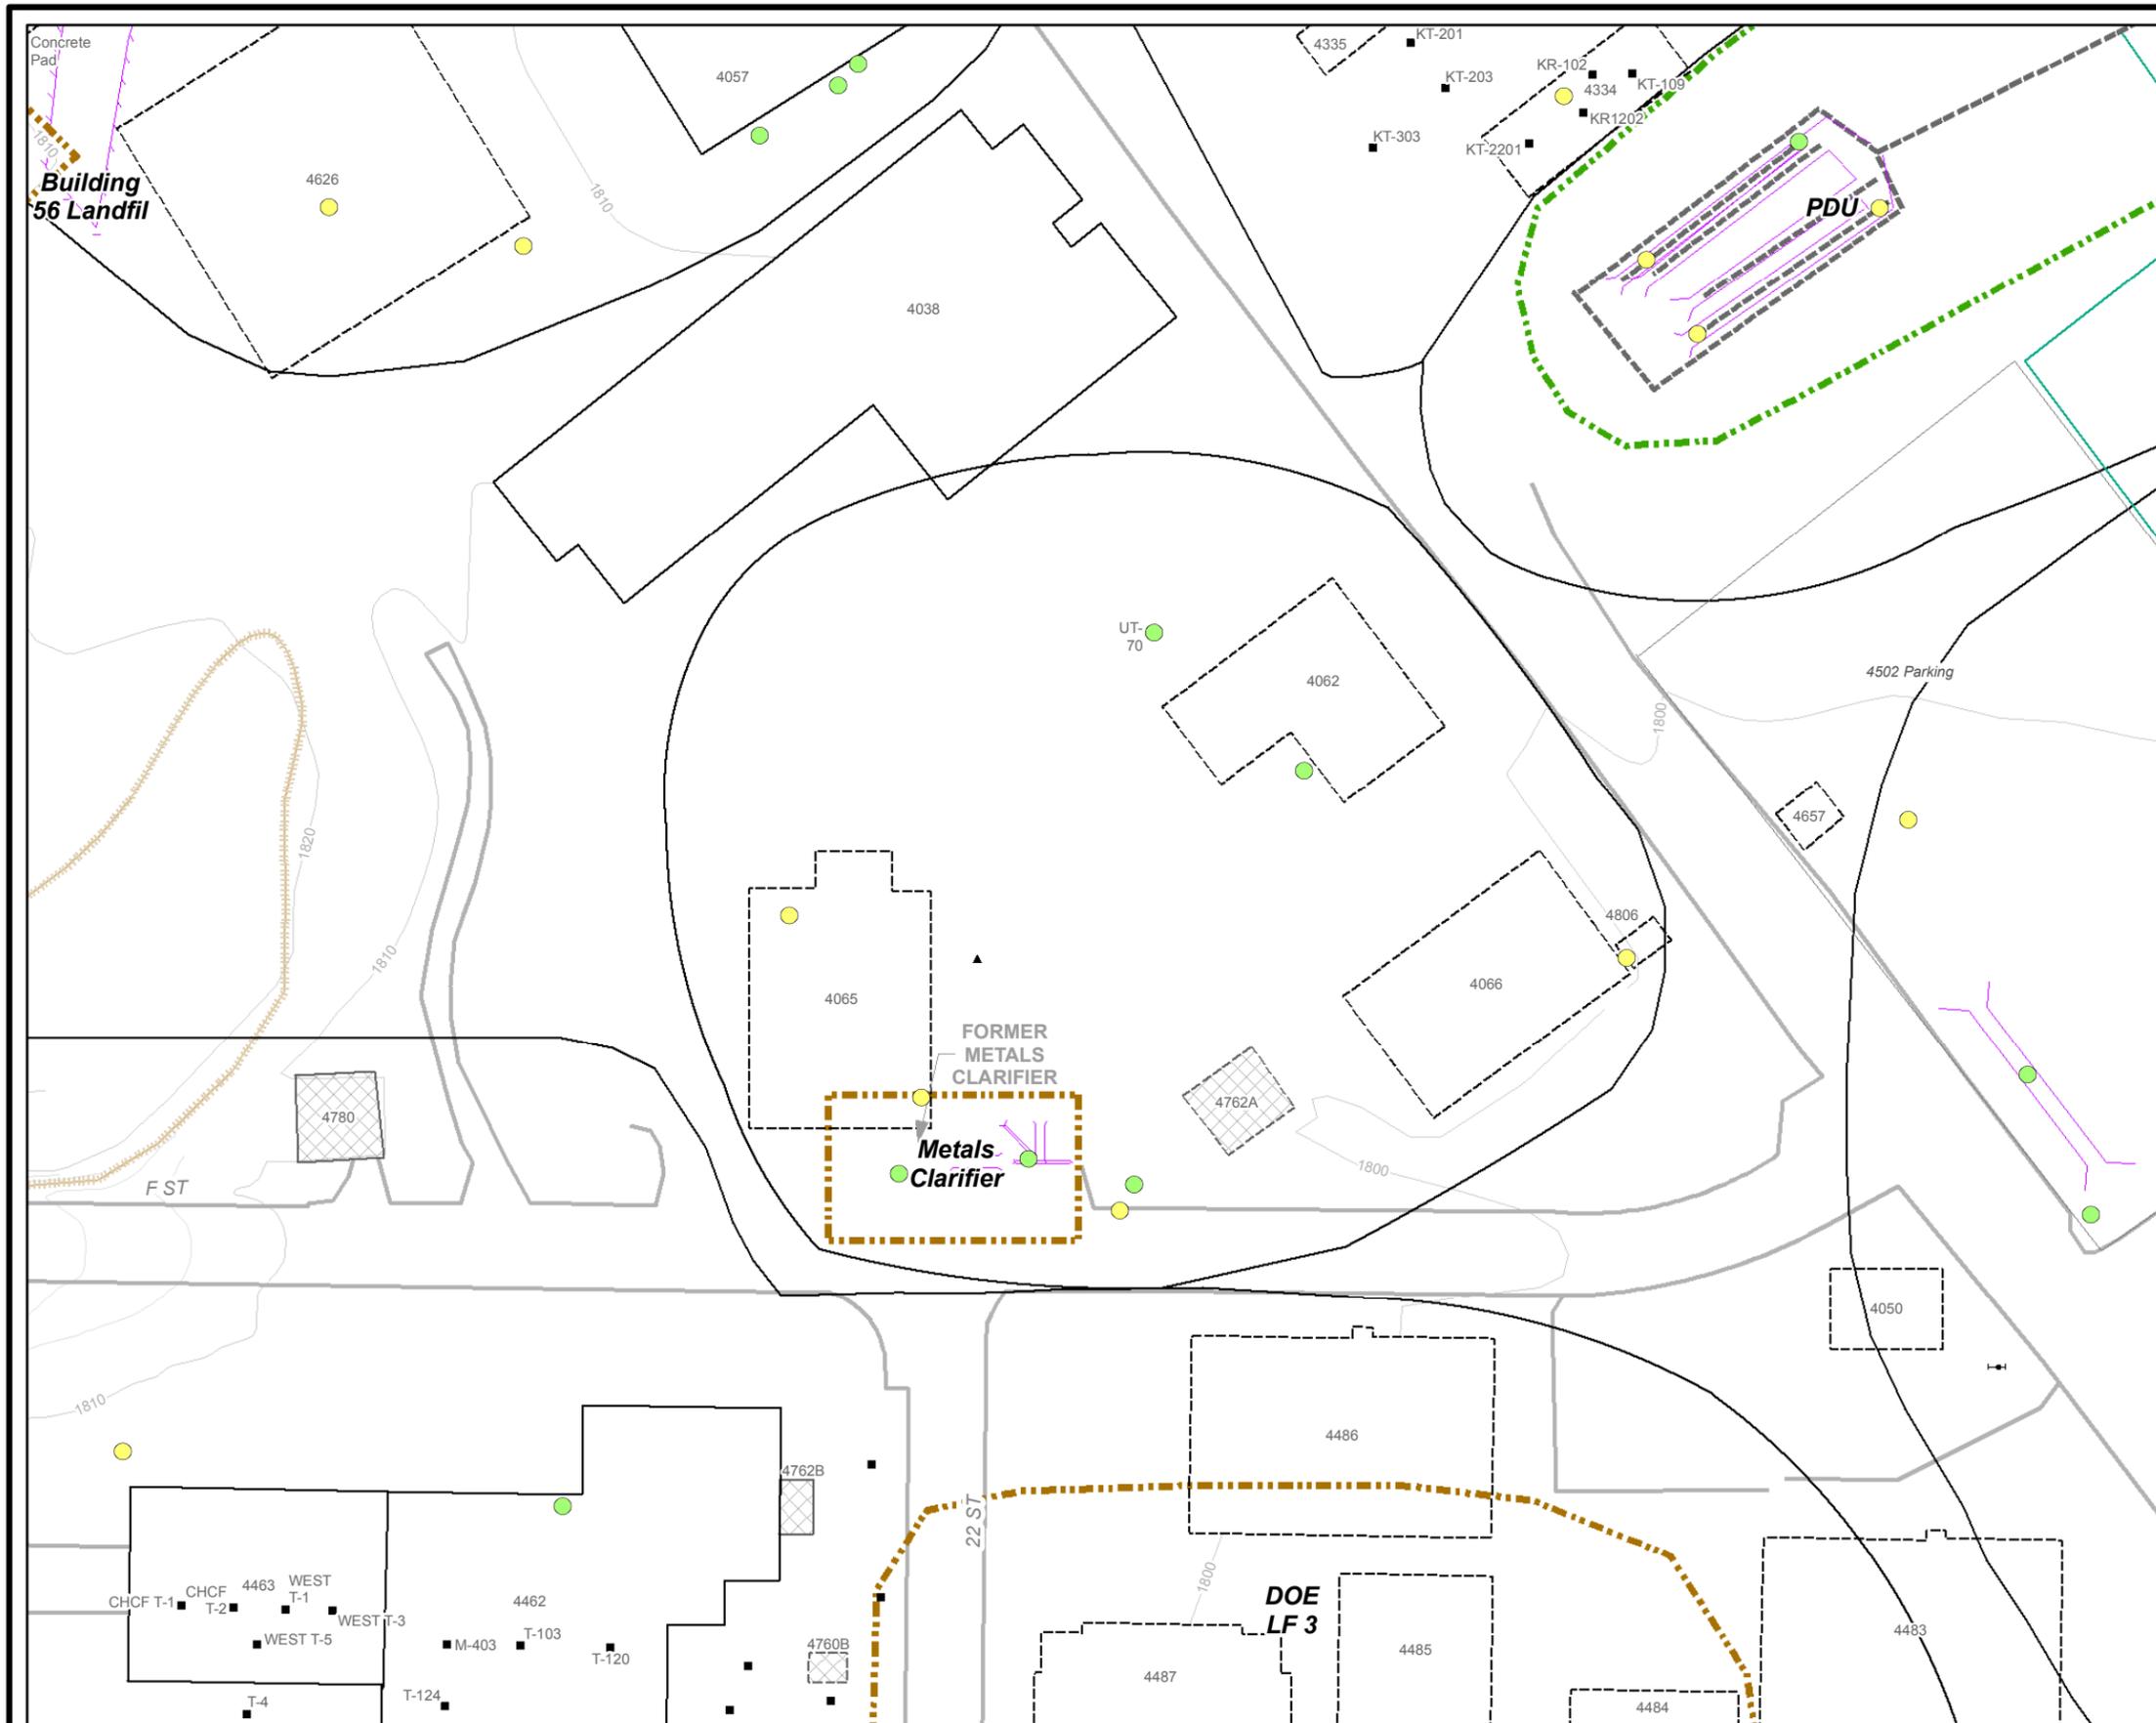
**SVOCs in Soil  
Building 65 Metals Laboratory  
Clarifier RFI Site**

- Bis(2-ethylhexyl) phthalate and di-n-octyl phthalate were detected at concentrations less than their respective RBSLs. Further characterization of SVOCs in soil is not recommended at the Building 65 Metals Laboratory Clarifier Site.
- Out of the 13 samples collected, three had detectable levels of polynuclear aromatic hydrocarbons (PAHs).
  - 2-Methylnaphthalene, benzo(a) anthracene, benzo(b)fluoranthene, benzo(ghi)perylene, fluoranthene, fluorene, naphthalene, phenanthrene, and pyrene were detected at concentrations that did not exceed their respective RBSLs.

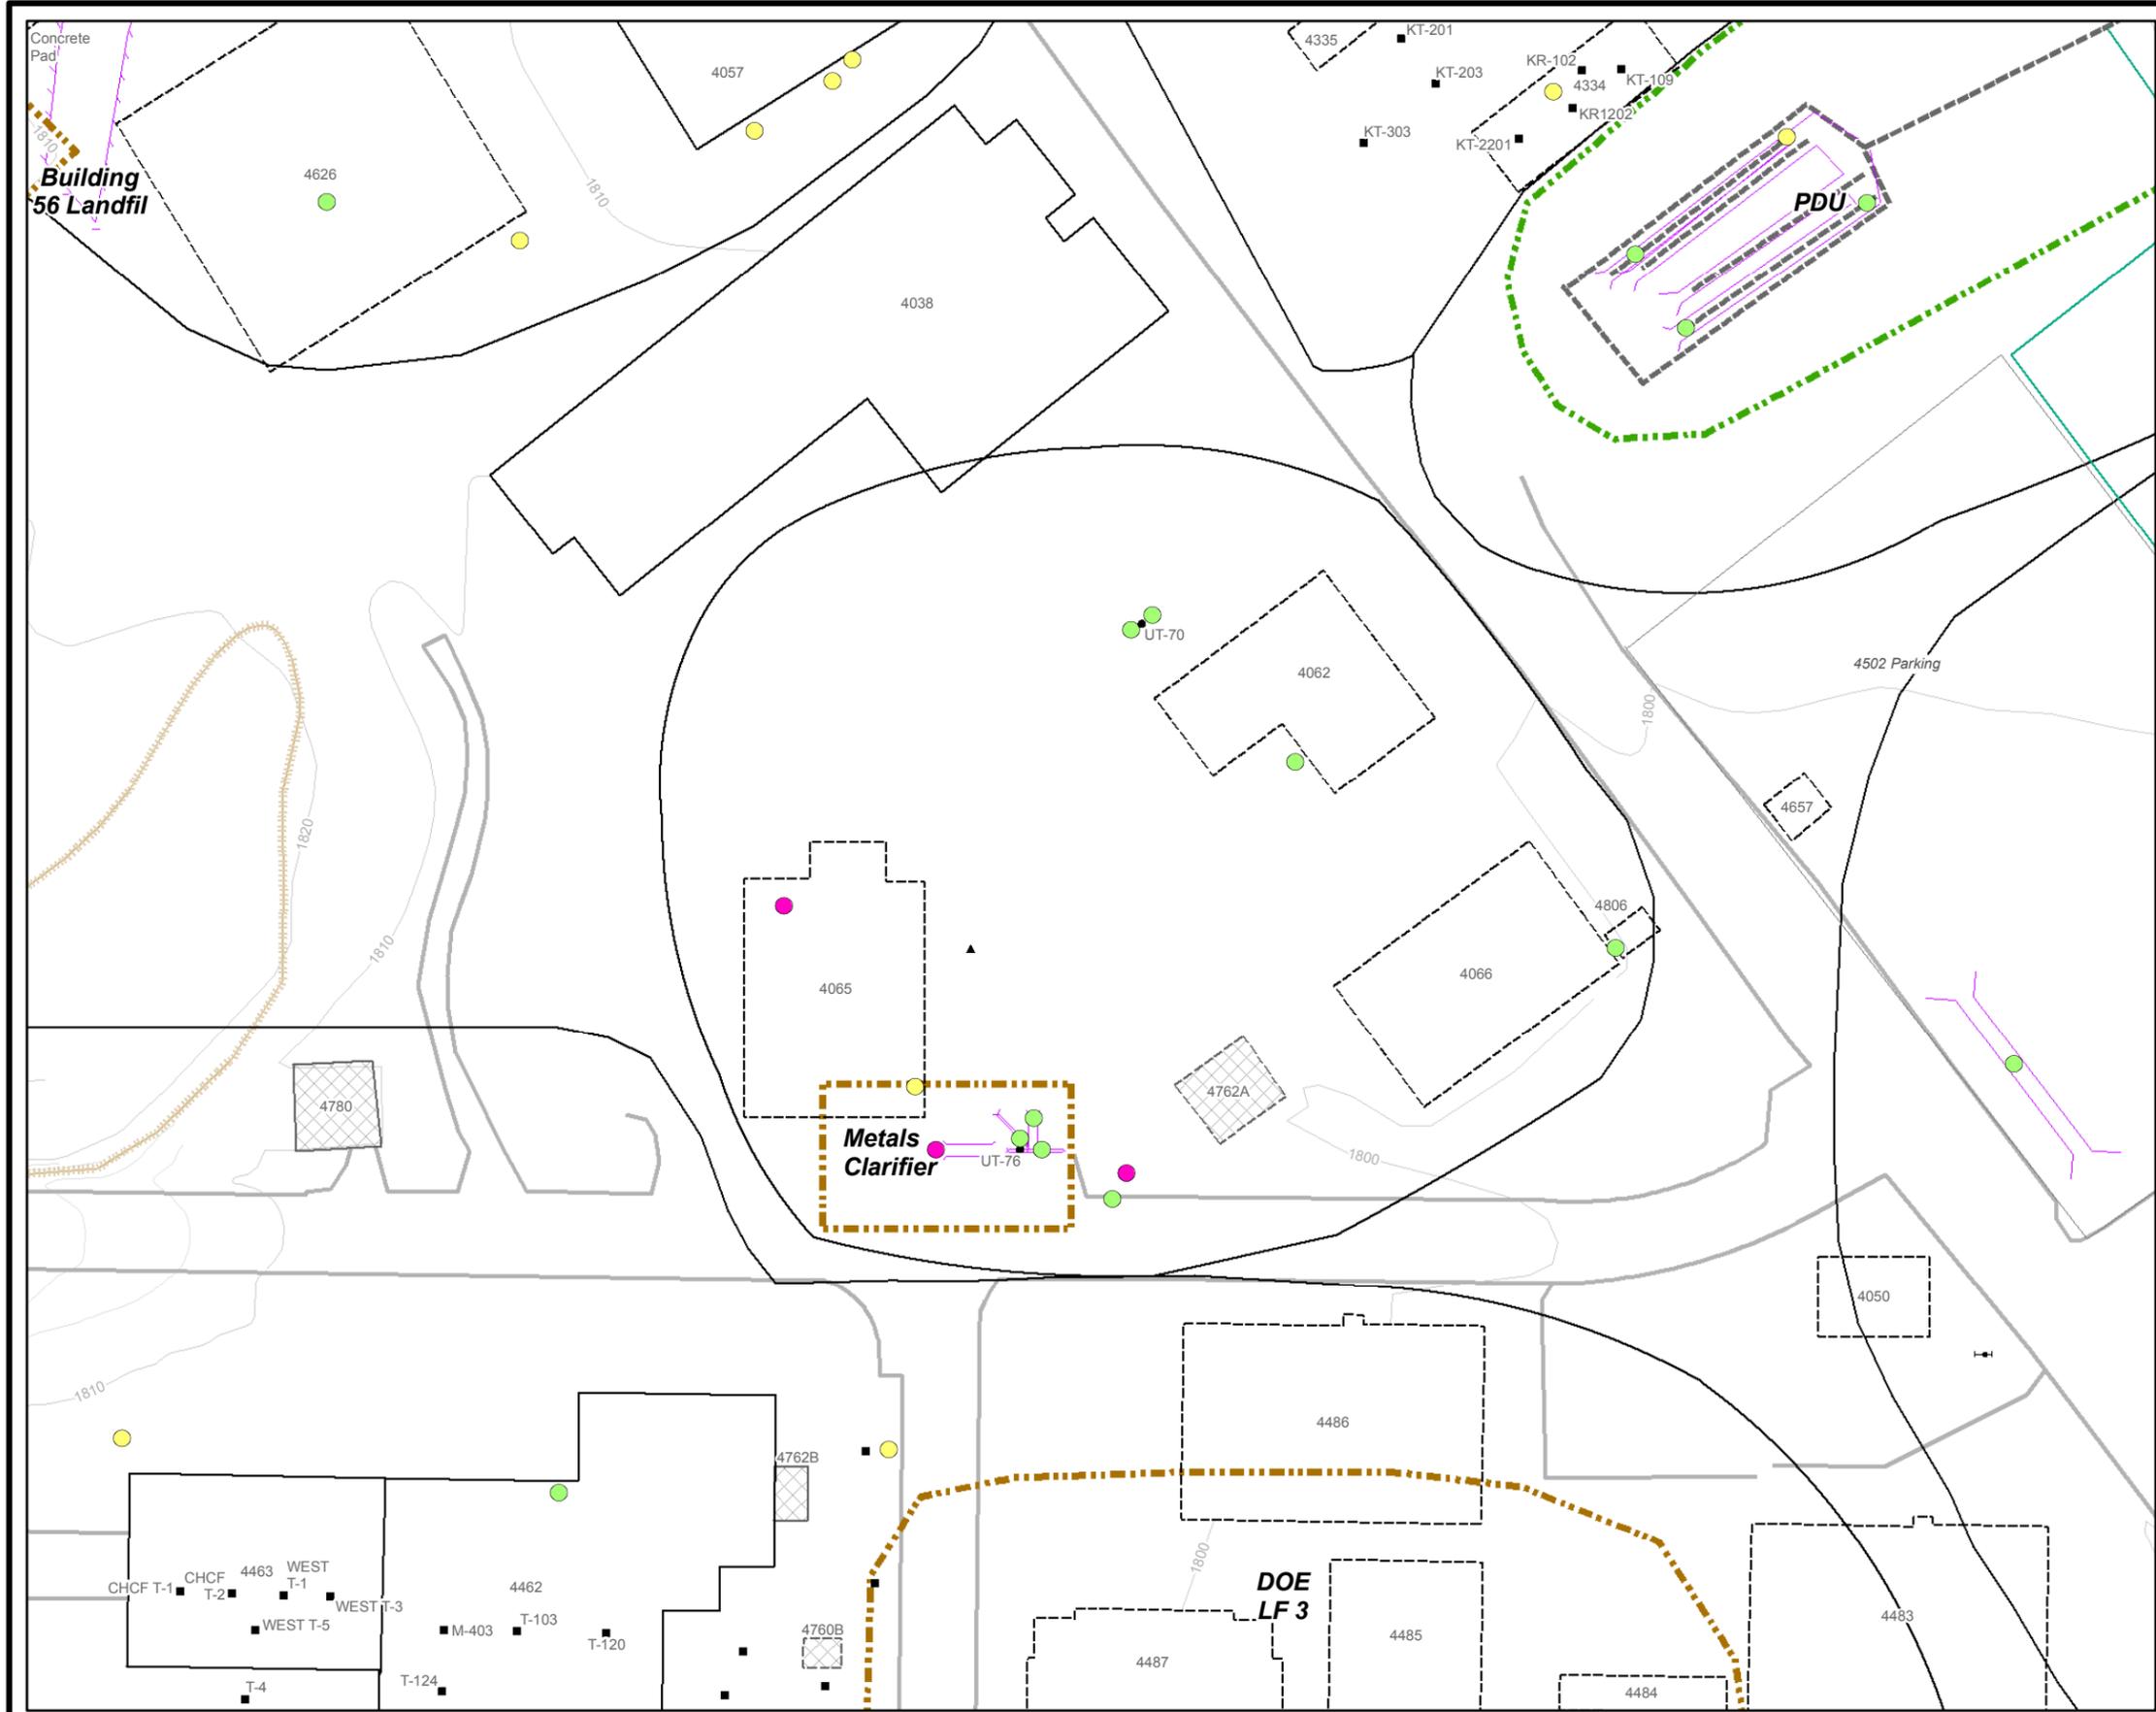
**Figure  
M.3-3**

**TPH in Soil**

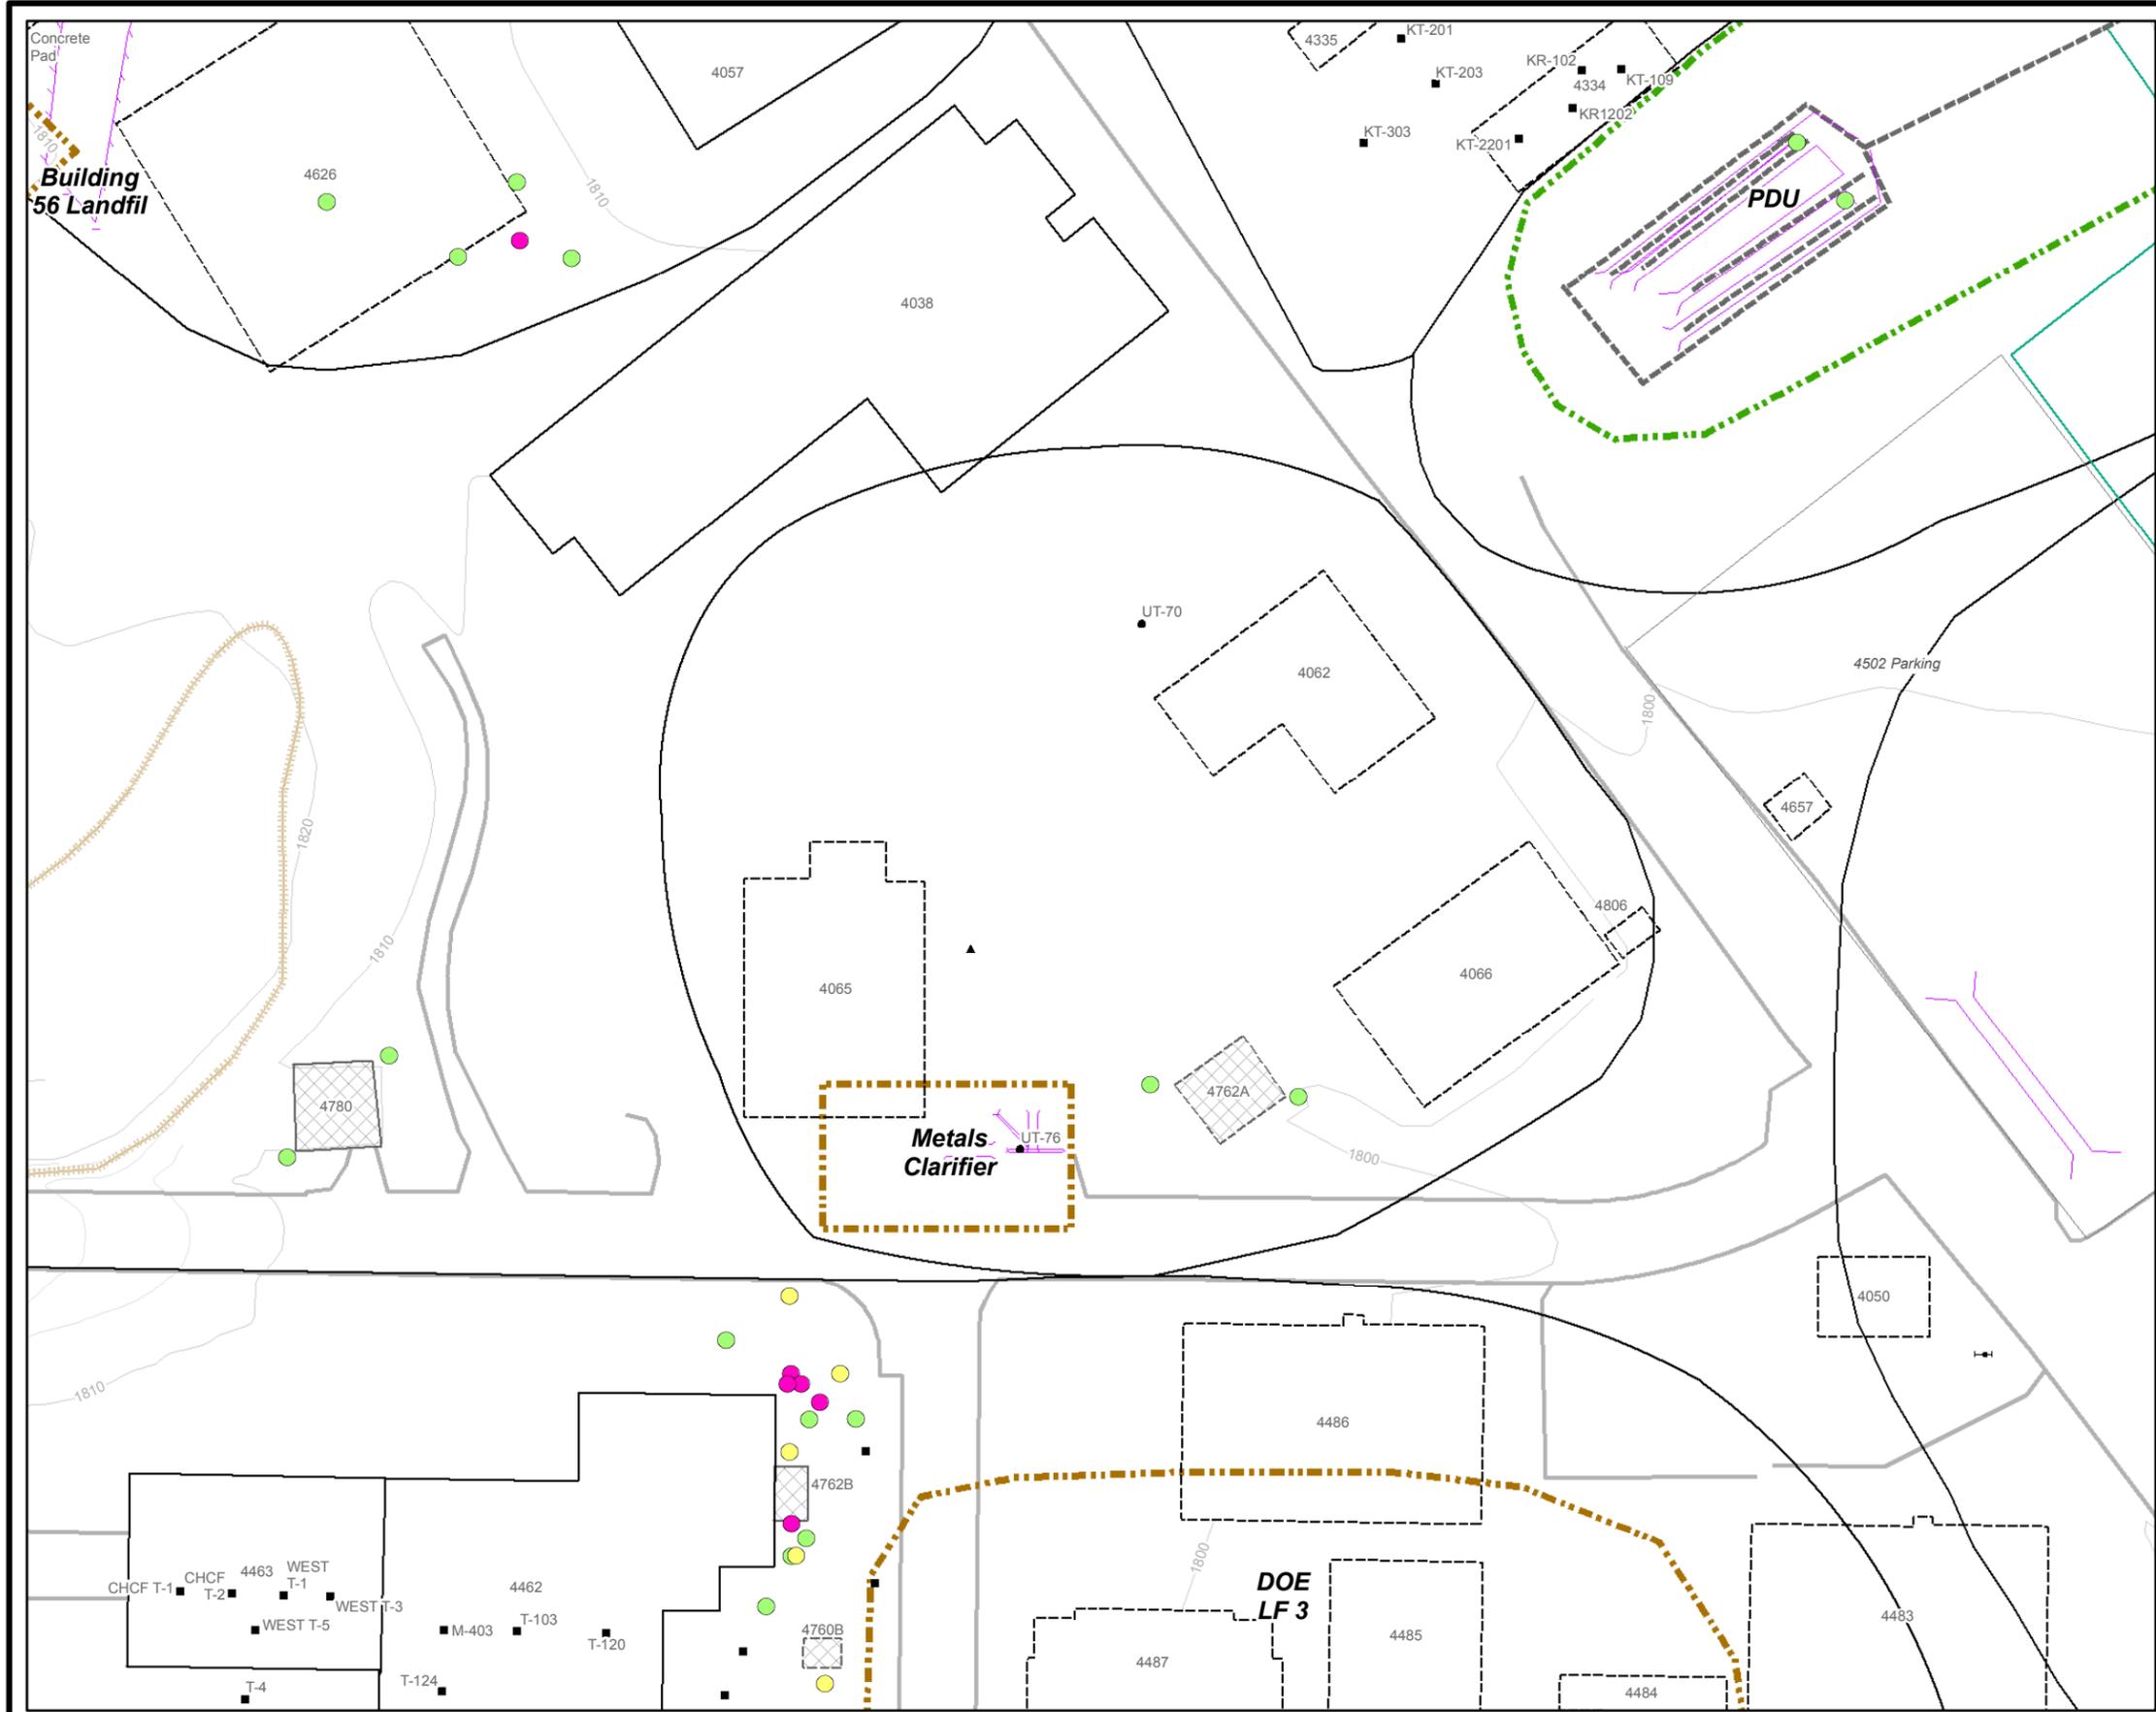
**Figure  
M.3-4**

**PCBs in Soil**

Two soil samples were collected at two locations and analyzed for PCBs (see to Figure M.3-4). PCBs were not detected in either sample and further characterization for PCBs in soil is not recommended at the Building 65 Metals Laboratory Clarifier Site.

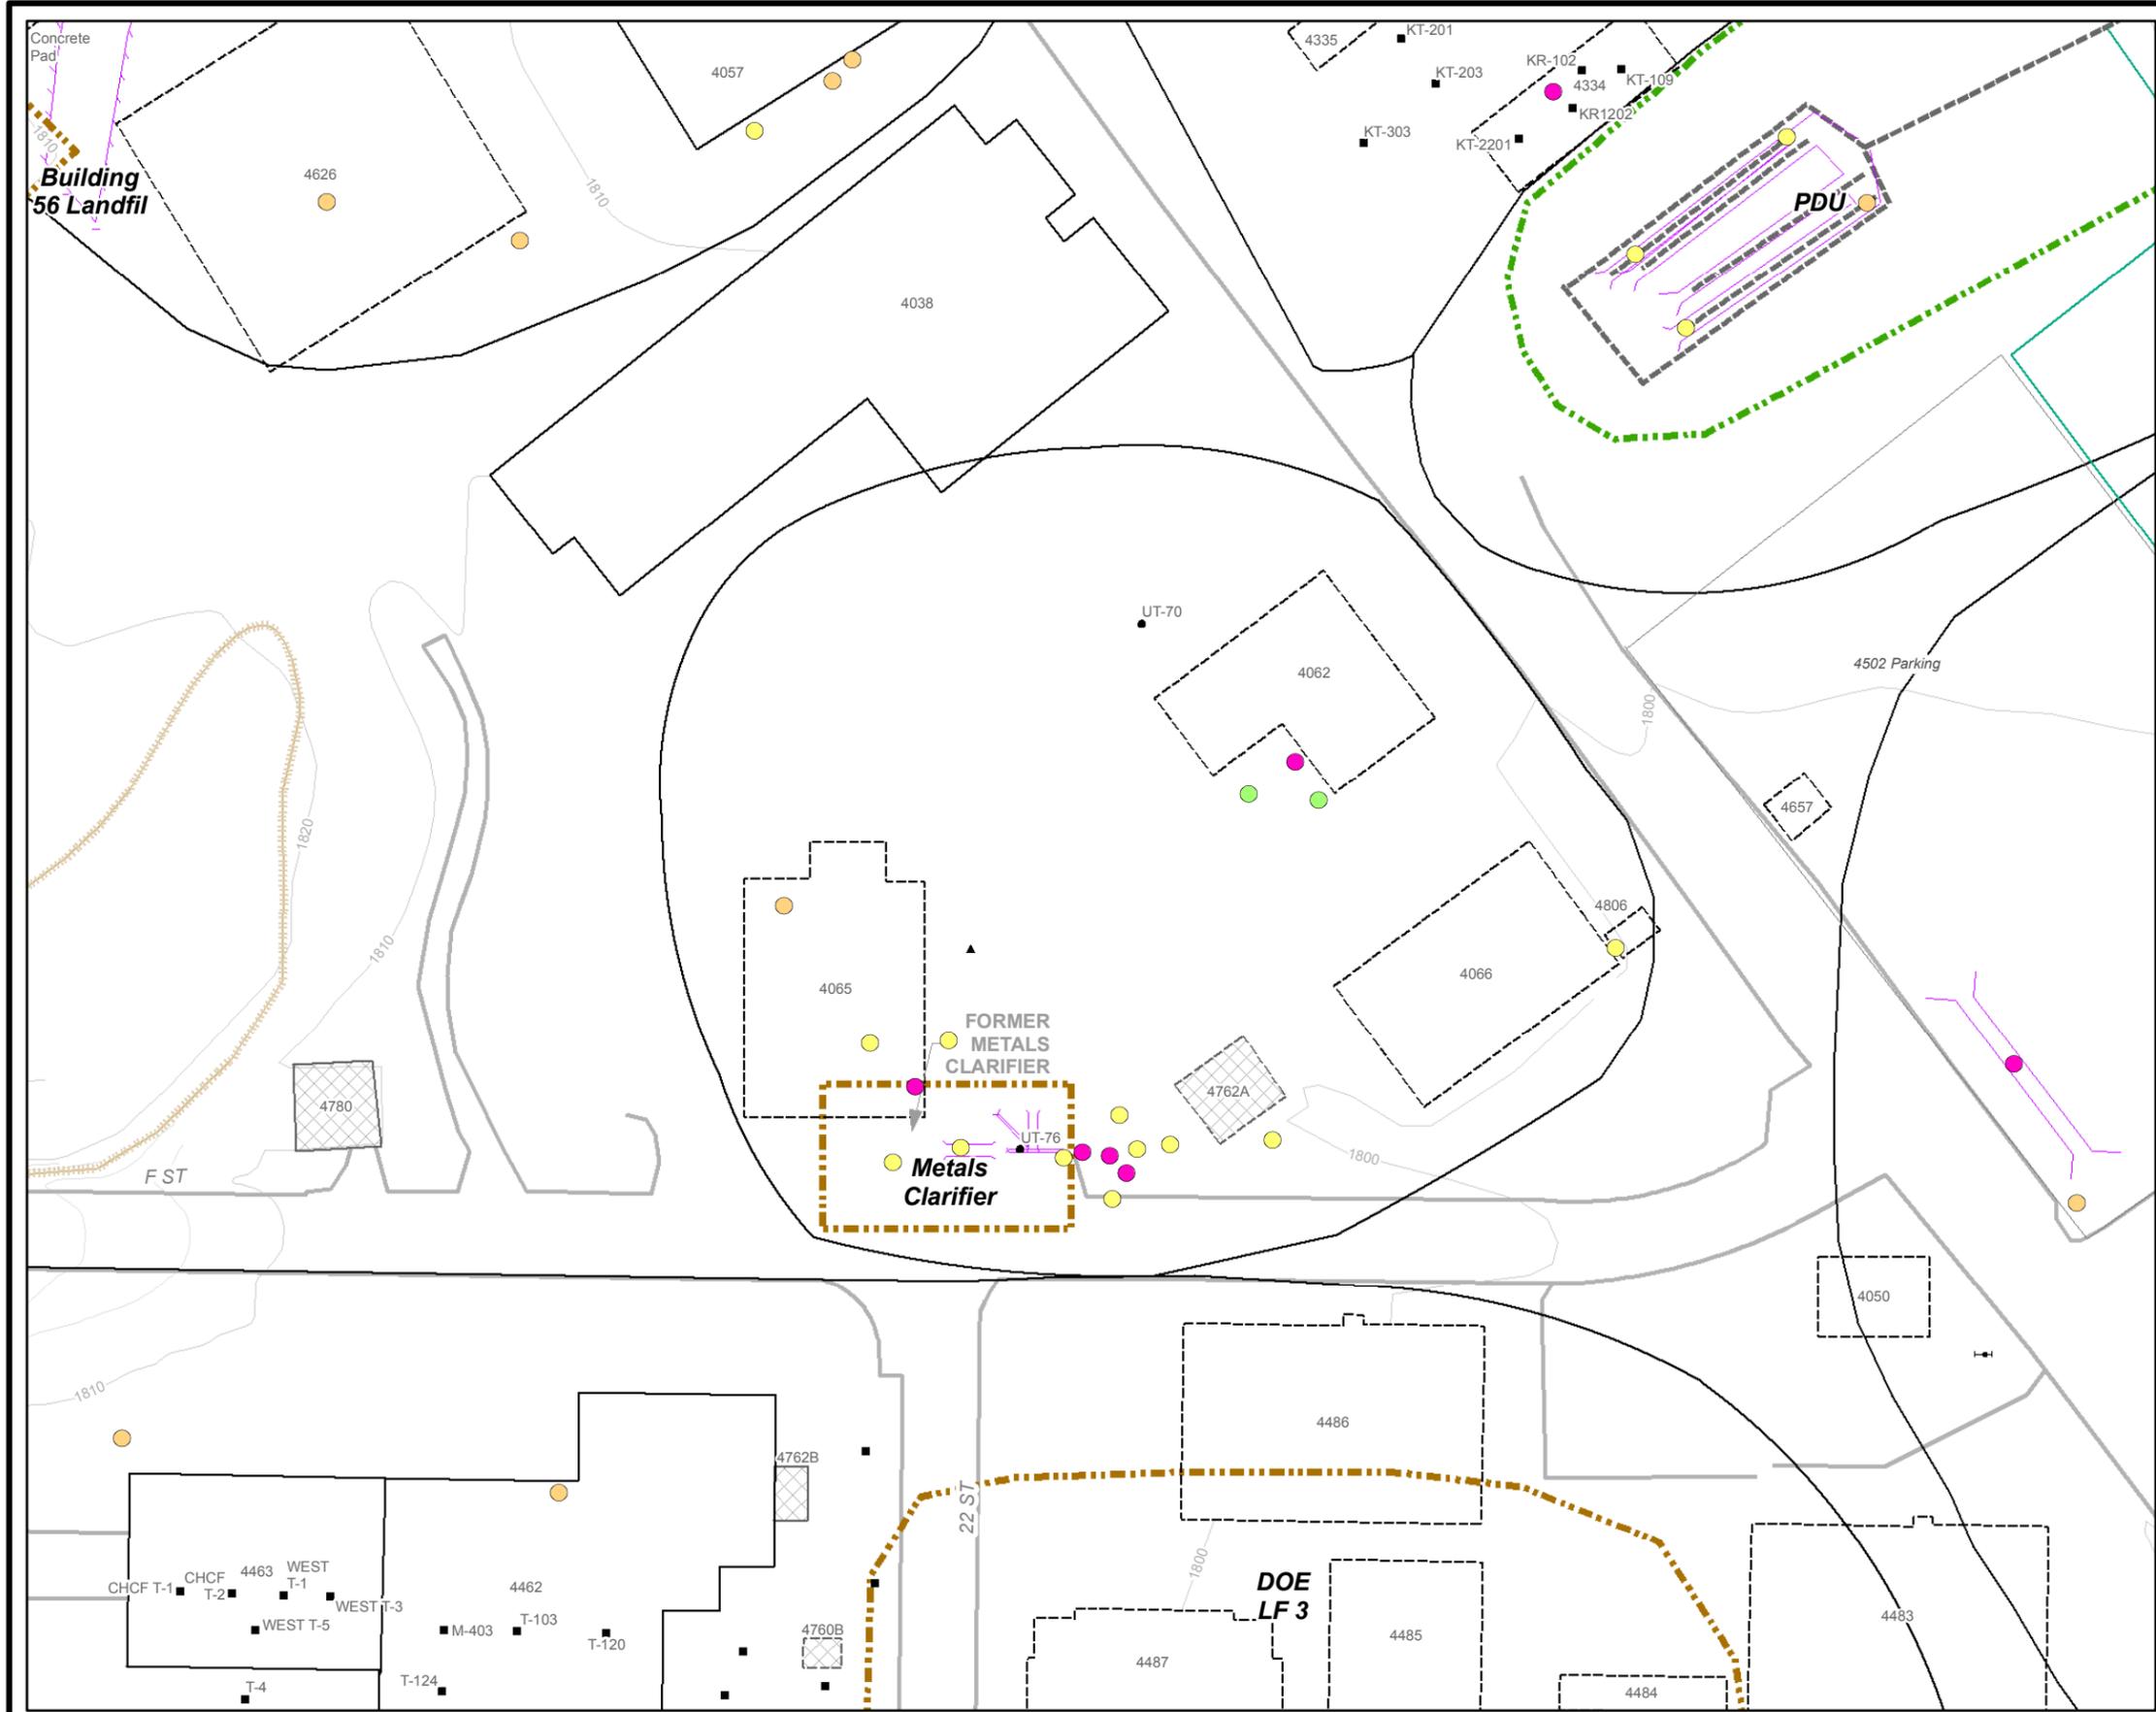
**Figure  
M.3-5**

**Metals in Soil**

- Selenium (background concentration of 0.655 mg/kg, Ecological RBSL of 0.17 mg/kg) was detected at concentrations ranging from 0.4 J mg/kg to 1.1 mg/kg. Selenium was detected above background and Ecological RBSL in one sample collected from U5BS1201 at a depth of 5 to 6 feet bgs (1.1 mg/kg) (screening sample location collected at Building 4062). Selenium was not detected in the surface soil sample (0 to 1 foot bgs) or in the sample collected from 9 to 10 feet bgs at this location. Therefore, it is unlikely that the selenium observed at 5 feet bgs is indicative of a release at this location, and further characterization of this metal is not recommended.

background does not extend vertically. In addition, no elevated zinc concentrations were detected in the soil samples collected in the four borings adjacent to MCBS1000. Therefore, further characterization of zinc at the Building 65 Metals Laboratory Clarifier Site is not recommended.

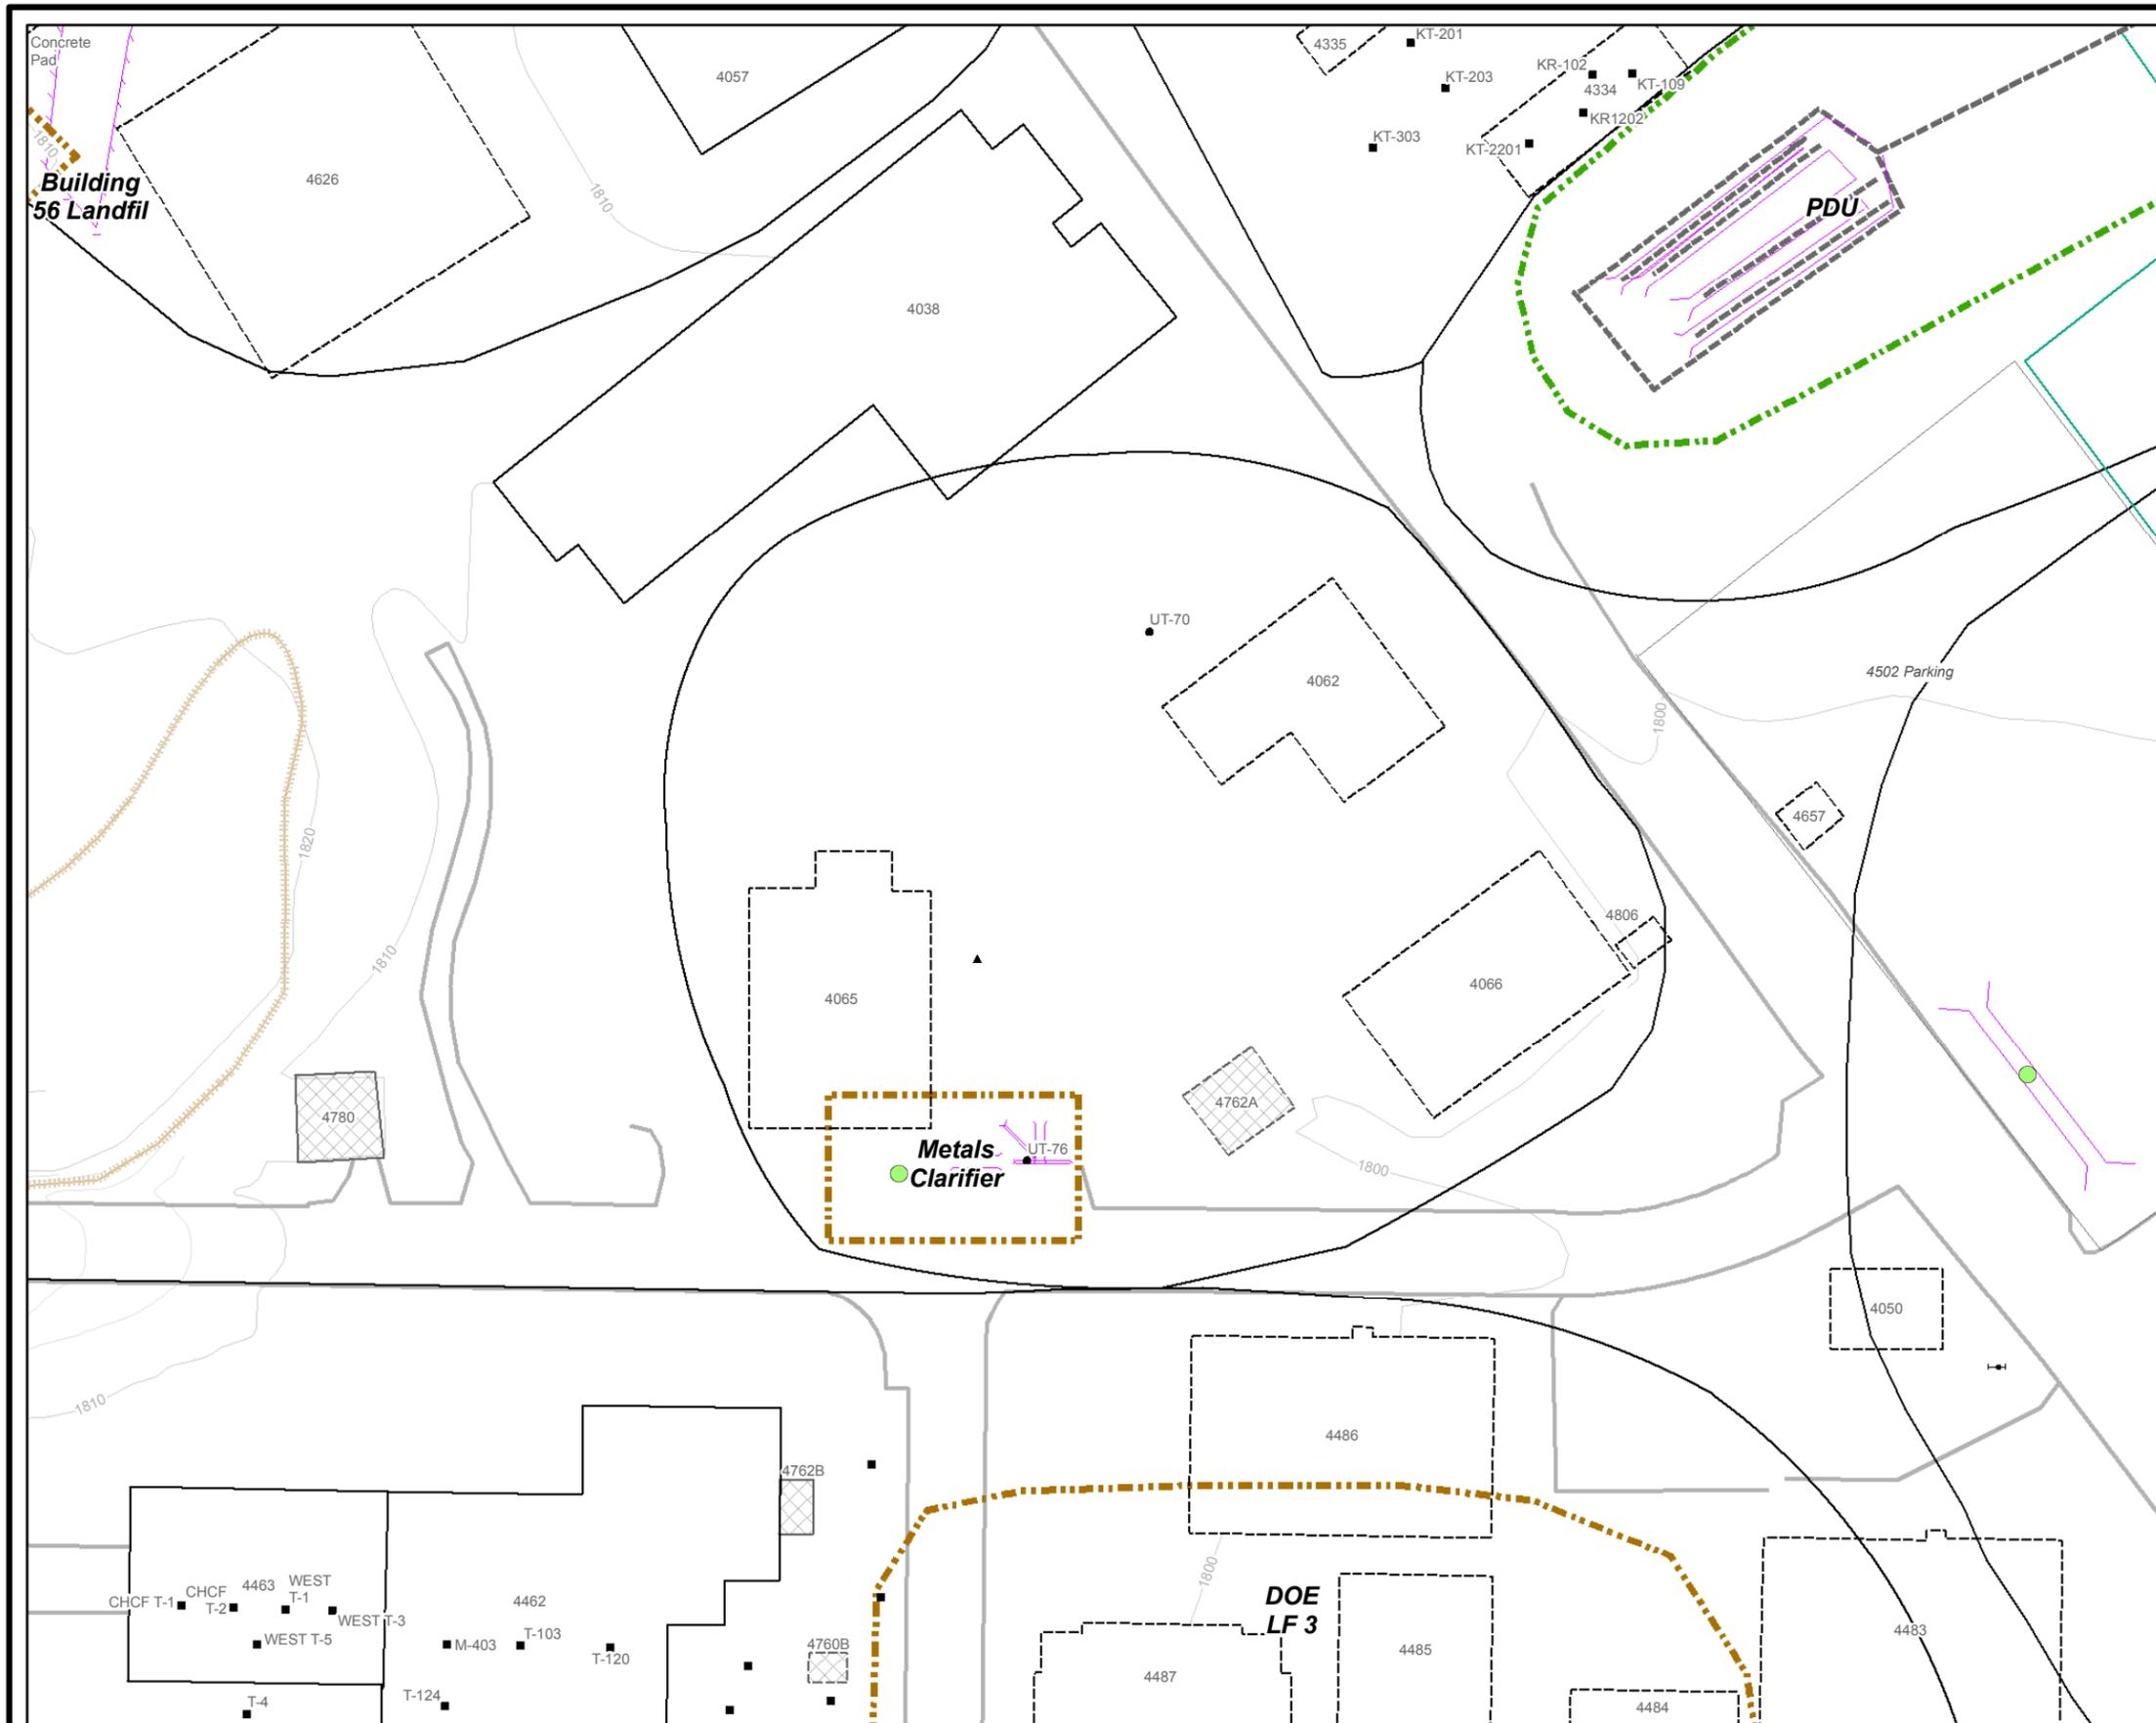
**Energetics in Soil**

One soil sample was collected and analyzed for energetics. No detectable levels of energetics were observed (refer to Figure M.3-6). Further characterization for energetics in soil is not recommended at the Building 65 Metals Laboratory Clarifier Site.
