**GROUP 7 – NORTHERN PORTION OF AREA IV  
RCRA FACILITY INVESTIGATION REPORT  
SANTA SUSANA FIELD LABORATORY  
VENTURA COUNTY, CALIFORNIA**

***VOLUME II – RFI SITE REPORTS***

***BUILDING 4133 SODIUM BURN FACILITY (SWMU 7.2)***

**June 2009**

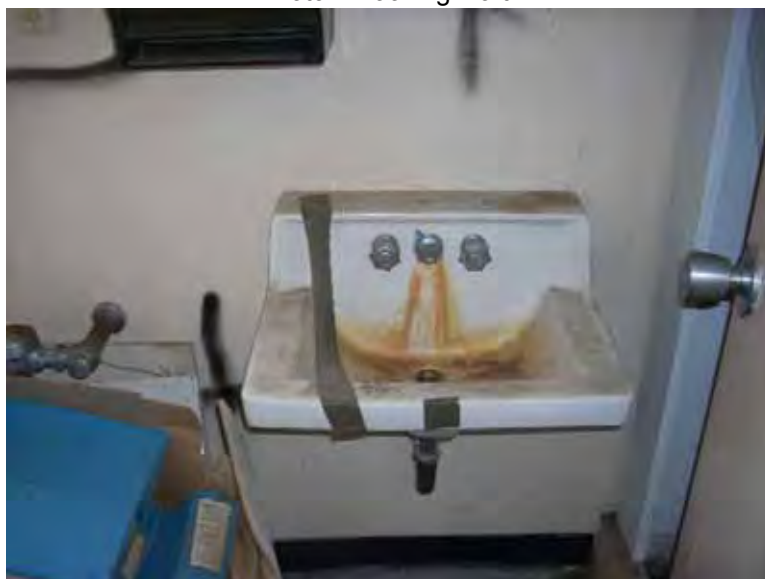
Feature Type: **Sink: Bathroom**  
Operational Use / Process: **Sanitary waste conveyance**  
Associated Chemicals: **None**  
Discharge: **Yes**  
Size: **Area (LxWxH in inches): 18 x 22 x 6**  
Construction Material: **Porcelain**  
Status: **Closed/Inactive**

General Condition: **Intact**  
Debris: **No**  
Staining: **Yes (rust only)**  
Odor: **No**  
PID Reading: **N/A**  
Likelihood of Impact from Feature: **Unlikely**

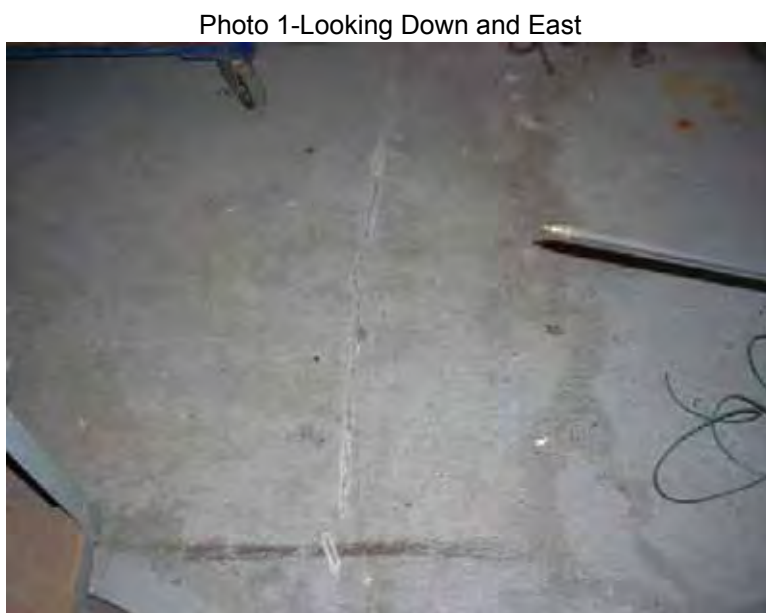
Feature Type: **Cracked Concrete**  
Operational Use / Process: **The area was used to burn sodium metal and sodium-potassium alloy**  
Associated Chemicals: **Metals (Na and NaK), Bases (sodium and potassium hydroxides)**  
Discharge: **No**  
Size: **Length (inches): 50**  
Construction Material: **Concrete**  
Status: **Closed/Inactive**

General Condition: **Compromised, cracked**  
Debris: **No**  
Staining: **No**  
Odor: **No**  
PID Reading: **N/A**  
Likelihood of Impact from Feature: **Potential impact from use of area as a sodium burn facility**

Sampling Warranted?: **Yes, sample post-demolition**  
Sampling Description/Notes: **Sample soil beneath concrete due to feature's known chemical use**  
Sampling Type: **Soil**  
Sample ID Number(s):  
Analyses: **VOCs, SVOCs, metals, TPH, pH**

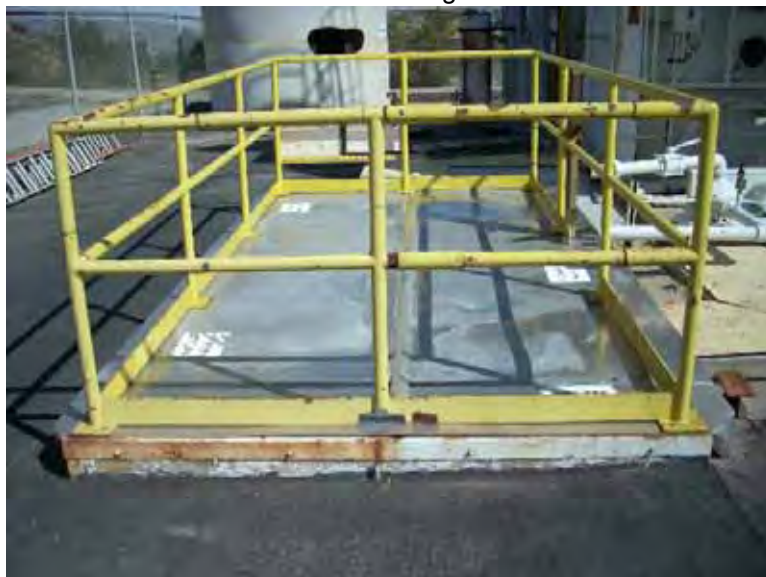
Photo 1-Looking East

Sampling Warranted?: **Yes, sample post-demolition**  
Sampling Description/Notes: **Sample soil beneath concrete due to feature's known chemical use and documented spills**  
Sampling Type: **Soil**

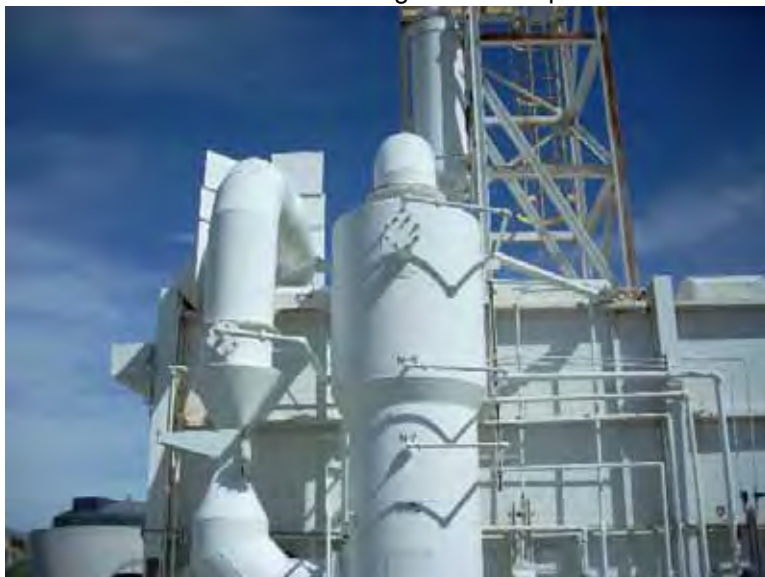
Photo 1-Looking East and Up

Sampling Warranted?: **Yes, sample post-demolition**  
Sampling Description/Notes: **Sample soil beneath concrete due to feature's known chemical use and documented spills**  
Sampling Type: **Soil**  
Sample ID Number(s):

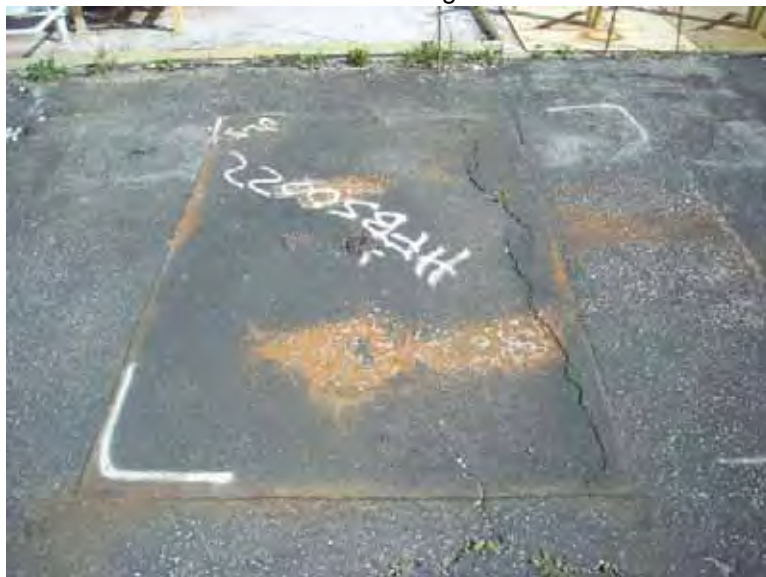
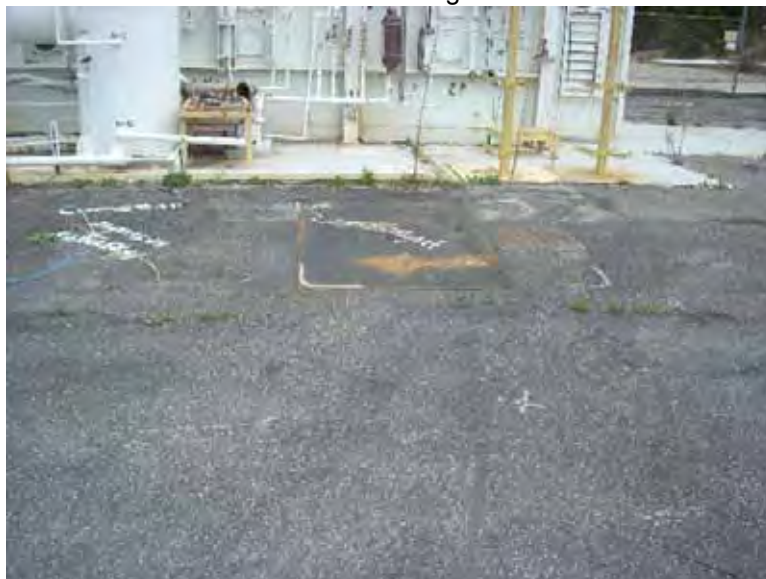
Photo 1-Looking East

Sampling Warranted?: **Yes, sample pre-demolition**  
Sampling Description/Notes: **One sample was collected at the former location of tank T-2**  
Sampling Type: **Soil**  
Sample ID Number(s): **HFBS0022**

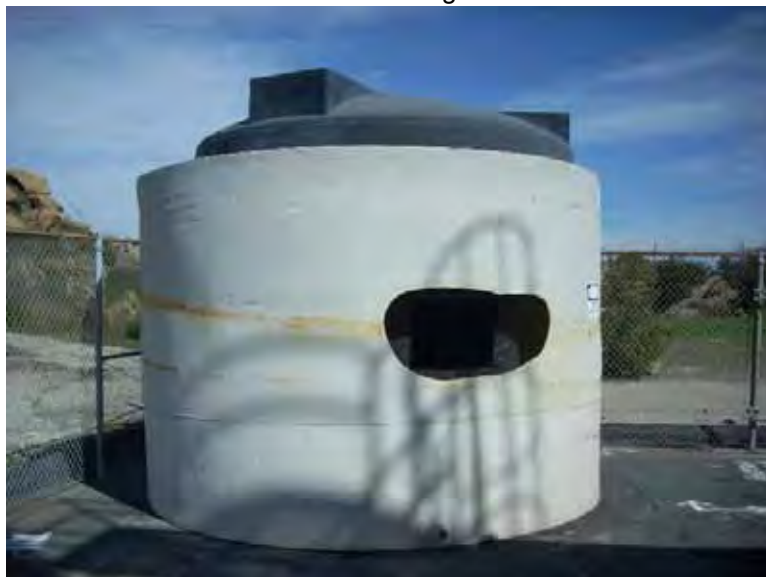
Photo 1-Looking East

Sampling Warranted?: **Yes, inspect and sample, if warranted**  
Sampling Description/Notes: **Sample if staining/impact is detected**  
Sampling Type: **Soil**  
Sample ID Number(s):

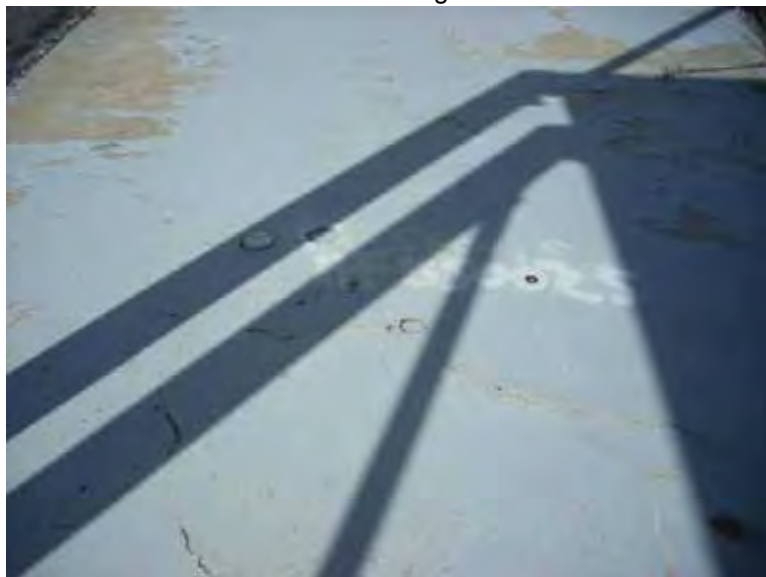
Photo 1-Looking South

Sampling Warranted?: **Yes, sample pre-demolition**  
Sampling Description/Notes: **HFBS0025 is approx. 10 feet to the north of HFBS0027**  
Sampling Type: **Soil**  
Sample ID Number(s): **HFBS0025 and HFBS0027**  
Analyses: **metals, TPH, pH**

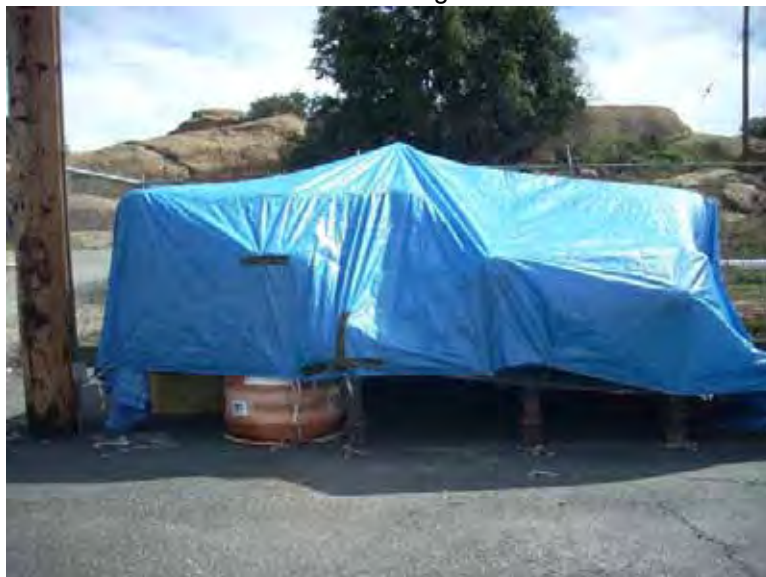
Photo 1-Looking South

Sampling Warranted?: **Yes, inspect and sample, if warranted**  
Sampling Description/Notes: **Sample if staining/impact is detected**  
Sampling Type: **Soil**  
Sample ID Number(s):  
Analyses: **VOCs, SVOCs, metals, TPH, pH**

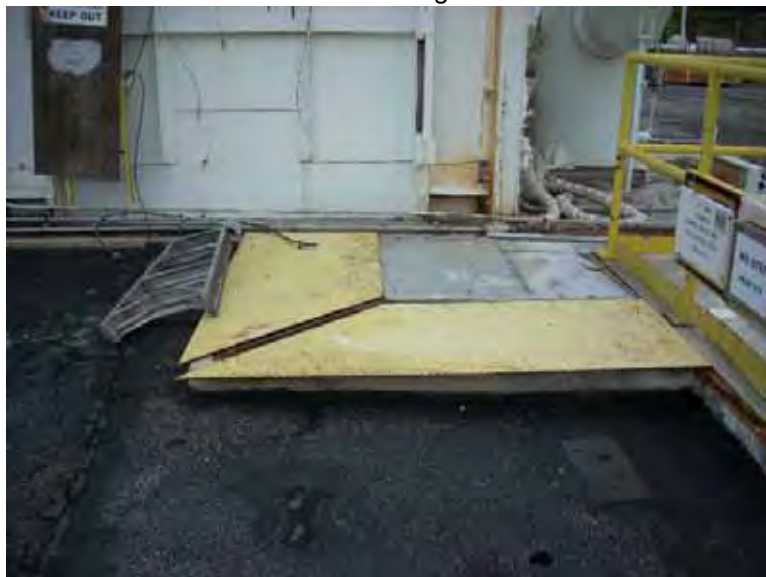
Photo 1-Looking South

Sampling Warranted?: **Yes, inspect and sample, if warranted**  
Sampling Description/Notes: **Sample if staining/impact is detected**  
Sampling Type: **Soil**  
Sample ID Number(s):  
Analyses: **metals, pH**

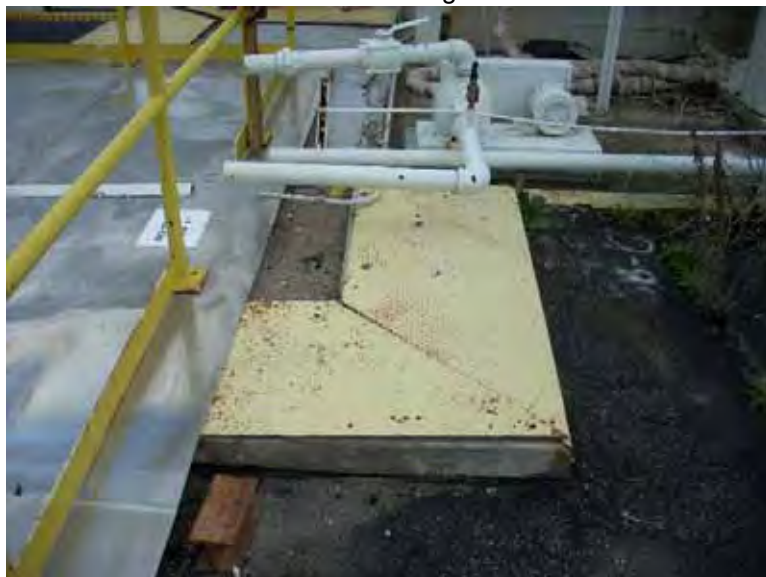
Photo 1-Looking East

Sampling Warranted?: **Yes, inspect and sample, if warranted**  
Sampling Description/Notes: **Sample if staining/impact is detected**  
Sampling Type: **Soil**  
Sample ID Number(s):  
Analyses: **metals, pH**
