Addendum No. 5 to

Master Work Plan/Field Sampling and Analysis  
Plan, Co-Located Chemical Sampling at Area IV  
Santa Susana Field Laboratory, Ventura County,  
California

EPA Subarea 6 Soil Sampling

July 2011

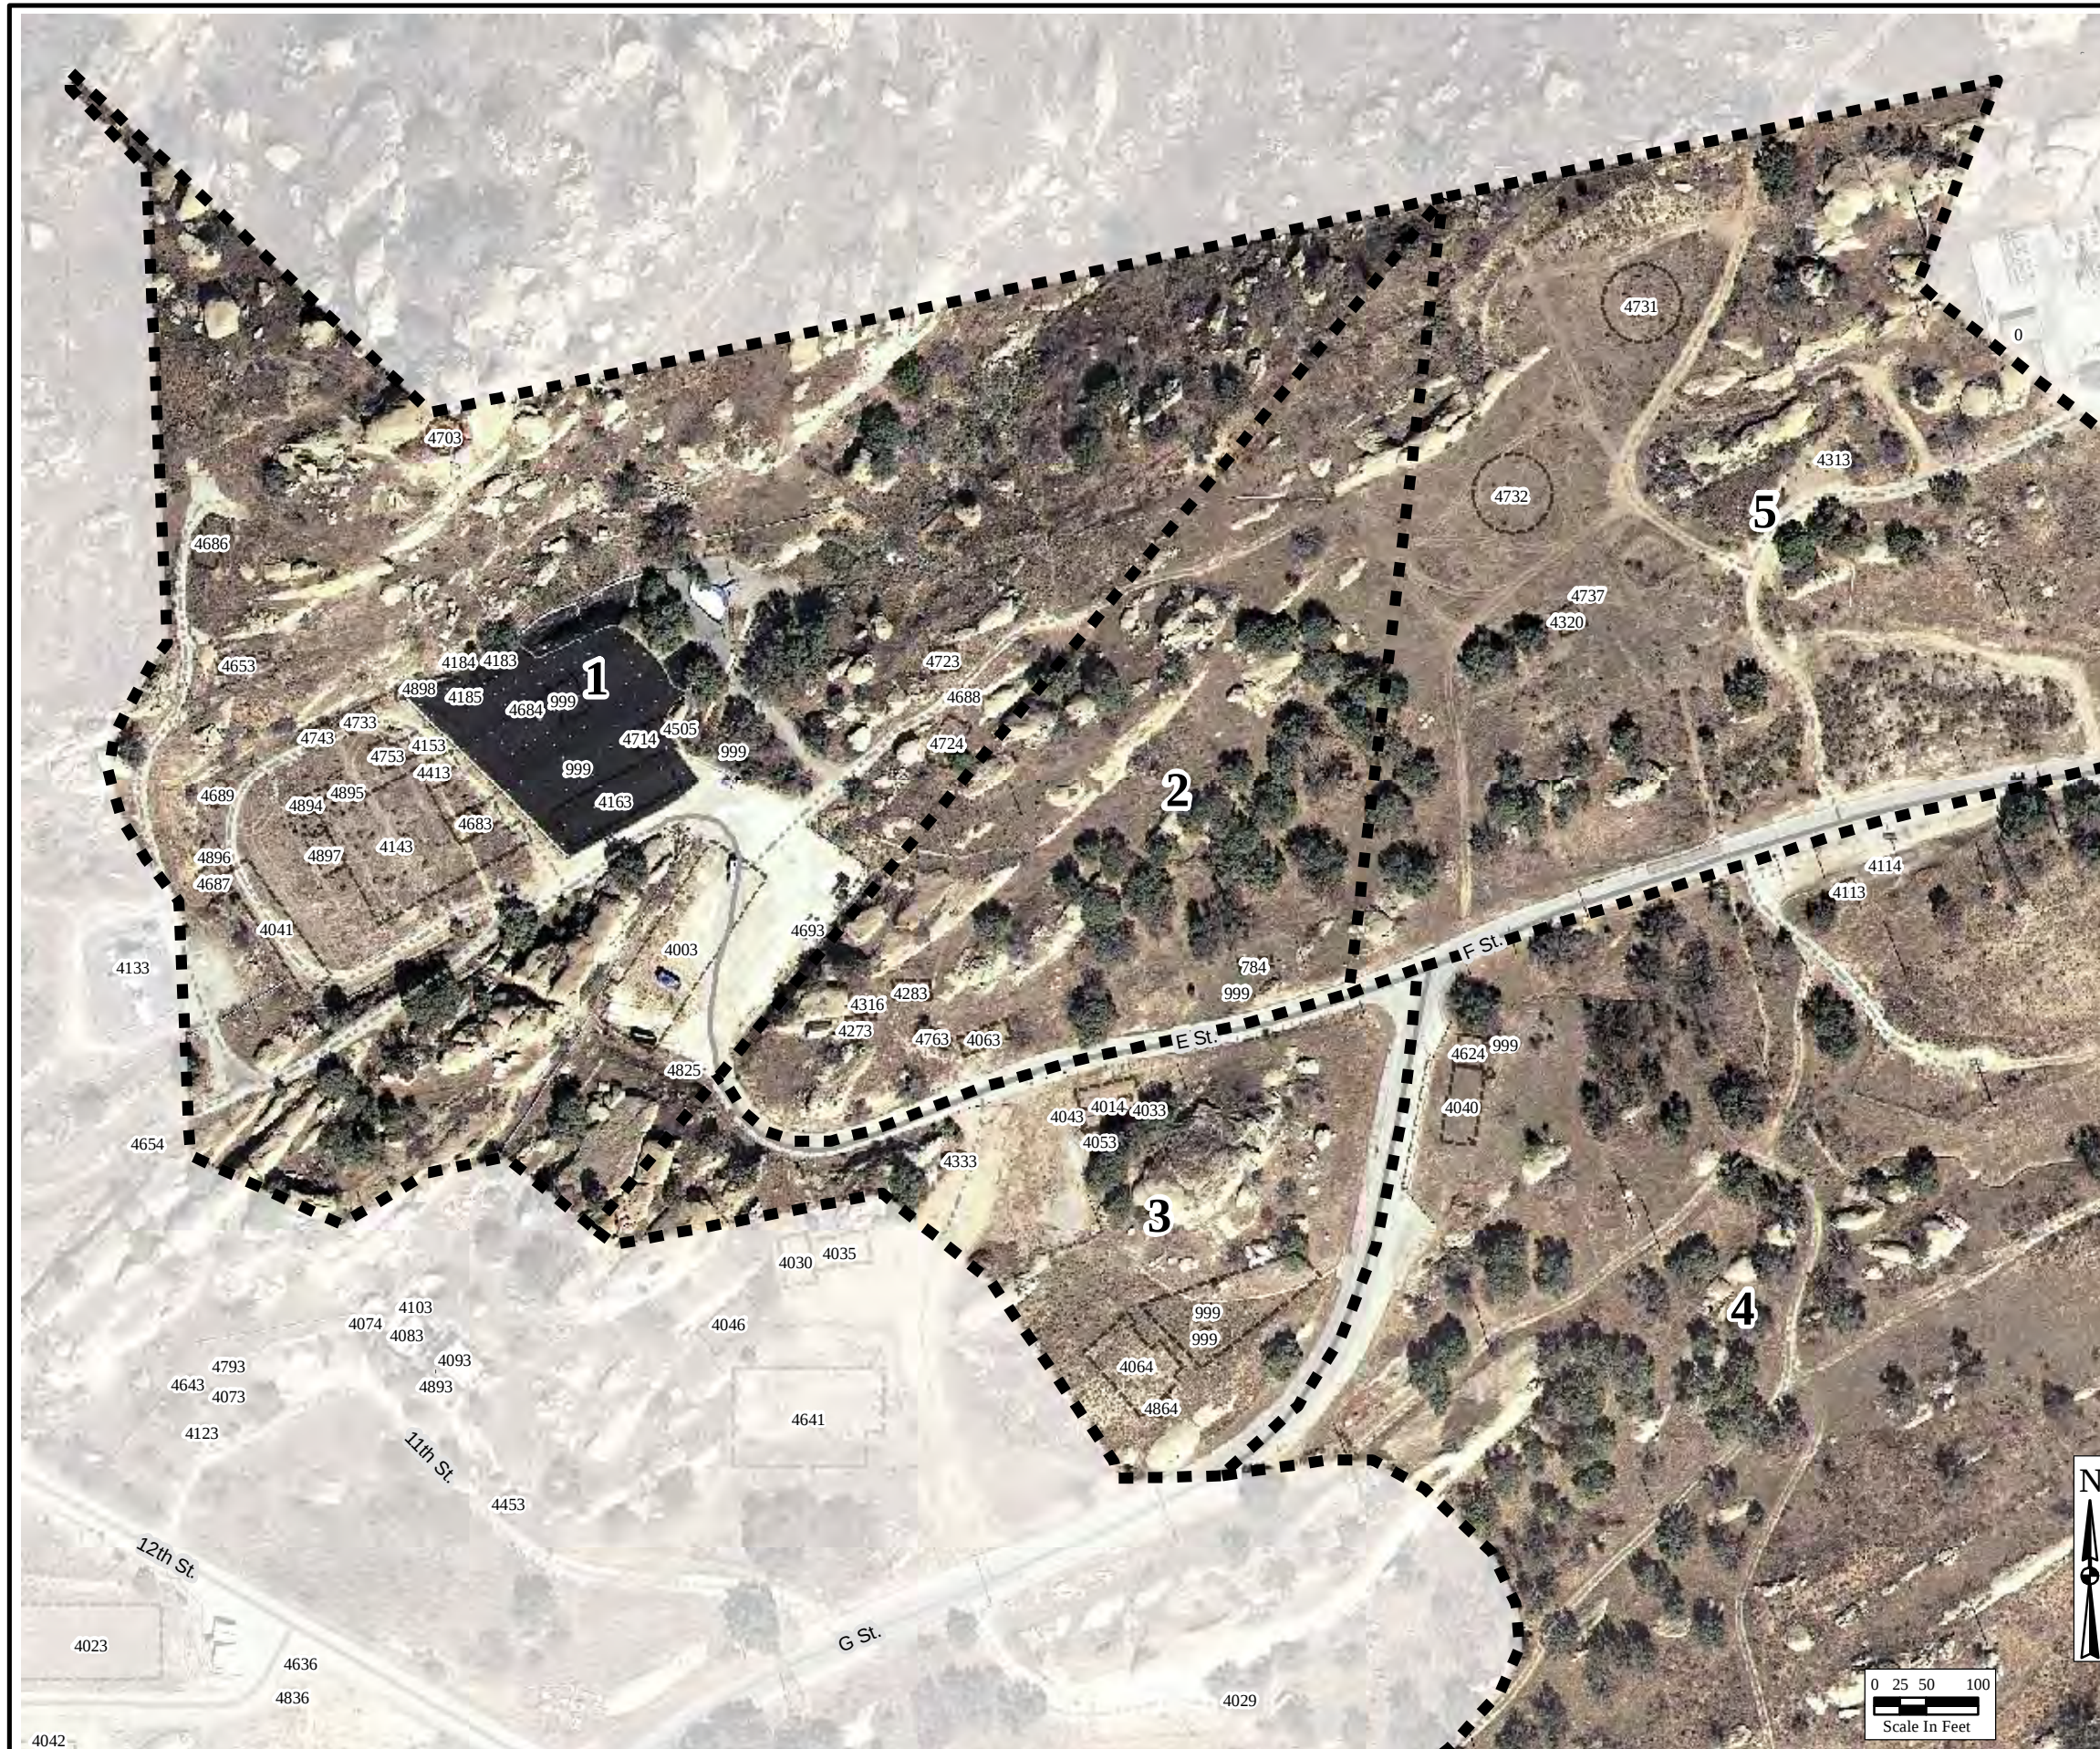
**Figure 1**  
**Subarea 6 Base Map**  
**Santa Susana Field Laboratory**

Figure 1 is a layout of EPA's Subarea 6. The proposed sample locations are shown on Figures 2 through 6, which were taken from EPA's Subarea 6 FSP Addendum (HGL 2011). EPA's description and rationale for the soil sample locations in Subarea 6 are summarized in Table 1.
