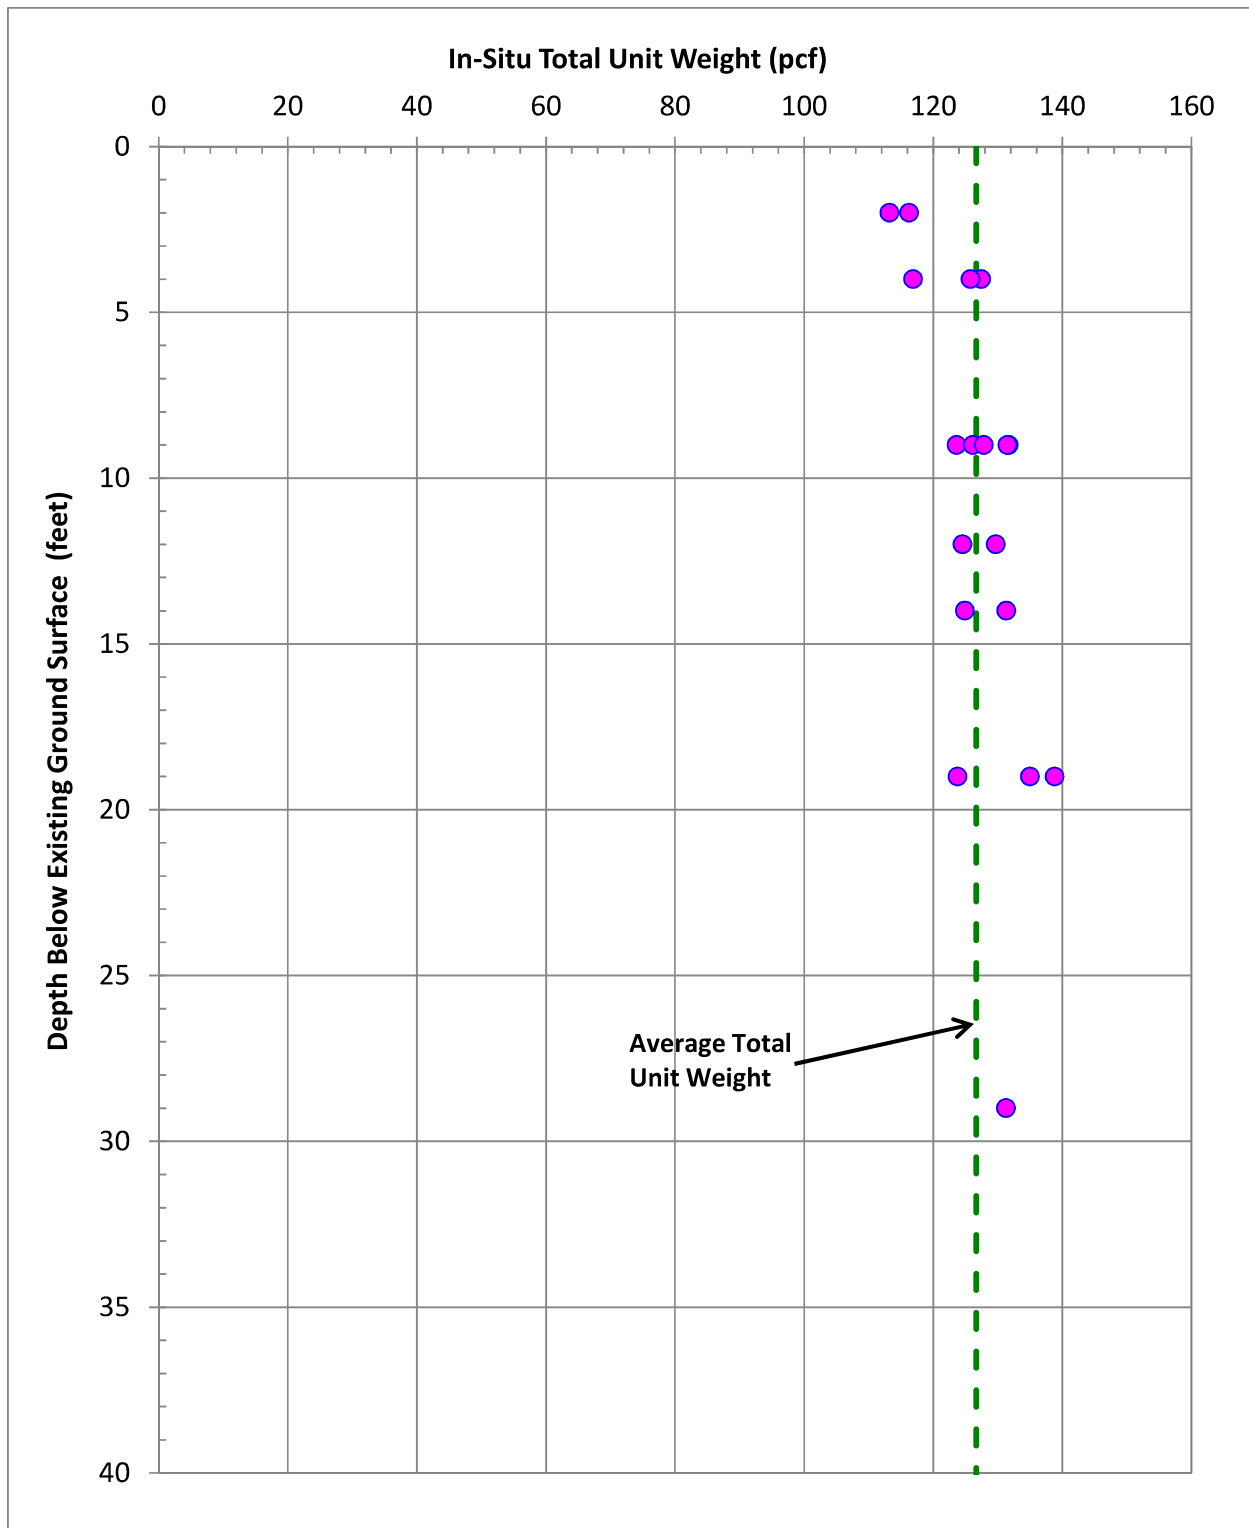
Figure 9 – Total Unit Weight versus Depth

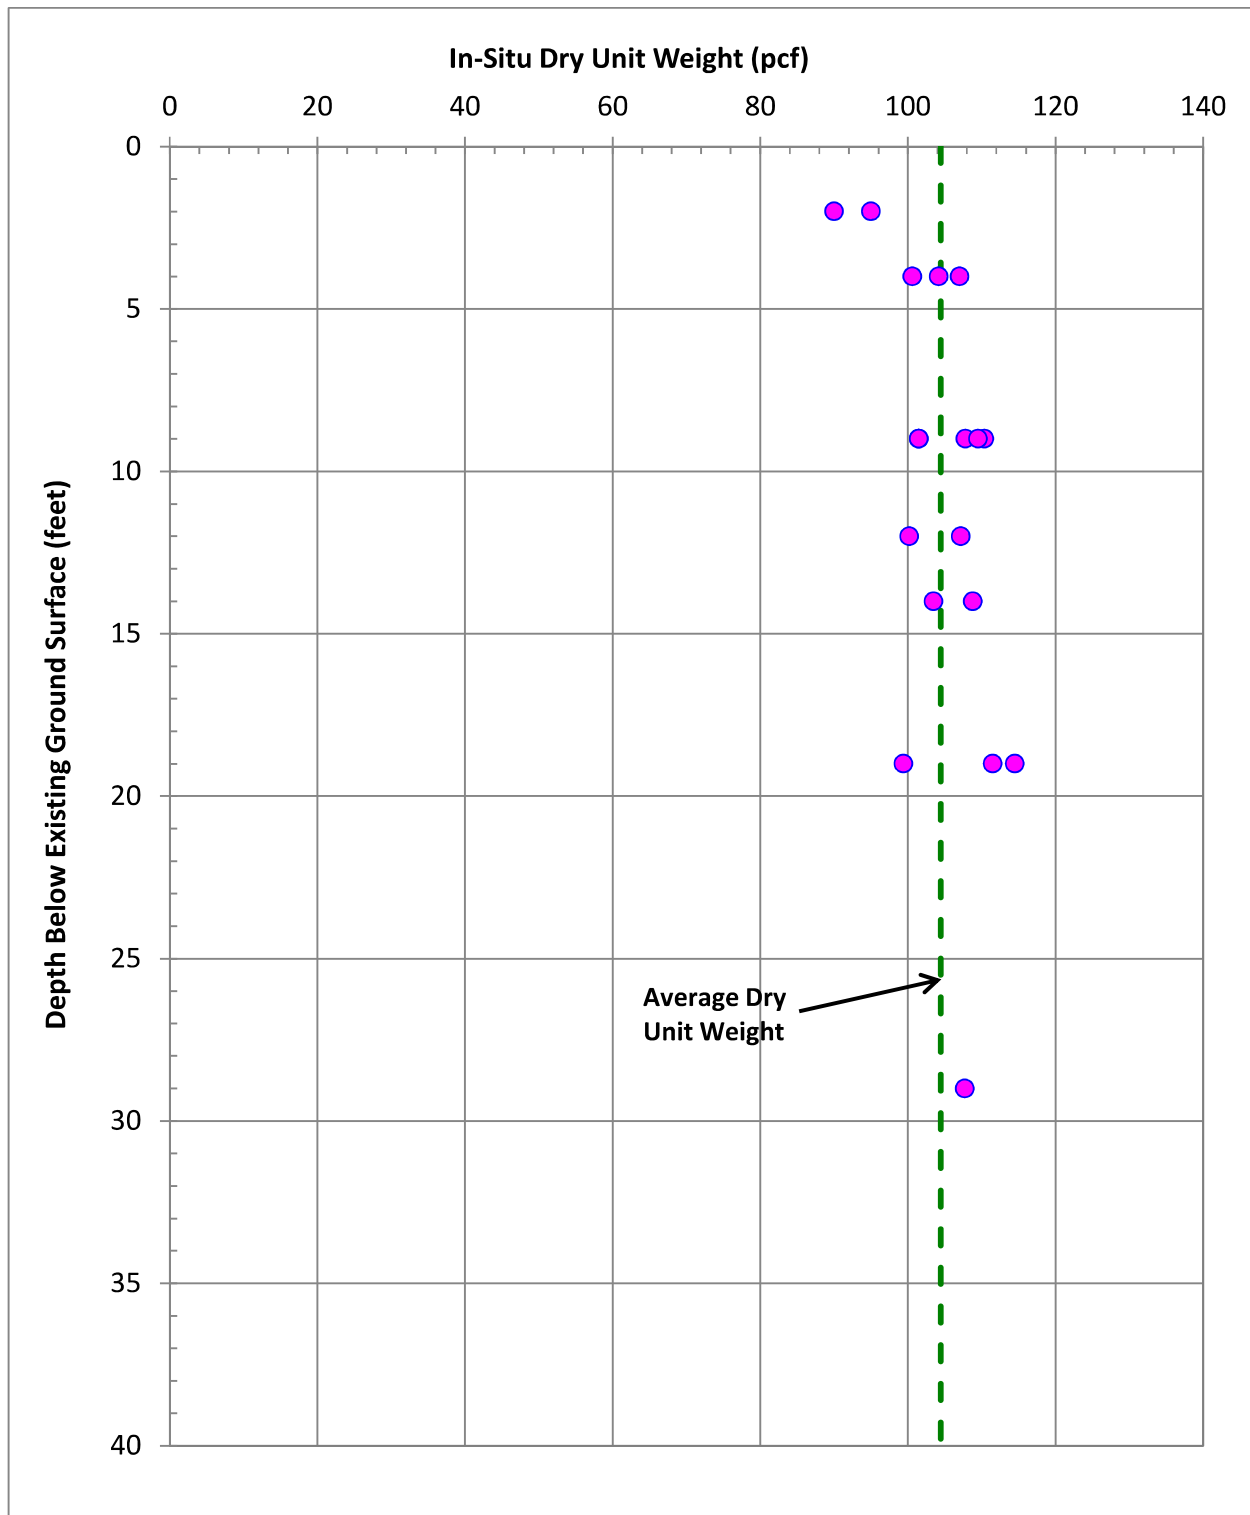
Figure 10 – Dry Unit Weight versus Depth

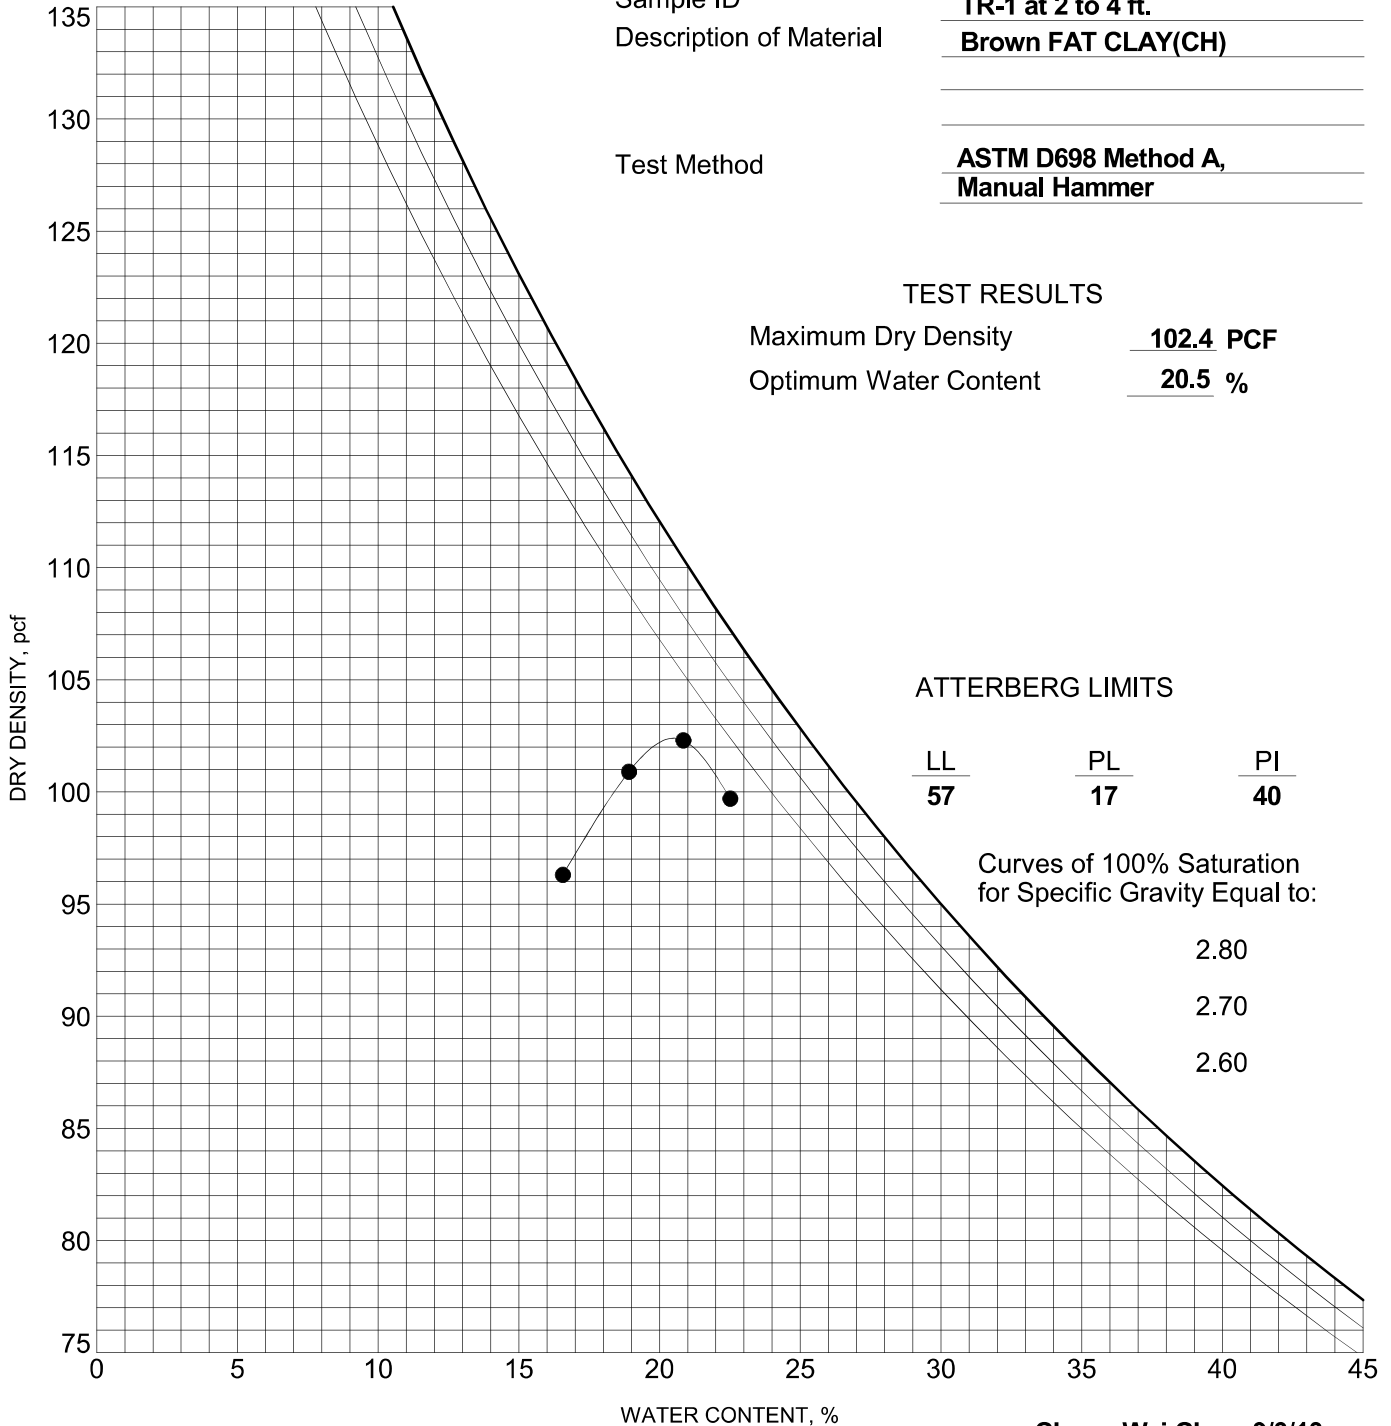
# MOISTURE-DENSITY RELATIONSHIP

Sample ID TR-1 at 2 to 4 ft.  
 Description of Material Brown FAT CLAY(CH)  
 Test Method ASTM D698 Method A,  
 Manual Hammer

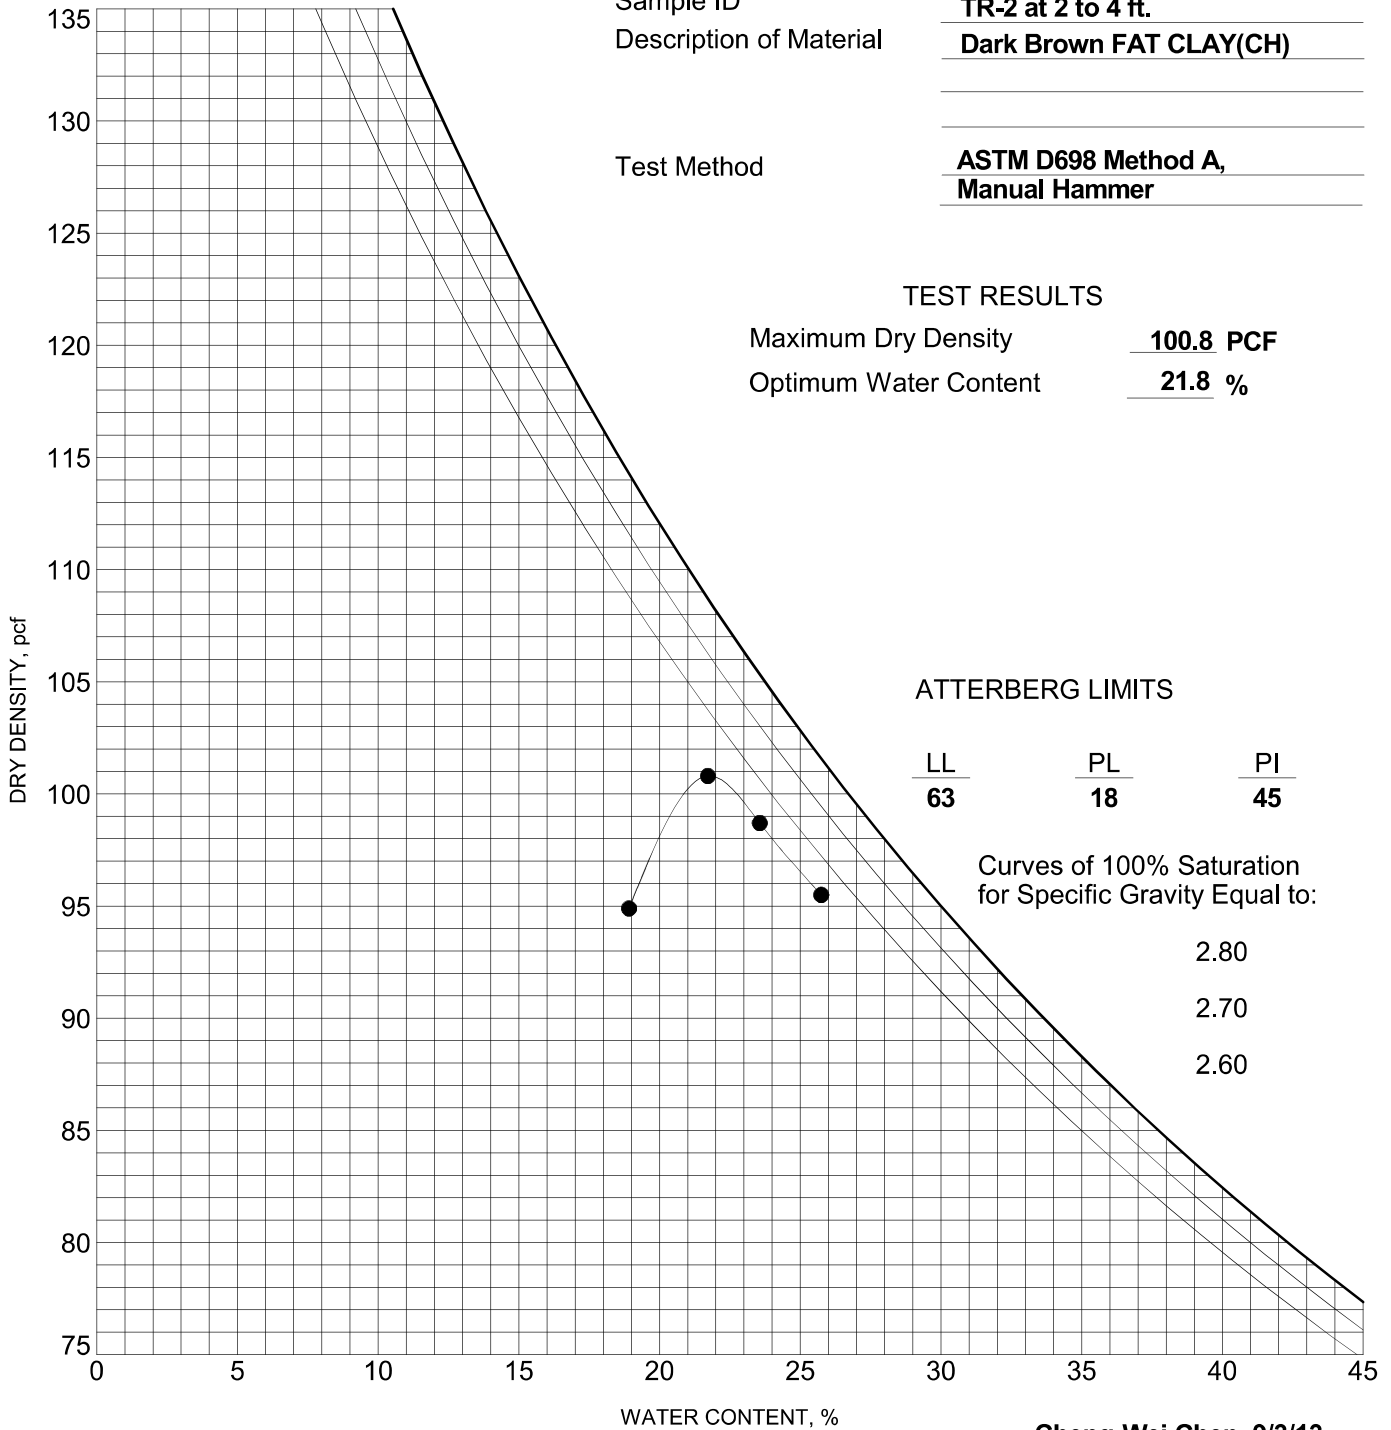
# MOISTURE-DENSITY RELATIONSHIP

Sample ID: TR-2 at 2 to 4 ft.  
 Description of Material: Dark Brown FAT CLAY(CH)  
 Test Method: ASTM D698 Method A, Manual Hammer

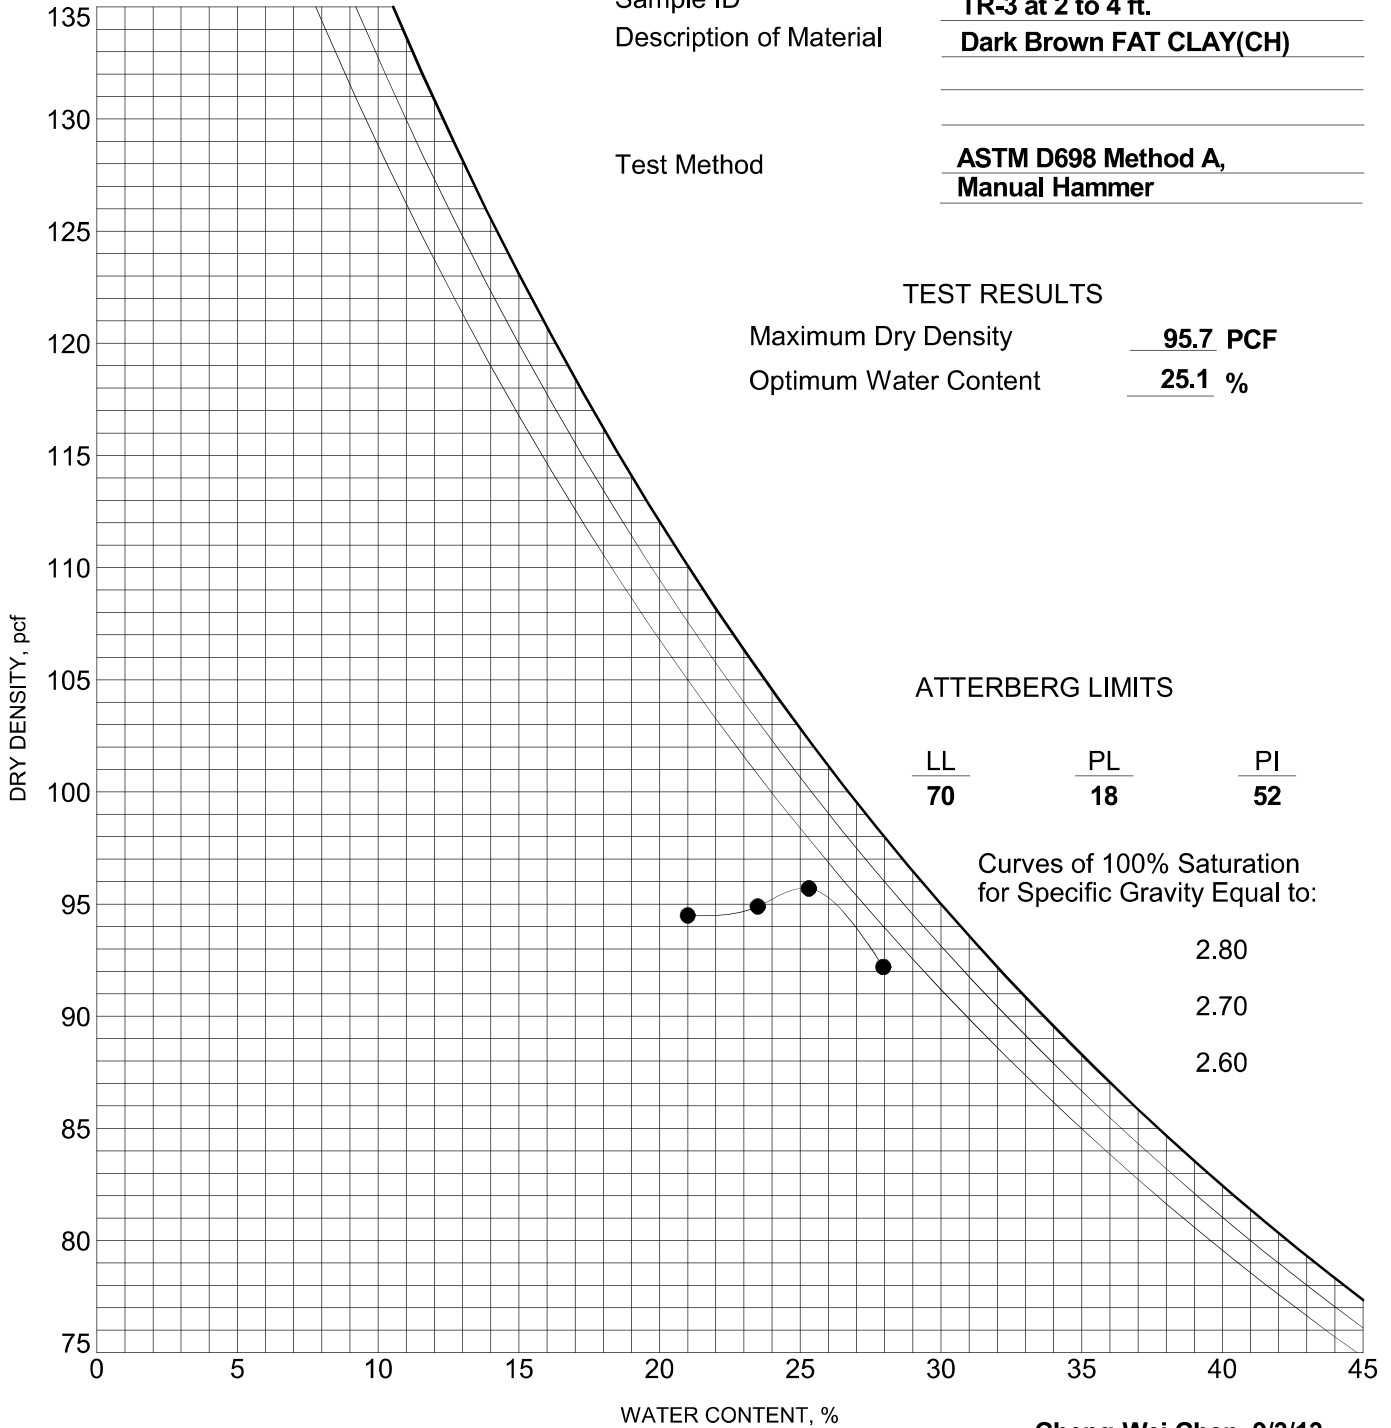
# MOISTURE-DENSITY RELATIONSHIP

Sample ID TR-3 at 2 to 4 ft.  
 Description of Material Dark Brown FAT CLAY(CH)  
 Test Method ASTM D698 Method A,  
 Manual Hammer

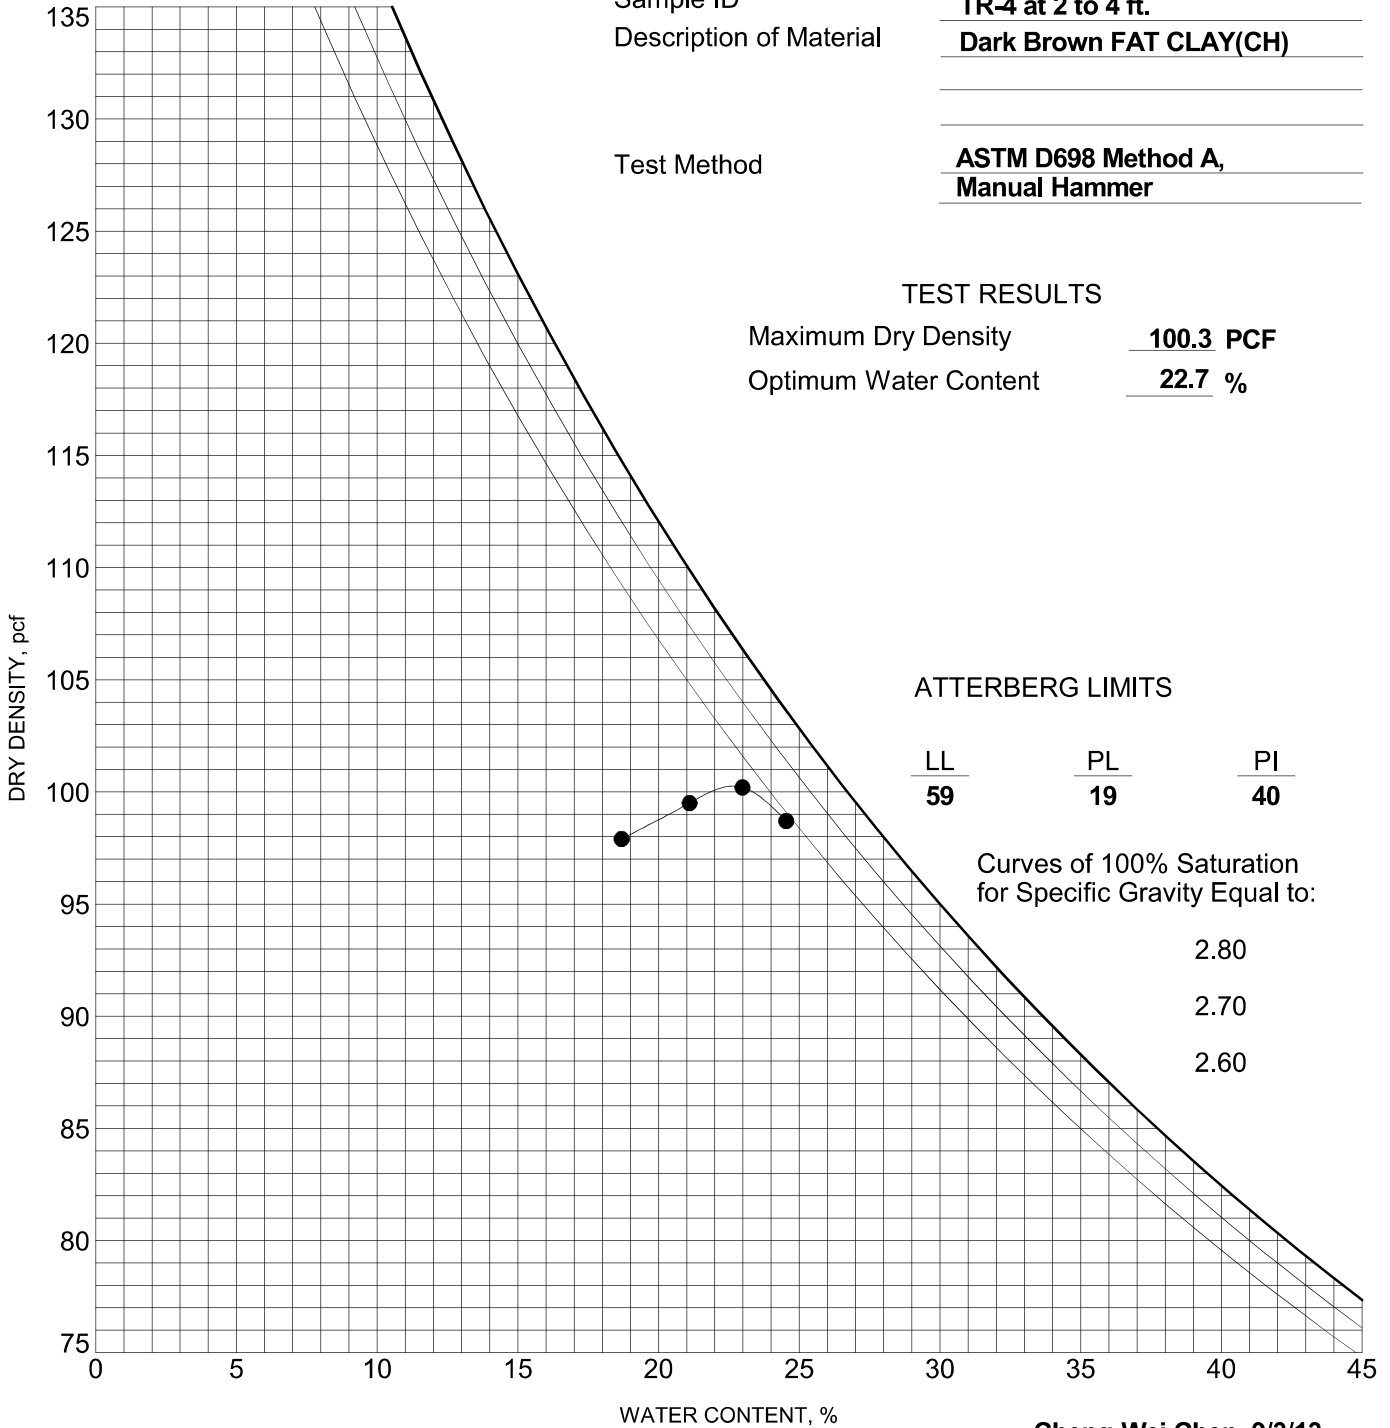
# MOISTURE-DENSITY RELATIONSHIP

Sample ID: TR-4 at 2 to 4 ft.  
 Description of Material: Dark Brown FAT CLAY(CH)  
 Test Method: ASTM D698 Method A, Manual Hammer

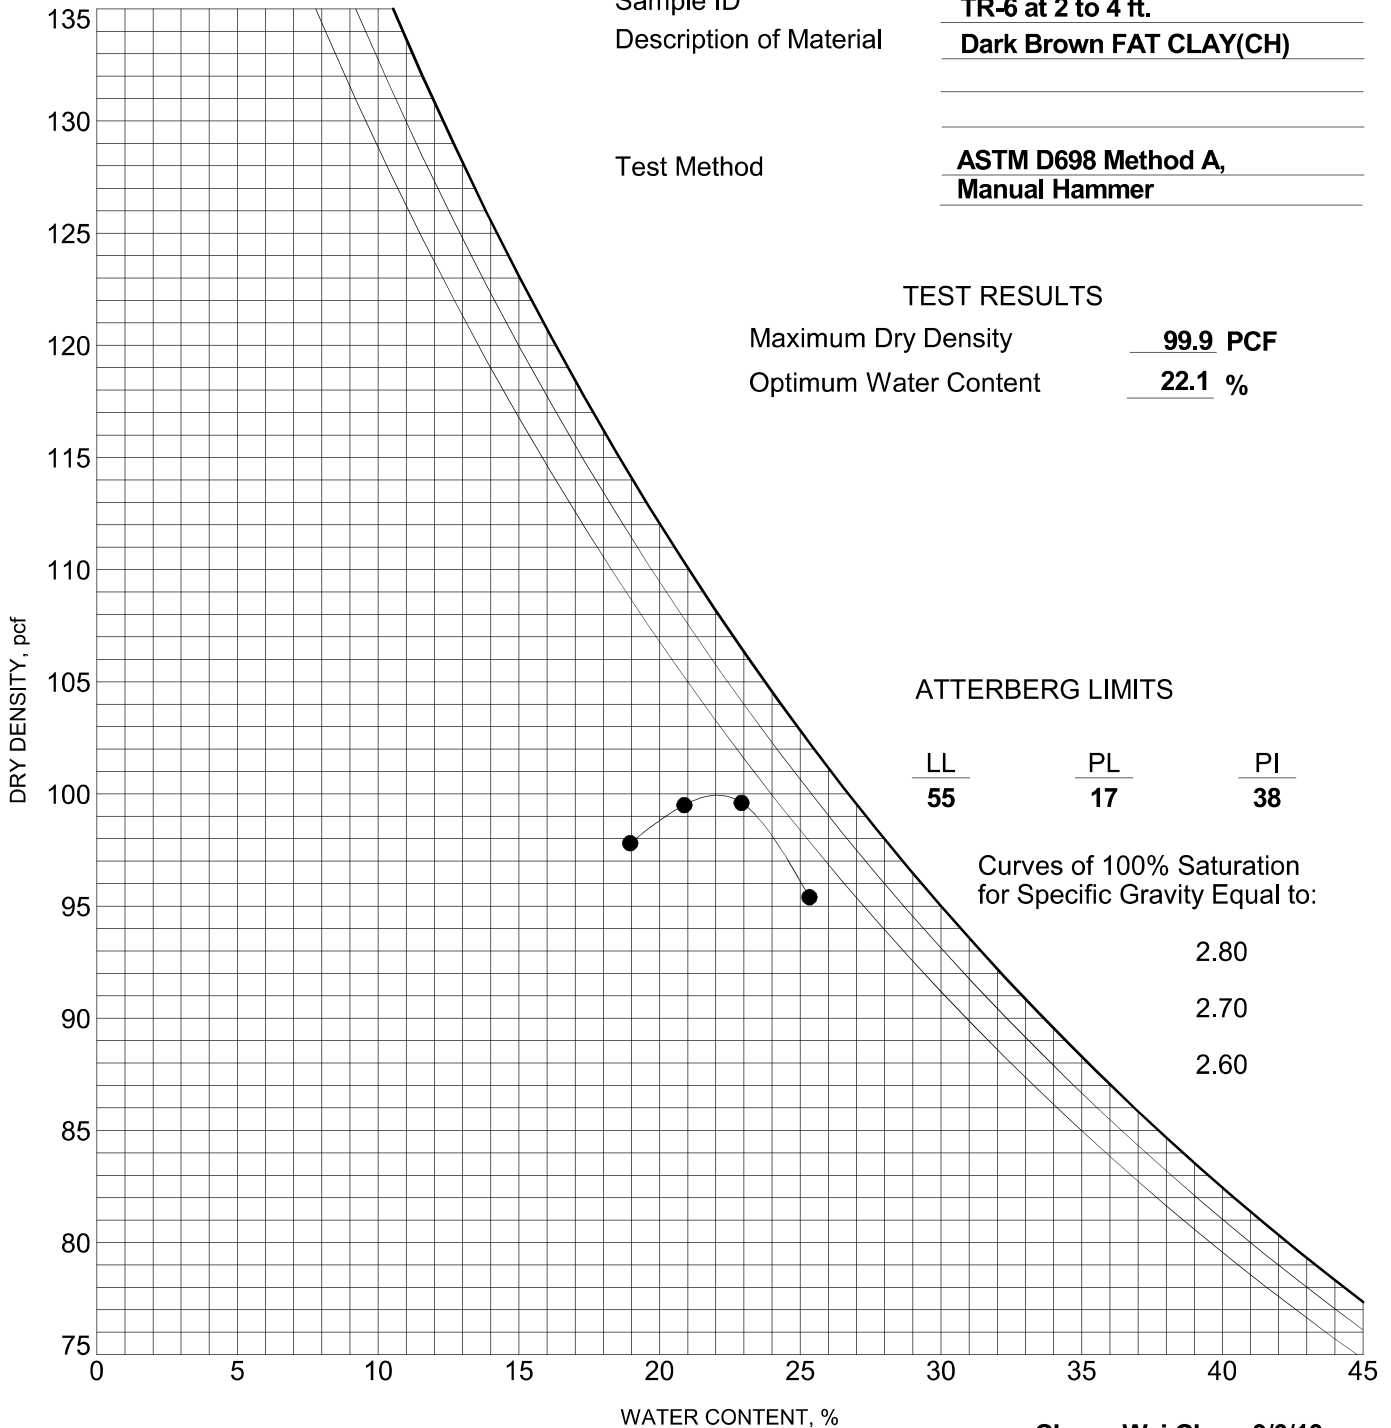
# MOISTURE-DENSITY RELATIONSHIP

Sample ID TR-6 at 2 to 4 ft.  
 Description of Material Dark Brown FAT CLAY(CH)  
 Test Method ASTM D698 Method A,  
 Manual Hammer

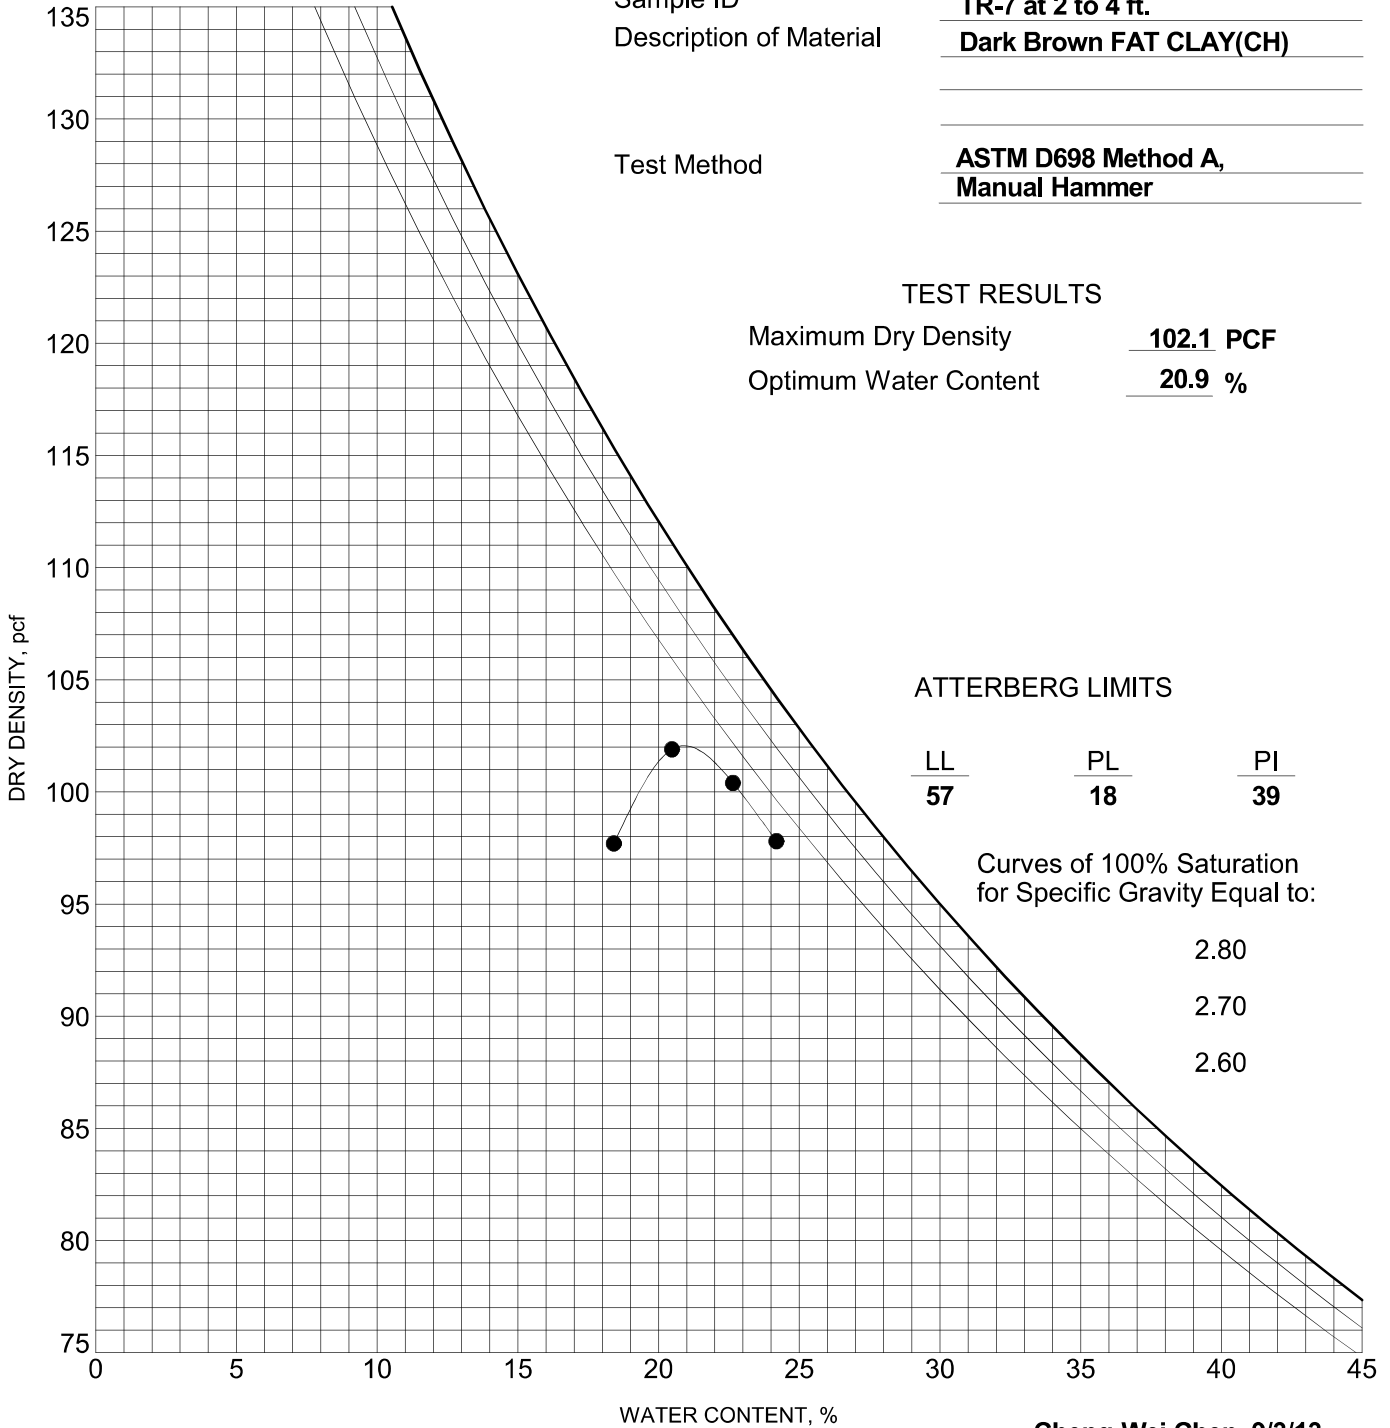
# MOISTURE-DENSITY RELATIONSHIP

Sample ID TR-7 at 2 to 4 ft.  
 Description of Material Dark Brown FAT CLAY(CH)  
 Test Method ASTM D698 Method A,  
 Manual Hammer

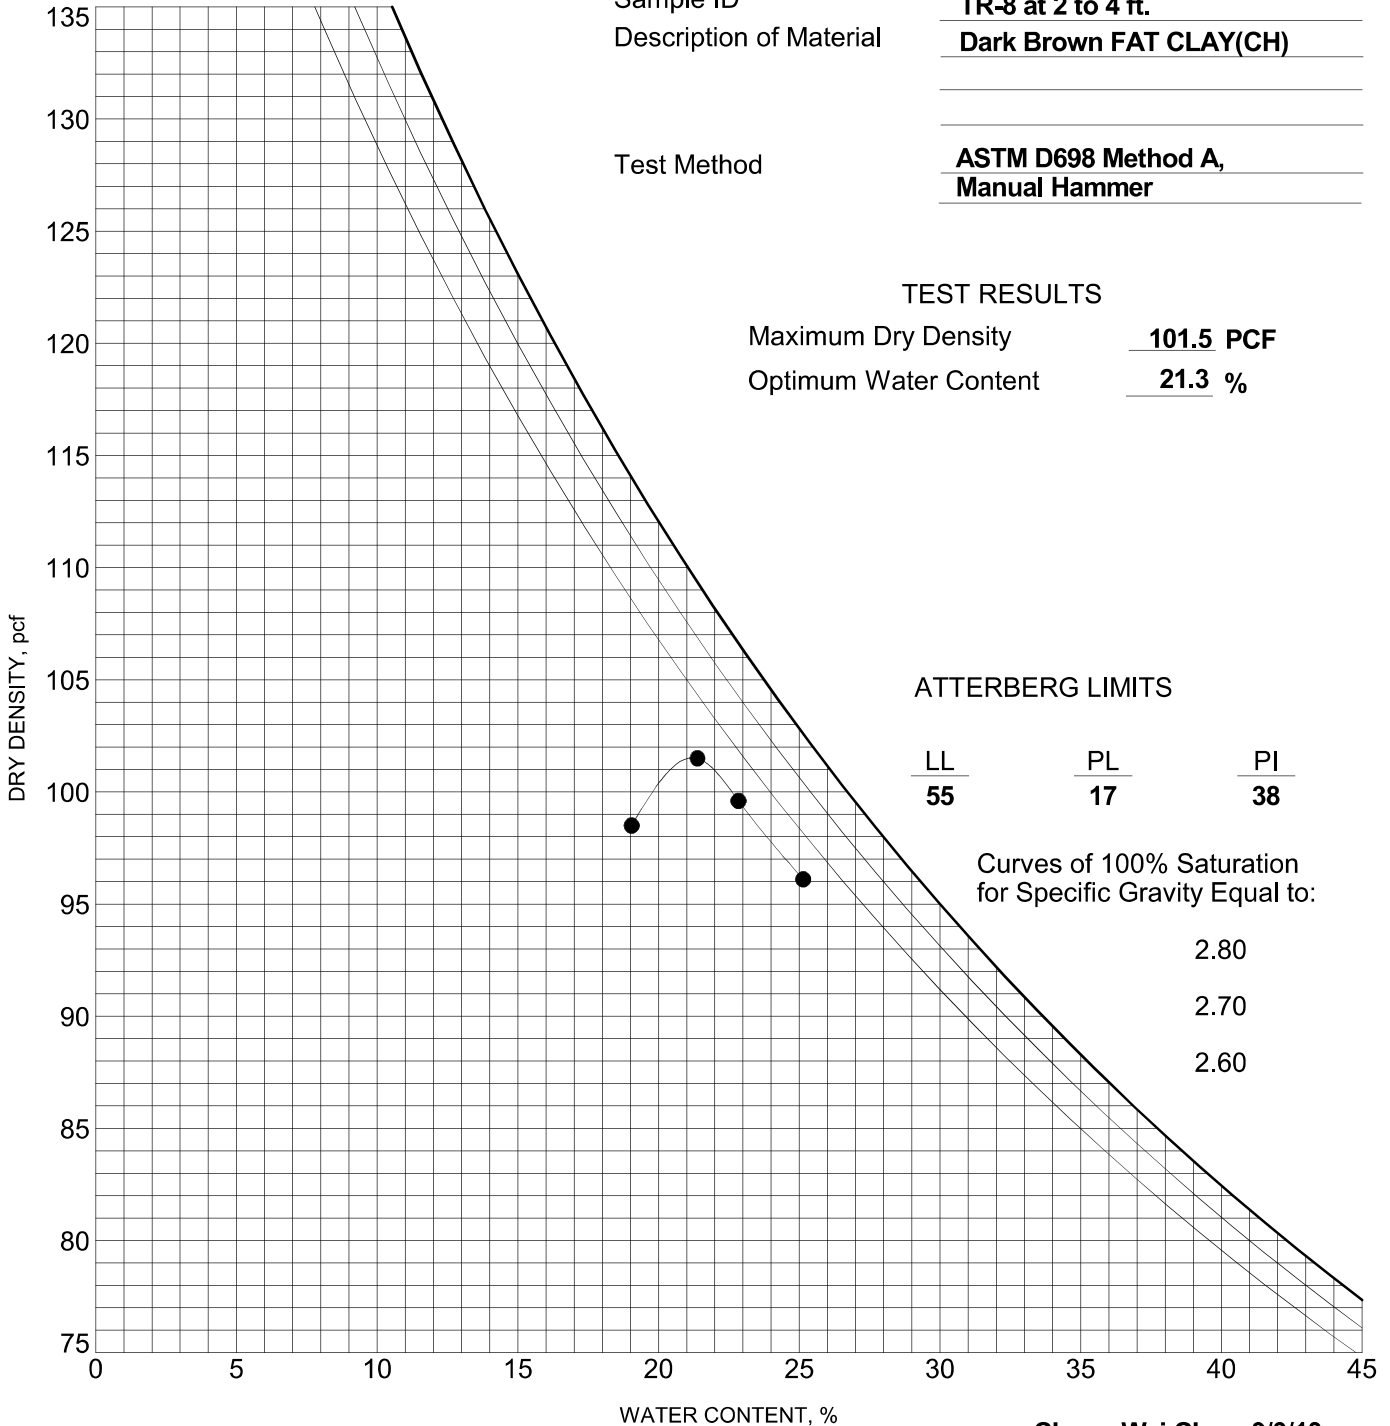
# MOISTURE-DENSITY RELATIONSHIP

Sample ID TR-8 at 2 to 4 ft.  
 Description of Material Dark Brown FAT CLAY(CH)  
 Test Method ASTM D698 Method A,  
 Manual Hammer

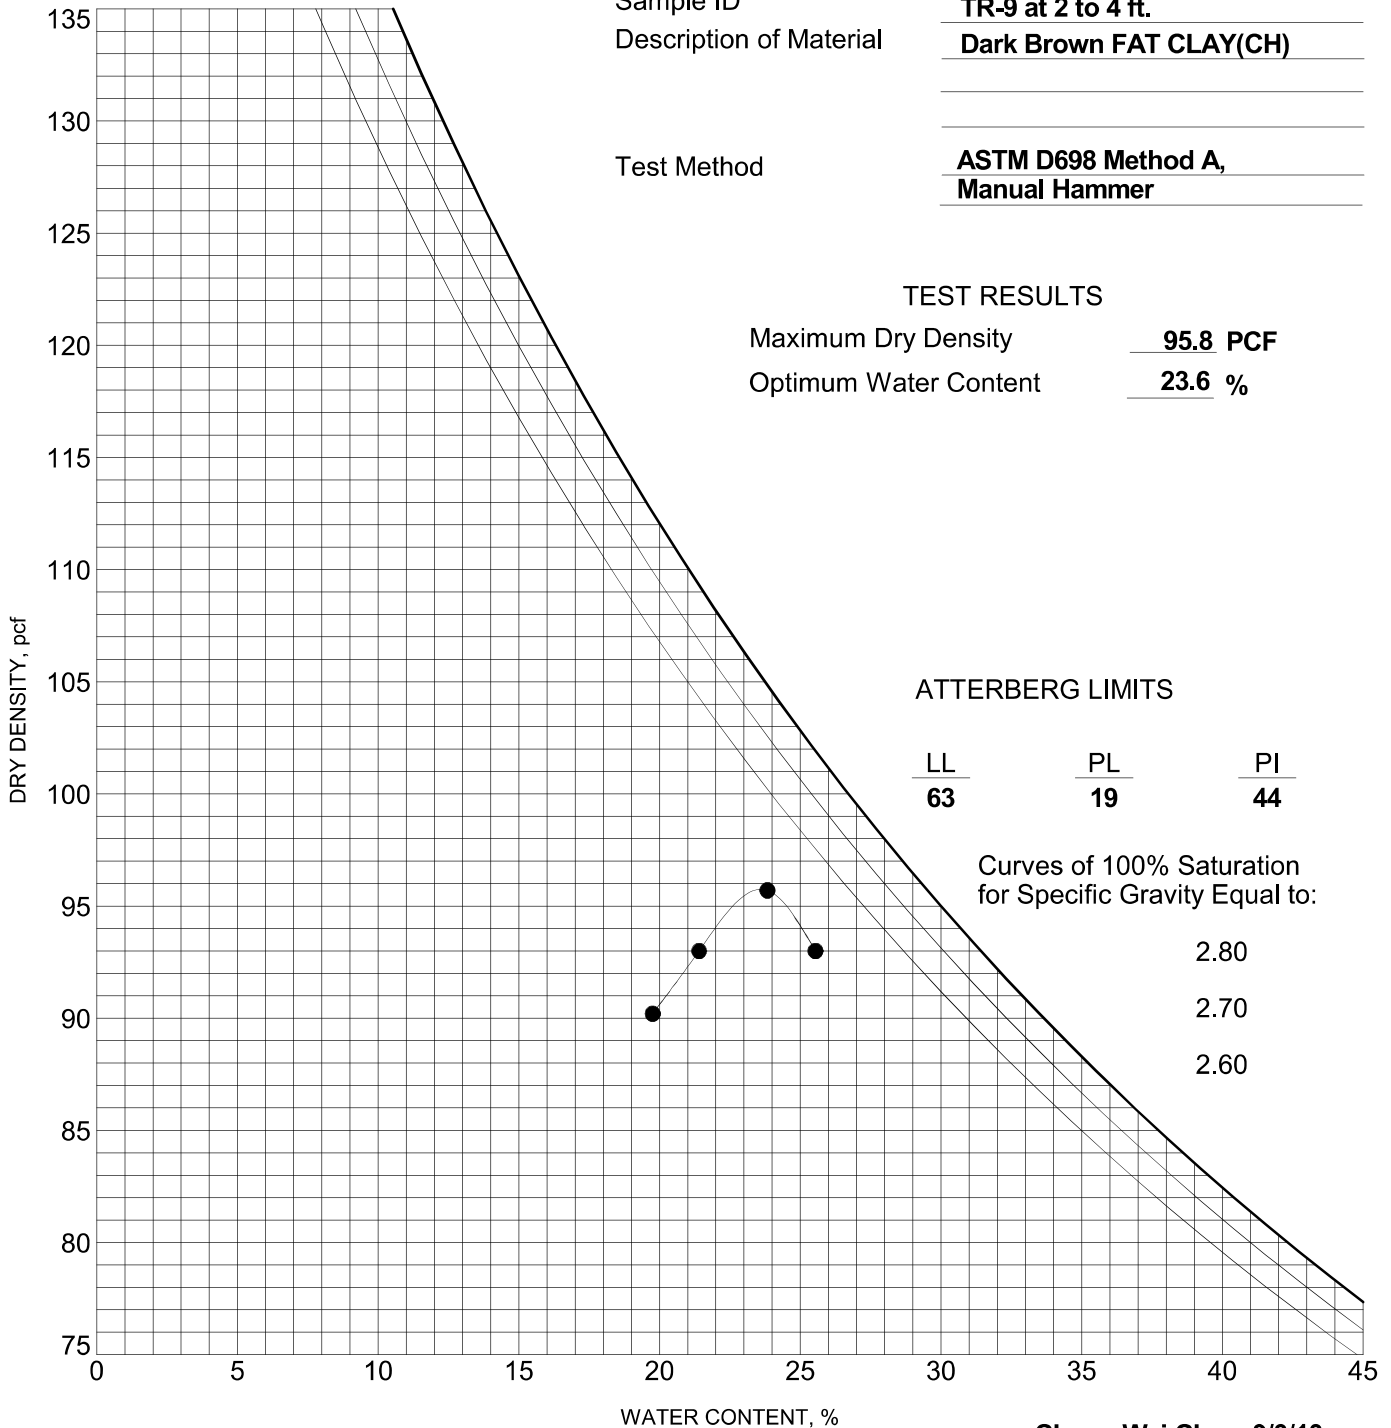
# MOISTURE-DENSITY RELATIONSHIP

Sample ID TR-9 at 2 to 4 ft.  
 Description of Material Dark Brown FAT CLAY(CH)  
 Test Method ASTM D698 Method A,  
 Manual Hammer

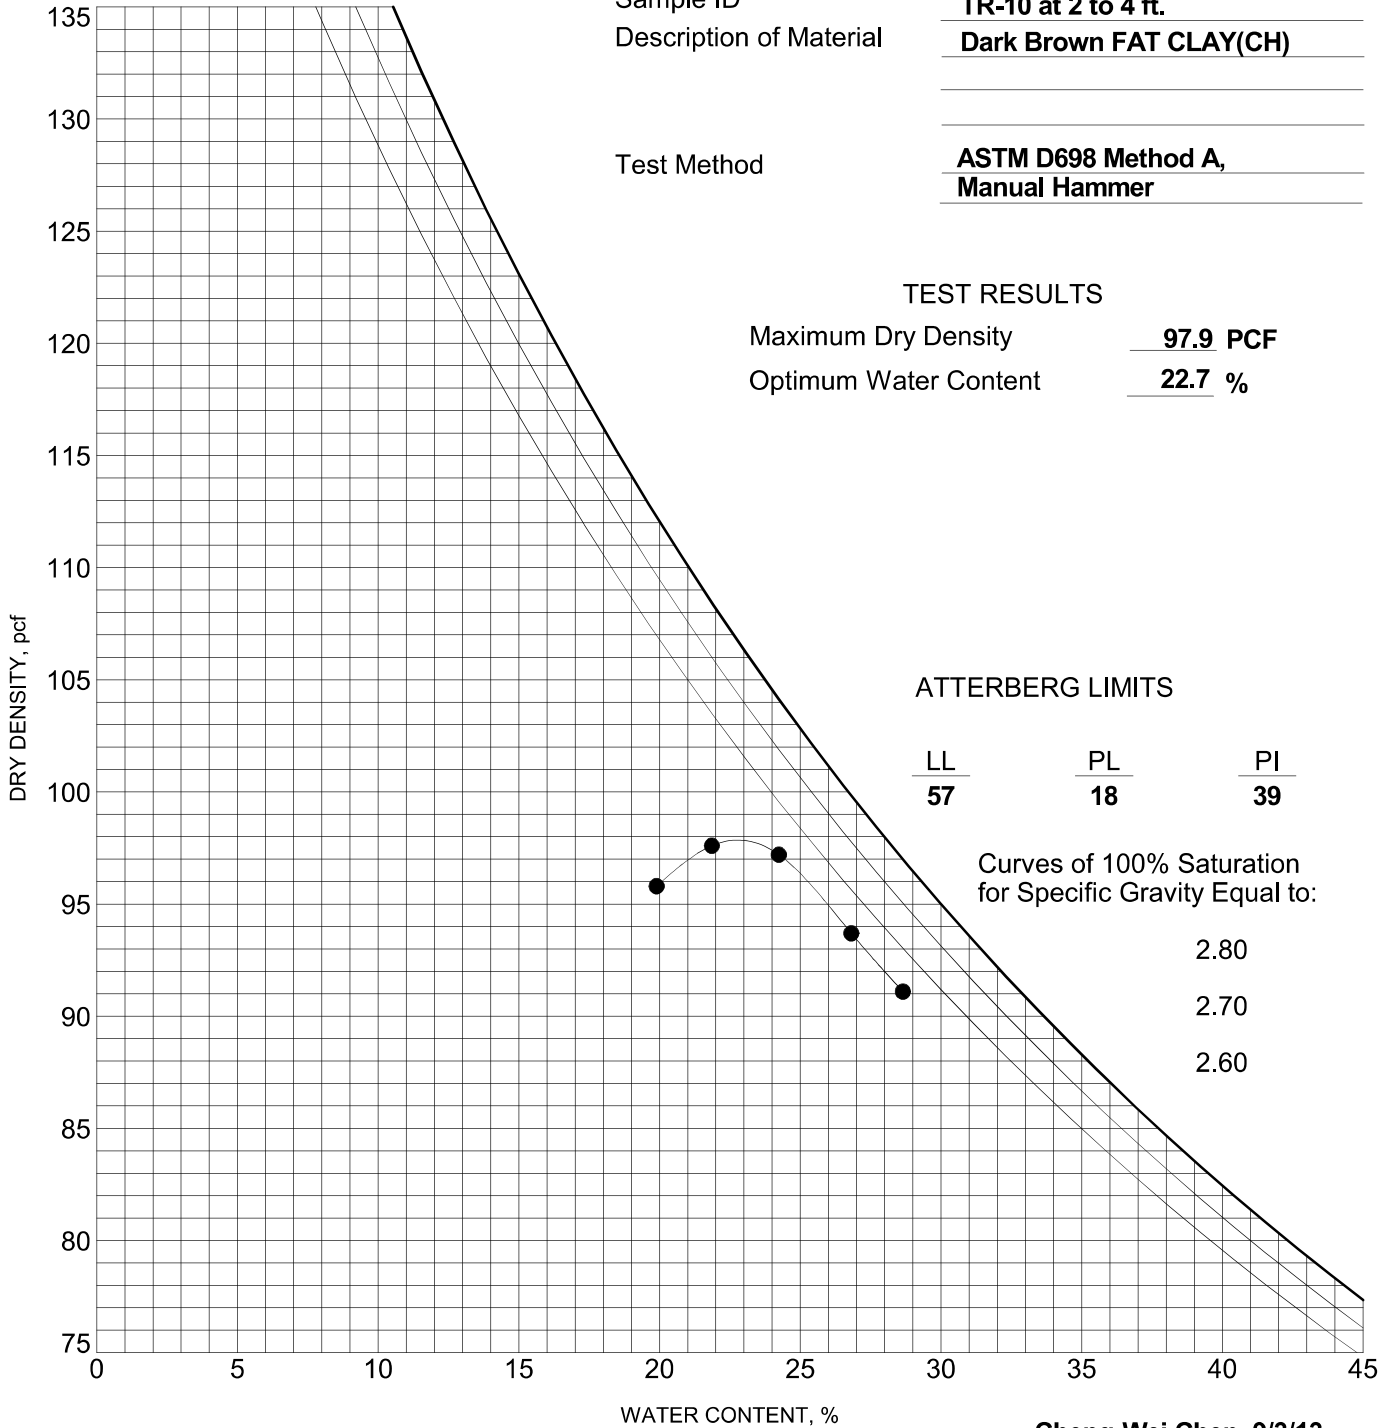
# MOISTURE-DENSITY RELATIONSHIP

Sample ID: TR-10 at 2 to 4 ft.  
 Description of Material: Dark Brown FAT CLAY(CH)  
 Test Method: ASTM D698 Method A, Manual Hammer

Curves of 100% Saturation for Specific Gravity Equal to:  
 2.80  
 2.70  
 2.60
