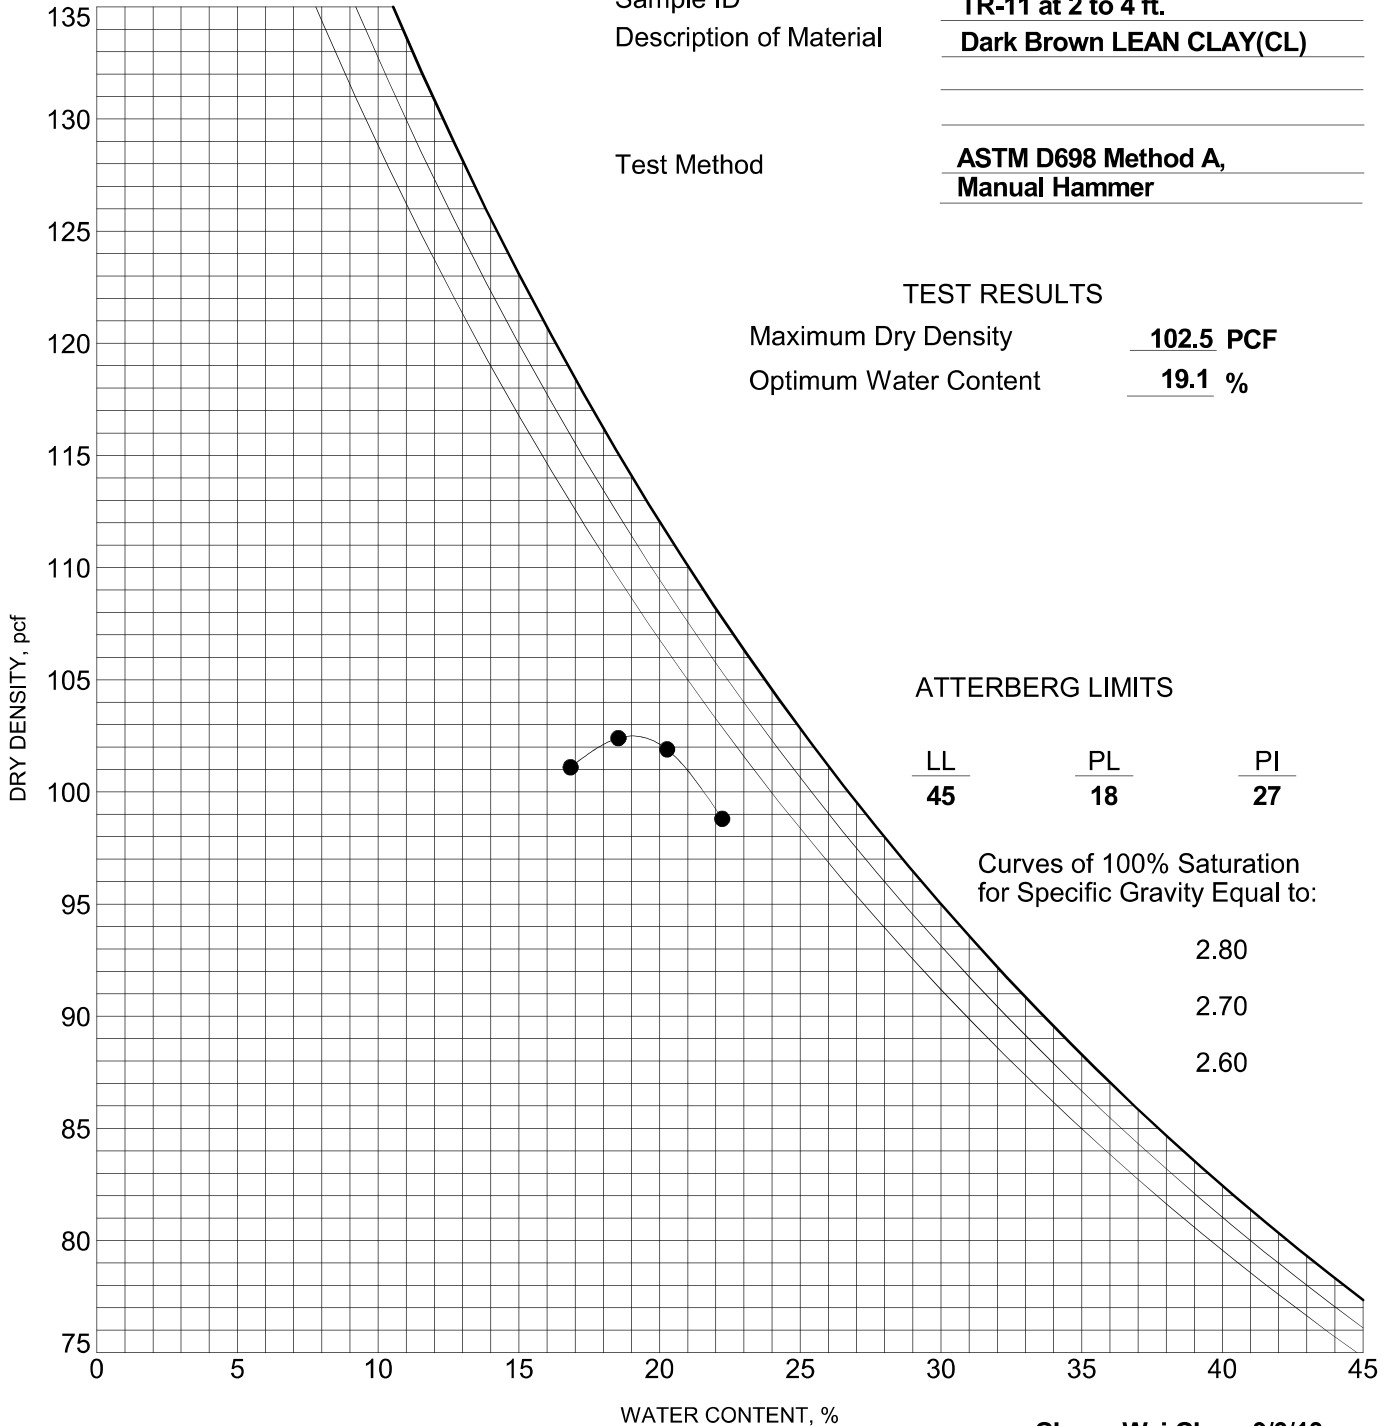
# MOISTURE-DENSITY RELATIONSHIP

Sample ID TR-11 at 2 to 4 ft.  
 Description of Material Dark Brown LEAN CLAY(CL)  
 Test Method ASTM D698 Method A,  
 Manual Hammer

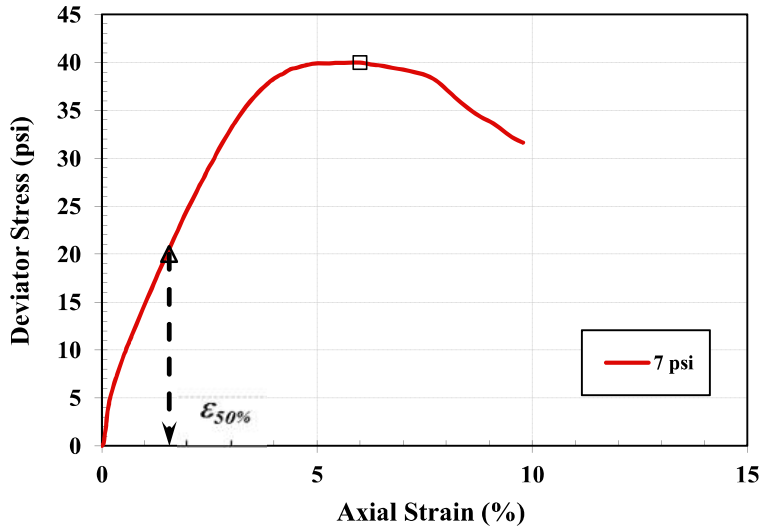
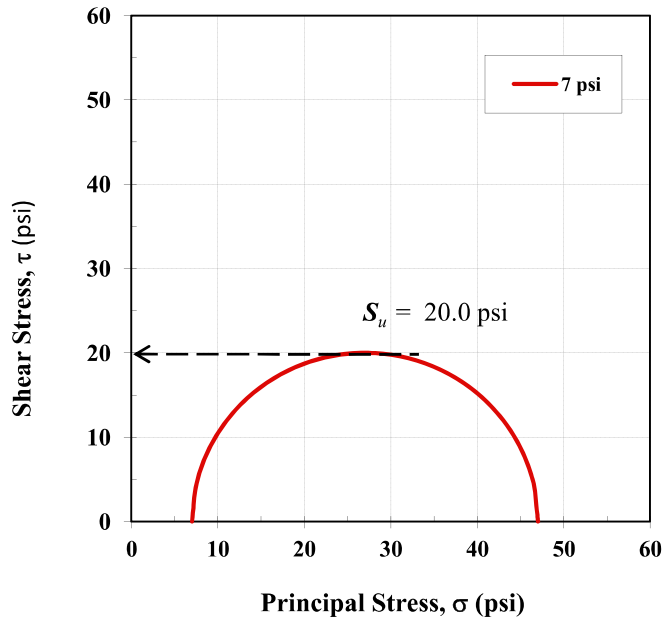
Principal Stress Difference vs. Axial Strain

Mohr Circles (Total Stress) for Peak Stress at Failure

Initial Specimen Conditions		
Specimen No.	1	
Confining Pressure (psi)	7.0	
Avg. Diameter (in)	D <sub>o</sub>	2.83
Avg. Height (in)	H <sub>o</sub>	5.69
In-situ Moisture Content (%)	w <sub>o</sub>	24.3
Total Unit Weight (pcf)	γ <sub>total</sub>	126.1
Dry Unit Weight (pcf)	γ <sub>dry</sub>	101.5
Saturation (%)	S <sub>r</sub>	99.6
Void Ratio	e <sub>o</sub>	0.66
Specific Gravity (Assumed)	G <sub>s</sub>	2.70

Stresses at Failure	
Maximum Deviator Stress (psi)	40.0
Axial Strain at Failure (%)	6.0
Axial Strain at 50% of q <sub>u</sub> (%)	1.6
Total Stresses at Failure	
Major Principal Stress, σ <sub>1</sub> (psi)	47.0
Minor Principal Stress, σ <sub>3</sub> (psi)	7.0

Note: The test specimen was nearly saturated; the Mohr-Coulomb failure envelope was taken as a horizontal straight line. Failure was determined at the maximum deviator stress or deviator stress at 15 % axial strain, whenever is obtained first.

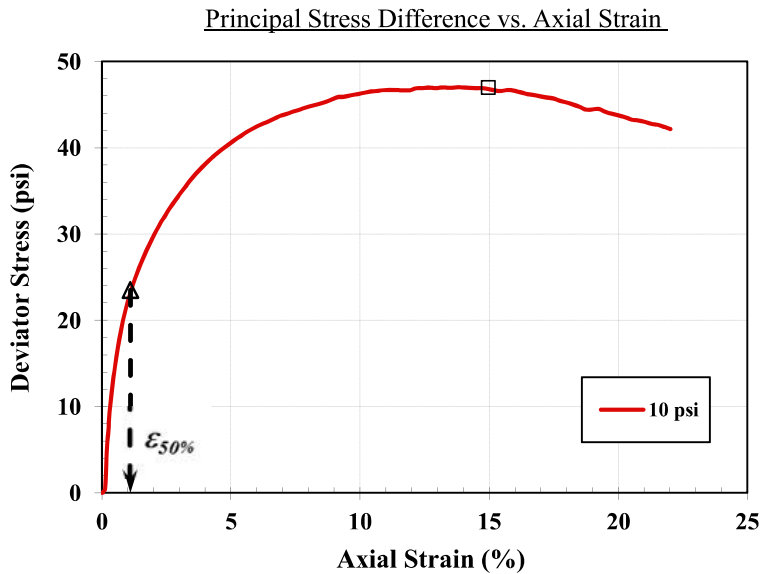
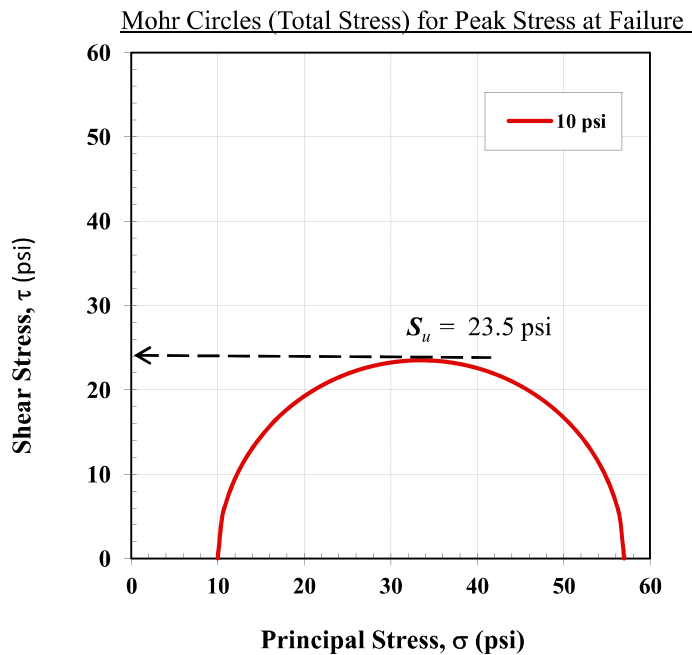
Client: M. A. Mortenson Company      RRC Project No.: 130222      Type of Specimen: Shelby Tube  
 Project: Chilocco Wind Farm      Test Method: ASTM D 2850      Strain Rate (%/min): 1 % / min  
 Sample No.: T-19 at 12 ft.      Test Date: 9/3/2013      Type of Test: Q-Test

Initial Specimen Conditions		
Specimen No.	1	
Confining Pressure (psi)	10.0	
Avg. Diameter (in)	$D_o$	2.81
Avg. Height (in)	$H_o$	5.68
In-situ Moisture Content (%)	$w_o$	21.0
Total Unit Weight (pcf)	$\gamma_{total}$	129.7
Dry Unit Weight (pcf)	$\gamma_{dry}$	107.2
Saturation (%)	$S_r$	100.0
Void Ratio	$e_o$	0.57
Specific Gravity (Assumed)	$G_s$	2.70

Stresses at Failure	
Maximum Deviator Stress (psi)	47.0
Axial Strain at Failure (%)	15.0
Axial Strain at 50% of $q_u$ (%)	1.1
Total Stresses at Failure	
Major Principal Stress, $\sigma_1$ (psi)	57.0
Minor Principal Stress, $\sigma_3$ (psi)	10.0

Note: The test specimen was nearly saturated; the Mohr-Coulomb failure envelope was taken as a horizontal straight line. Failure was determined at the maximum deviator stress or deviator stress at 15 % axial strain, whenever is obtained first.

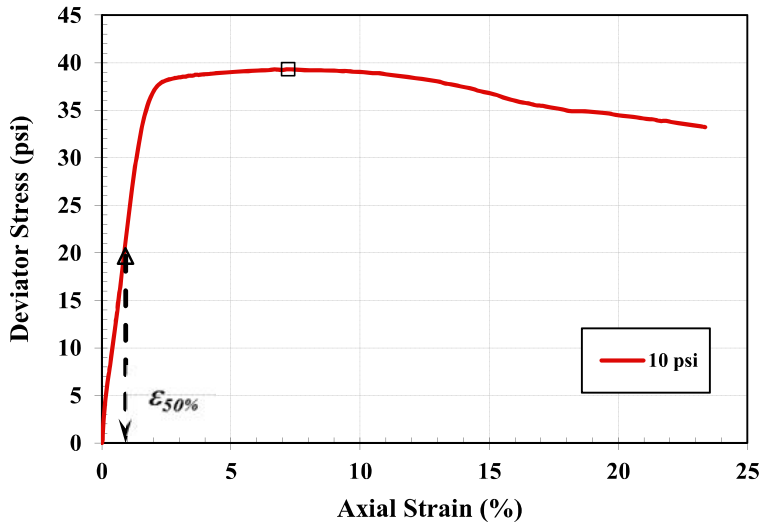
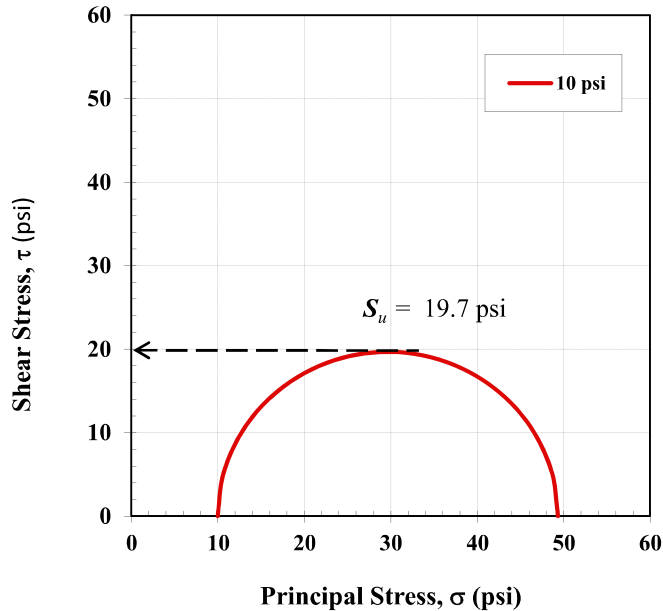
Principal Stress Difference vs. Axial Strain

Mohr Circles (Total Stress) for Peak Stress at Failure

Initial Specimen Conditions		
Specimen No.	1	
Confining Pressure (psi)	10.0	
Avg. Diameter (in)	D <sub>o</sub>	2.83
Avg. Height (in)	H <sub>o</sub>	5.67
In-situ Moisture Content (%)	w <sub>o</sub>	20.7
Total Unit Weight (pcf)	γ <sub>total</sub>	124.9
Dry Unit Weight (pcf)	γ <sub>dry</sub>	103.5
Saturation (%)	S <sub>r</sub>	87.9
Void Ratio	e <sub>o</sub>	0.63
Specific Gravity (Assumed)	G <sub>s</sub>	2.70

Stresses at Failure	
Maximum Deviator Stress (psi)	39.3
Axial Strain at Failure (%)	7.2
Axial Strain at 50% of q <sub>u</sub> (%)	0.9
Total Stresses at Failure	
Major Principal Stress, σ <sub>1</sub> (psi)	49.3
Minor Principal Stress, σ <sub>3</sub> (psi)	10.0

Note: The test specimens were partially saturated. Failure was determined at the maximum deviator stress or deviator stress at 15 % axial strain, whichever is obtained first.

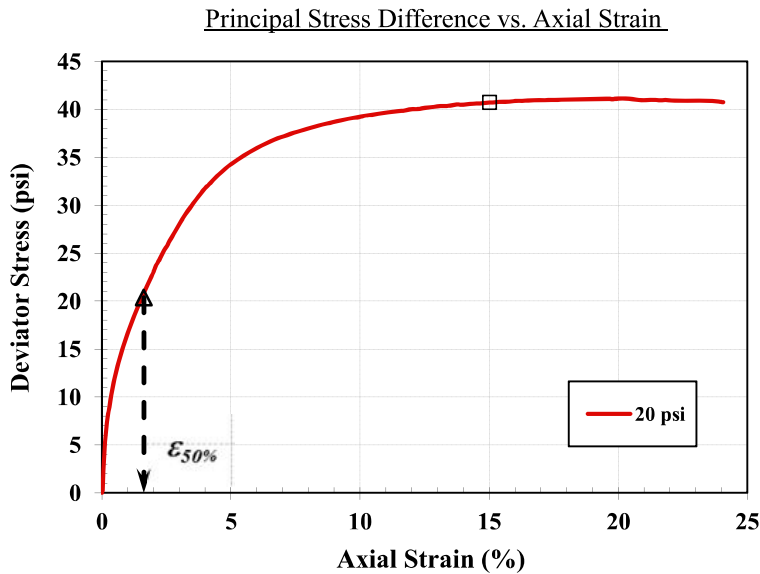
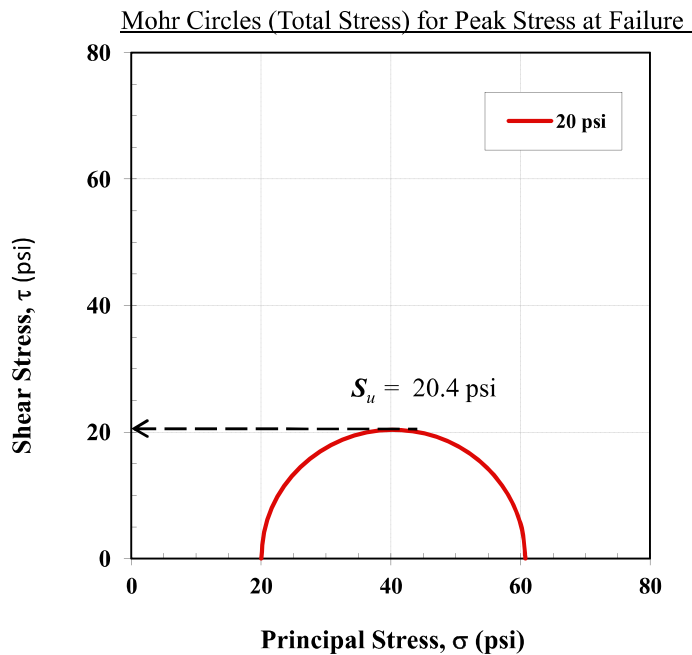
Client: M. A. Mortenson Company      RRC Project No.: 130222      Type of Specimen: Shelby Tube  
 Project: Chilocco Wind Farm      Test Method: ASTM D 2850      Strain Rate (%/min): 1 % / min  
 Sample No.: T-41 at 29 ft.      Test Date: 9/3/2013      Type of Test: Q-Test

Initial Specimen Conditions		
Specimen No.	1	
Confining Pressure (psi)	20.0	
Avg. Diameter (in)	$D_o$	2.84
Avg. Height (in)	$H_o$	5.68
In-situ Moisture Content (%)	$w_o$	21.9
Total Unit Weight (pcf)	$\gamma_{total}$	131.3
Dry Unit Weight (pcf)	$\gamma_{dry}$	107.7
Saturation (%)	$S_r$	100.0
Void Ratio	$e_o$	0.56
Specific Gravity (Assumed)	$G_s$	2.70

Stresses at Failure	
Maximum Deviator Stress (psi)	40.7
Axial Strain at Failure (%)	15.0
Axial Strain at 50% of $q_u$ (%)	1.6
Total Stresses at Failure	
Major Principal Stress, $\sigma_1$ (psi)	60.7
Minor Principal Stress, $\sigma_3$ (psi)	20.0

Test Results	
Friction Angle, $\phi_u$ ( $^\circ$ )	--
Cohesion Intercept, $C_u$ (psi)	--
Undrained Shear Strength, $S_u$ (tsf)	1.47

Note: The test specimen was nearly saturated; the Mohr-Coulomb failure envelope was taken as a horizontal straight line. Failure was determined at the maximum deviator stress or deviator stress at 15 % axial strain, whenever is obtained first.

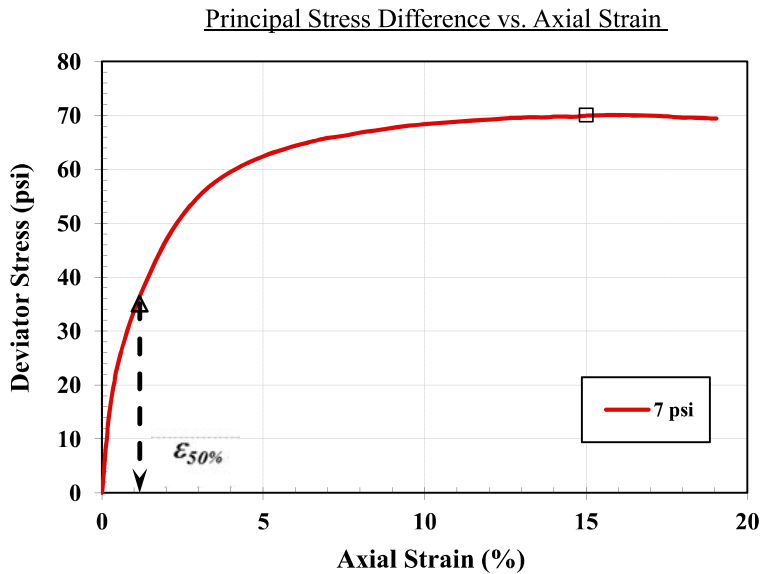
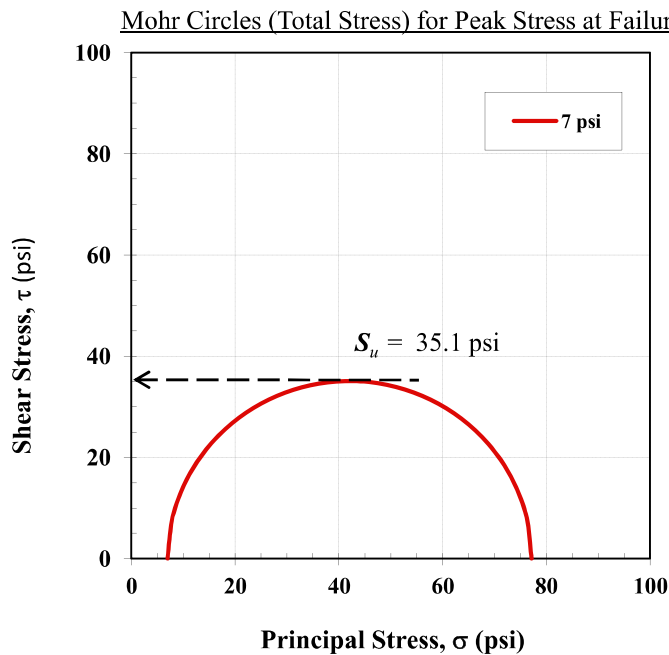
Client: M. A. Mortenson Company      RRC Project No.: 130222      Type of Specimen: Shelby Tube  
 Project: Chilocco Wind Farm      Test Method: ASTM D 2850      Strain Rate (%/min): 1 % / min  
 Sample No.: T-67 at 9 ft.      Test Date: 9/3/2013      Type of Test: Q-Test

Initial Specimen Conditions		
Specimen No.	1	
Confining Pressure (psi)	7.0	
Avg. Diameter (in)	$D_o$	2.84
Avg. Height (in)	$H_o$	5.68
In-situ Moisture Content (%)	$w_o$	20.1
Total Unit Weight (pcf)	$\gamma_{total}$	131.5
Dry Unit Weight (pcf)	$\gamma_{dry}$	109.5
Saturation (%)	$S_r$	100.0
Void Ratio	$e_o$	0.54
Specific Gravity (Assumed)	$G_s$	2.70

Stresses at Failure	
Maximum Deviator Stress (psi)	70.1
Axial Strain at Failure (%)	15.0
Axial Strain at 50% of $q_u$ (%)	1.2
Total Stresses at Failure	
Major Principal Stress, $\sigma_1$ (psi)	77.1
Minor Principal Stress, $\sigma_3$ (psi)	7.0

Test Results	
Friction Angle, $\phi_u$ ( $^\circ$ )	--
Cohesion Intercept, $C_u$ (psi)	--
Undrained Shear Strength, $S_u$ (tsf)	2.52

Note: The test specimen was nearly saturated; the Mohr-Coulomb failure envelope was taken as a horizontal straight line. Failure was determined at the maximum deviator stress or deviator stress at 15 % axial strain, whenever is obtained first.

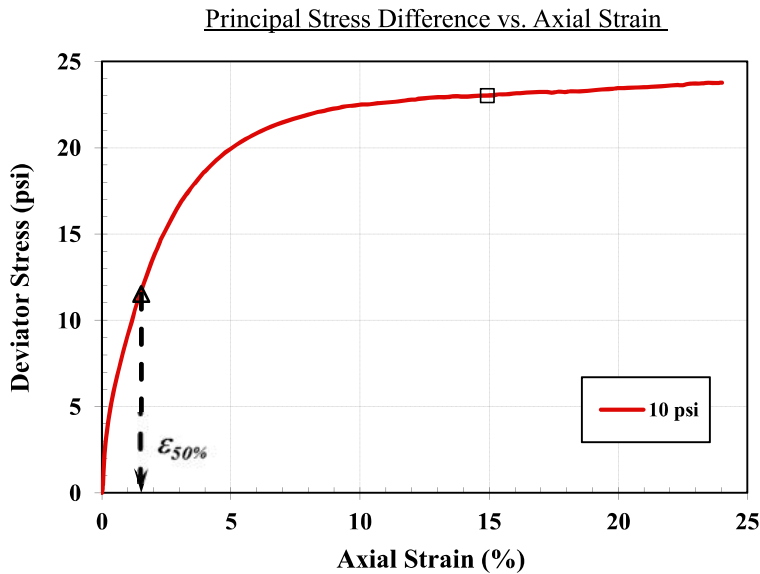
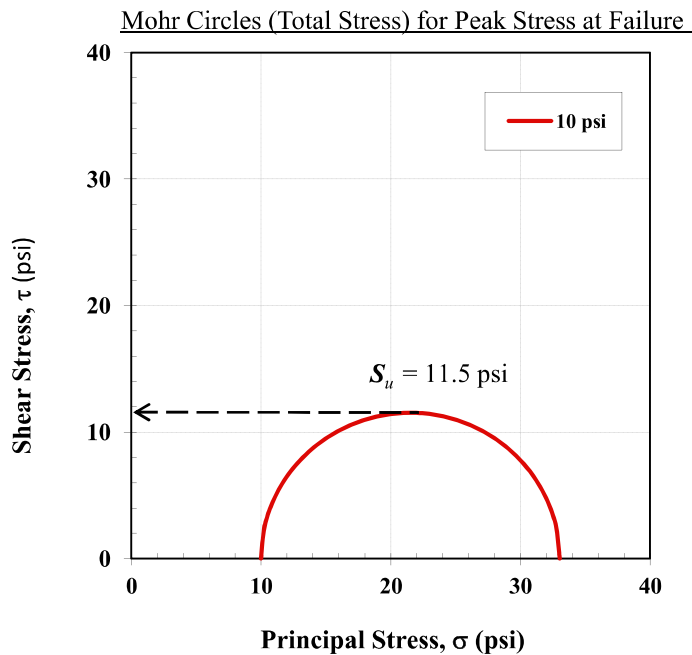
Client: M. A. Mortenson Company	RRC Project No.: 130222	Type of Specimen: Shelby Tube
Project: Chilocco Wind Farm	Test Method: ASTM D 2850	Strain Rate (%/min): 1 % / min
Sample No.: T-67 at 14 ft.	Test Date: 9/3/2013	Type of Test: Q-Test

Initial Specimen Conditions	
Specimen No.	1
Confining Pressure (psi)	7.0
Avg. Diameter (in)	$D_o$ 2.79
Avg. Height (in)	$H_o$ 5.68
In-situ Moisture Content (%)	$w_o$ 20.7
Total Unit Weight (pcf)	$\gamma_{total}$ 131.2
Dry Unit Weight (pcf)	$\gamma_{dry}$ 108.8
Saturation (%)	$S_r$ 100.0
Void Ratio	$e_o$ 0.55
Specific Gravity (Assumed)	$G_s$ 2.70

Stresses at Failure	
Maximum Deviator Stress (psi)	23.0
Axial Strain at Failure (%)	14.9
Axial Strain at 50% of $q_u$ (%)	1.5
Total Stresses at Failure	
Major Principal Stress, $\sigma_1$ (psi)	33.0
Minor Principal Stress, $\sigma_3$ (psi)	10.0

Note: The test specimen was nearly saturated; the Mohr-Coulomb failure envelope was taken as a horizontal straight line. Failure was determined at the maximum deviator stress or deviator stress at 15 % axial strain, whenever is obtained first.

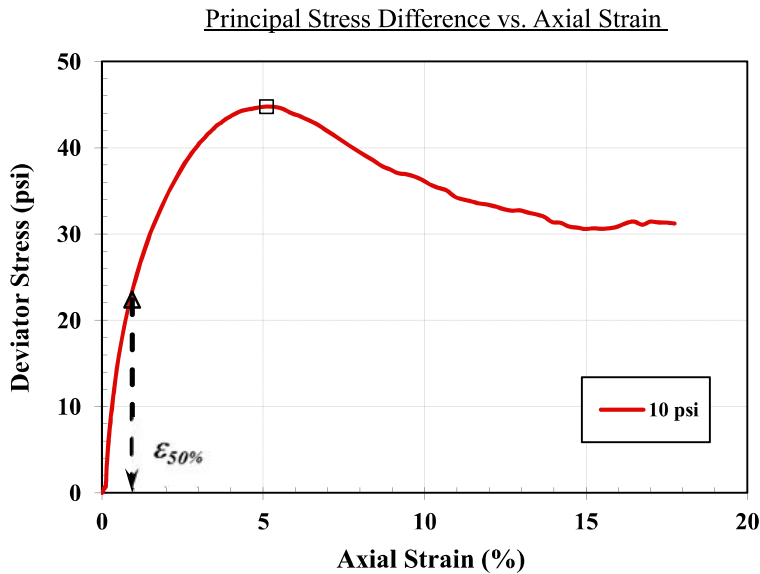
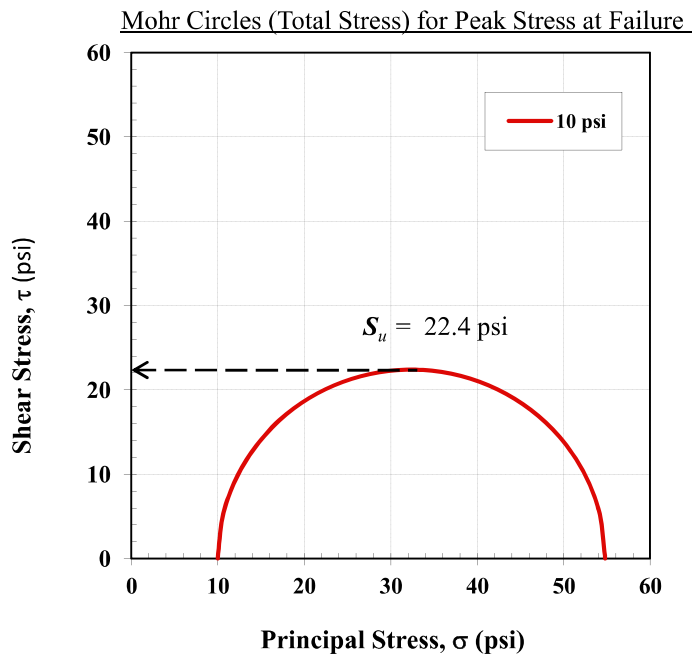
Client: M. A. Mortenson Company      RRC Project No.: 130222      Type of Specimen: Shelby Tube  
 Project: Chilocco Wind Farm      Test Method: ASTM D 2850      Strain Rate (%/min): 1 % / min  
 Sample No.: T-71 at 12 ft.      Test Date: 9/4/2013      Type of Test: Q-Test

Initial Specimen Conditions		
Specimen No.	1	
Confining Pressure (psi)	10.0	
Avg. Diameter (in)	$D_o$	2.84
Avg. Height (in)	$H_o$	5.68
In-situ Moisture Content (%)	$w_o$	24.3
Total Unit Weight (pcf)	$\gamma_{total}$	124.5
Dry Unit Weight (pcf)	$\gamma_{dry}$	100.2
Saturation (%)	$S_r$	97.1
Void Ratio	$e_o$	0.68
Specific Gravity (Assumed)	$G_s$	2.70

Stresses at Failure	
Maximum Deviator Stress (psi)	44.8
Axial Strain at Failure (%)	5.1
Axial Strain at 50% of $q_u$ (%)	0.9
Total Stresses at Failure	
Major Principal Stress, $\sigma_1$ (psi)	54.8
Minor Principal Stress, $\sigma_3$ (psi)	10.0

Note: The test specimen was nearly saturated; the Mohr-Coulomb failure envelope was taken as a horizontal straight line. Failure was determined at the maximum deviator stress or deviator stress at 15 % axial strain, whenever is obtained first.

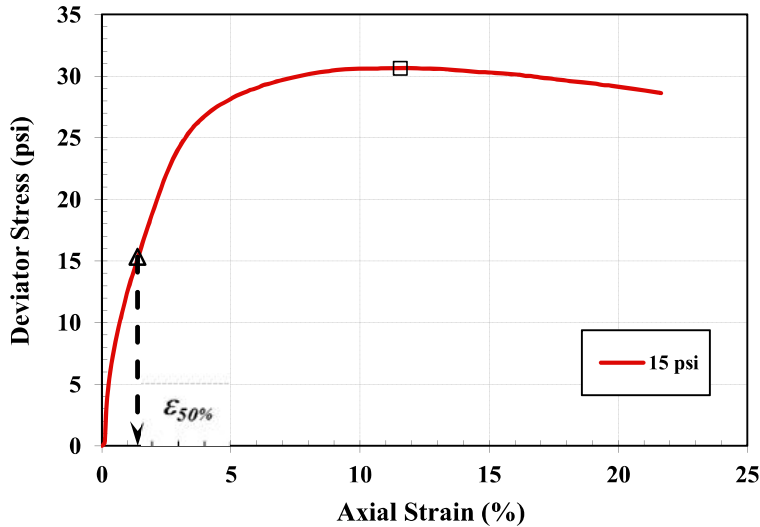
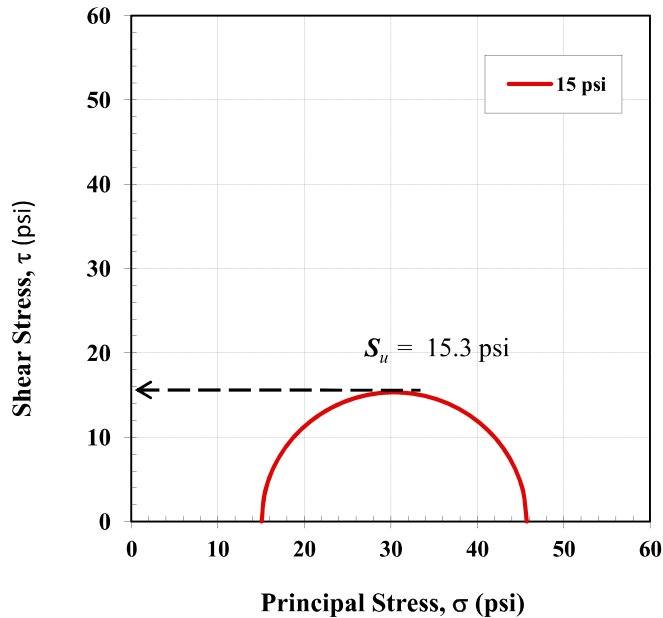
Principal Stress Difference vs. Axial Strain

Mohr Circles (Total Stress) for Peak Stress at Failure

Initial Specimen Conditions		
Specimen No.	1	
Confining Pressure (psi)	15.0	
Avg. Diameter (in)	$D_o$	2.85
Avg. Height (in)	$H_o$	5.68
In-situ Moisture Content (%)	$w_o$	24.5
Total Unit Weight (pcf)	$\gamma_{total}$	123.7
Dry Unit Weight (pcf)	$\gamma_{dry}$	99.4
Saturation (%)	$S_r$	95.0
Void Ratio	$e_o$	0.70
Specific Gravity (Assumed)	$G_s$	2.70

Stresses at Failure	
Maximum Deviator Stress (psi)	30.7
Axial Strain at Failure (%)	11.6
Axial Strain at 50% of $q_u$ (%)	1.4
Total Stresses at Failure	
Major Principal Stress, $\sigma_1$ (psi)	45.7
Minor Principal Stress, $\sigma_3$ (psi)	15.1

Note: The test specimen was nearly saturated; the Mohr-Coulomb failure envelope was taken as a horizontal straight line. Failure was determined at the maximum deviator stress or deviator stress at 15 % axial strain, whenever is obtained first.

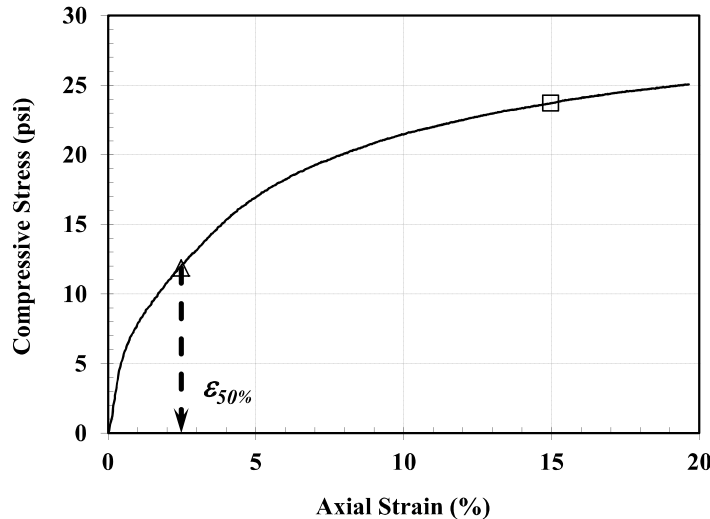
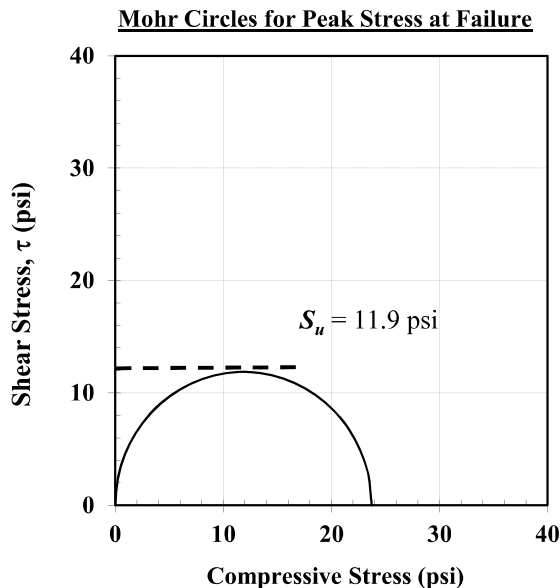
Initial Specimen Conditions		
Specimen No.		1
Avg. Diameter (in)	$D_o$	2.83
Avg. Height (in)	$H_o$	5.68
In-situ Moisture Content (%)	$w_o$	19.1
Total Unit Weight (pcf)	$\gamma_{total}$	127.5
Dry Unit Weight (pcf)	$\gamma_{dry}$	107.0
Saturation (%)	$S_r$	95.1
Void Ratio	$e_o$	0.55
Specific Gravity (Assumed)	$G_s$	2.65

Stresses at Failure	
Unconfined Compressive Strength, $q_u$ (psi)	23.7
Axial Strain at Failure (%)	15.0
Axial Strain at 50% of $q_u$ (%)	2.5
Total Stresses at Failure	
Major Principal Stress, $\sigma_1$ (psi)	23.7
Minor Principal Stress, $\sigma_3$ (psi)	0.0
<b>Undrained Shear Strength, <math>S_u</math> (tsf)</b>	<b>0.85</b>

Note: Failure was determined at the maximum deviator stress or deviator stress at 15 % axial strain, whenever is obtained first.

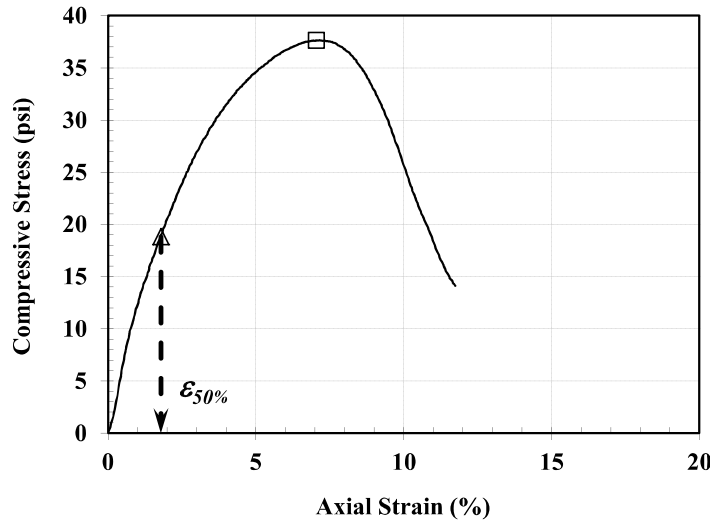
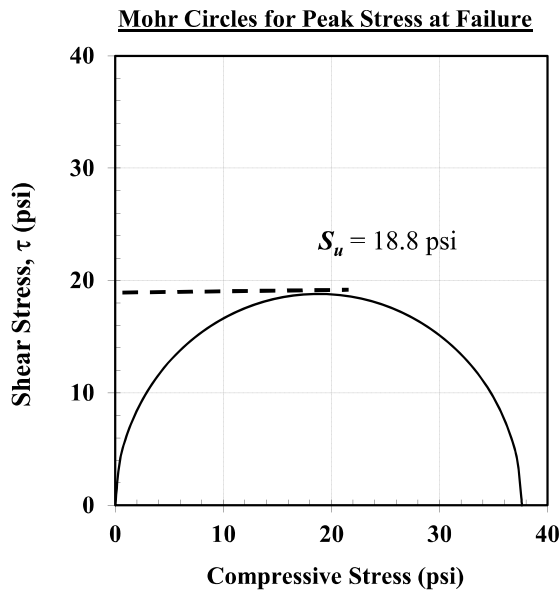
Initial Specimen Conditions		
Specimen No.		1
Avg. Diameter (in)	$D_o$	2.83
Avg. Height (in)	$H_o$	5.68
In-situ Moisture Content (%)	$w_o$	19.3
Total Unit Weight (pcf)	$\gamma_{total}$	131.7
Dry Unit Weight (pcf)	$\gamma_{dry}$	110.4
Saturation (%)	$S_r$	100.0
Void Ratio	$e_o$	0.50
Specific Gravity (Assumed)	$G_s$	2.65

Stresses at Failure	
Unconfined Compressive Strength, $q_u$ (psi)	37.6
Axial Strain at Failure (%)	7.0
Axial Strain at 50% of $q_u$ (%)	1.8
Total Stresses at Failure	
Major Principal Stress, $\sigma_1$ (psi)	37.6
Minor Principal Stress, $\sigma_3$ (psi)	0.0
<b>Undrained Shear Strength, <math>S_u</math> (tsf)</b>	<b>1.35</b>

Note: Failure was determined at the maximum deviator stress or deviator stress at 15 % axial strain, whenever is obtained first.

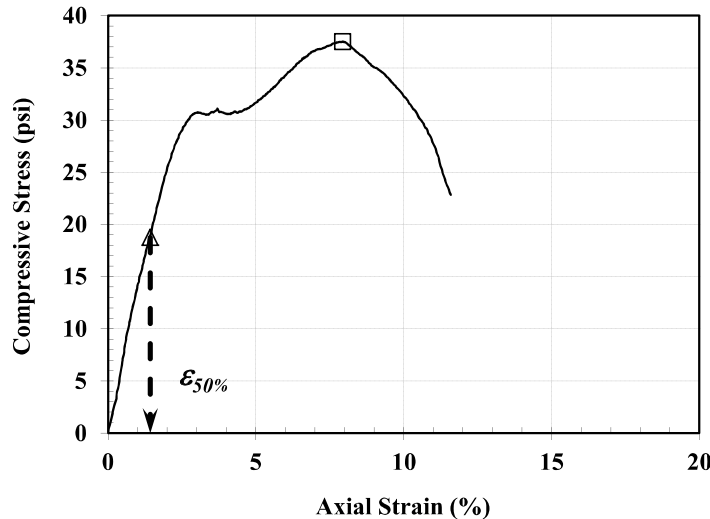
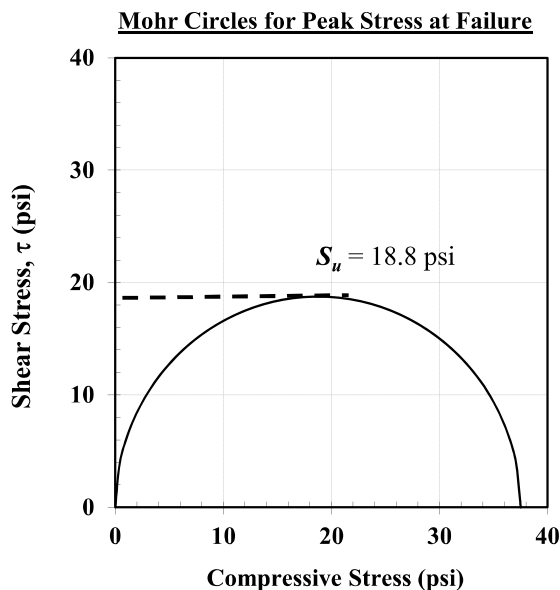
Initial Specimen Conditions		
Specimen No.		1
Avg. Diameter (in)	$D_o$	2.80
Avg. Height (in)	$H_o$	5.68
In-situ Moisture Content (%)	$w_o$	17.9
Total Unit Weight (pcf)	$\gamma_{total}$	134.9
Dry Unit Weight (pcf)	$\gamma_{dry}$	114.5
Saturation (%)	$S_r$	100.0
Void Ratio	$e_o$	0.45
Specific Gravity (Assumed)	$G_s$	2.65

Stresses at Failure	
Unconfined Compressive Strength, $q_u$ (psi)	37.5
Axial Strain at Failure (%)	7.9
Axial Strain at 50% of $q_u$ (%)	1.4
Total Stresses at Failure	
Major Principal Stress, $\sigma_1$ (psi)	37.5
Minor Principal Stress, $\sigma_3$ (psi)	0.0
<b>Undrained Shear Strength, <math>S_u</math> (tsf)</b>	<b>1.35</b>

Note: Failure was determined at the maximum deviator stress or deviator stress at 15 % axial strain, whenever is obtained first.

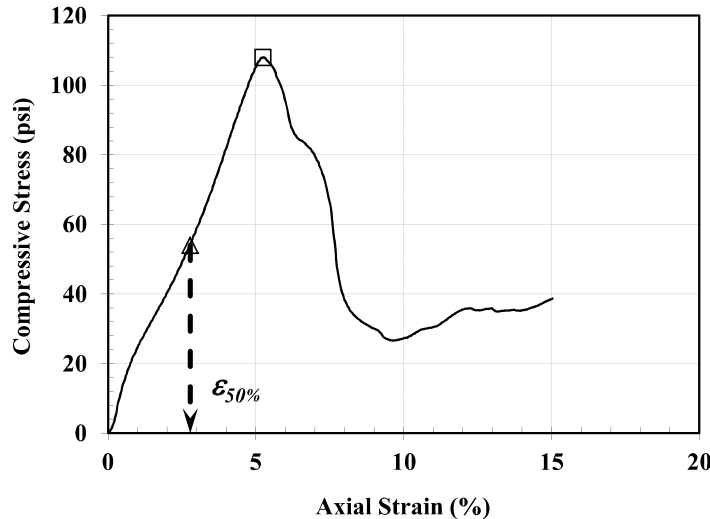
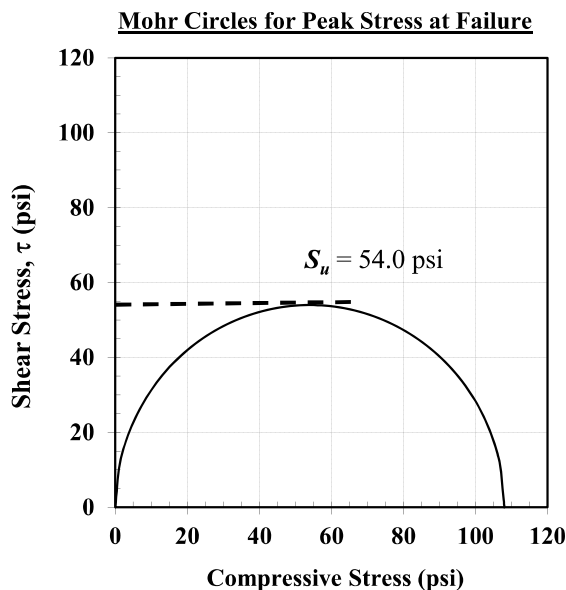
Initial Specimen Conditions		
Specimen No.		1
Avg. Diameter (in)	$D_o$	2.83
Avg. Height (in)	$H_o$	5.68
In-situ Moisture Content (%)	$w_o$	20.7
Total Unit Weight (pcf)	$\gamma_{total}$	125.8
Dry Unit Weight (pcf)	$\gamma_{dry}$	104.2
Saturation (%)	$S_r$	93.8
Void Ratio	$e_o$	0.59
Specific Gravity (Assumed)	$G_s$	2.65

Stresses at Failure	
Unconfined Compressive Strength, $q_u$ (psi)	108.0
Axial Strain at Failure (%)	5.2
Axial Strain at 50% of $q_u$ (%)	2.8
Total Stresses at Failure	
Major Principal Stress, $\sigma_1$ (psi)	108.0
Minor Principal Stress, $\sigma_3$ (psi)	0.0
<b>Undrained Shear Strength, <math>S_u</math> (tsf)</b>	<b>3.89</b>

Note: Failure was determined at the maximum deviator stress or deviator stress at 15 % axial strain, whenever is obtained first.

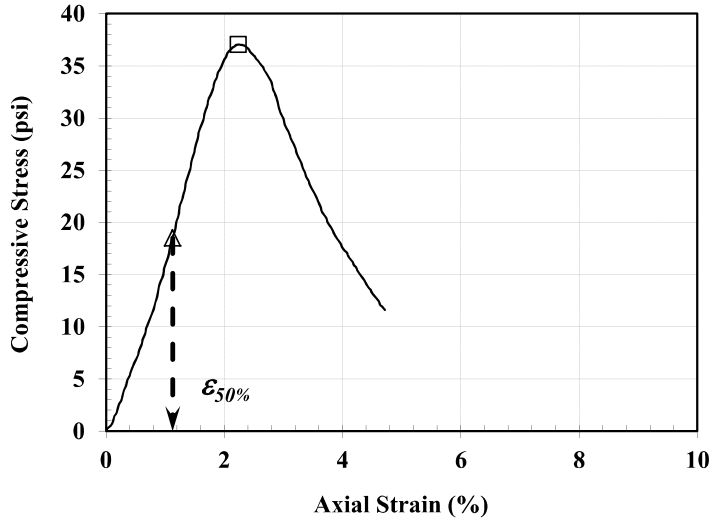
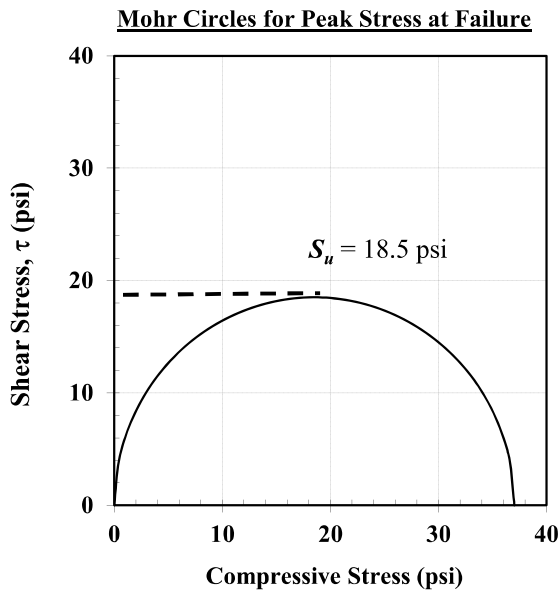
Initial Specimen Conditions		
Specimen No.		1
Avg. Diameter (in)	$D_o$	2.84
Avg. Height (in)	$H_o$	5.68
In-situ Moisture Content (%)	$w_o$	18.6
Total Unit Weight (pcf)	$\gamma_{total}$	127.9
Dry Unit Weight (pcf)	$\gamma_{dry}$	107.8
Saturation (%)	$S_r$	92.3
Void Ratio	$e_o$	0.53
Specific Gravity (Assumed)	$G_s$	2.65

Stresses at Failure	
Unconfined Compressive Strength, $q_u$ (psi)	37.0
Axial Strain at Failure (%)	2.2
Axial Strain at 50% of $q_u$ (%)	1.1
Total Stresses at Failure	
Major Principal Stress, $\sigma_1$ (psi)	37.0
Minor Principal Stress, $\sigma_3$ (psi)	0.0
<b>Undrained Shear Strength, <math>S_u</math> (tsf)</b>	<b>1.33</b>

Note: Failure was determined at the maximum deviator stress or deviator stress at 15 % axial strain, whenever is obtained first.

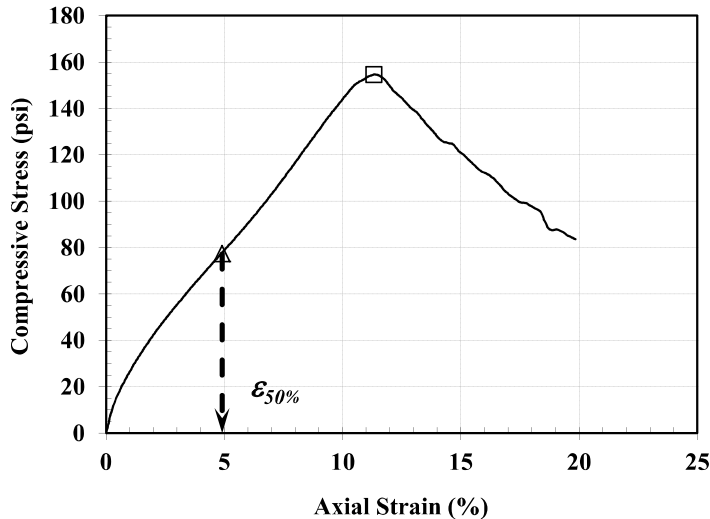
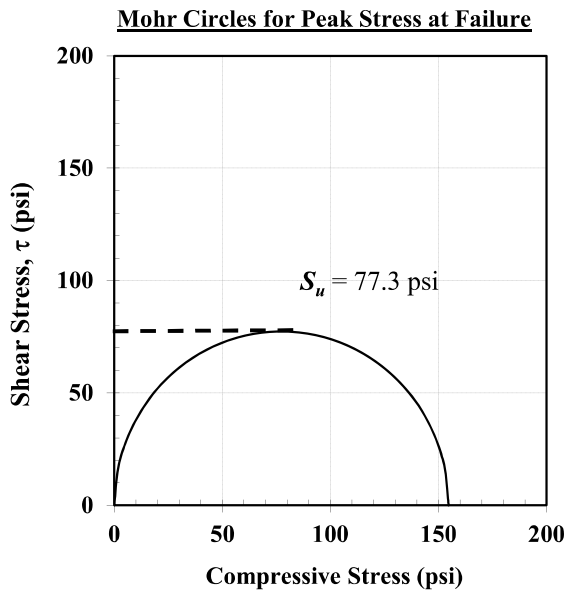
Initial Specimen Conditions		
Specimen No.		1
Avg. Diameter (in)	$D_o$	2.83
Avg. Height (in)	$H_o$	5.69
In-situ Moisture Content (%)	$w_o$	16.2
Total Unit Weight (pcf)	$\gamma_{total}$	116.9
Dry Unit Weight (pcf)	$\gamma_{dry}$	100.6
Saturation (%)	$S_r$	67.4
Void Ratio	$e_o$	0.64
Specific Gravity (Assumed)	$G_s$	2.65

Stresses at Failure	
Unconfined Compressive Strength, $q_u$ (psi)	154.7
Axial Strain at Failure (%)	11.3
Axial Strain at 50% of $q_u$ (%)	4.9
Total Stresses at Failure	
Major Principal Stress, $\sigma_1$ (psi)	154.7
Minor Principal Stress, $\sigma_3$ (psi)	0.0
<b>Undrained Shear Strength, <math>S_u</math> (tsf)</b>	<b>5.57</b>

Note: Failure was determined at the maximum deviator stress or deviator stress at 15 % axial strain, whenever is obtained first.

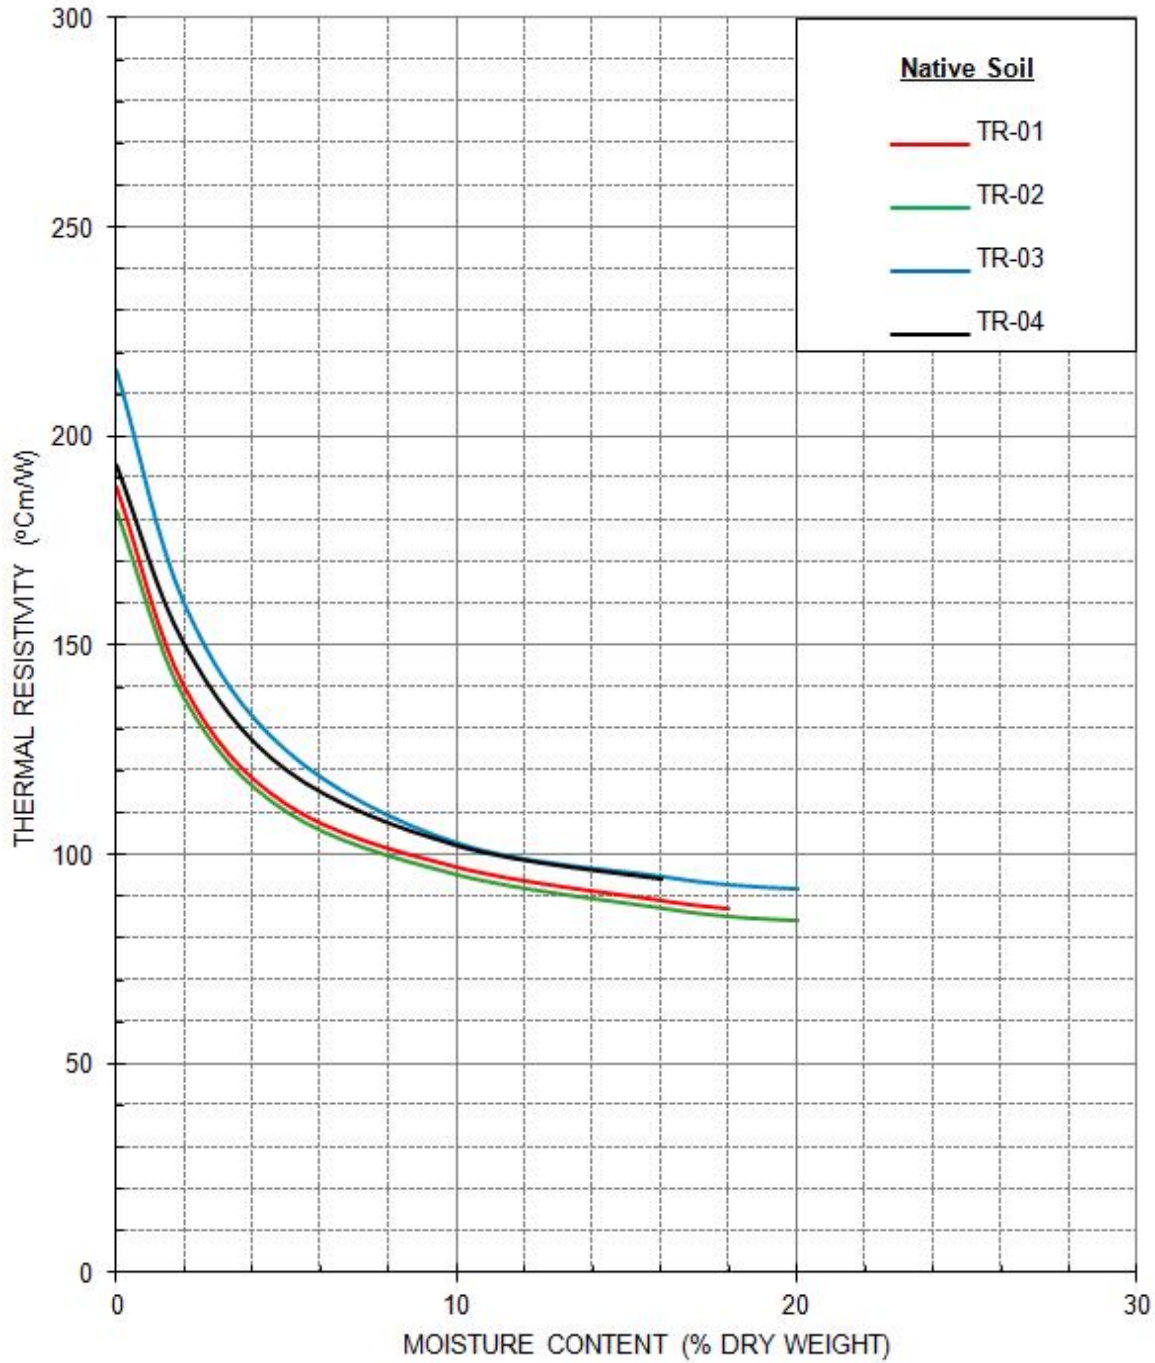
## THERMAL DRYOUT CURVES

**Test Procedure:** For thermal dryout characterization tests the bulk samples were re-compacted at the 'as received' moisture content and at 90% of the standard Proctor density provided by RRC. The tests were conducted in accordance with the IEEE standard (442). The results are tabulated below and the thermal dryout curves are presented in **Figures 1 to 3.**

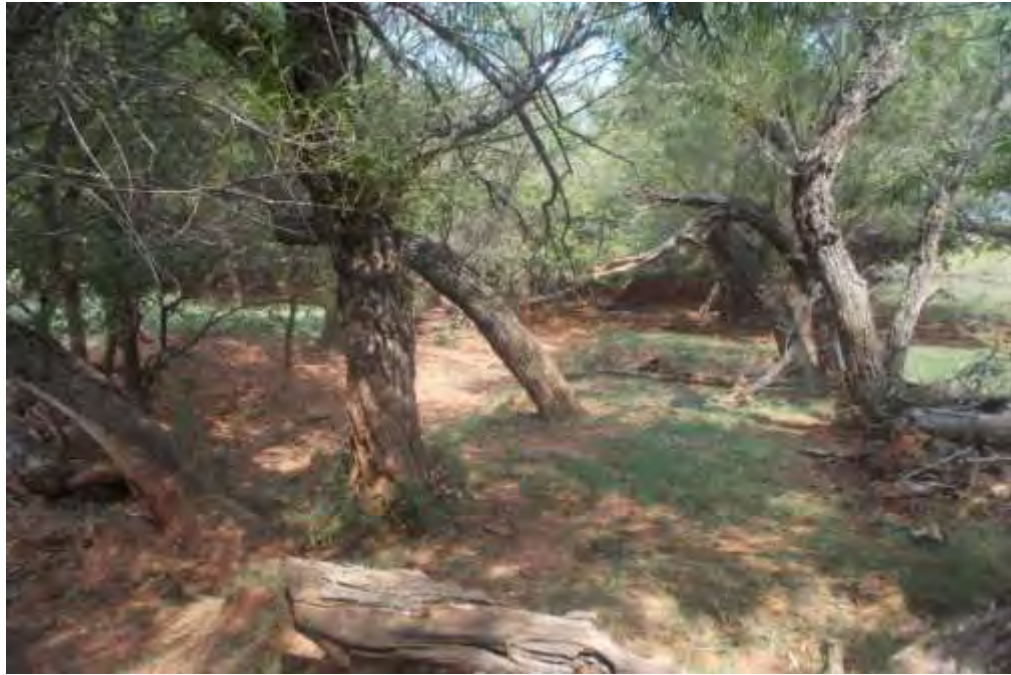
Description:  
FS-5

**FS-5** is identified as an ephemeral stream that may originate outside the project area on the north and traveling south through the project area as an unnamed tributary to Chilocco Creek. The stream channel had a full channel width of 10 feet with a full channel depth of 2 feet and an 800 M of 10 feet. At the time of investigation, no water was observed within the referenced stream channel. Nevertheless, based on the stream features and a discernible 800 M, it would appear that FS-5 meets the criteria necessary for jurisdictional classification by the SACE.

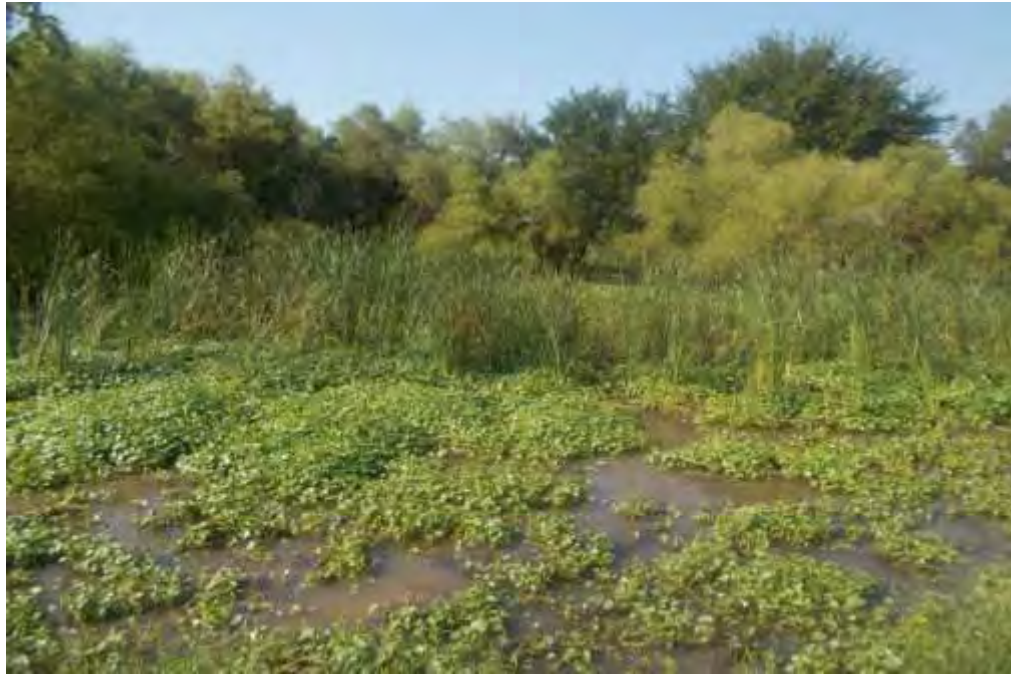
Description:  
FS-6A

**FS-6A** has been identified as an herbaceous wetland located outside of the construction right-of-way. This area was investigated during the field survey and was found to exhibit positive indicators from each of the three parameters (hydrophytic vegetation, hydric soil, and hydrology).

Dominant herbaceous vegetation in the area consisted of cattail, lac, illo, d, c, eed, and spire. Hydrology indicators included surface water high, water table, saturation, and hydrogen sulfide odor. Based on information obtained from the RCS, the site the assessment site is underlain by rainola Ashport complex with percent slopes. In addition, the soils observed during the site visit consisted of a layer of lochroma. Detailed soil survey maps are located in Appendix D.

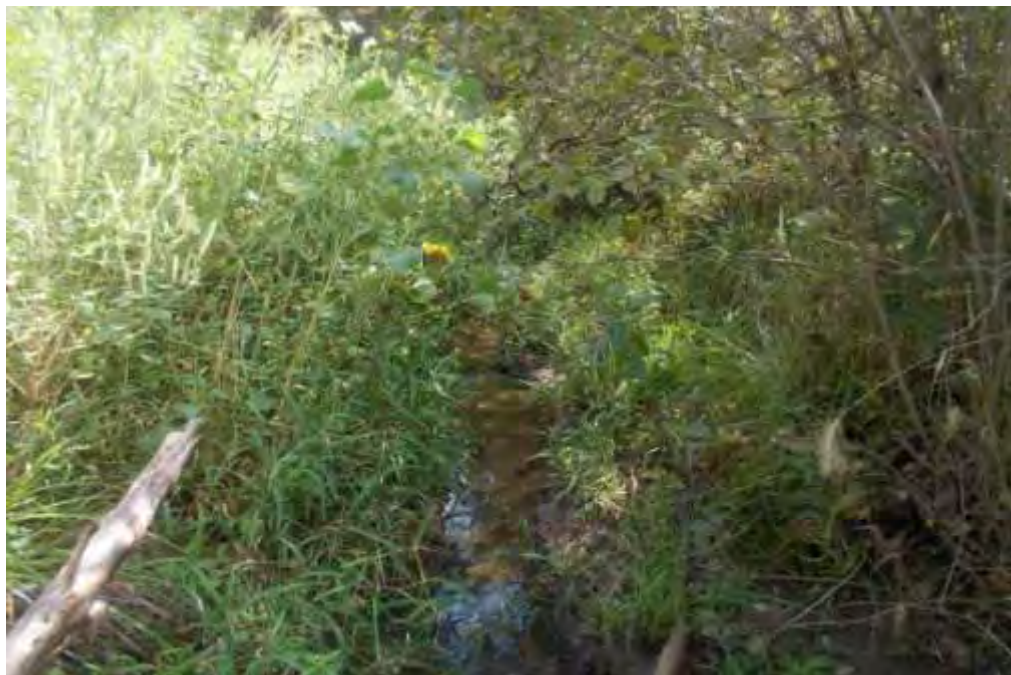
Description:  
FS-7

**FS-7** is identified as an intermittent stream waterway originating outside of the project area on the west and traveling east within the project area as an unnamed tributary to Chilocco Creek. The stream channel had a full bank width of feet with a full bank depth of feet and an M of feet. At the time of investigation, no water was observed within the referenced stream channel. Nevertheless, based on the stream features and a discernible M, it would appear that S meets the criteria necessary for jurisdictional classification by the SACE.

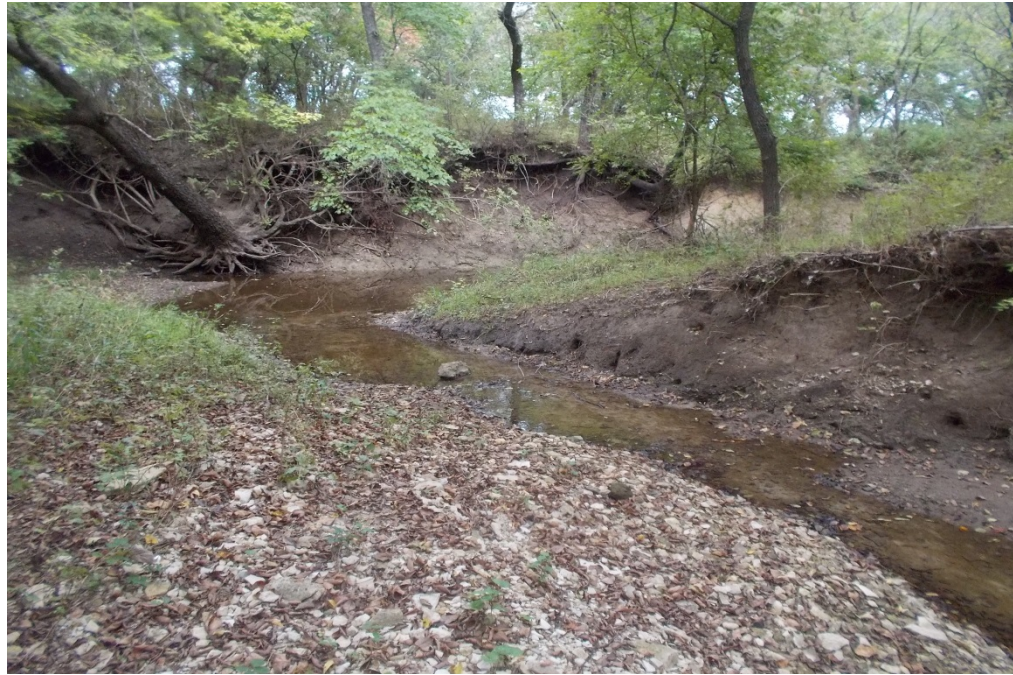
Description:  
FS-9

**FS-9** is identified as an intermittent stream waterway located outside of the construction right-of-way (ROW). It originates outside of the project area on the west and travels northeast within the project area as an unnamed tributary to Chilocco Cree. The stream channel had a full channel width of 10 feet with a full channel depth of 2 feet and an average M of 10 feet. At the time of investigation, no water was observed within the referenced stream channel. Nevertheless, based on the stream features and a discernible 100 M, it would appear that SAA meets the criteria necessary for jurisdictional classification by the SACE.

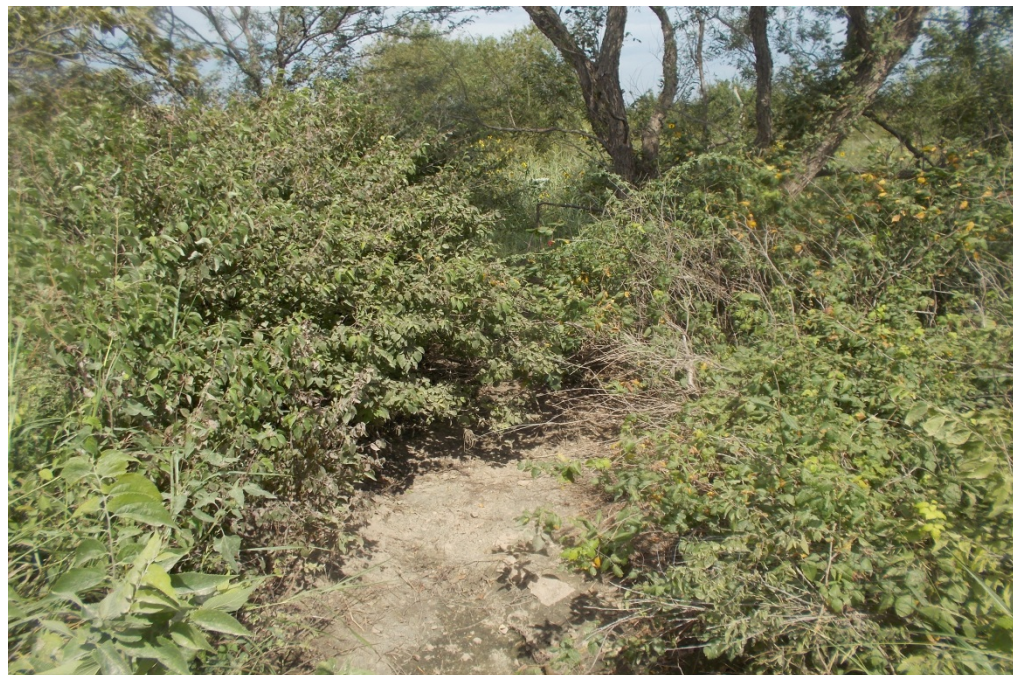
Description:  
FS-10

**FS-10** is identified as an ephemeral stream waterway originating outside of the project area on the south and traveling north through the project area as an unnamed tributary to Chilocco Creek. The stream channel had a full bank width of 10 feet with a full bank depth of 10 feet and an 800 M of 10 feet. At the time of investigation, no water was observed within the referenced stream channel. Nevertheless, based on the stream features and a discernible 800 M, it would appear that S1000 meets the criteria necessary for jurisdictional classification by the SACE. Utility line construction activities cross S1000 and will have an area of disturbance of 0.0000 acres. Therefore, S1000 can be disturbed utilizing conventional trenching methods operating under BMPs set forth under 22 P 00 provisions.
